MORDIALLOC FREEWAY PROJECT

Independent Reviewer and Environmental Auditor

Quarterly Construction Audit

Report 2, June 2020

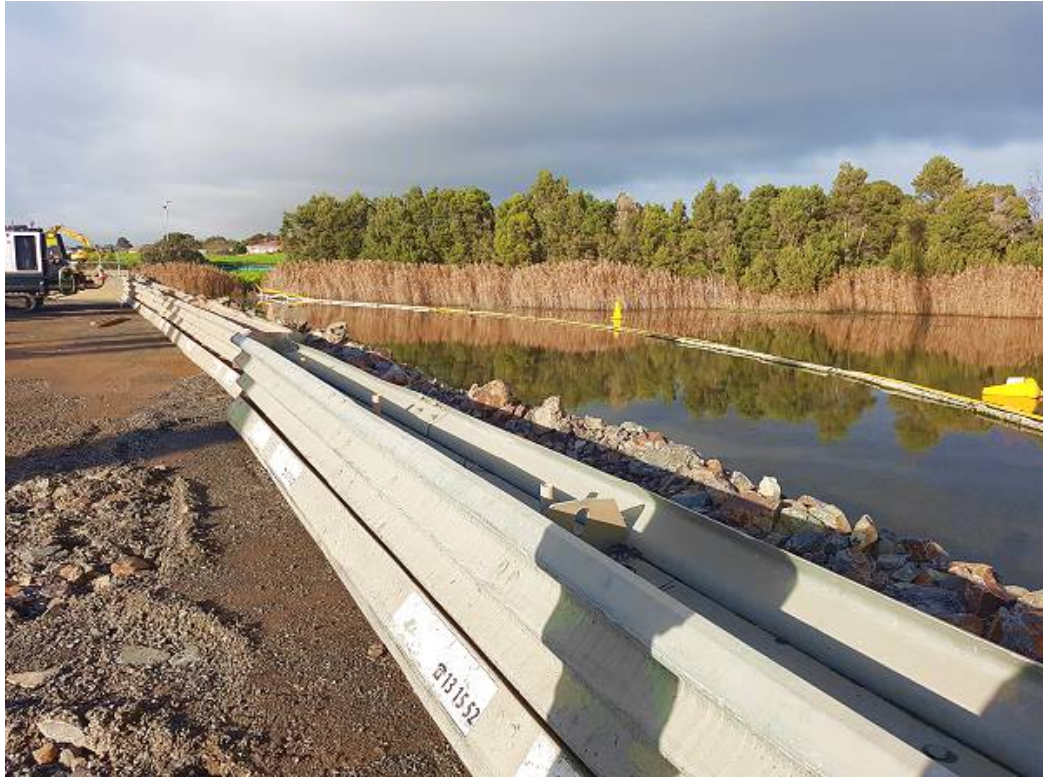
Above: Silt curtains around the Waterways piling platform appeared effective in containing sediment.

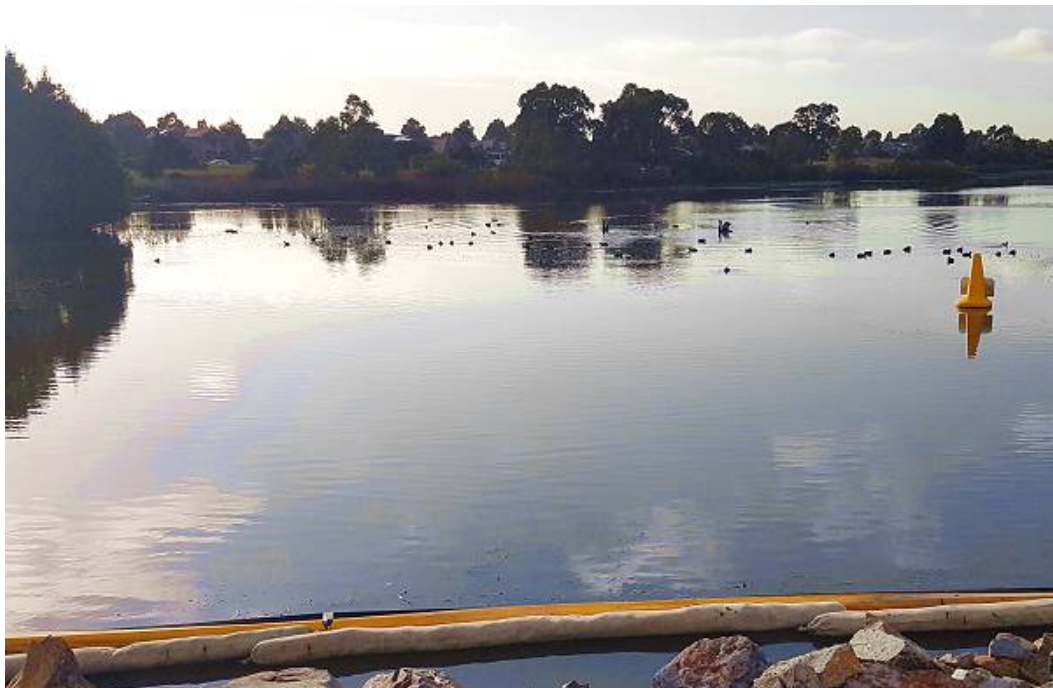
Above: Waterbirds and swans were prolific in the Waterways. A number were seen perching on the silt curtains and on small islands immediately next to the work zone and appeared unconcerned with the construction activities occurring at the time.

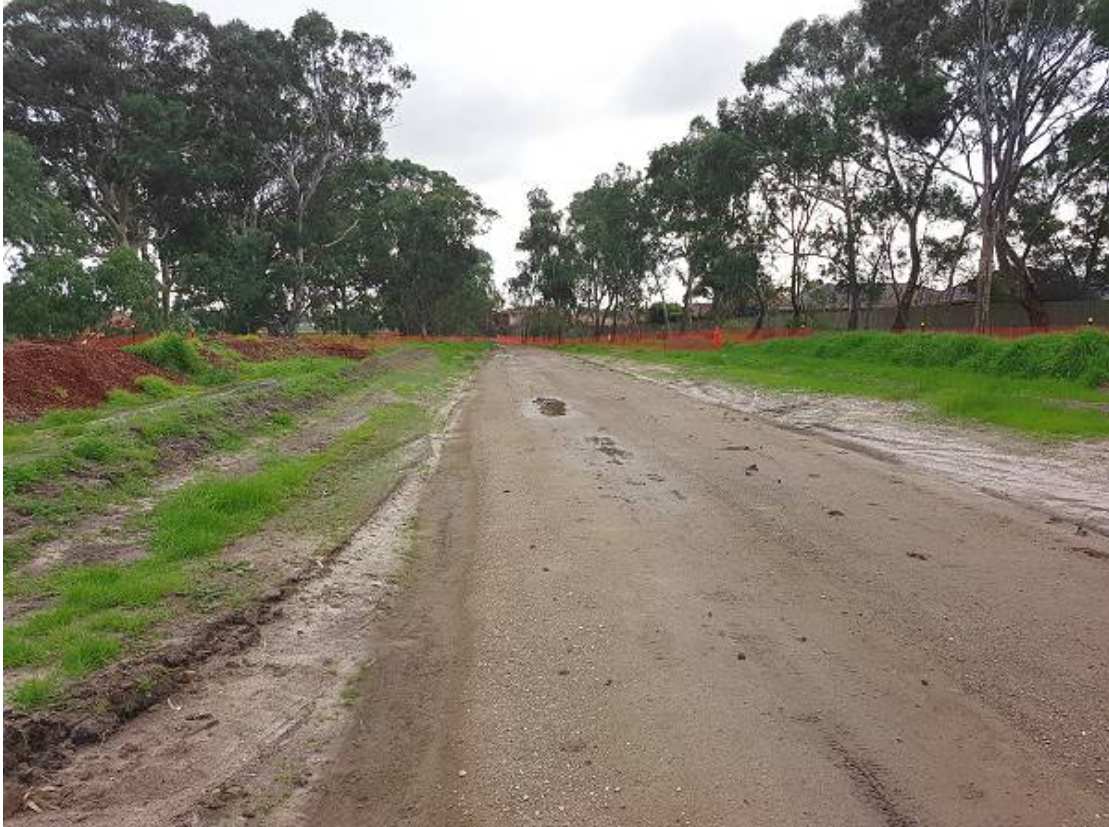
Above: The fauna plans required a small number of significant trees to be retained on either side of the access road south of Centre Dandenong Road. However, the project has made efforts to retain all vegetation that was outside of the immediate works areas.

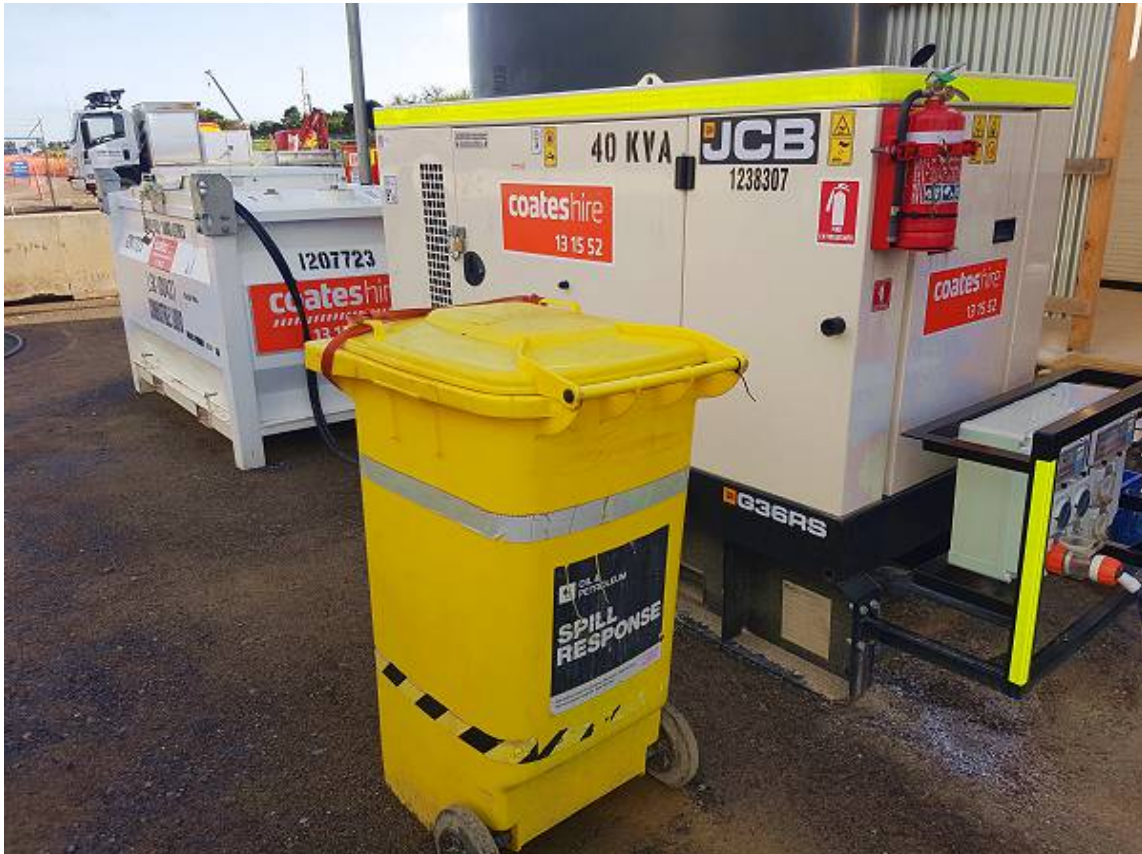
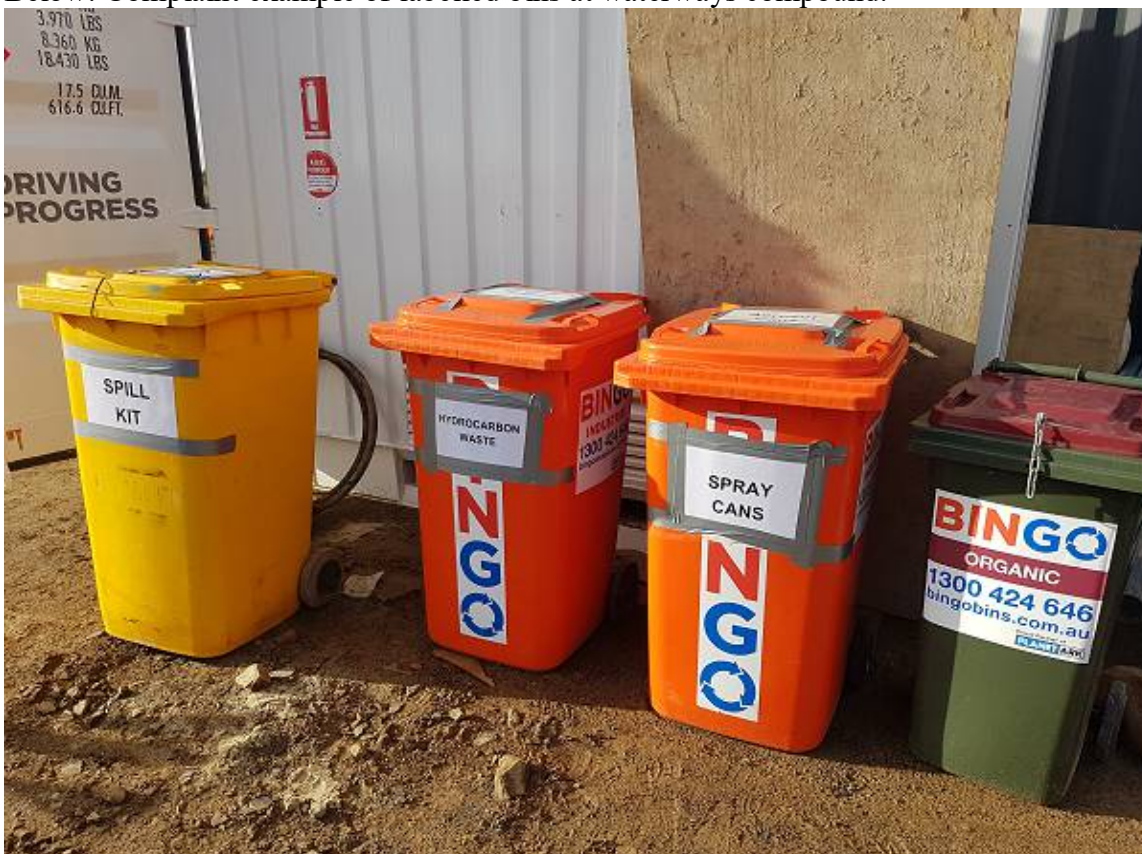
Above: Compliant example of spill kits located next to generator at waterways compound
 Below: Complaint example of labelled bins at waterways compound.

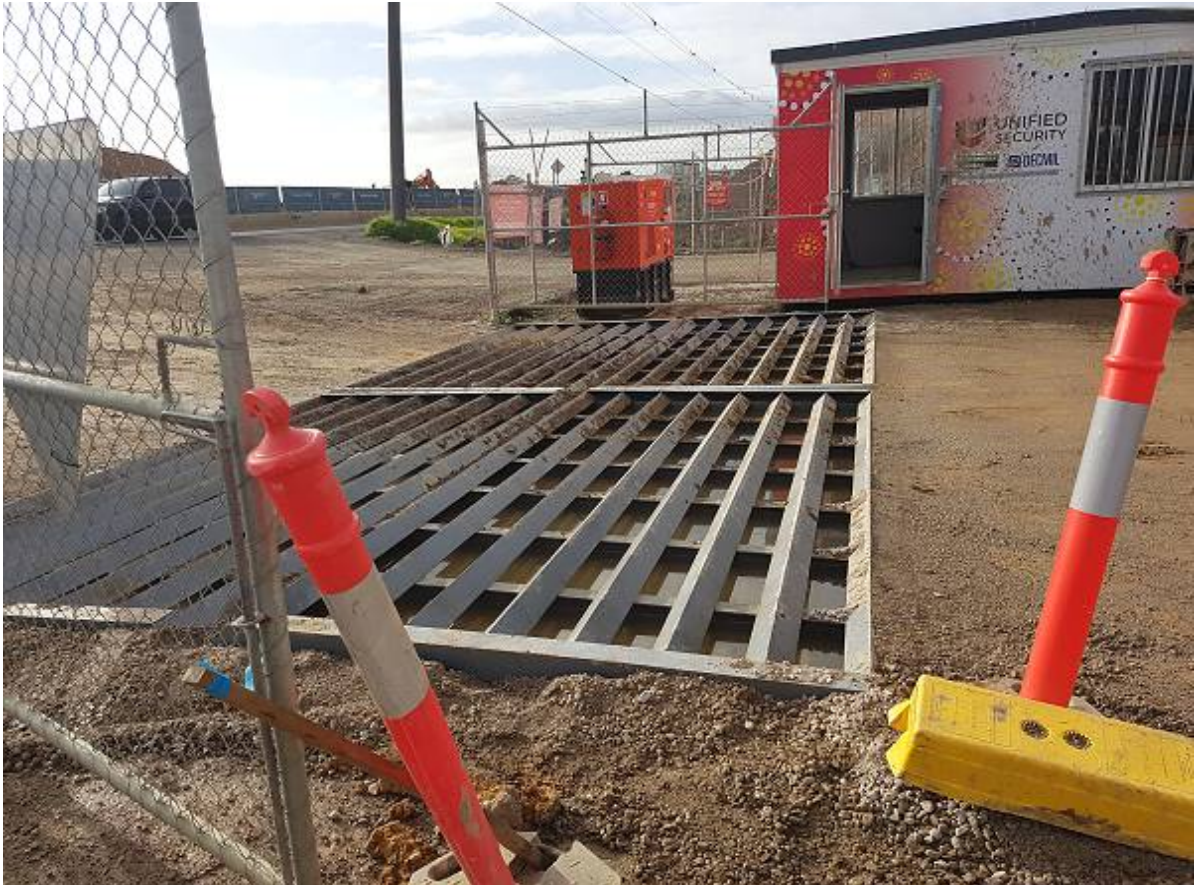
Above: Additional rumble grids installed at exit of Governor Rd compound to more effectively clean trucks exiting site.

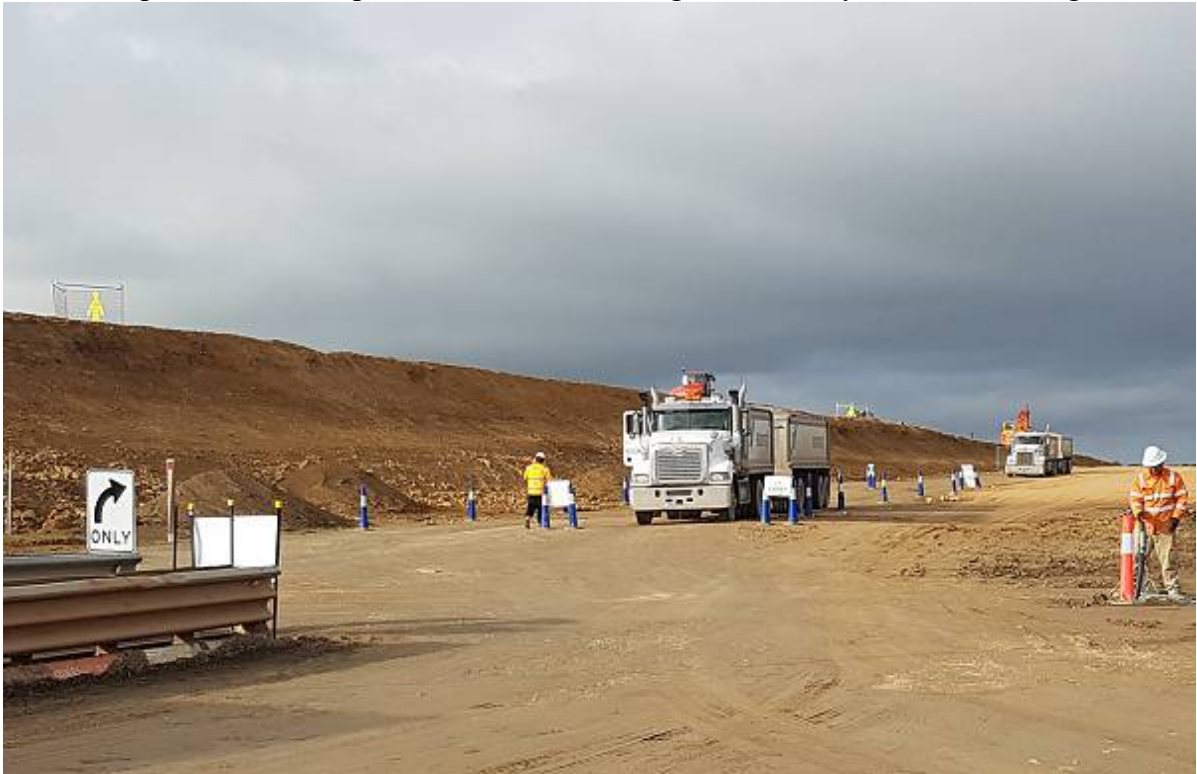
Below: Truck inspection checkpoint at Governor Rd is now staffed and sign posted. Trucks need to stop and drivers inspect trucks for rocks caught between tyres before exiting the site.

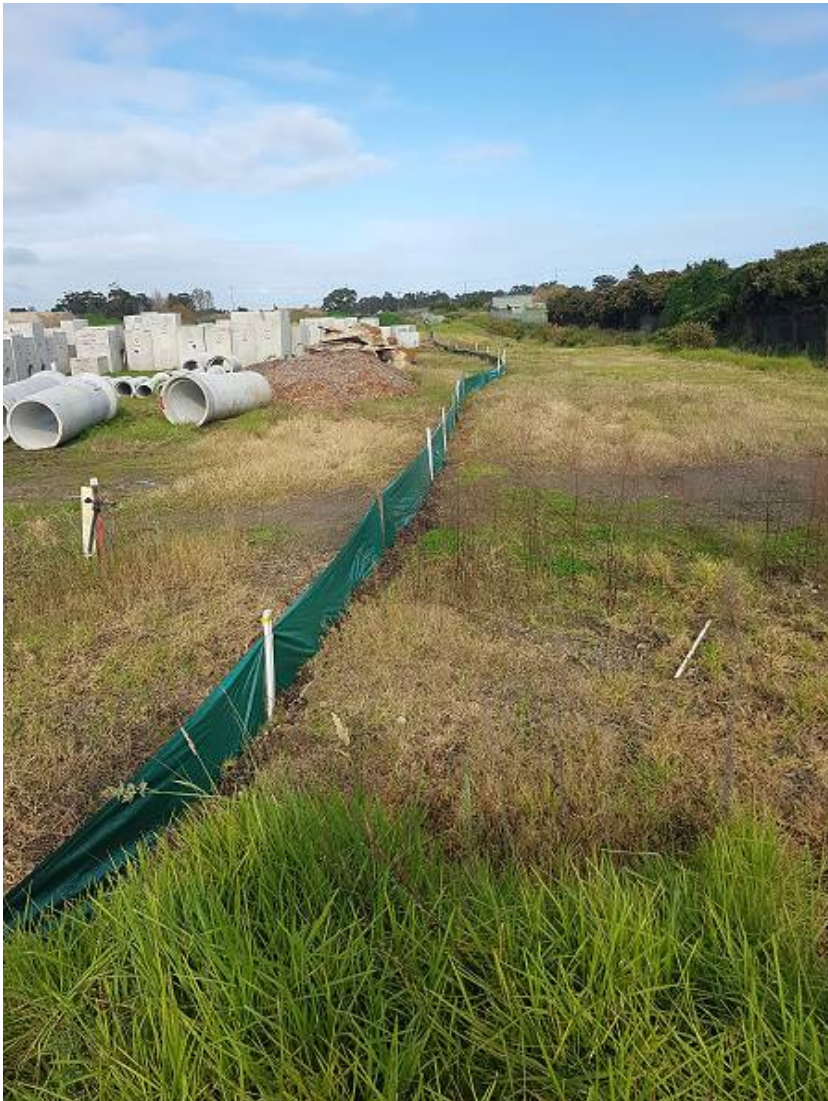
Left: The sediment fence south of Zone 1, Gate 4 was extended, as required by the previous audit recommendation.

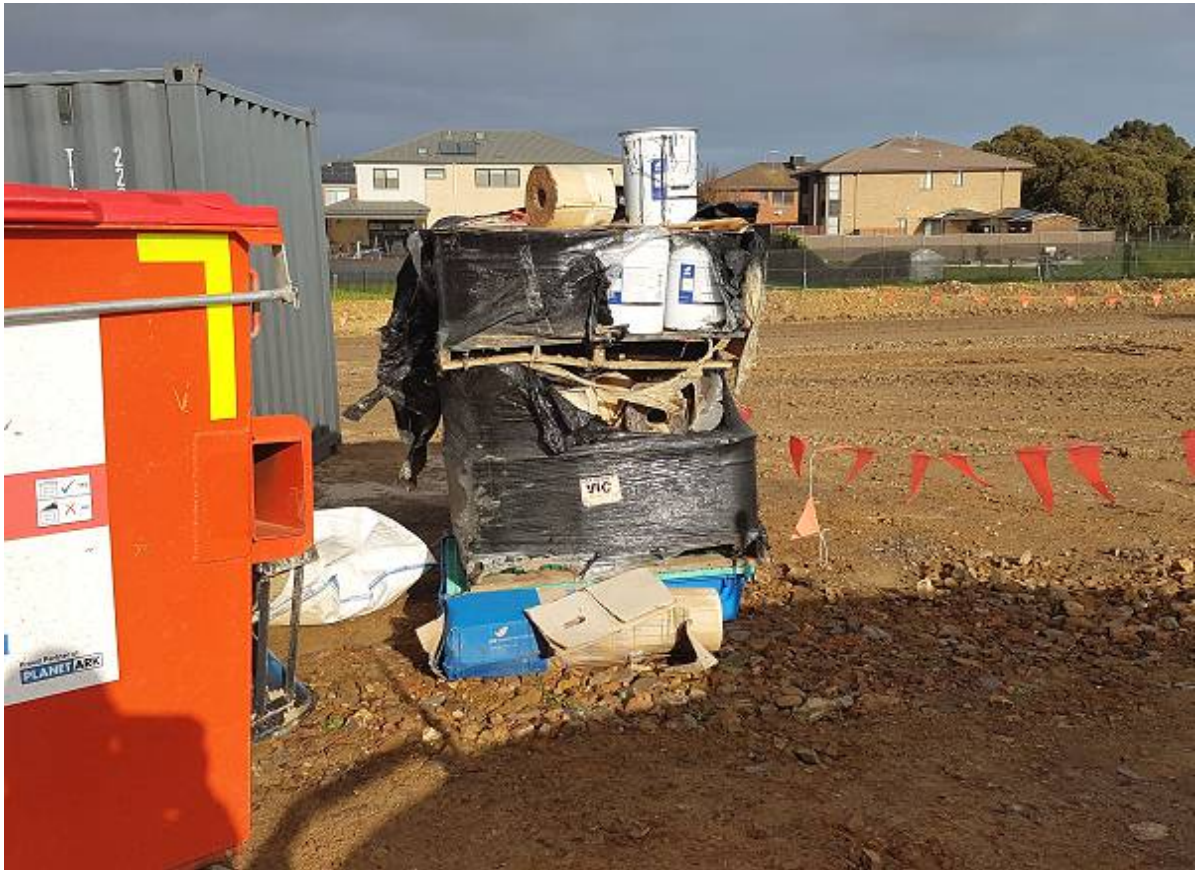
Above: Contractor's storage area - Drums of a sealing compound stored on a bunded pallet south of the Waterways piling area. One side of the drums was over the edge of the spill tray, therefore leaks may not be captured. Also, the material was a flammable good and should be stored in a flammable cabinet.

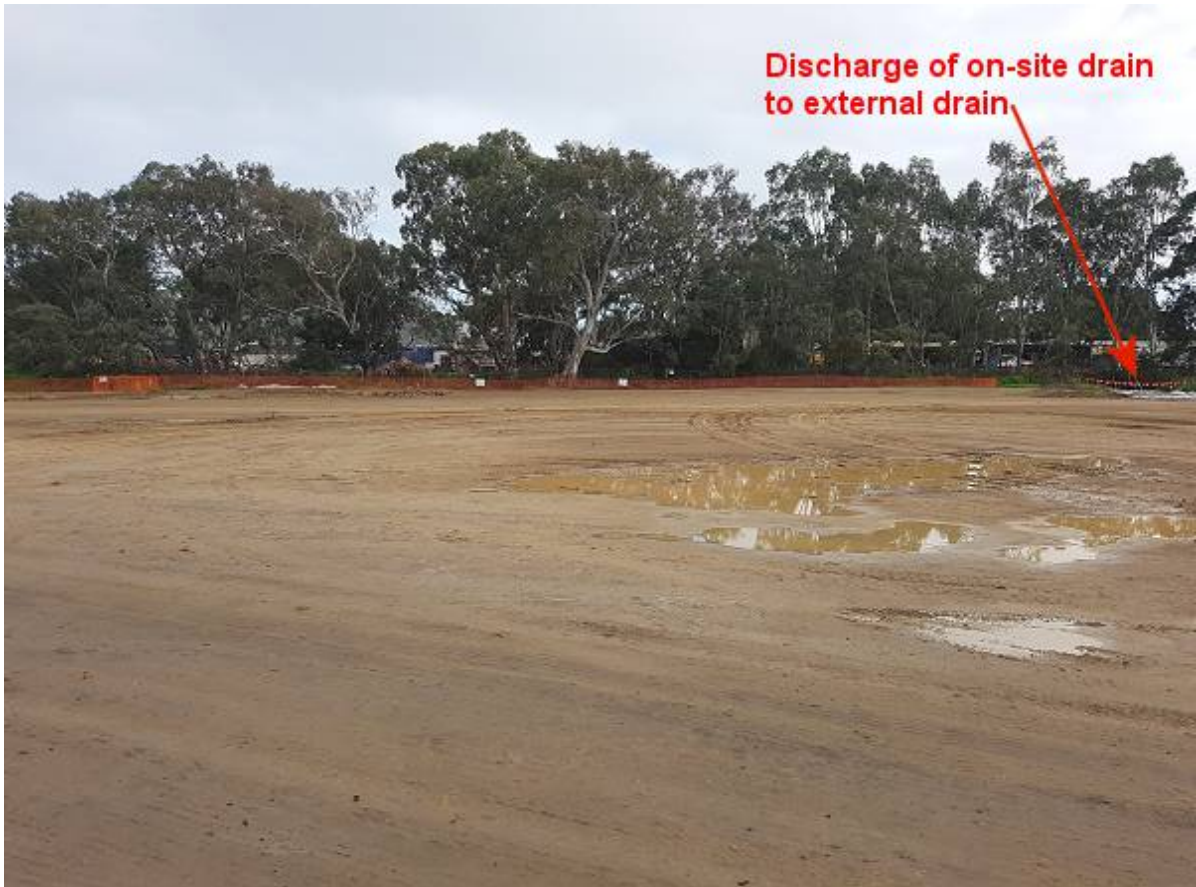
Above: The western boundary of the construction zone south of Centre Dandenong Road does not have a silt fence. However, there is significant vegetation which has been retained along the boundary and in Old Dandenong drain itself. Stormwater monitoring data collected before and after this area, following heavy rain events, should be reviewed to determine if there is a need for sediment fencing. A small, shallow on-site drain also leads down to the Old Dandenong drain. The on-site drain has been blocked, however, it is unclear if the internal drain has sufficient capacity to contain run-off from the site during a severe storm event.
