Yan Yean Road Upgrade – Stage 2:
Kurrak Road to Bridge Inn Road

Technical Report C

Arboriculture Assessment

17 July 2020

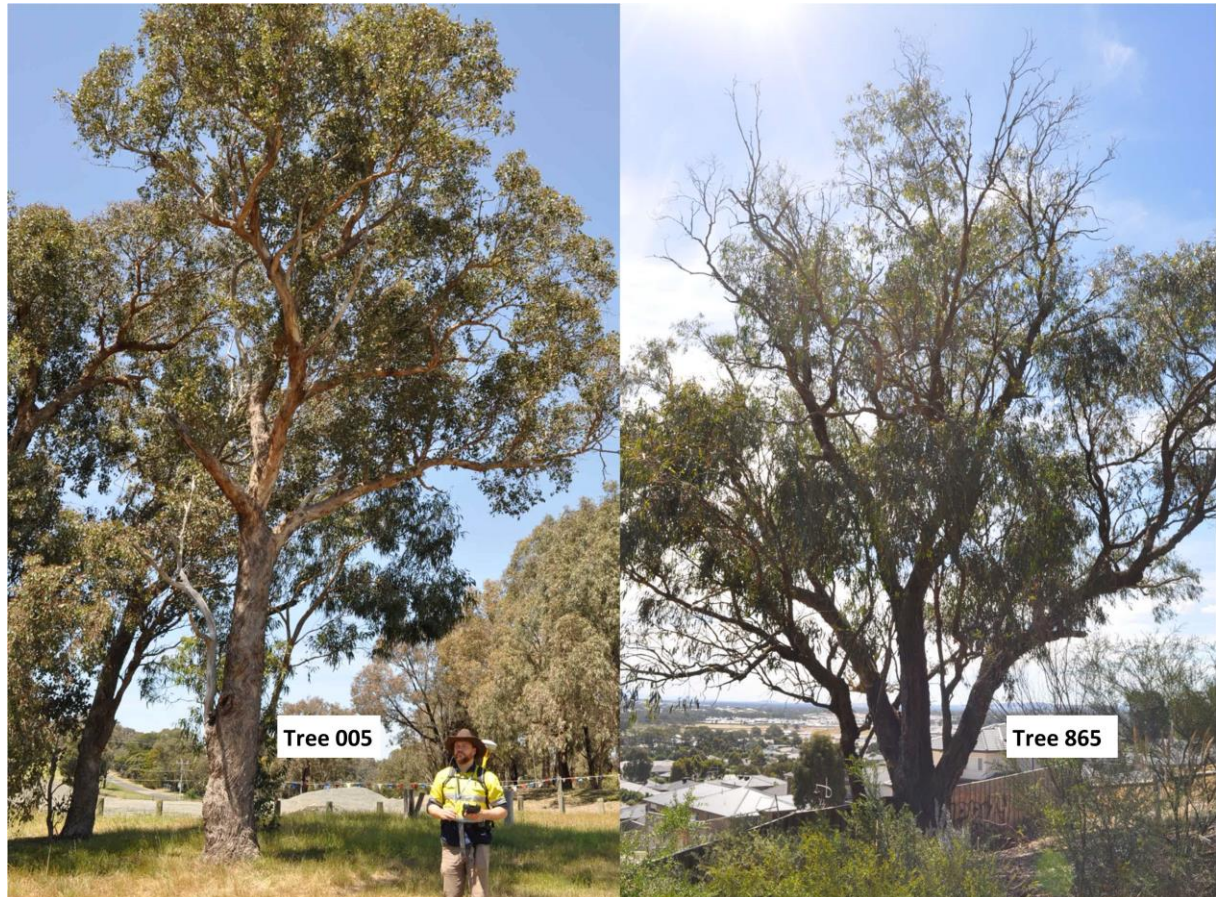
Figure 4: Predominant indigenous eucalypts Red Box (Tree 005) and Long-leaved Box (Tree 865) at the site

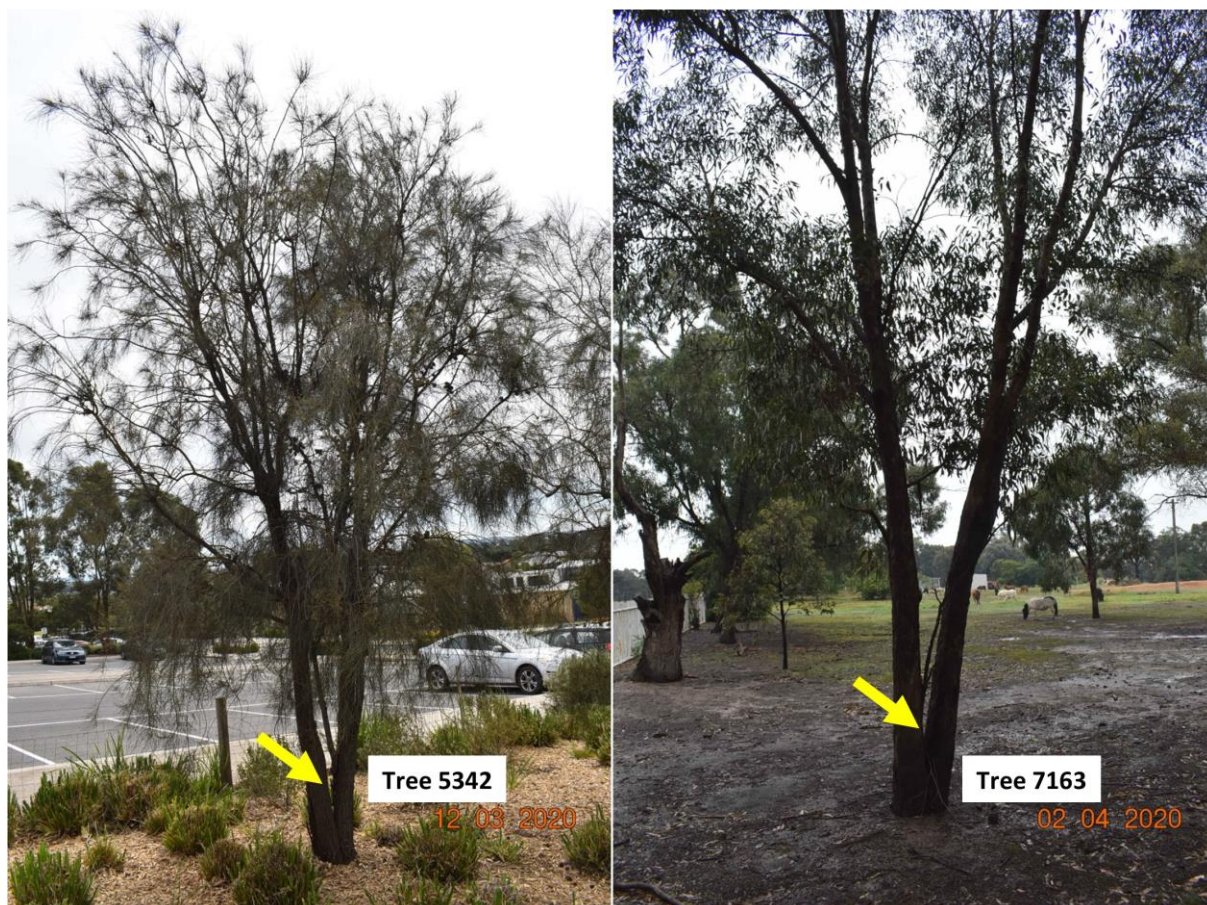
Codominant stems containing included bark is a major defect noticed within assessed trees (Figure 5). With traditional branch attachment, the branch and trunk fibres overlap each other as they grow forming a strong, embedded attachment. With codominant stems, this is not the case as the fibres run roughly parallel and don't knit together. This form of attachment is regarded as weaker and more prone to failure (Kane, Farrell, Zedaker, Loferski & Smith 2008; Harris, Clark & Matheny 1999; Shigo 1991). When combined with included bark, it is often only a matter of time until the stems fail.

Figure 5: Trees 5342 and 7163 showing the presence of codominant stems

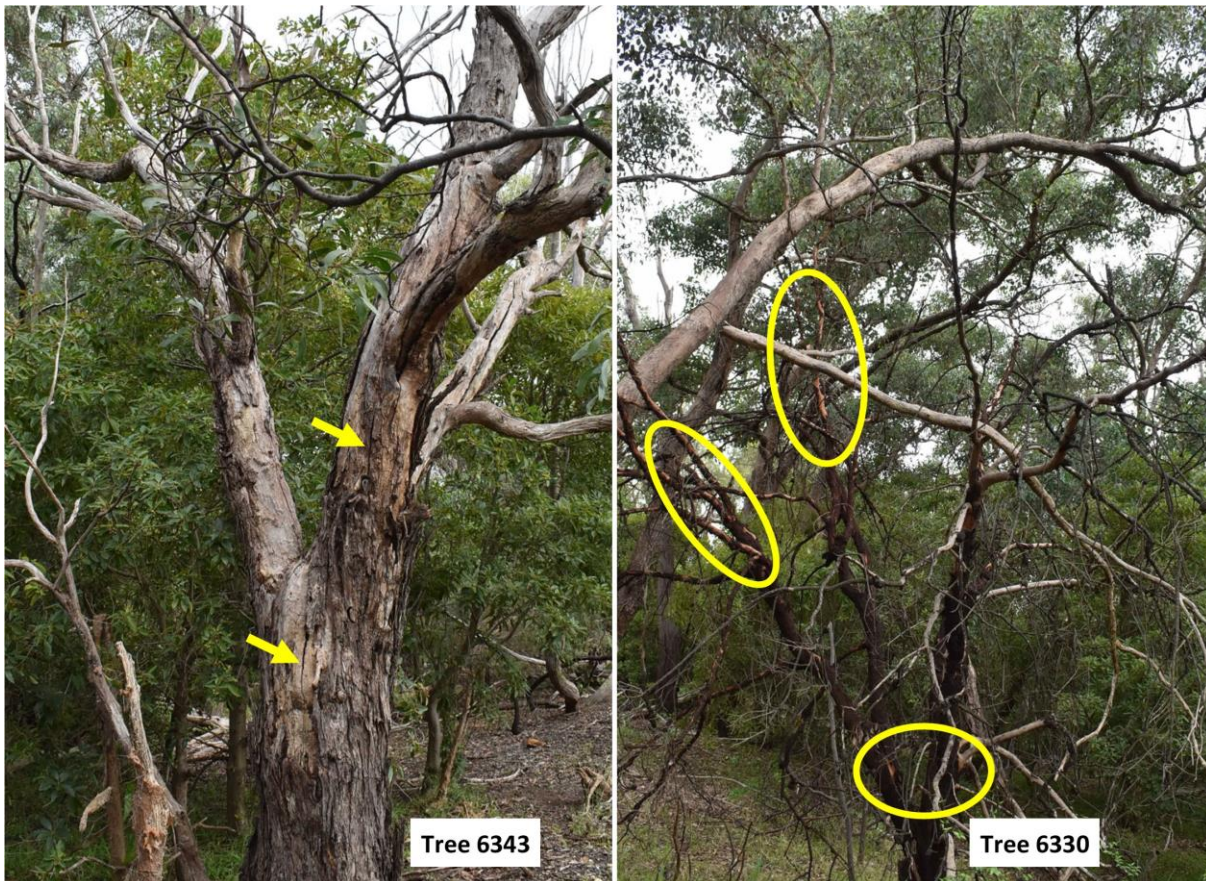
The presence of borers has resulted in many trees having low to no retention value. Borer attack can be severe on stressed trees whereas healthy trees have normally been able to tolerate the infestation. Red Stringybark, Long-leaved Box, Cherry Ballart and Golden wattle are the tree species mostly affected by borers. Jewel Beetle and Longicorn Beetle are key members of wood borers which attack trunks and roots of a wide variety of trees including eucalypts and wattles (Jones *et al.*, 2015). Splits or cracks in the trunk is another defect to reduce the value of the tree that has been occasionally observed (Figure 6). Three dead trees (Tree 665, 813 and 836) were classified as hazardous. They are recommended for removal as soon as possible.

Figure 6: Presence of splits (in Tree 6343) and borers (in Tree 6330) in assessed trees

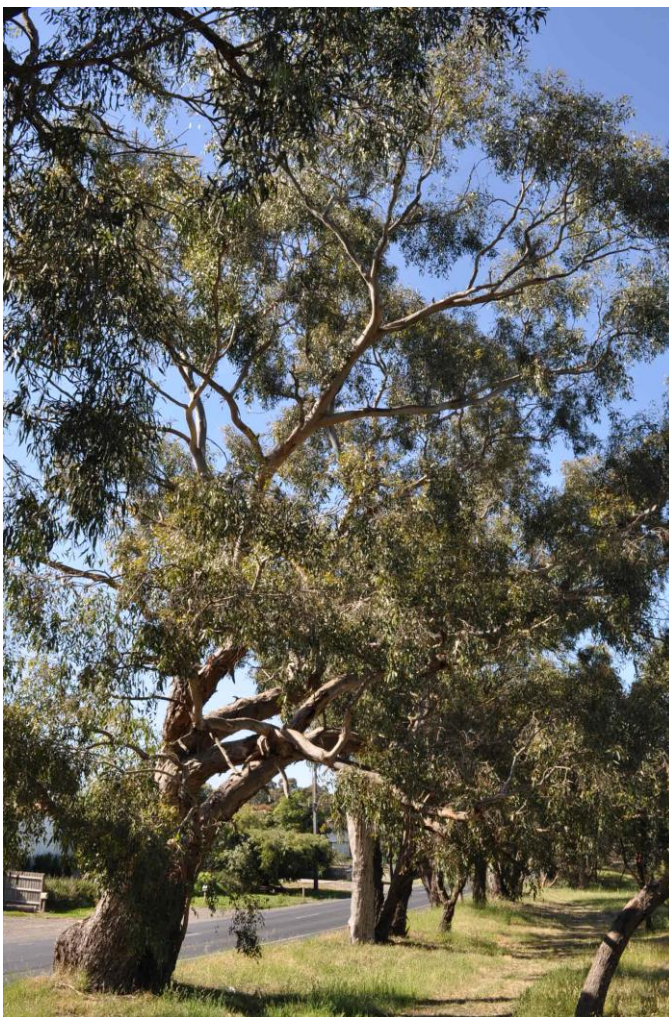
Tree 230, the Studley Park Gum *Eucalyptus studleyensis*, is an uncommon hybrid between Swamp Gum *Eucalyptus ovata* and River Red Gum *Eucalyptus camaldulensis* and assessed with good health and good structure (Figure 7).

Figure 7: Tree 230, Studley Park Gum *Eucalyptus studleyensis* assessed as very high retention value

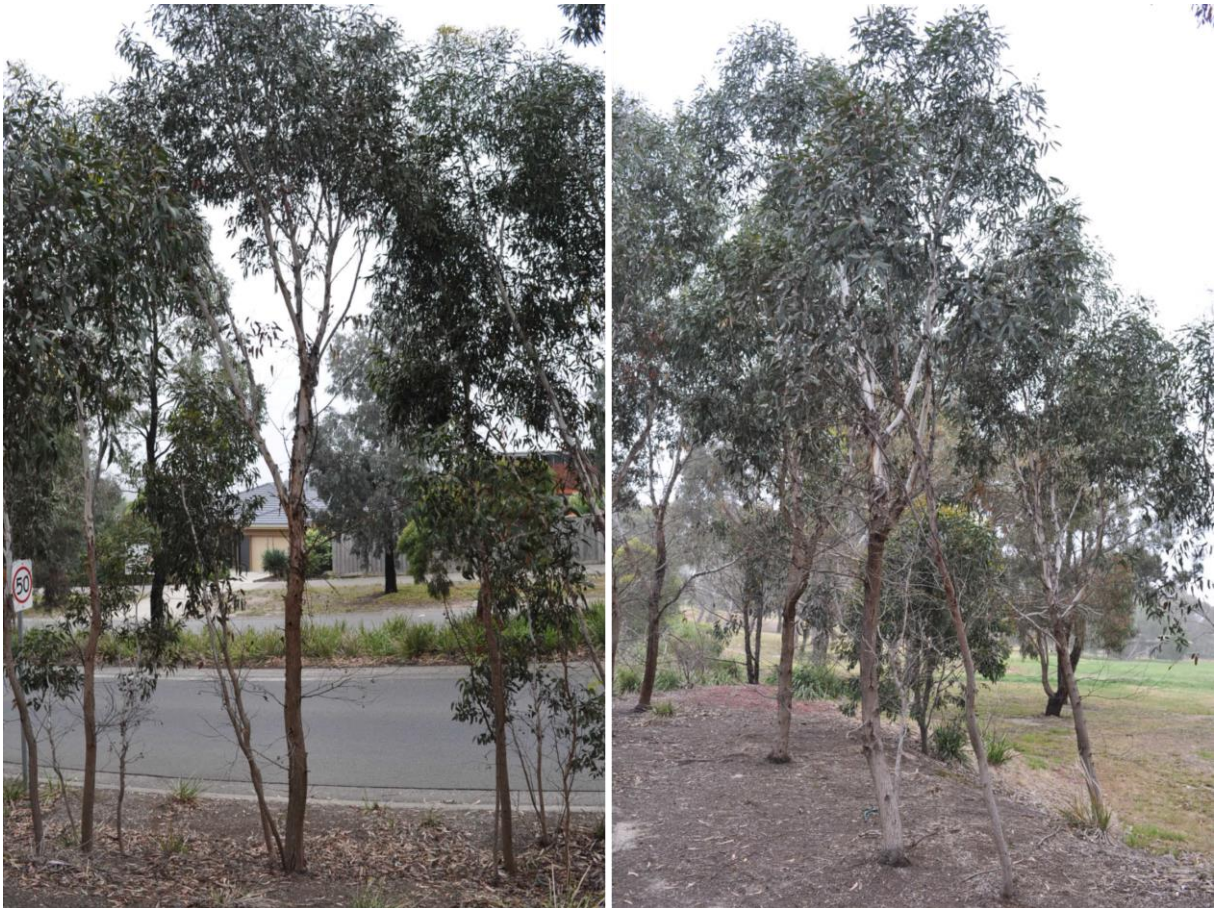
A total of 1,532 trees assessed in this category are eucalypt tree species (Figure 9). Though grouped as low retention value, it is recommended to accommodate the retention of young eucalypts with good health and structure wherever possible.

Figure 9: Juvenile eucalypt trees assessed as low retention value

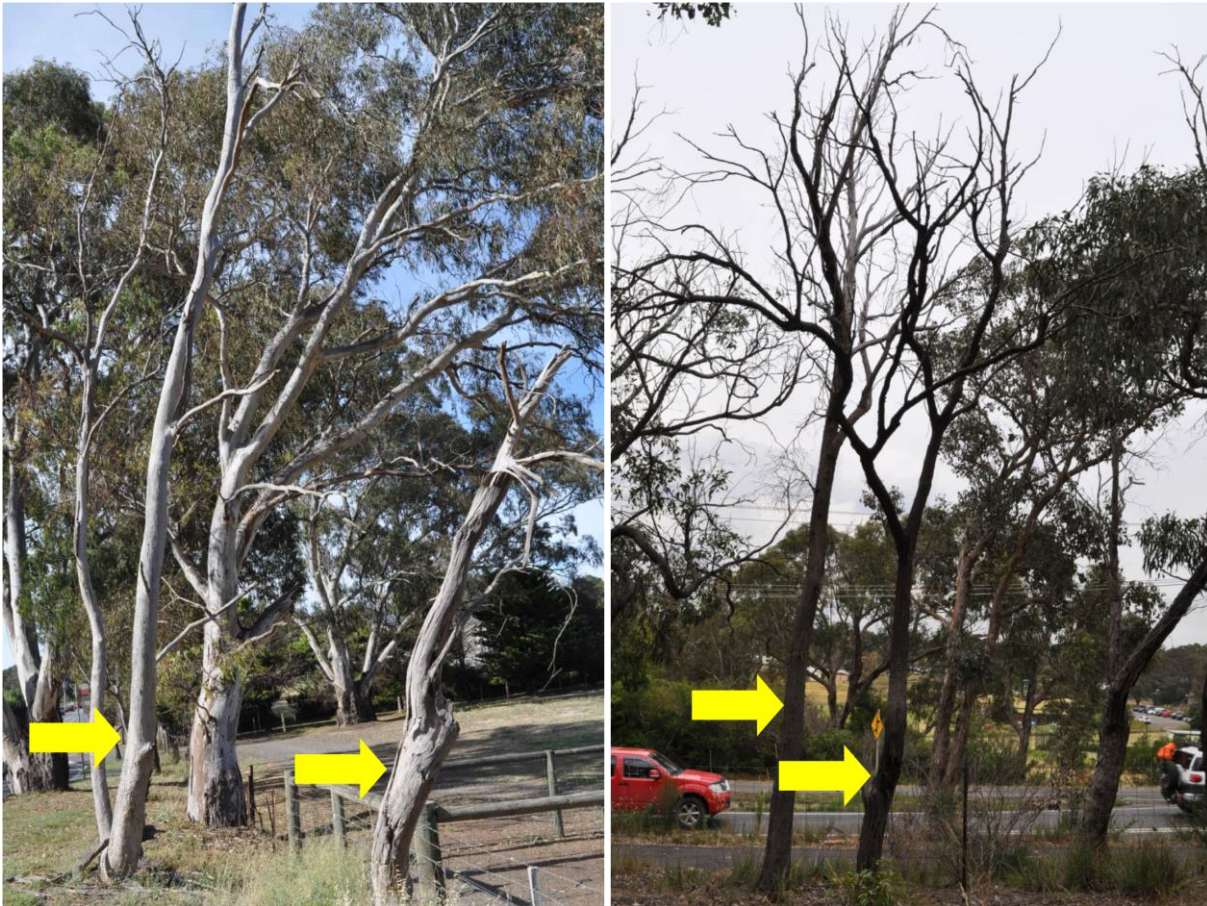
A total of 189 trees were assessed with no retention value. They should be removed irrespective of the design as they are hazardous. 183 trees with no retention value are eucalypt species (Figure 10).

Figure 10: Dead eucalypt trees assessed with no retention value
