Assessment of proposed road design at  
the intersection of Yan Yean Road and  
Bridge Inn Road, Doreen

## **Root Investigation Report**

**Prepared For:** WSP

**28 May 2019**

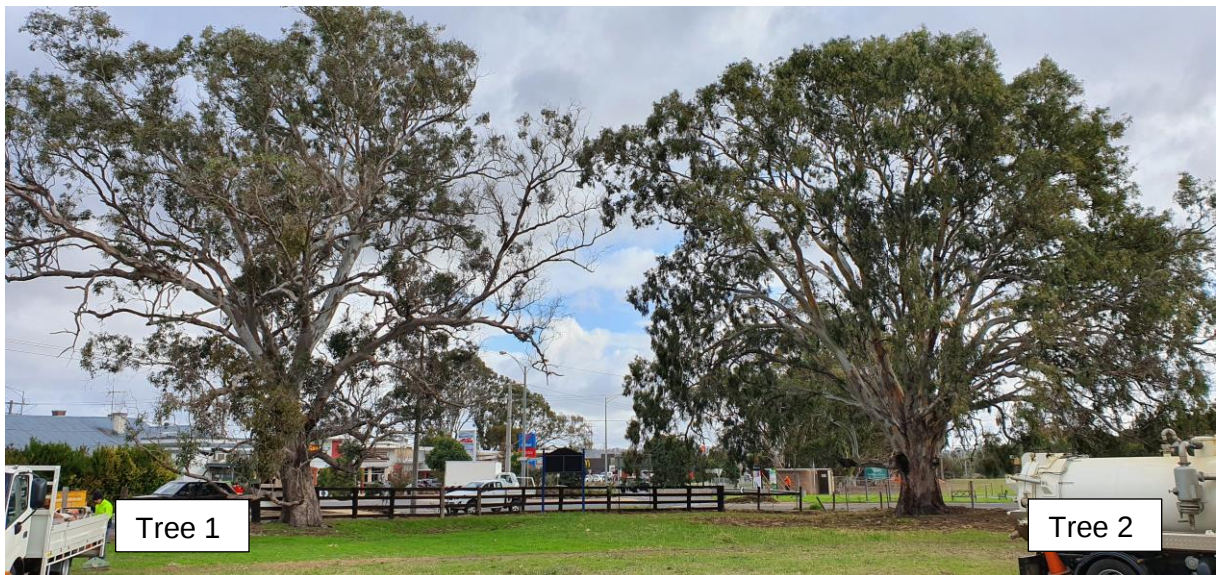
Tree 1 is generally in a state of decline. As described by Krishnaraj (2018), 'it is evident that the tree is declining but over a long term (Figure 5). The tree has an asymmetric canopy with an irregular branching pattern. The canopy is sparse with horizontally extending branches within the paddock and it has a lean in general towards the road'. There is also significant psyllid damage throughout the canopy.

Tree 2 is generally in good condition for its size and age. There is a good canopy of foliage, minimal deadwood and no signs of pest or disease likely to be causing decline.

Figure 5: Trees 1 and 2

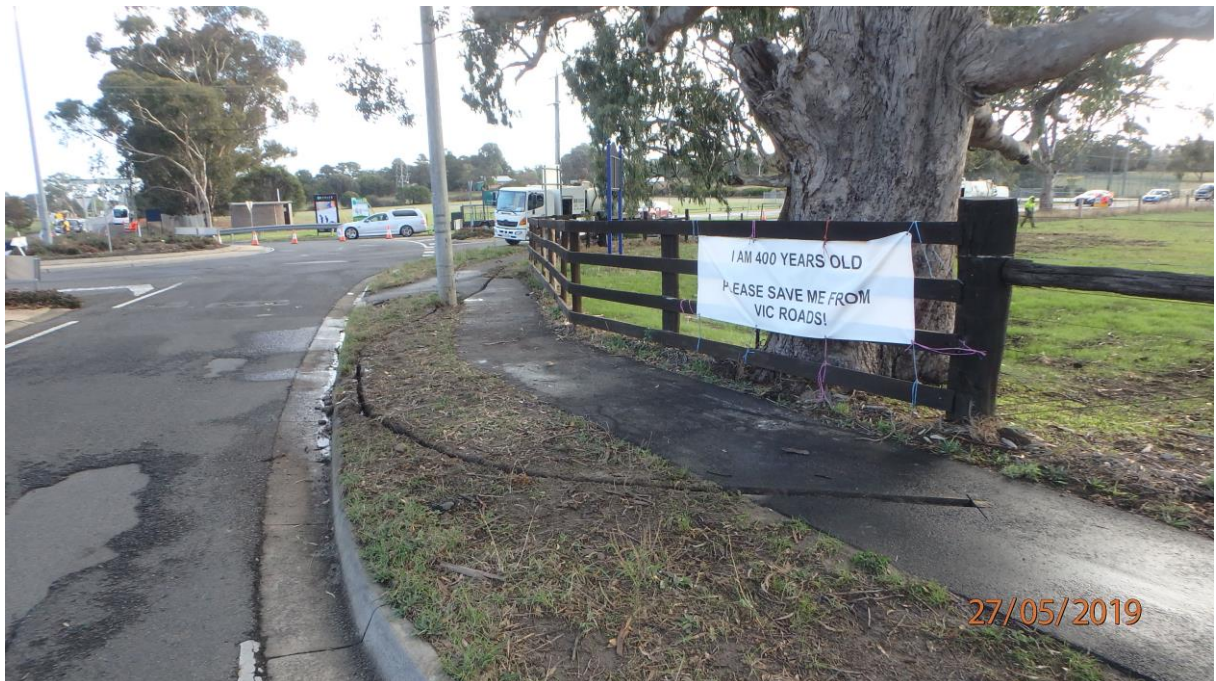
Trench 1 comprised a line from Tree 1 (Figure 6), along the back of existing kerb (where the proposed alignment proceeds into the running lane), through private property (Figure 7) and past Tree 2, heading north (Figure 8).

No roots were identified in Trench 1 along its length. Some of the factors that have lead to this include:

Figure 6: Trench 1 near Tree 1.

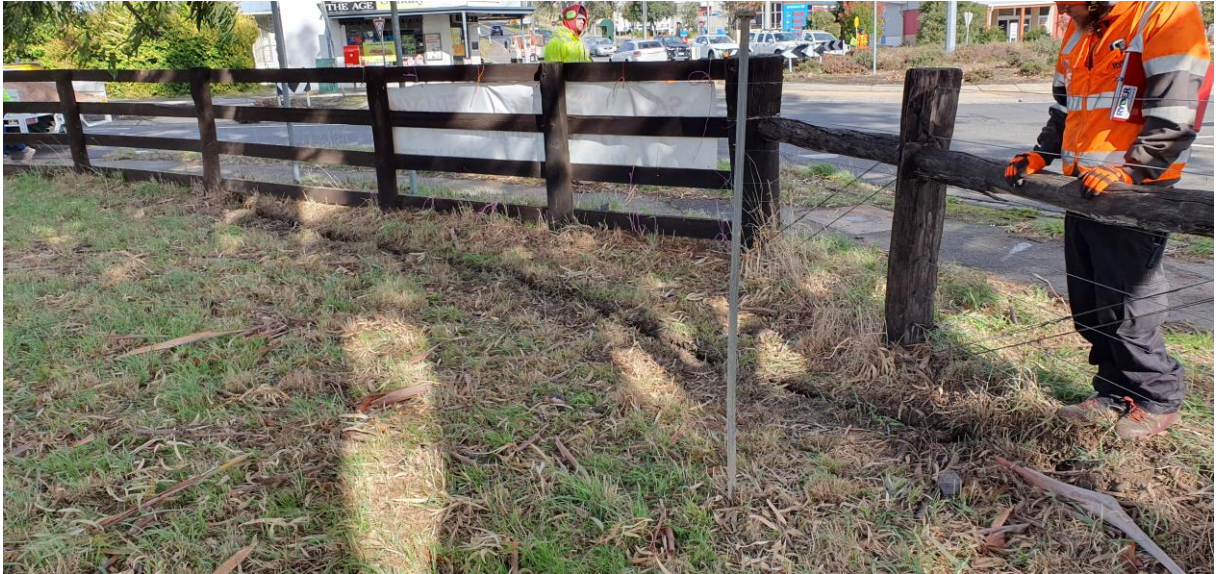
Figure 7: Trench 1 where it crosses into private property

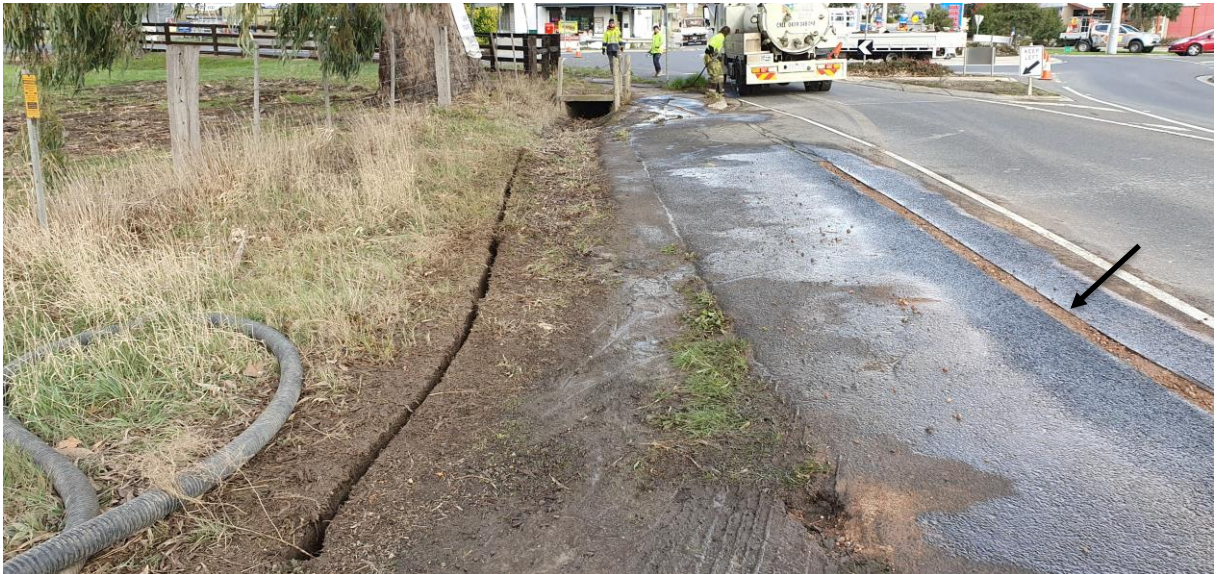
Whilst the initial alignment was proposed just off the running lane, attempts to get through the asphalt were unsuccessful due to a depth in excess of 250-300mm. Instead, the trench was excavated on the eastern side of the asphalt spoon drain. Beyond a depth of approximately 400mm, the ground was a heavy clay and very hard to excavate. This has implications when limiting tree root growth.

Figure 8: Trench 1 on the western side of the asphalt drain. Failed asphalt cut to the right.

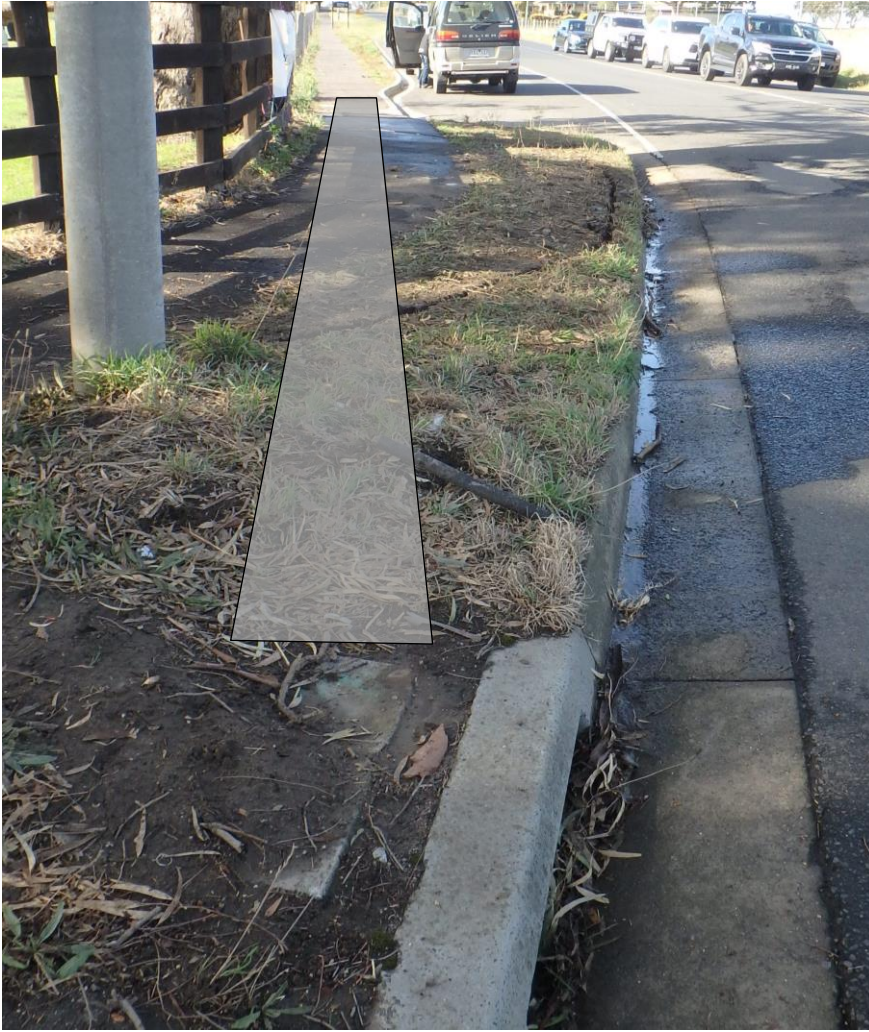
1. A large stormwater installed along the southern section near Tree 1 has cut all roots. It was approximately 400-500mm diameter and buried approximately 700mm deep (Figure 9).
2. Telstra and NBN, both installed near the tree are likely to have damaged roots over the years near both trees.
3. The deep culvert and box drain have acted as a substantial barrier to tree roots.
4. The depth of the road layer is substantial. Hydro excavation of the road edge suggested an impermeable layer of 300-400mm. When combined with a compacted sub-base of another ~300mm, it is likely to have prevented root growth.

Figure 9: Approximate alignment of drainage pipe has cut all roots.

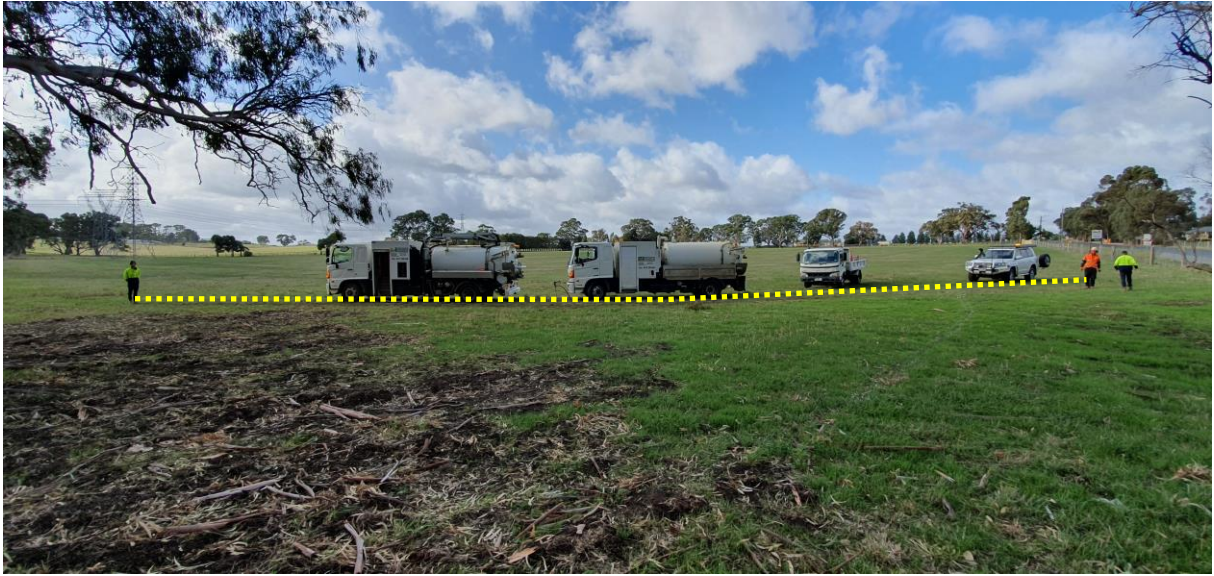
Trench 2 was a 40m section at a 15m offset to both trees in the paddock on the north-east side (Figure 4 and Figure 10). This location was chosen following discussion with Will Parker as the initial drawing supplied was found to be not to scale.

Along the 40m length of the trench, no roots greater than ~5mm diameter were identified. Within this size category, several were found; however, they may have been attached to the many, small saplings growing in the area. These had been grazed or slashed many times resulting in very little above ground biomass; however, relatively large root systems.

Figure 10: Trench 2.

2. If the design is shifted to the north-east, consideration is given to how the hydrology can be maintained within the small catchment to ensure the trees continue to receive water long-term.
