# **MORDIALLOC FREEWAY PROJECT**

Independent Reviewer and Environmental Auditor

Quarterly Construction Audit

Report 3, September 2020

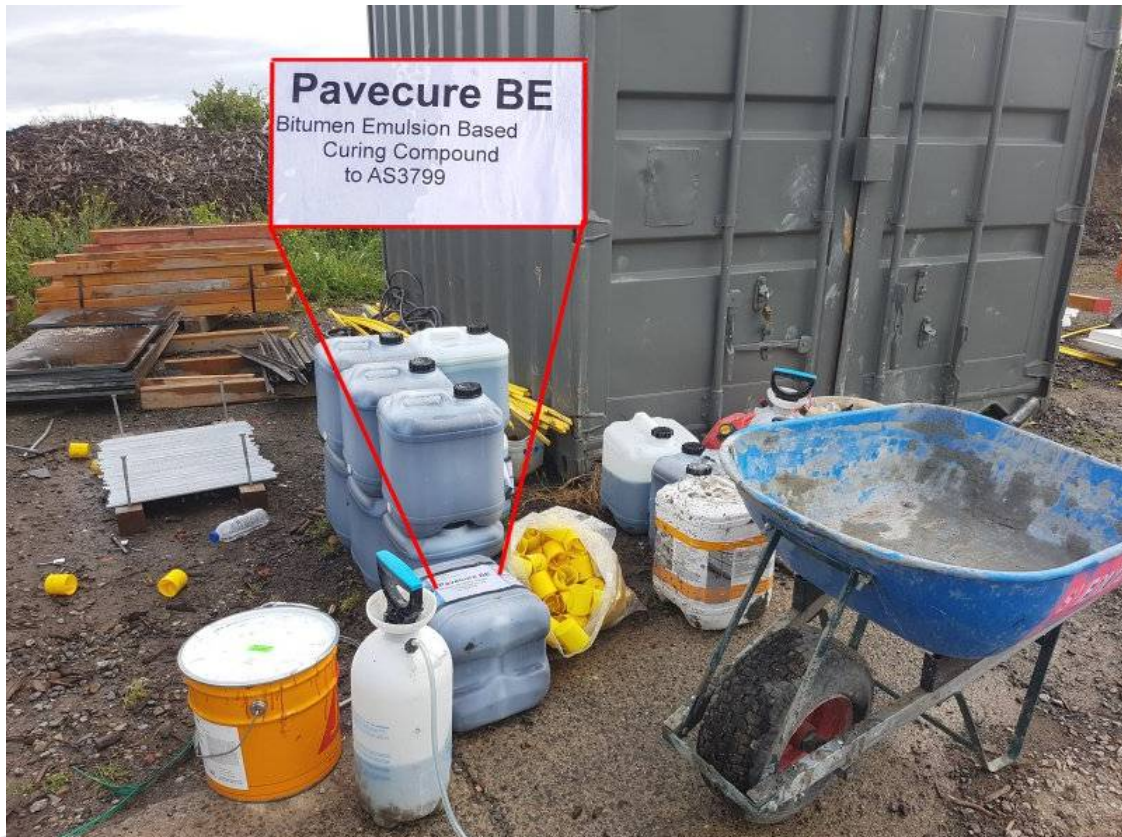
Above: 20L containers of fluids stored on bare soil at the landfill bridging structure works area. A contractor was asked to place these materials in the storage container. This occurred before the inspection of the area was completed.

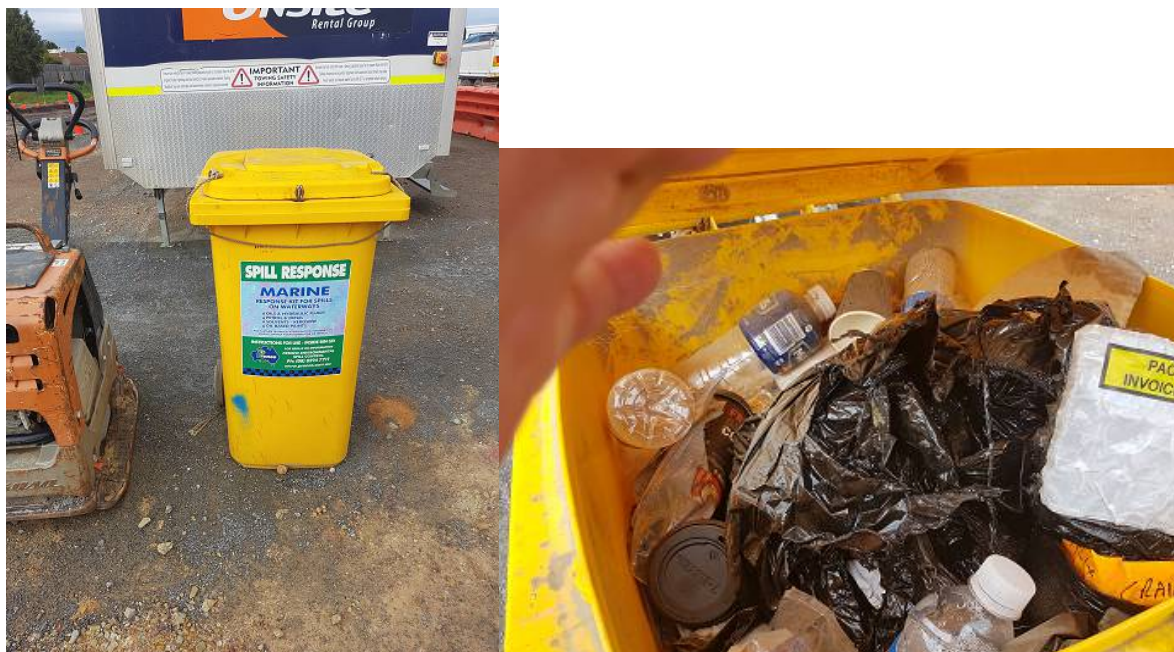
Above: The spill kit located at the Centre Dandenong Road compound was being used as a rubbish bin.

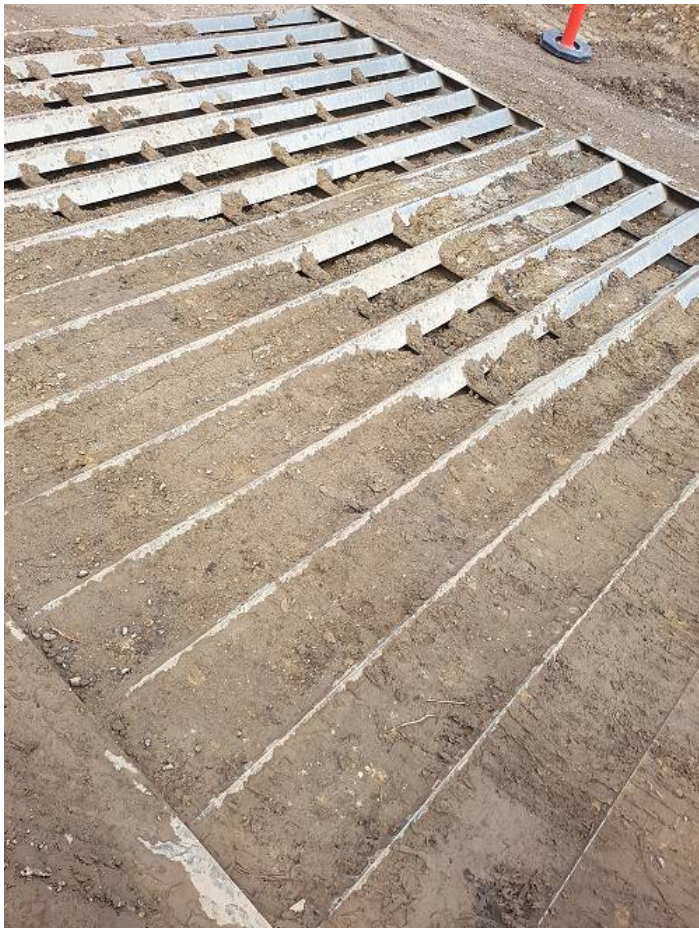
Left: The rumble grid located at the Centre Dandenong Road works exit required cleaning.

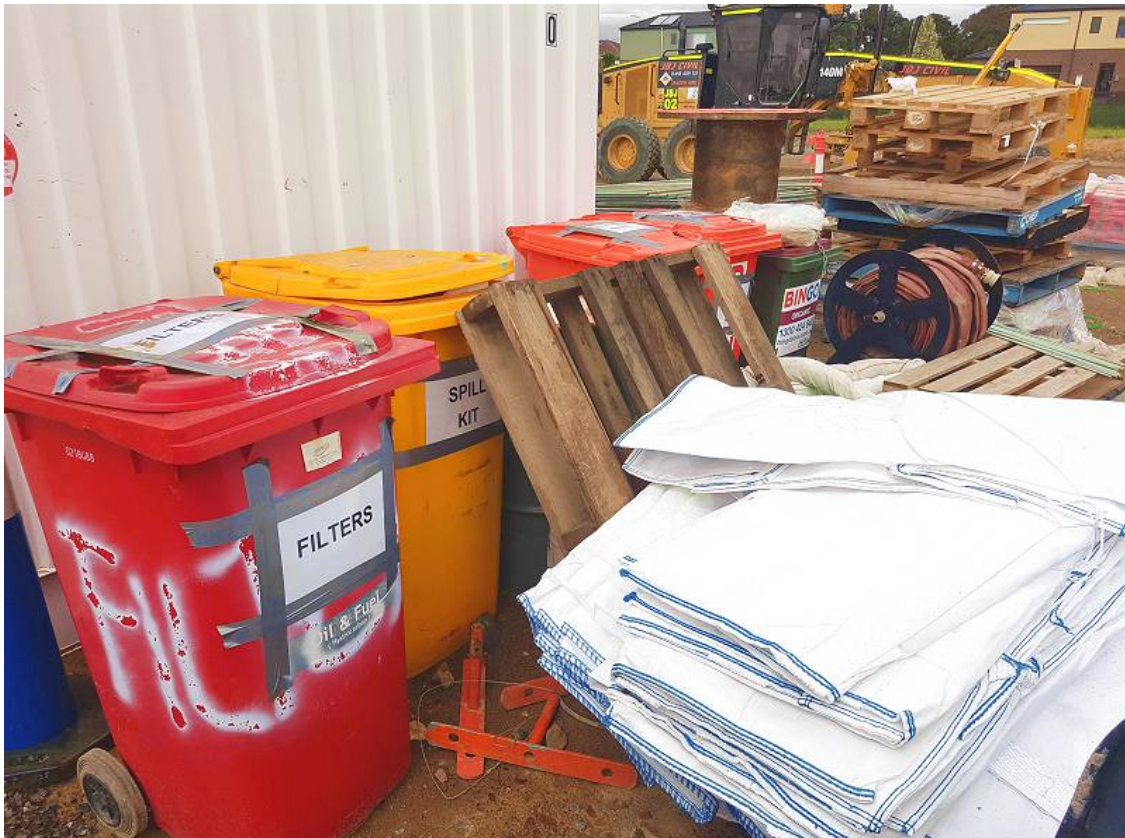
Above: The spill kit and waste bins at the contractor's storage area south of the Waterways piling area were inaccessible due to storage of material against the bins.

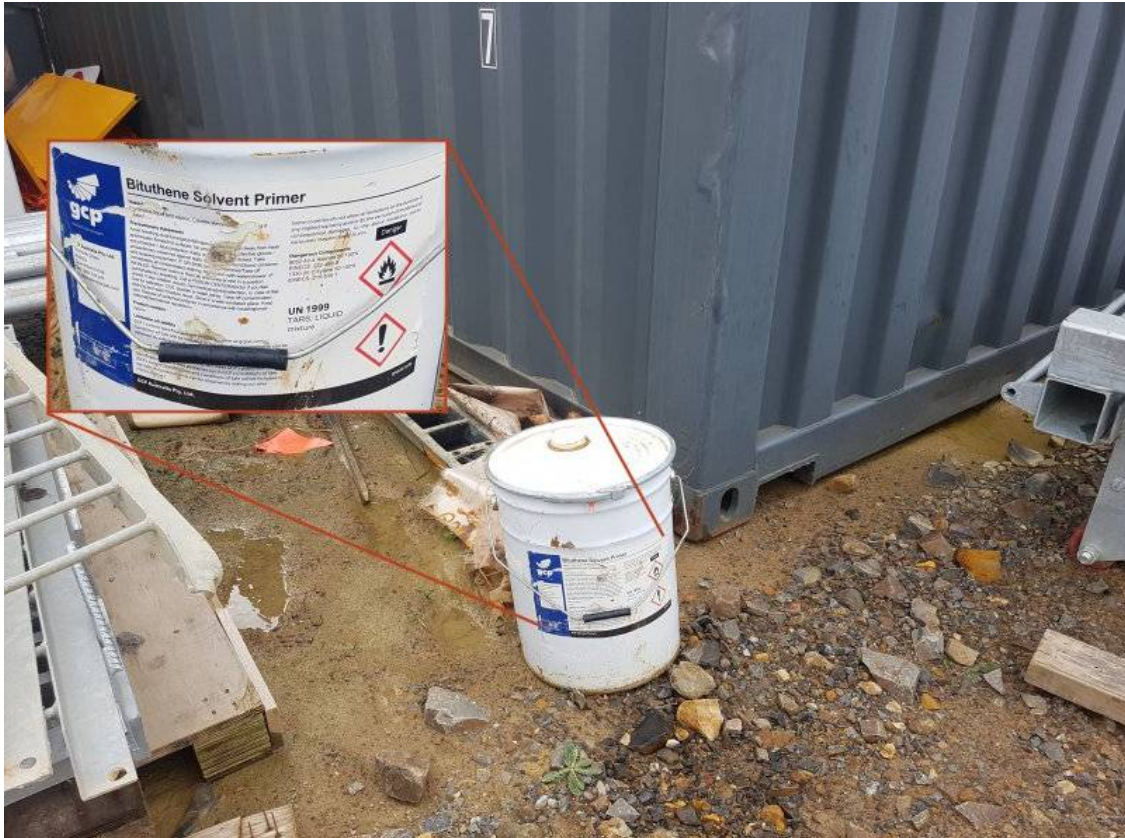
Above: Drum of bitumen solvent primer stored on bare soil at the contractor's storage area south of the Waterways piling area

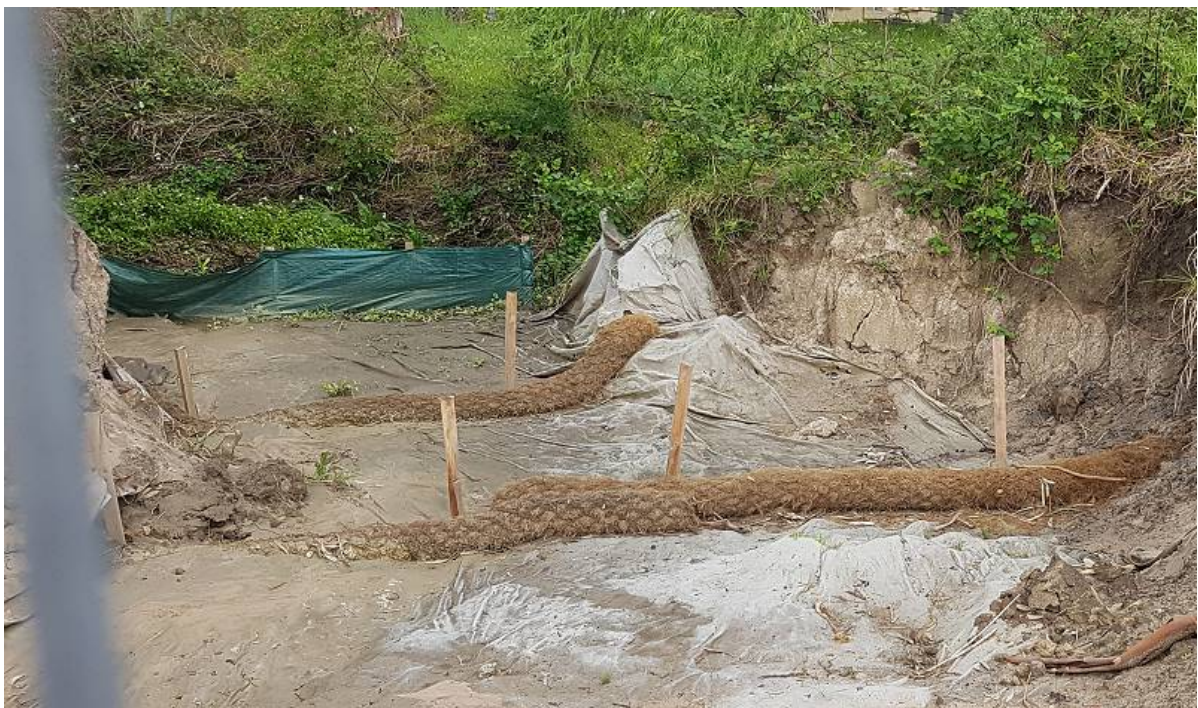
Above: Discharge point into drain approximately 20m south of Centre Dandenong Road.

The area pictured above is receiving run-off from the portion of the constructions site close to Centre Dandenong Road. The coir logs and sediment fence have retained sediment,

The contract specification requires any sedimentation ponds or basins to be designed to adequately treat the volume of water that could be collected. However, due to the lack of room, it is not possible to install a suitably large settling pond. Therefore, alternate treatment methods to remove any suspended sediment are required. The following methods should be considered.

The treatment area could be scraped out to increase the depth slightly and re-establish the surface with geofabric covered with a layer of ballast. This will slow the flow of water down and prevent erosion of the surface. Two sets of coir logs should be installed across the treatment area. The sediment fence should be re-established, however, it should extend partially up the side of the bank to prevent water running around the fence. A coir log can be placed along the base of the fence to help prevent water scoring out the base of the fence. An overflow should be installed at the mid point of the sediment fence (refer to diagrams below). Alternatives that achieve the water quality objectives can also be implemented.

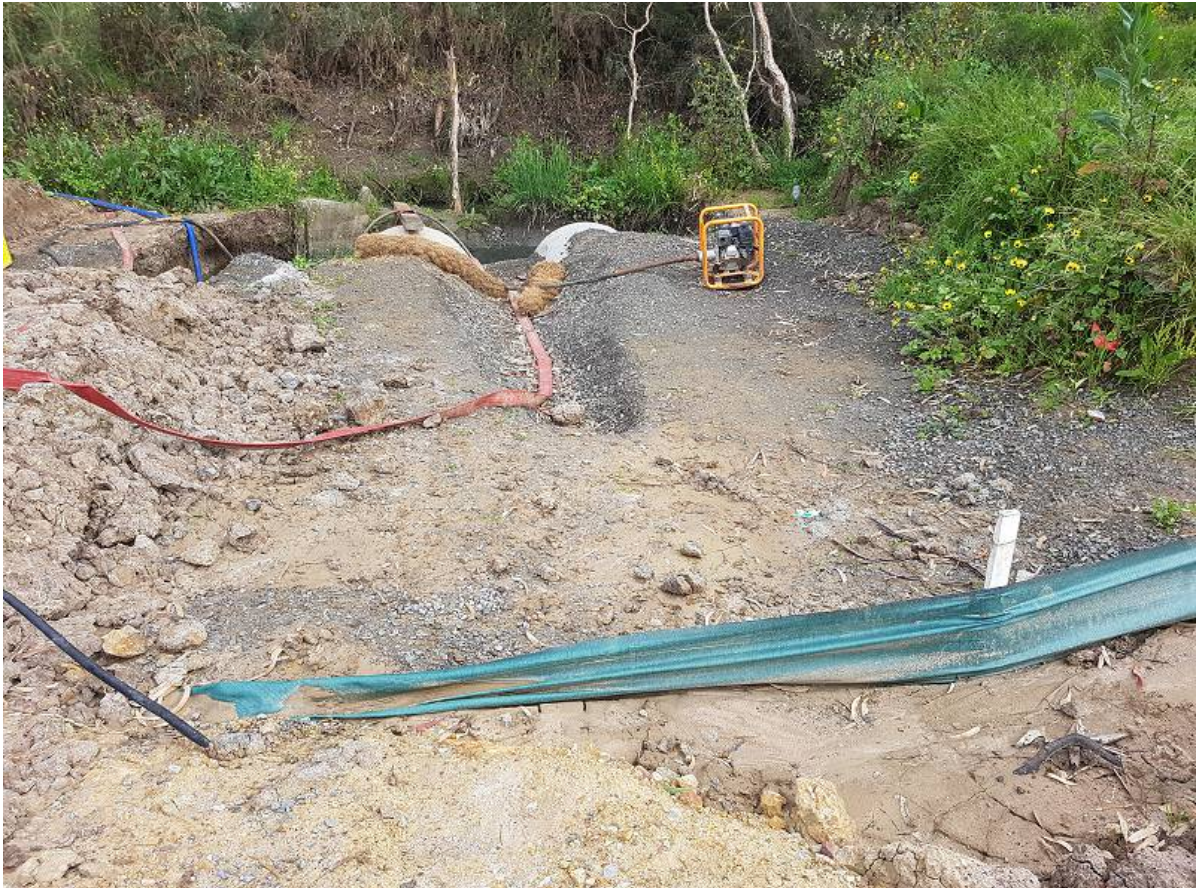
Above: Discharge point into drain approximately 100m south of Centre Dandenong Road.

The sediment fence at the top of the treatment area has been partially buried by soil. As stated for the previous treatment area, the sediment fence acts as a dam and water builds up and flows around the fence causing scouring of the underlying soil. Again, it is not possible to install a large settling pond and alternate treatment methods should be installed and the following should be considered.

The catchment for this area is larger than the area discussed above, therefore the holding capacity should be increased. The surface should again be stabilised with geofabric and ballast. The water currently discharges via a 500mm pipe that appears to have existed before construction commenced. The larger catchment for this location will produce a larger volume of water during rain events compared to the treatment area discussed above. Therefore, it would be preferable to treat this water further before it is discharged. The 500mm pipe inlet should therefore be blocked and a suitably sized pump installed to discharge the water through a length of slotted “agi-pipe” placed along the vegetated boundary of the site. This will allow water to trickle through the dense grass and undergrowth. The majority of the water will likely soak into the soil and the remainder will be filtered through the vegetation before it enters the drain (refer to diagrams below). Again, alternatives that achieve the water quality objectives can also be implemented.
