MORDIALLOC FREEWAY PROJECT

Quarterly Construction Audit

Report 6, June 2021

Quarterly Construction Audit, June 2021

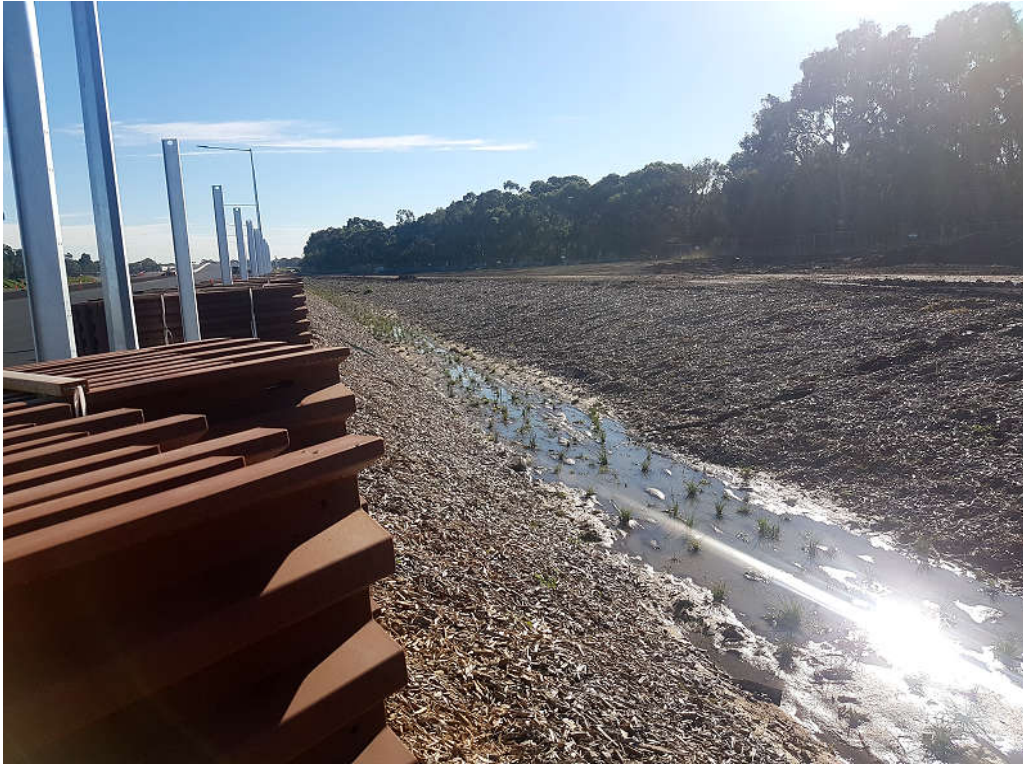
Above: Completed swale drain with screening panels awaiting installation.

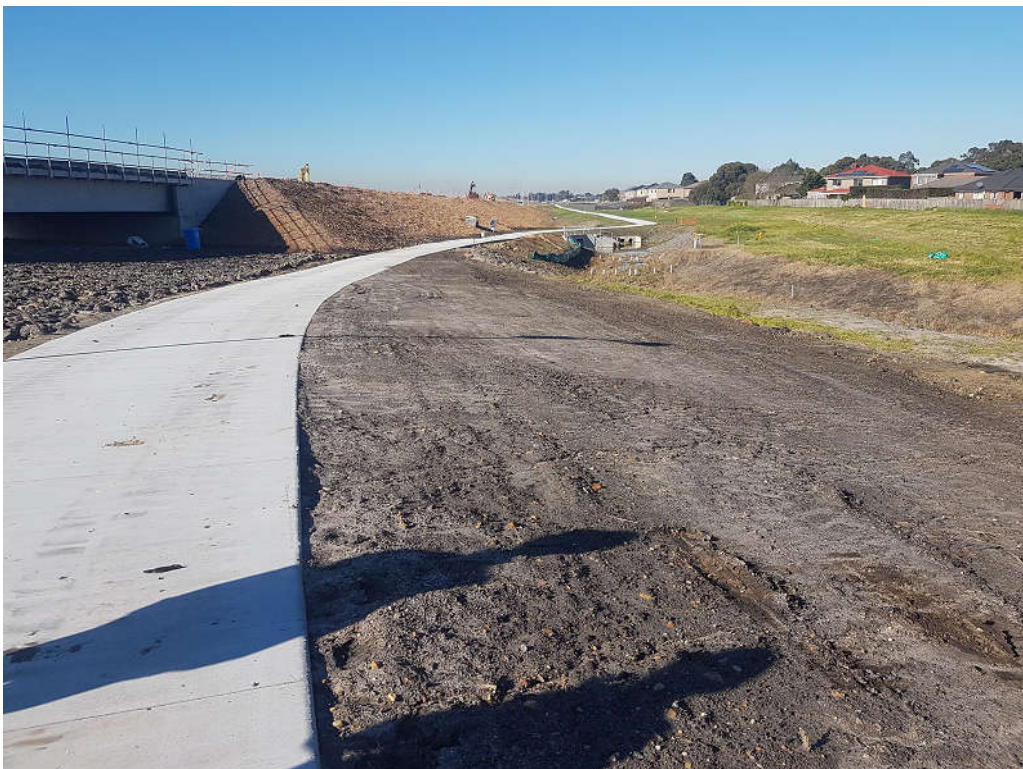
Above: New public pathway in Waterway area. Landscaping in progress.
