# **MORDIALLOC FREEWAY PROJECT**

Independent Reviewer and Environmental Auditor

Quarterly Construction Audit

Report 4, December 2020

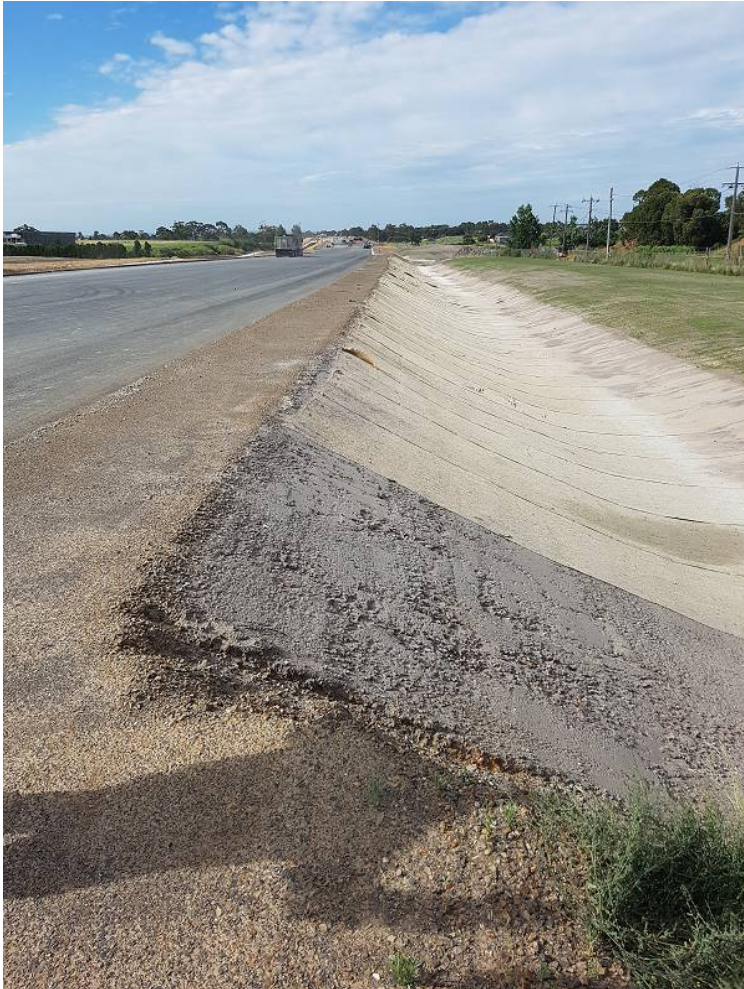
Left: Northern section of project. Majority of roadway is sealed and landscaping mainly completed with topsoil and jute matting applied to swales. Perimeter area has been topsoiled and grassed.

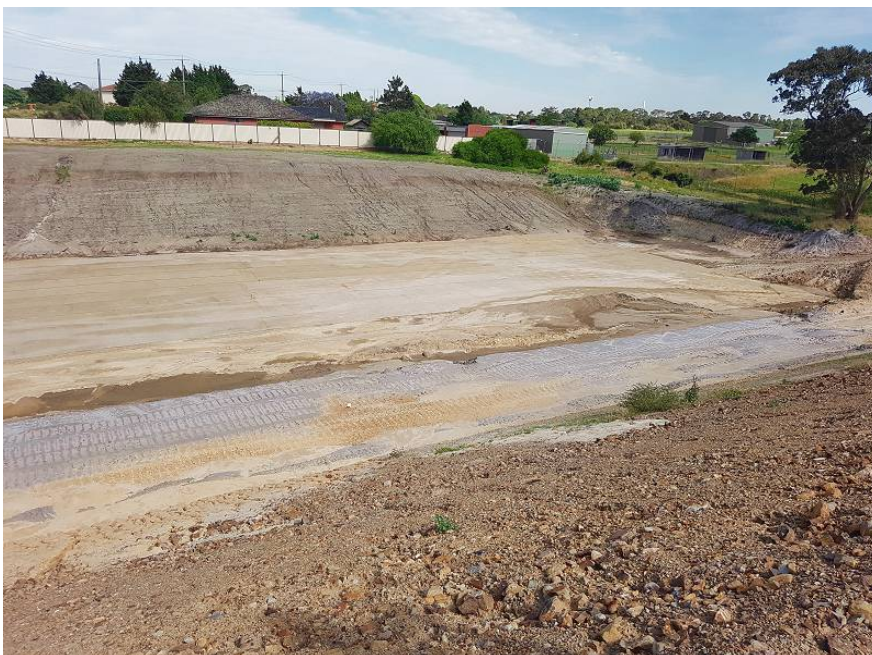
Left: One of the large, permanent stormwater retention basins. Topsoil and jute matting was being applied to the base.

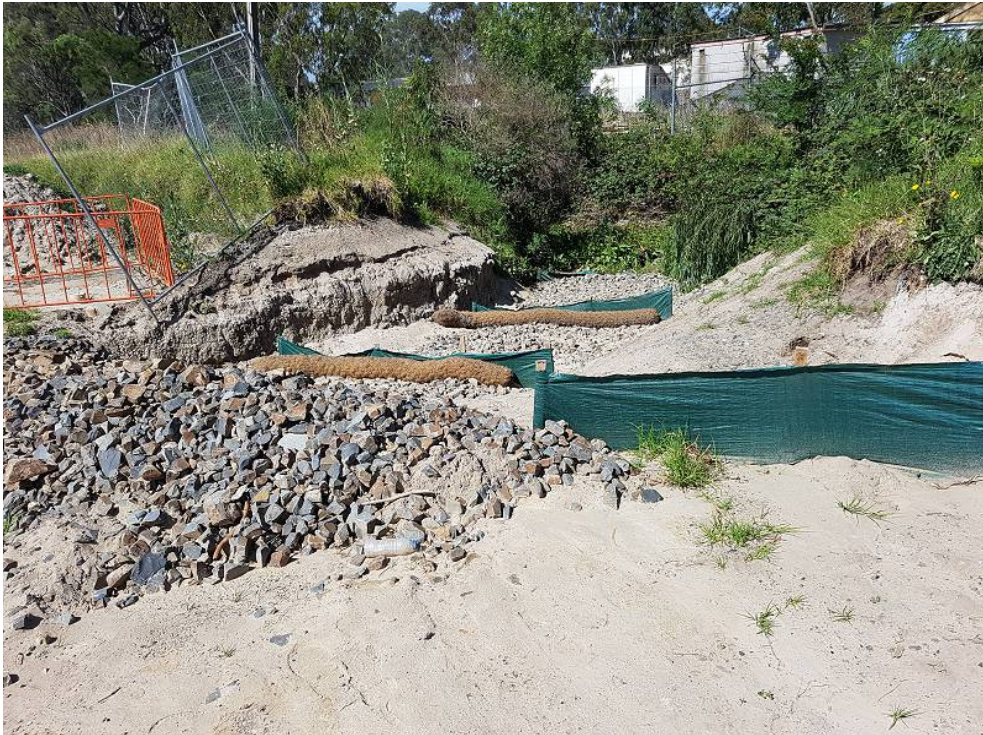
The following two photographs are areas south of Lower Dandenong Road. The sediment control devices were found inadequate at the previous audit, but have been upgraded.

Above: The area immediately south of Lower Dandenong Road. Sediment fences and coir logs have been installed to slow down runoff water. Ballast filled trenches have also been installed to further slow down the runoff and collect sediment.

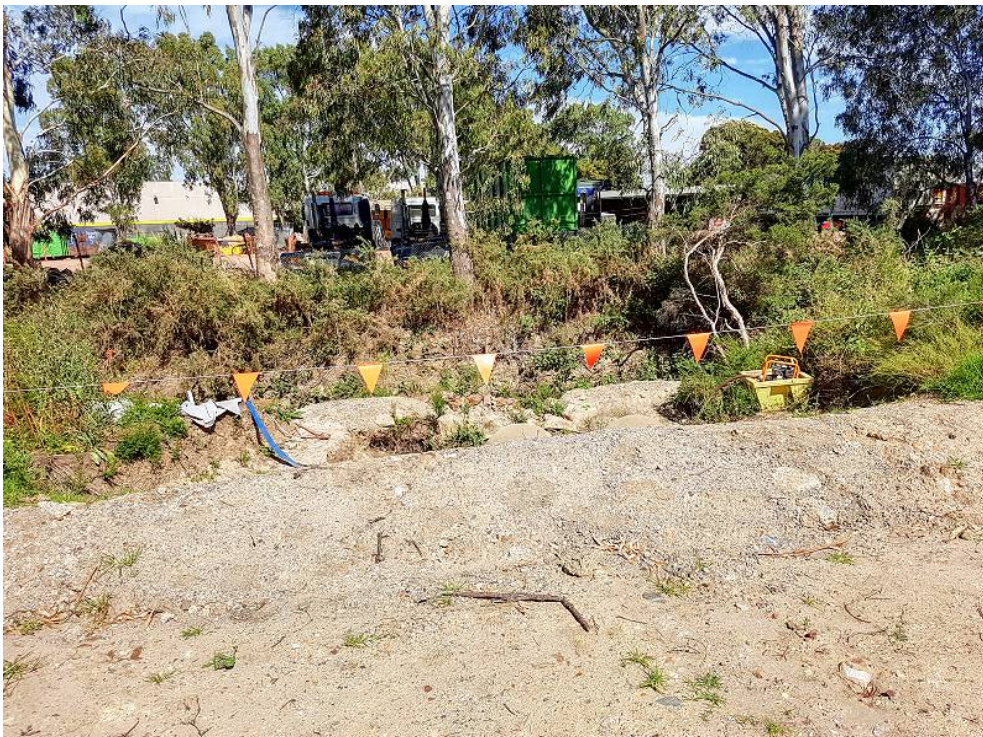
Above: The drainage area further south of Lower Dandenong Road has been bunded, preventing any runoff entering the area directly.

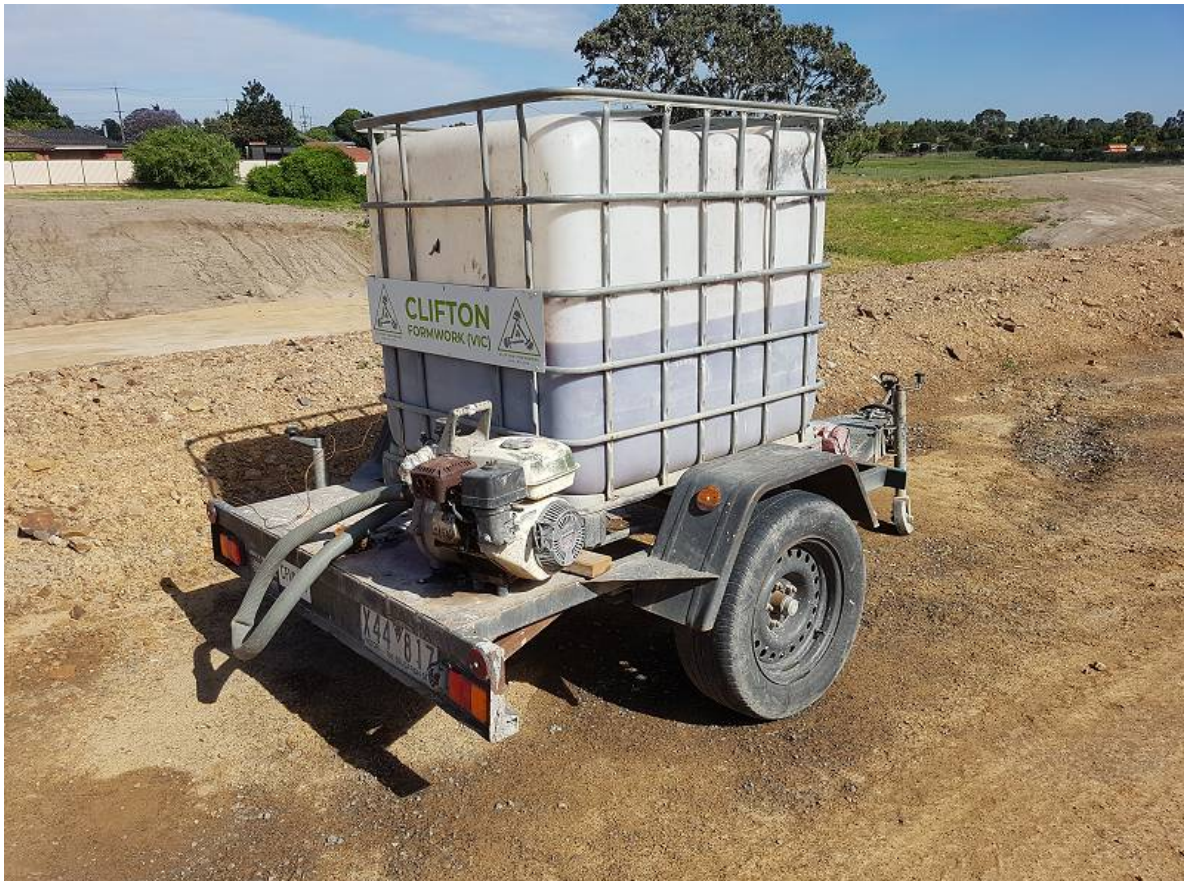
The site inspection only identified one issue related to the proper storage and labelling of chemical containers. The site inspection noted significant progress in road sealing, landscaping and grassing of the works area, particularly the northern section of the project site.

Above: The one issue of concern was the unlabelled IBC used by a sub-contractor that was found in Zone 1. Enquiries during the audit identified the material as a concrete curing compound that is sprayed onto the concrete.
