# **MORDIALLOC FREEWAY PROJECT**

Quarterly Construction Audit

Report 5, March 2021

Quarterly Construction Audit, March 2021

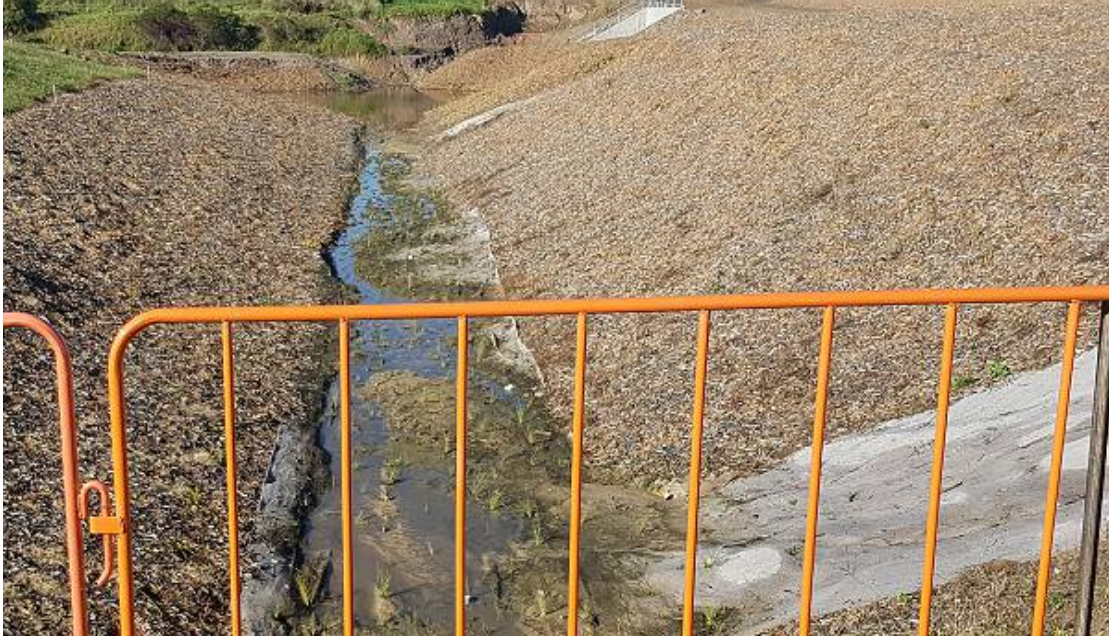
Above: Landscaping and stabilising part of the Old Dandenong Drain

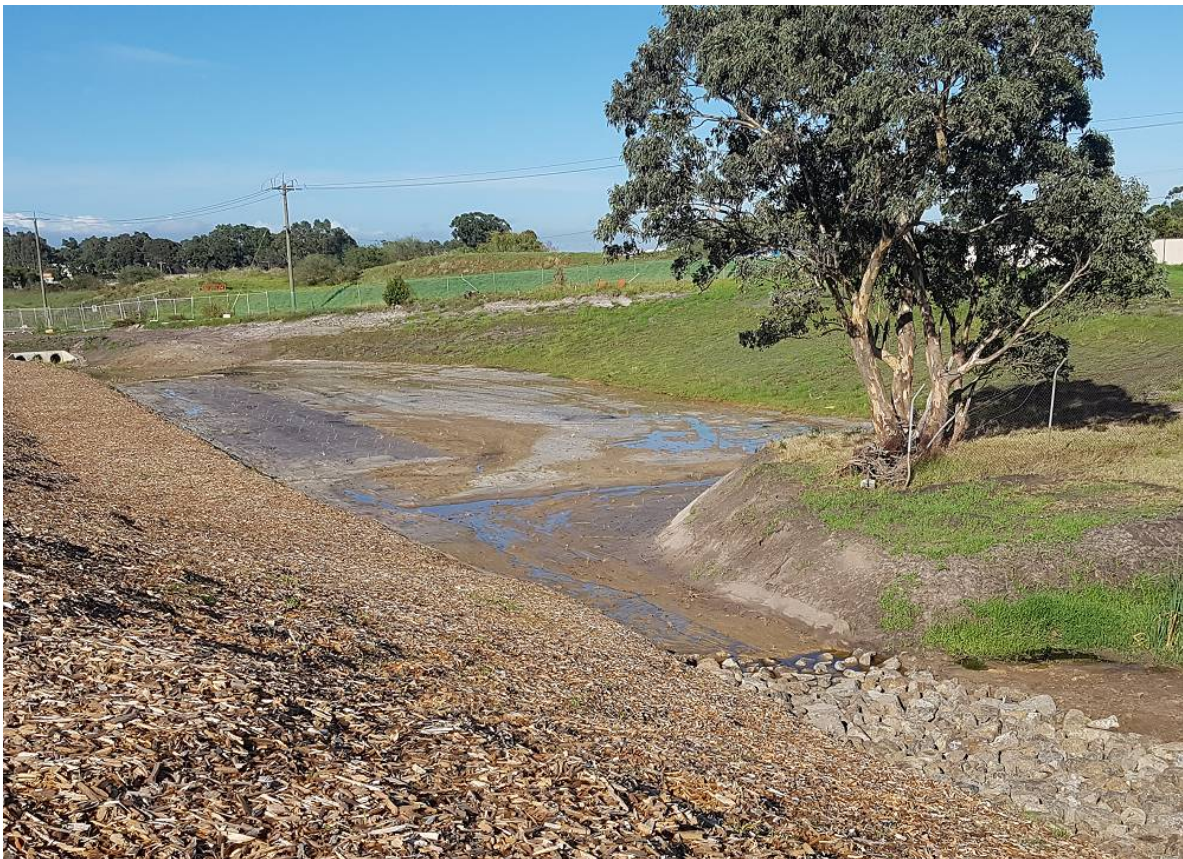
Above: Completed catchment pond in Area 1 with rock stabilised inlet channel (bottom right) and geofabric covered base which has been planted out with native grass.

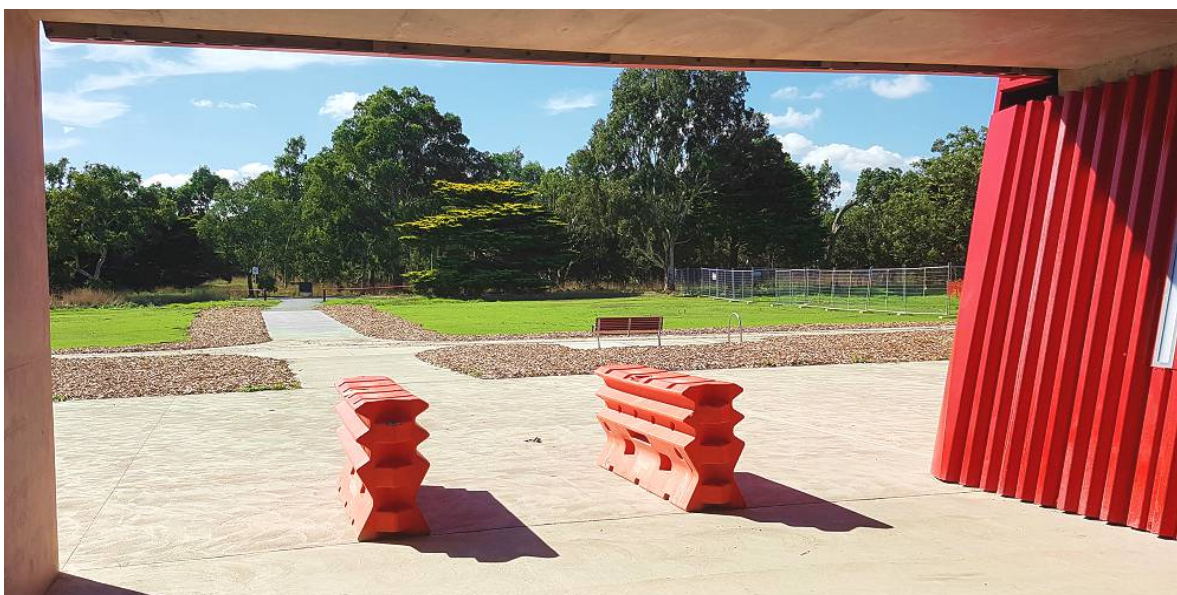
Above: Completed underpass with walking path and landscaping near the Parks Victoria offices.

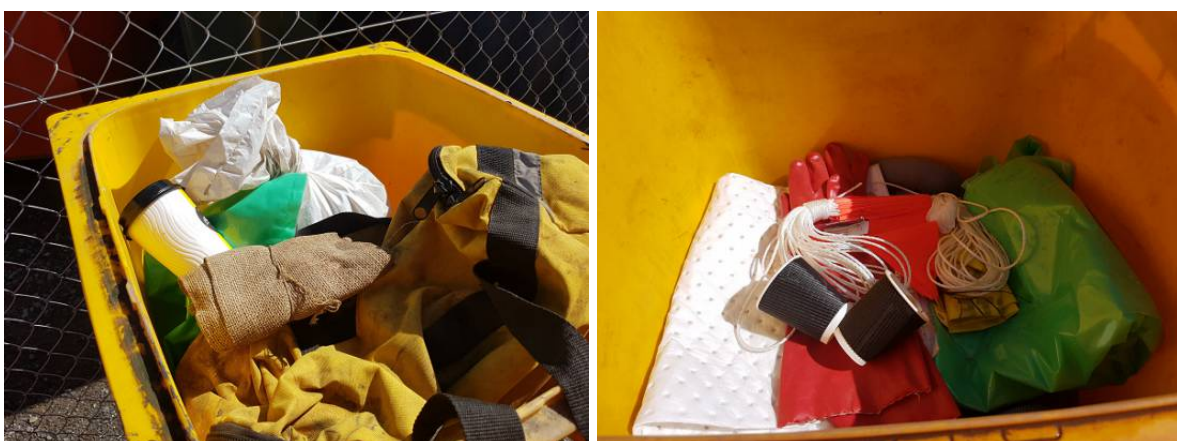
Above Left and Right: Two spare spill kits in the Waterway compound were being used as rubbish bins and contained empty coffee cups
