Assessment of trees along the proposed Mordialloc Bypass

Preliminary Tree Assessment Report

31 May 2018

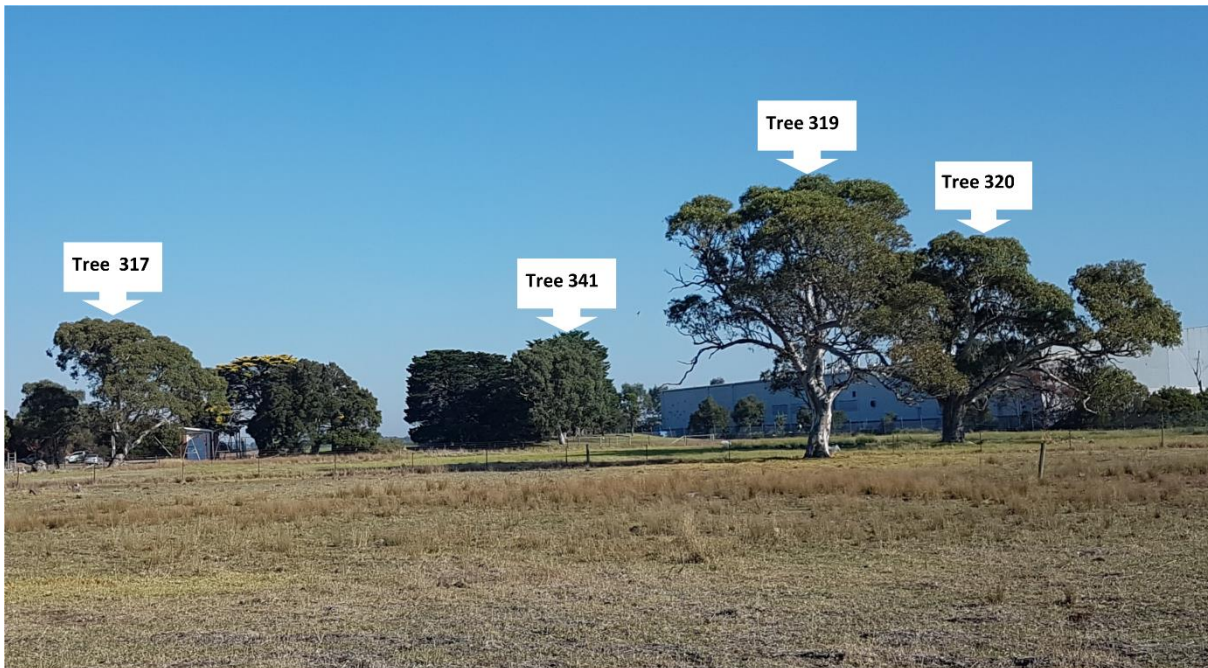
20 trees were assessed as very high retention value. They included Trees 317, 319, 320, 1,394, 1,397, 1,455, 1,456, 1,569, 1,572, 1,575, 1,576, 1,621, 1,685, 1,757, 1,861, 1,889, 1,893, 2,302, 2,936 and 2,991. All 20 trees assessed in this category are River Red Gum *Eucalyptus camaldulensis*. They are the largest and most significant trees at the project site, demonstrating good to very good health, fair to good structure and 20+ years of ULE (Figure 2). They can be a long-lived species capable of living upwards of 500-1000 years (Jacobs 1955). They should be retained and protected for their indigenous origin, habitat significance and massive size.

Figure 2: Large specimens of River Red Gum *Eucalyptus camaldulensis*

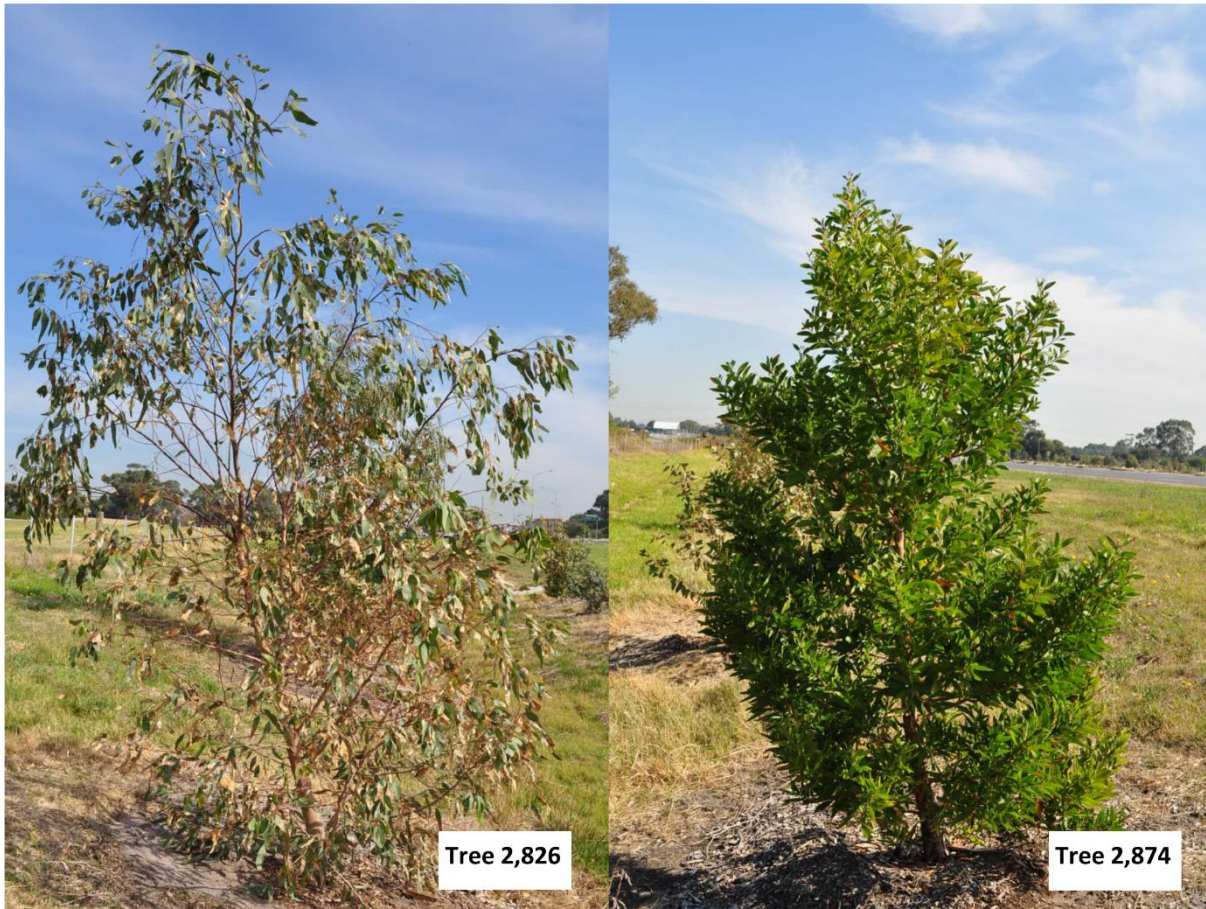
2,253 trees (72% of the tree population) were assessed as low retention value. In general, these are young or declining specimens with limited landscape value. Major tree species assessed in this category included 806 specimens of eucalypts, 357 specimens of Leyland Cypress, 355 specimens of melaleuca, 300 specimens of wattle and 137 specimens of sheoak. The majority of Leyland Cypress in this category are hedges along the boundary of a private nursery located within the project site. The planted young specimens of indigenous eucalypts and wattles along Dingley bypass are assessed in this category (Figure 3).

Figure 3: Young specimens of River Red Gum *Eucalyptus camaldulensis* and Blackwood *Acacia melanoxylon*.

Whilst these could be retained, they are not considered worthy of design alterations and could be compensated for with post construction landscape plantings.

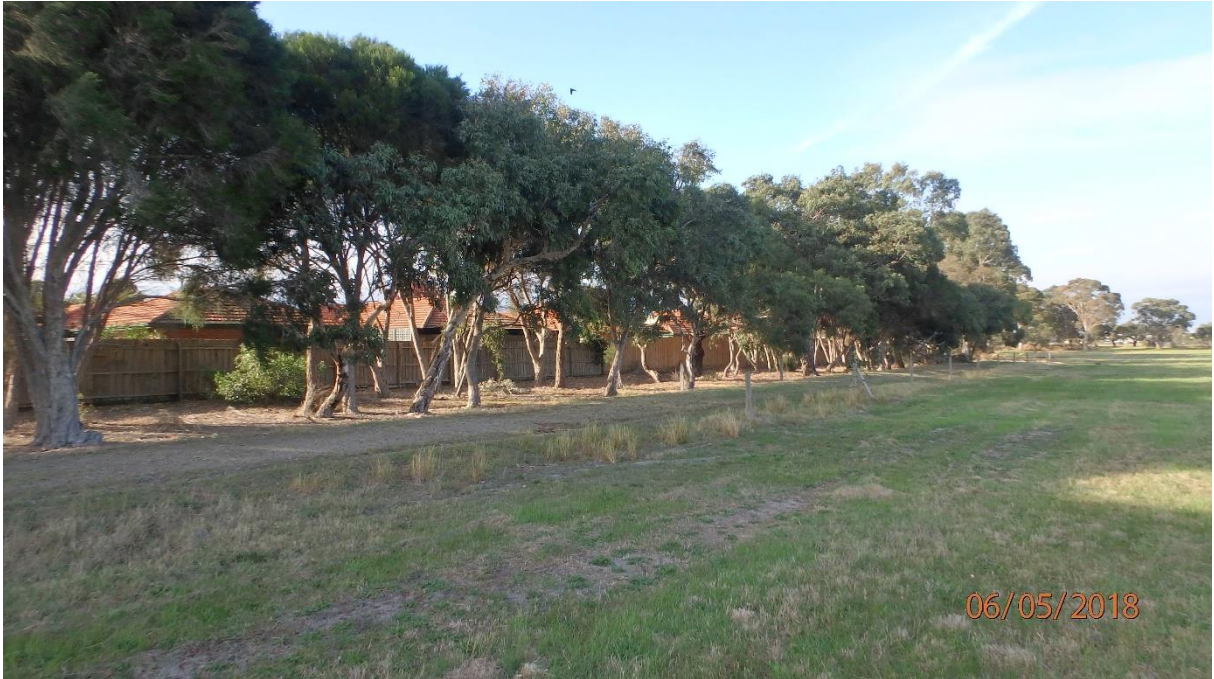
In general, the trees present a significant screen between the houses and currently vacant paddock. The trees are generally in good health, with fair structure and as a patch are likely to be functional for another 10-20 years. Within that time, it is likely that many of the Giant Honey Myrtle will fail. The River Red Gums are likely to survive significantly longer.

Figure 9: Planted row of Giant Honey Myrtle and River Red Gum.

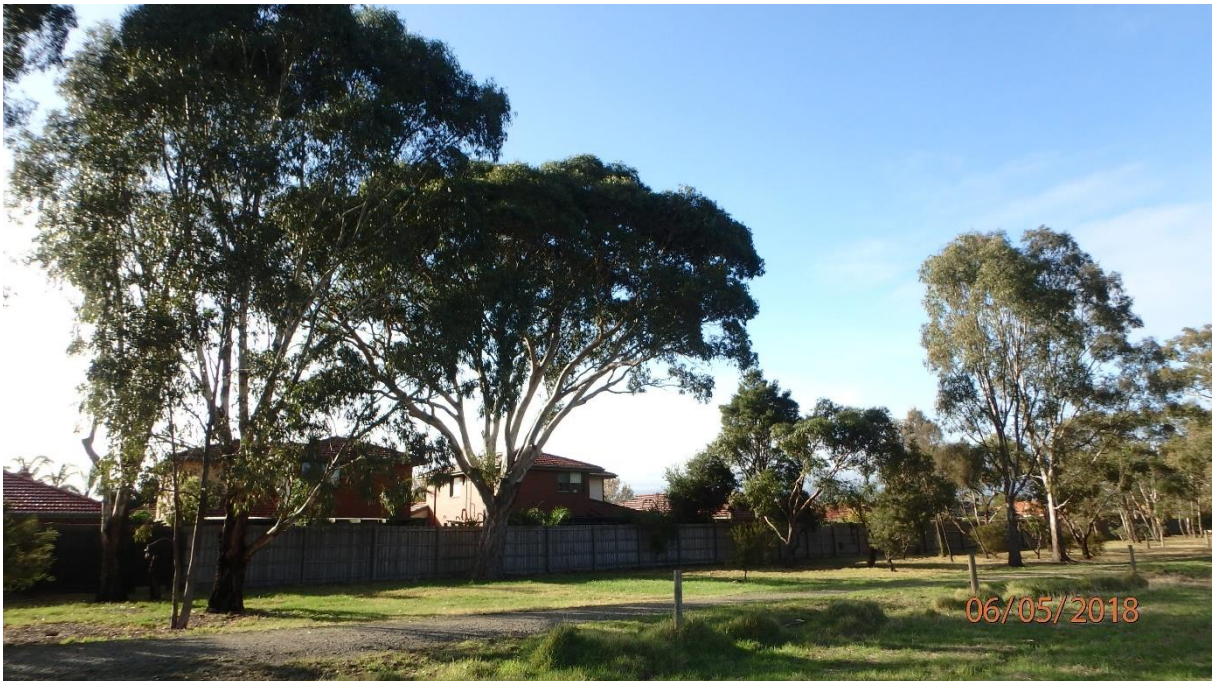
Figure 10: Large River Red Gum at the south end of the group area.

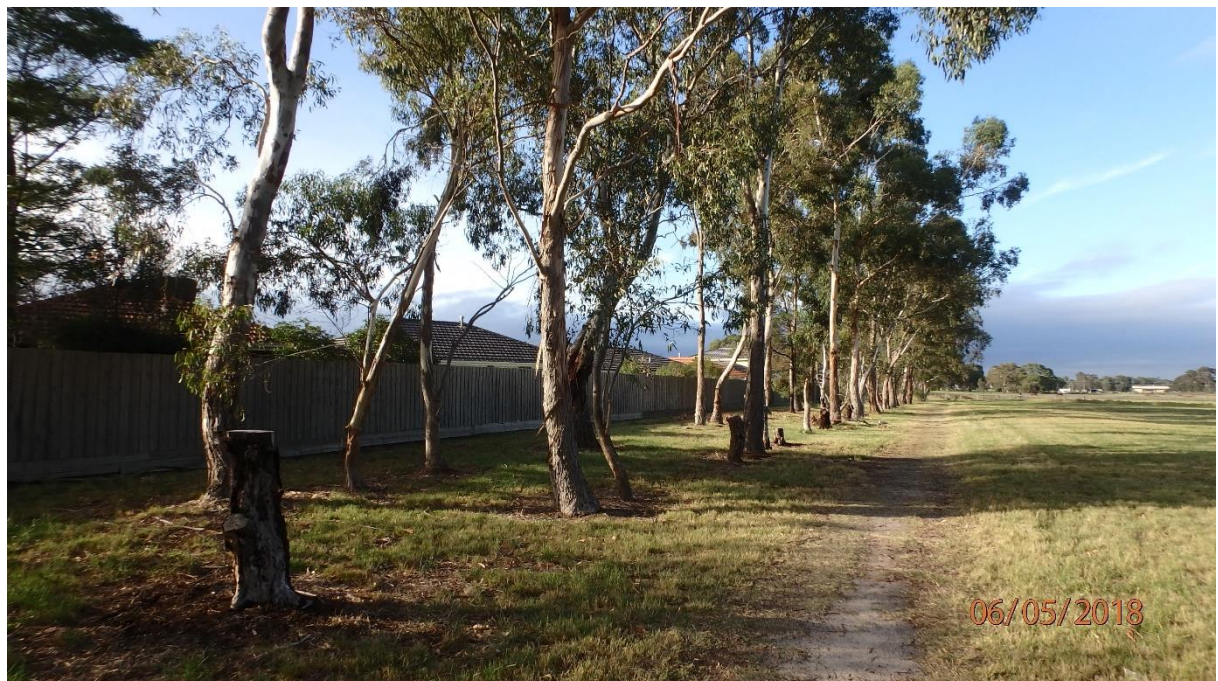
In general, the trees present a screen between the houses and currently vacant paddock. The trees are generally in good health, with fair structure and as a patch are likely to be functional for at least another 20 years. General pruning and tree management will be required as the trees continue to increase in size.

Figure 12: Planted row of mixed eucalypts heading south.

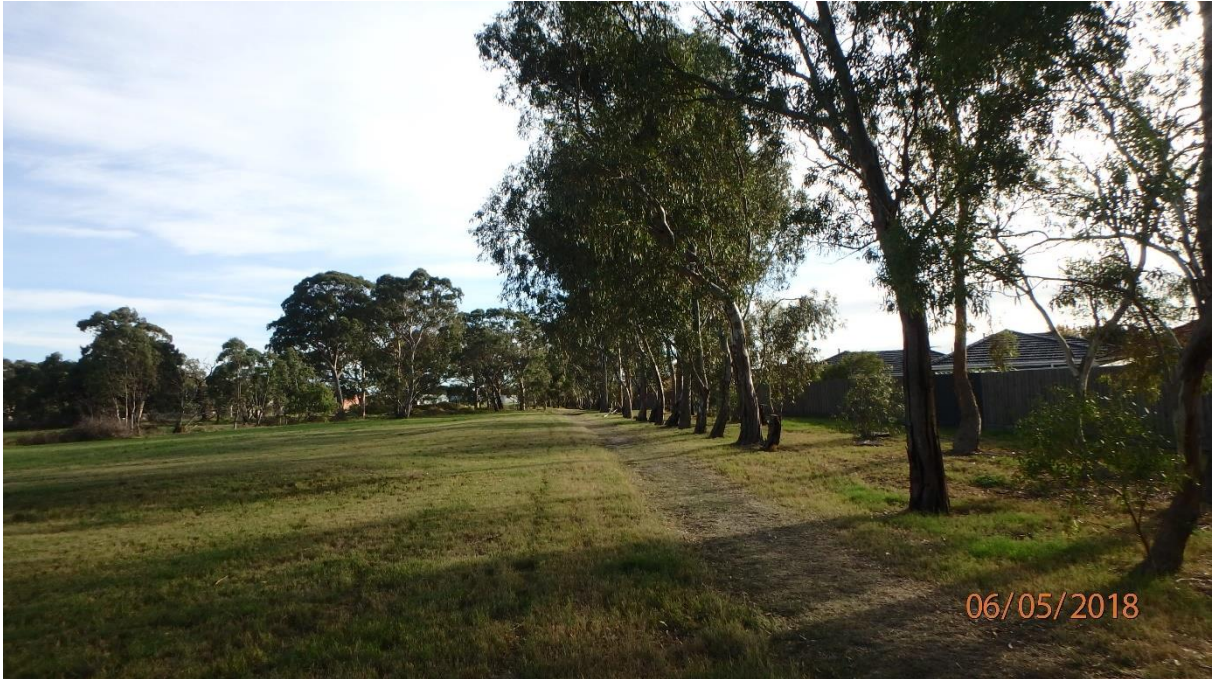
Figure 13: Planted row of mixed eucalypts heading north.

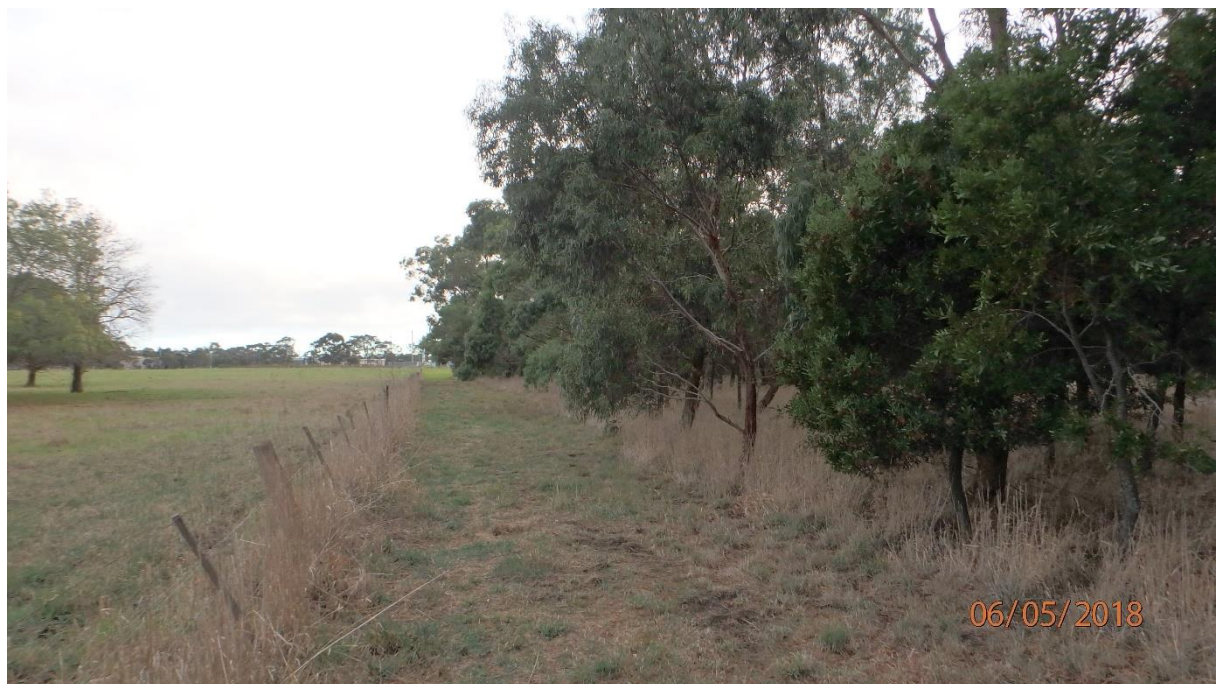
The trees are part of the park and are dense sections of bushland. The trees have good health and fair structure given that they have largely been left unmanaged. Canopy pruning may be a requirement as some of the trees have grown out and into the reserve area. The mapped buffer represents an area required for adequate protection of the trees.

Figure 15: River Red Gum at the northern edge of the patch.

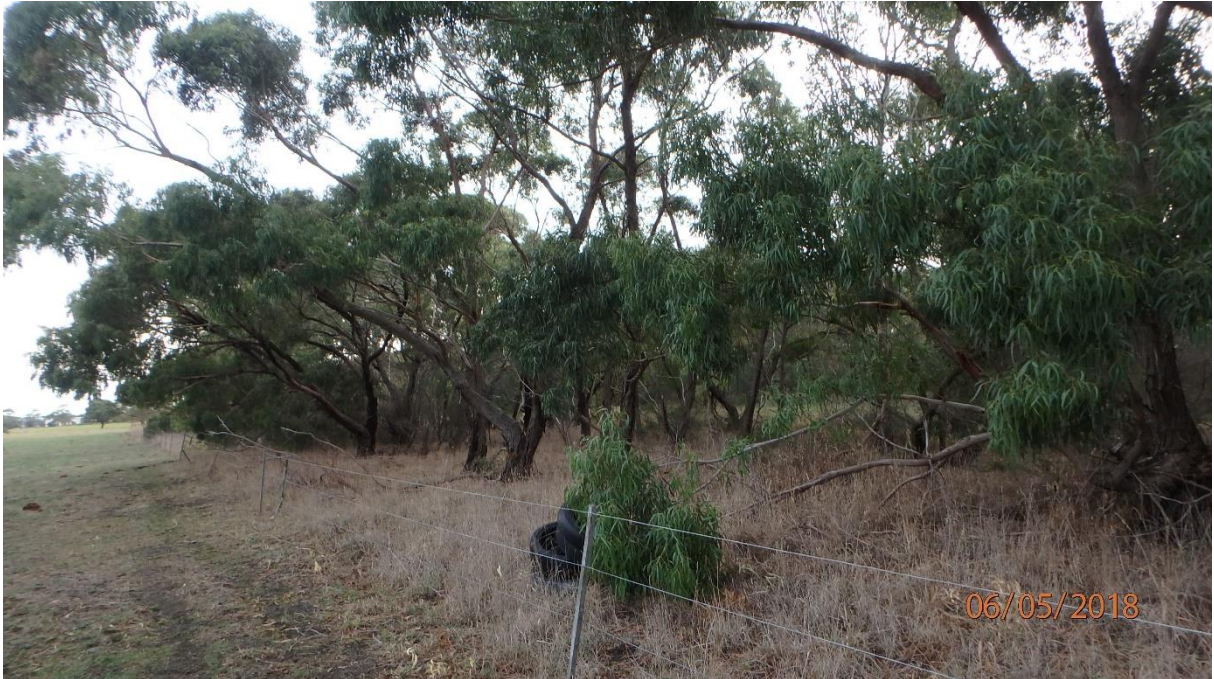
Figure 16: Gippsland Manna Gum within Braeside Park.

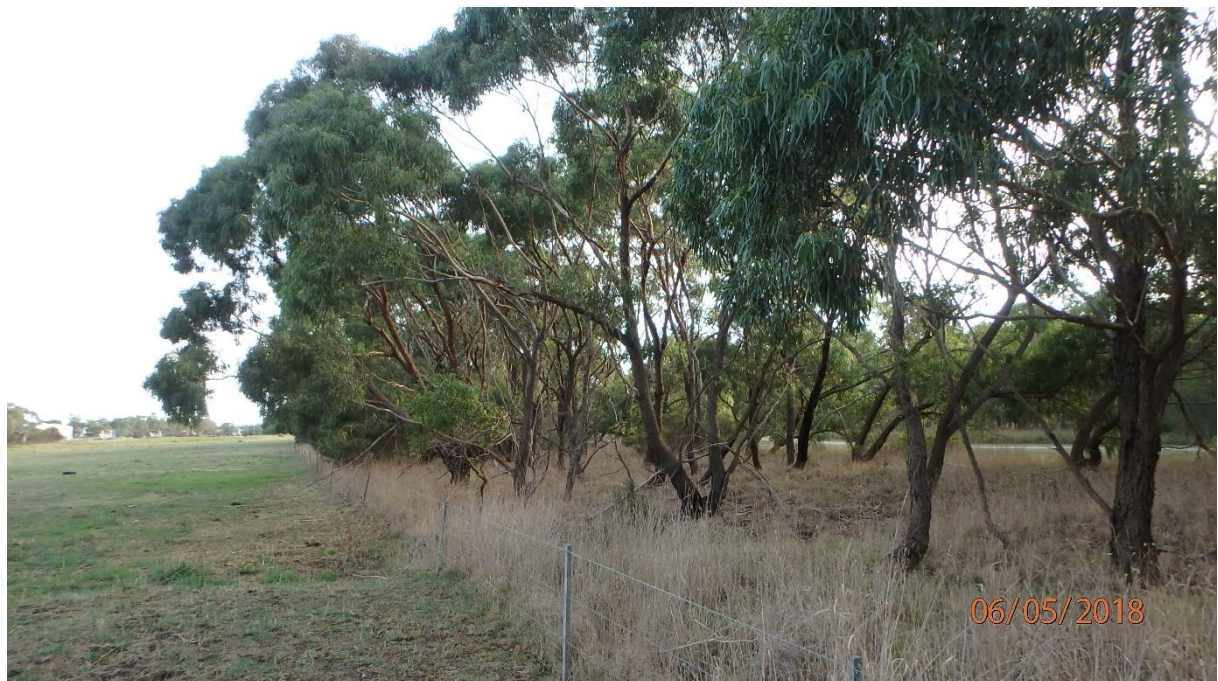
The trees are part of the park and are dense sections of bushland. The trees have good health and fair structure given that they have largely been left unmanaged. Canopy pruning may be a requirement as some of the trees have grown out and into the reserve area. The mapped buffer represents an area required for adequate protection of the trees.

Figure 18: Gippsland Manna Gum within Braeside Park as part of Group 4.

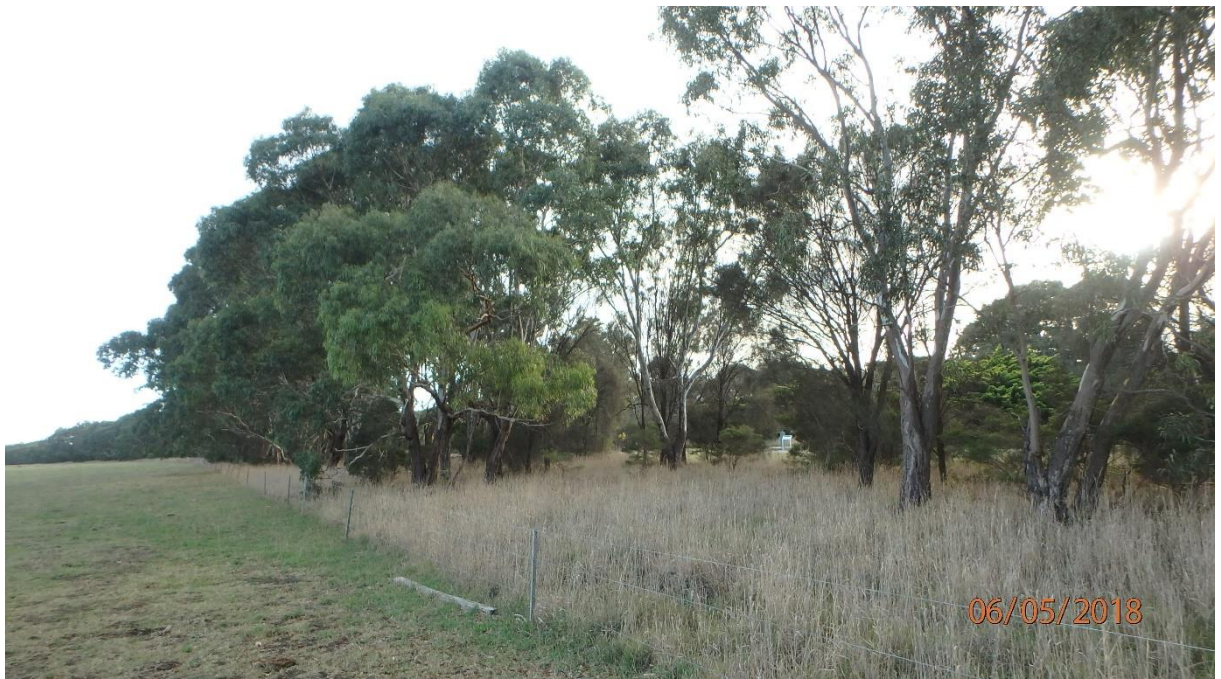
The trees are part of the park and provide a screen for trail users within the park to the vacant land to the west. The trees have good health and fair structure given that they have largely been left unmanaged. Canopy pruning may be a requirement as some of the trees have grown out and into the reserve area. The mapped buffer represents an area required for adequate protection of the trees. Detailed investigation of individual trees may result in a reduction of the required buffer intruding into the subject land.

Figure 20: River Red Gum within Braeside Park.

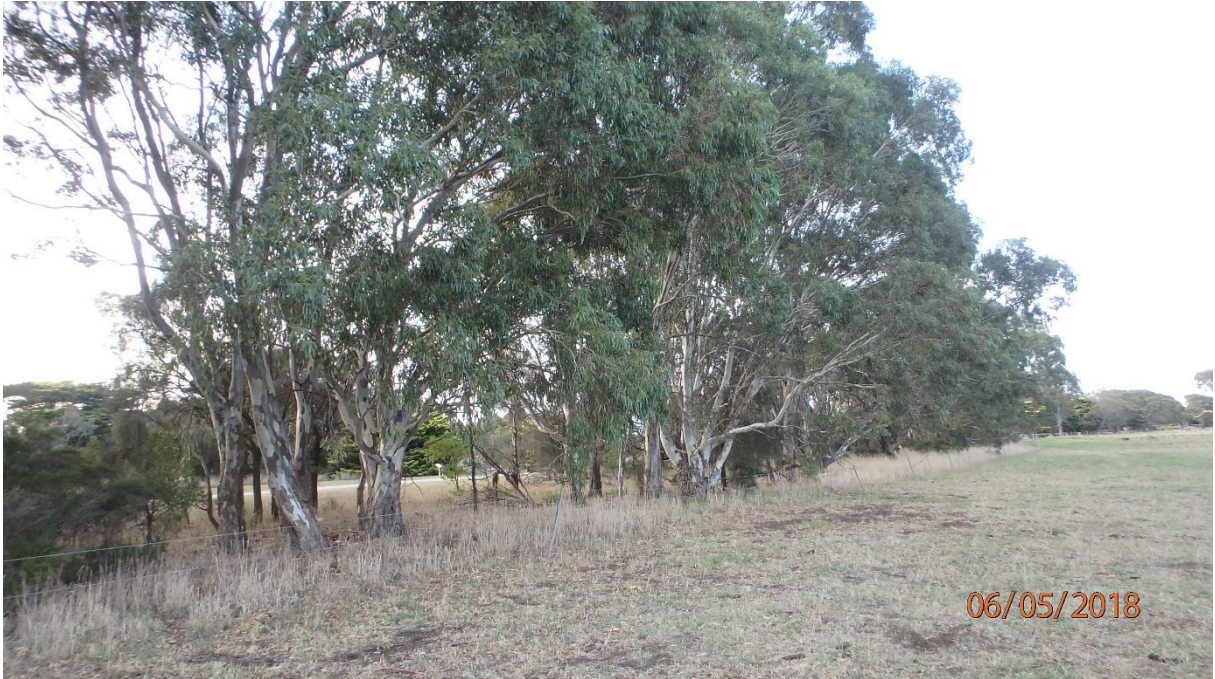
Figure 21: River Red Gum at the northern edge of the patch.

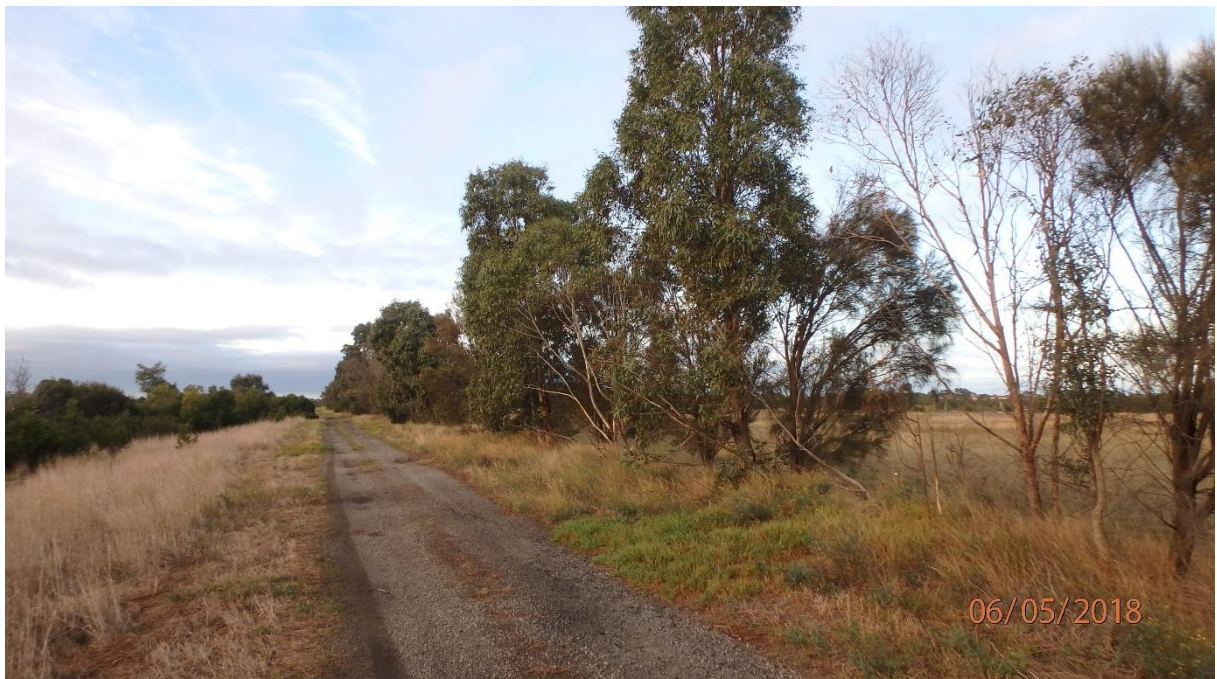
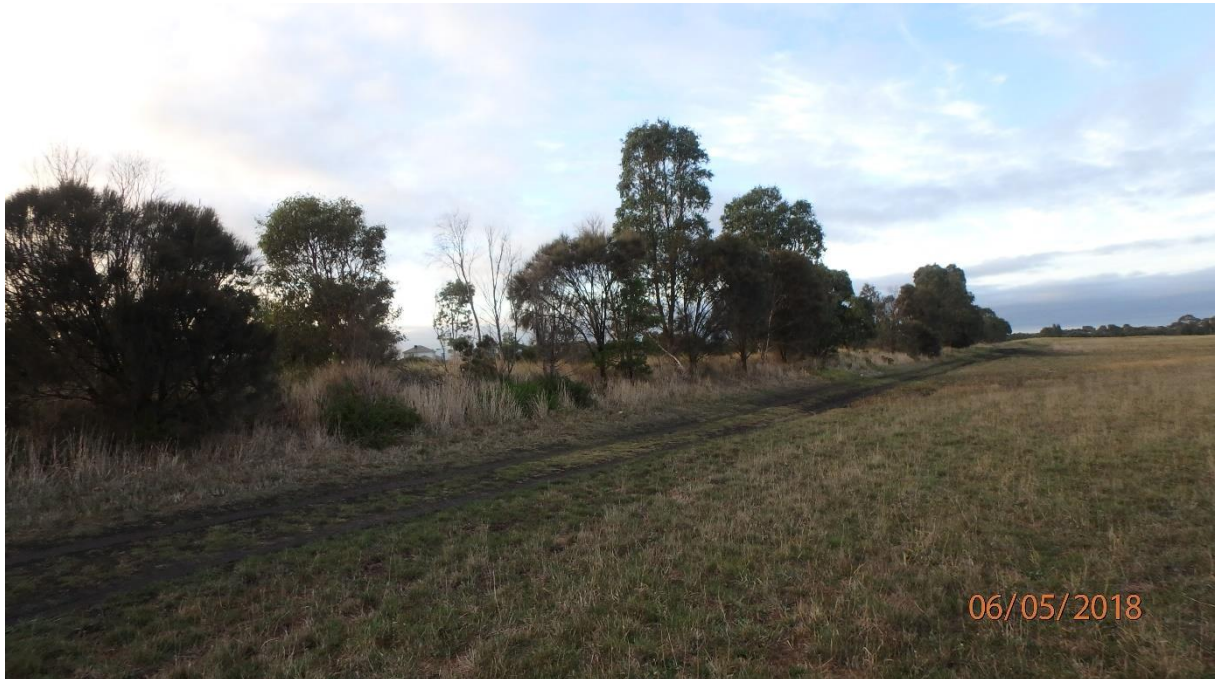
The trees have variable conditions and size dimensions ranging from 2-3m to 8-10m tall. A track exists on both sides of the strip of vegetation. A no-go zone of 6m width is ample to protect this row of vegetation.

Figure 23: Planted vegetation comprising Group 6.

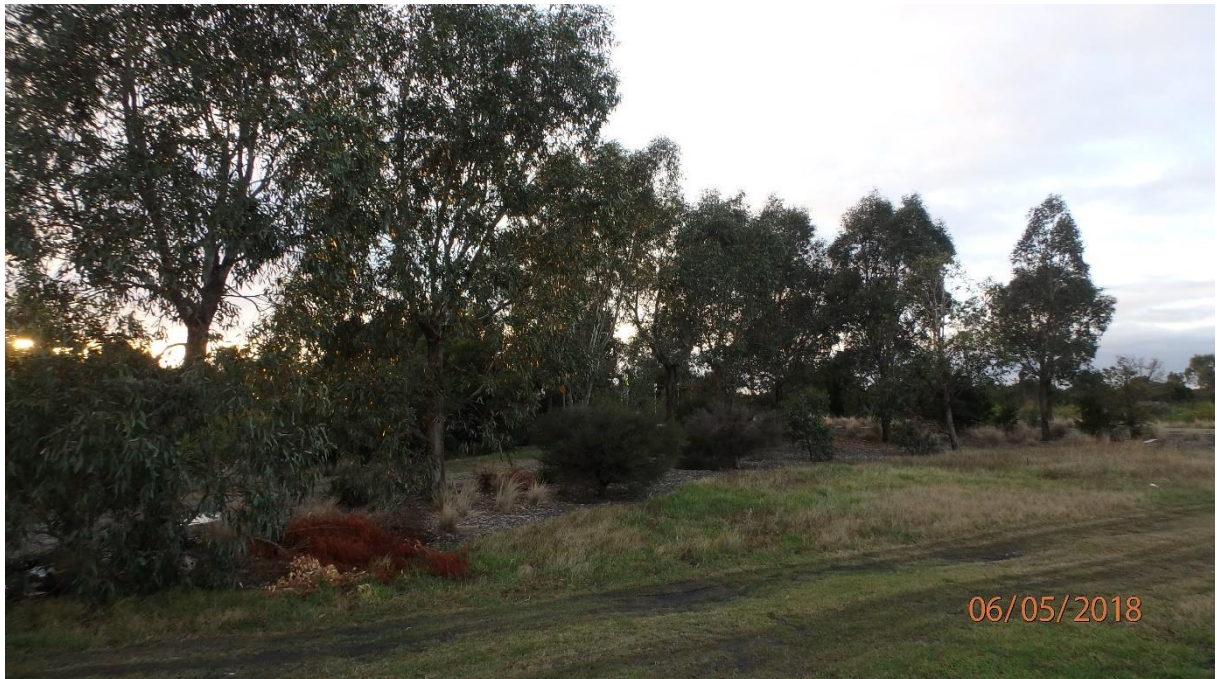
The trees have variable conditions and size dimensions ranging from 8-10m tall and trunks 20-30cm in diameter at breast height. A track exists through the middle of the patch (Figure 26).

Figure 26: Planted vegetation comprising Group 7.

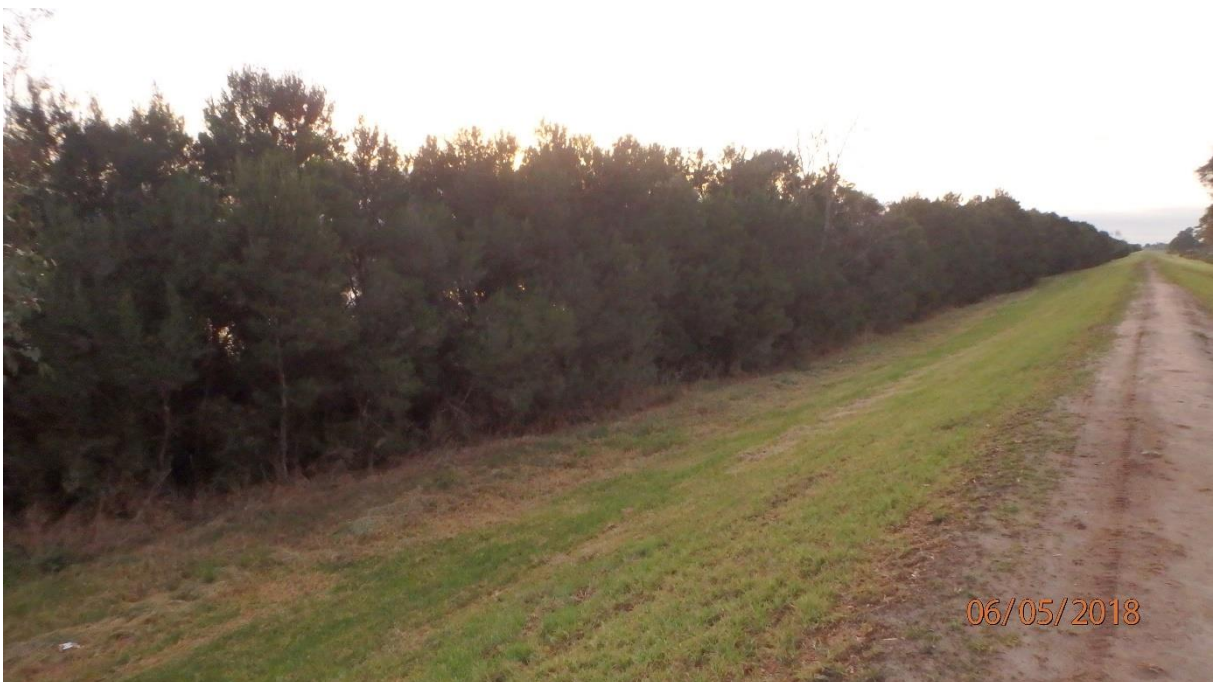
Group 8 is a long thicket of Swamp Paperbark growing along the water's edge running off Bowen Parkway (Figure 27). It comprises a dense patch of stems ranging from less than 5cm to ~20cm diameter. In general, a relatively small strip is required to protect these trees as they are mostly small trees with small protection zones (Figure 28).

Figure 28: Thicket of Swamp Paperbark along the water's edge comprising Group 8.

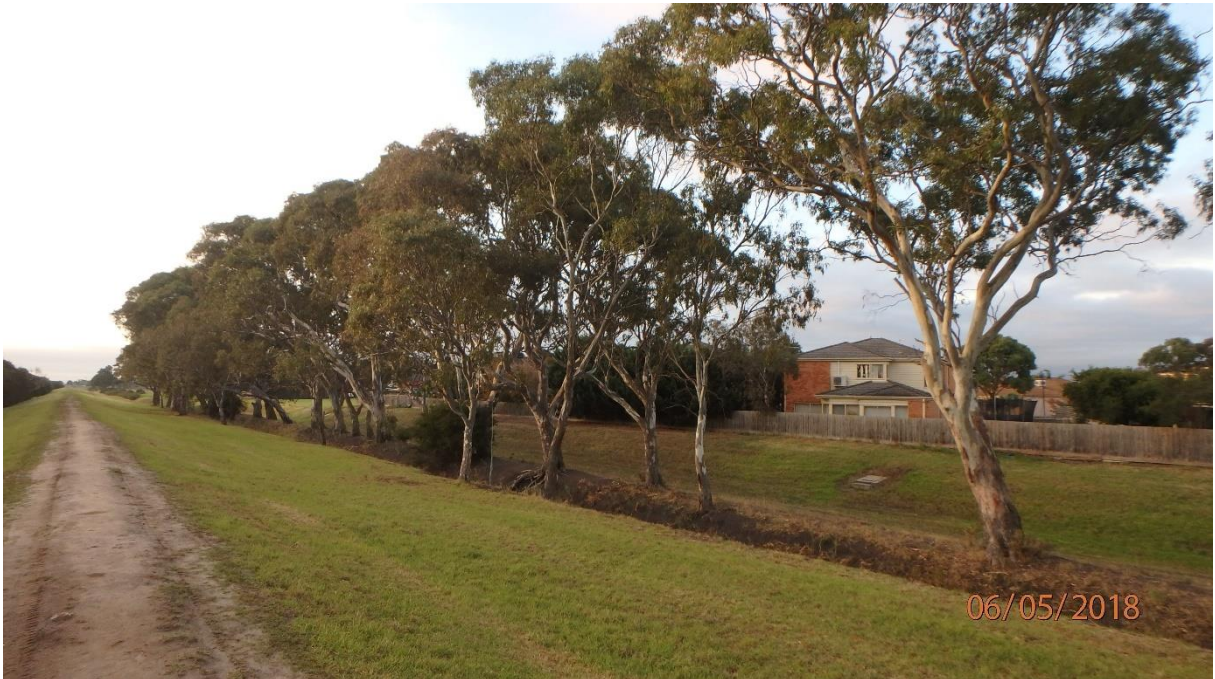
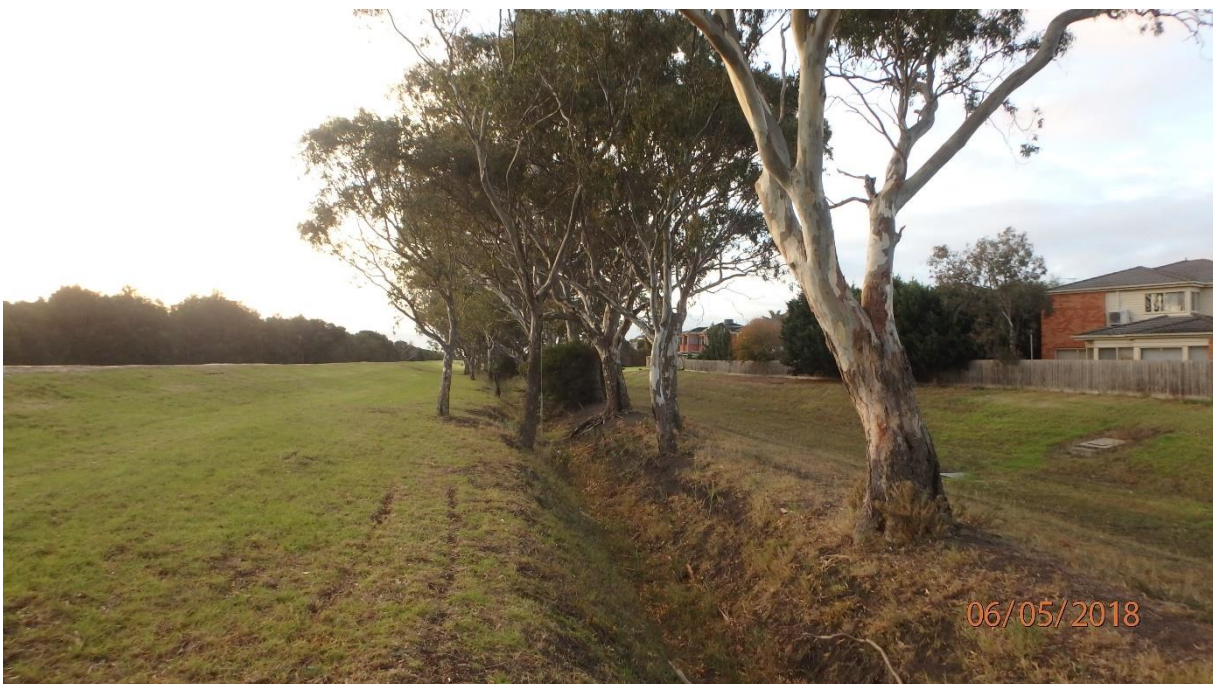
Group 9 is a row of River Red Gum growing along a narrow, deep channel. To the north of the trees is a levy and the south a deeper, wider channel drain. The offset as shown for the trees should ensure that they are sufficiently protected (Figure 29 and Figure 30)

Figure 29: River Red Gums growing along the channel comprising Group 9.

Figure 30: River Red Gums with a significant channel along the middle comprising Group 9.
