Appendix A Waterway Crossing and Alignment Mapbook

Appendix B Waterway Crossing Field Inspection Proformas

Waterway Crossing & Alignment including Flood Extent - Mapbook

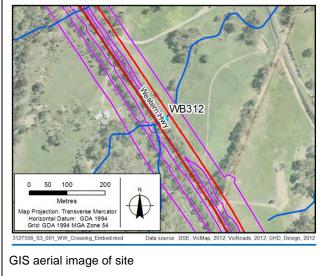
- Channel geometry	banks, then channel narrows do	wnstream through more veg e north west. This tributary is	wide, 2.5 m deep. Eroding exposed etated section. Upstream of Highway s shallower with a low flow channel 1 m to 3 m deep and 6 m wide.

- Channel gradient	0.8 %						
- Channel sinuosity	Low sinuosity; 1.07	Low sinuosity; 1.07					
Banks	Highly eroding banks. Some past vertical. Slumping and incision occurring. Some large remnant trees in bank. Fallen tree across channel lying across top of bank.						
Instream Features	Road bridge. Standing water under bridge. Sandy deposits on channel bed. Boulders (up to 1 m diameter) in place on upstream side of bridge as bank stabilisation. Some woody debris and vegetation debris- masses of acacia shrubs.						
Comments	Will need to protect right bank downstream of road bridge where large boulders have been put in place

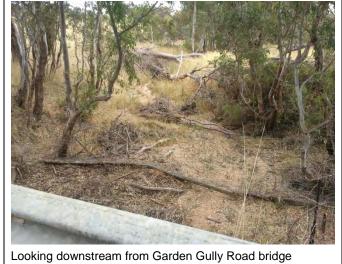
- Channel geometry	Channel wider at bridge, approx. 10 m across and up to 3 m deep. Some lateral erosion at/behind wing wall- both sides of bridge. Further from road bridge channel 2.5 m deep, 4 m wide. Low flow channel within channel 1 m wide, 0.4 m deep.

- Channel gradient	1.6 %					
- Channel sinuosity	Straight; 1.02					
Banks	Steep slopes. Some undercutting and slump. Banks vertical on downstream side of road bridge.					
Instream Features	Box culvert 2.4 m x 4.8 m. Bank attached sand bar. Terrace from low flow channel.					
Floodplain Description	Small dam levee on left bank, o	lowr	stream of bridge.

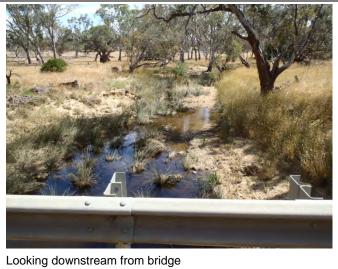
- Channel geometry	2 m deep, up to 5 m wide upstre bridge	eam o	of bridge. Channel opens	out, approx. 15 m wide at road		
- Channel gradient	0.2 %					
- Channel sinuosity	Moderately sinuous; 1.12					
Banks	Slump and undercutting. Large fallen tree across bank upstream of bridge.					
Instream Features	Bank attached sand bar. Small mid-stream sands bar downstream of bridge. Broad pool under Existing Highway.					
Floodplain Description	•	Broad floodplain. Downstream culvert small rise on right bank restricting floodplain. Vineyard downstream on right bank. Possibly with levees and internal drainage.

Regional River Health Strategy					
asin	Wimmera River, WMCA				
anagement Unit	4. Concongella Creek				
each	65: Upper Tributary of Allenvale Creek.				
C rating (score)	Moderate (19) ISC reach # 50				
ritical threats to sub- atchment					
cological Values					
quatic ecology	Reeds, grasses, sedges.				
isturbance rating	High				
norphic Classification	on Unconfined				
Up to 6 m wide, 2 – 1.5 m deep. Large sand deposit mid channel. Open water along most of reach- seep through dry sand bank section? Short banks. Some sandy islands mid-channel.					
channel. Some unde	rcutting.				
Open pools with narrower vegetated channels. Some woody debris recently washed in. Farm dam through middle of proposed alignment.					
Wide floodplain, approx. 100 m either bank. Parallel high flow channels on either bank. Existing Highway presents barrier to floodplain on left bank.					
Further downstream from crossing (coords E 665522 N 5885750) footprint from proposed alignment will severely impact on floodplain storage.

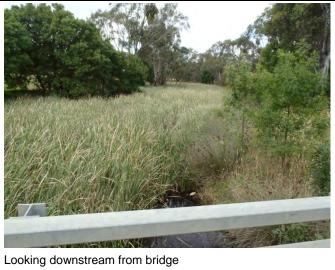
- Channel geometry	Channel width	20 m. Standing p	ool	approx. 0.6 – 0.8 m.		
- Channel gradient	0.3 %					
- Channel sinuosity	Sinuous; 1.35					
Banks	Well vegetated	k				
Instream Features	Stone riprap. Very large permanent pool.					
Floodplain Description	Large floodplain

Comment	Not much heig conditions.	Not much height between soffit of bridge and water level- esp. given site visit during dry summer conditions.

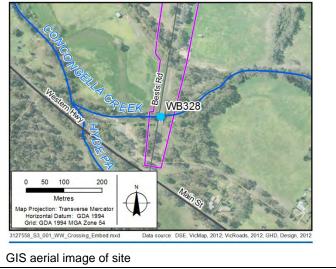
- Channel geometry	Channel geometry Wide channel, up to 20 m wide at Bests Bridge. Channel straight under bridge, begins to bend approx. 100 m downstream and 250 m upstream. Permanent pool of unknown depth under bridge. Island downstream of bridge.

- Channel gradient	0.2 %						
- Channel sinuosity	Low sinuosity; 1.06						
Banks	Gentle slopes, lightly vegetated with exposed sections. Some undercutting. Deposition of sands.						
Instream Features	Large pool under bridge. Vegetated island downstream of bridge. Bank attached bar.						
Floodplain Description	Constrained floodplain by Existing Highway on left bank.

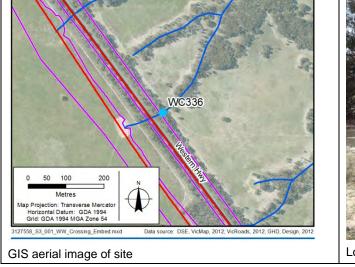
- Channel geometry	Unchannelled hillslope.						
- Channel gradient	3.6 %						
- Channel sinuosity	n/a						
Banks	n/a						
Instream Features	n/a						
Floodplain Description	No floodplain- confined; at top of hill.						
Comments	No culverts under Existing High	vay	sighted.

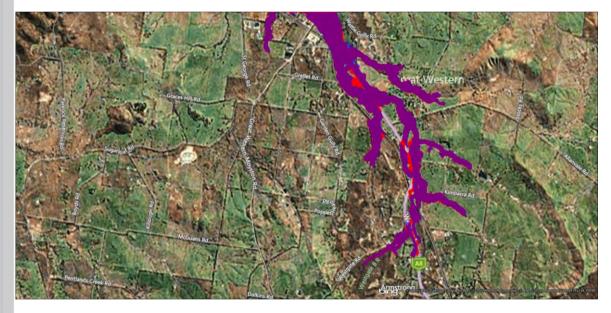
Figure 1: Comparison between iteration 2A design (blue) and existing (red) flooding

Both iterations show a 'no-worsening' in flooding for the most part with improvement in a number of

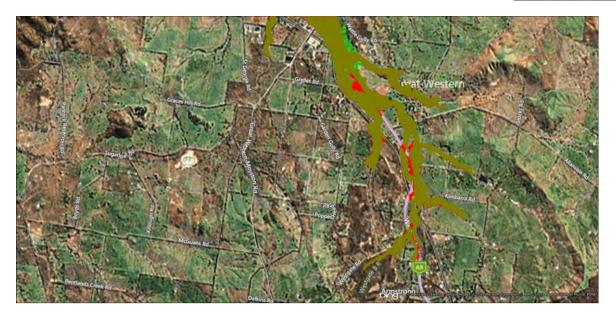
Figure 2: Comparison between iteration 2B design (green) and existing(red) flooding-Concongella Creek

areas. The bypass still holds back some of the flood water in 2A and does so significantly in 2B, which is by design. The effects of this detention can be seen in Great Western in Figure 3 and 4.

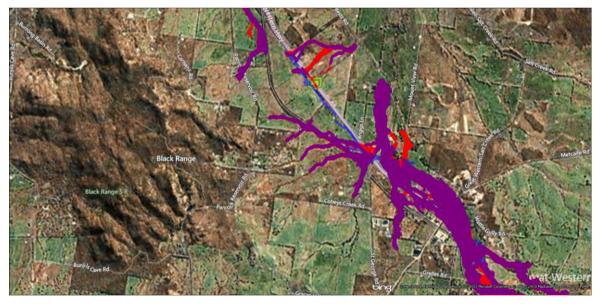
Figure 3: Comparison between iteration 2A design (blue) and existing (red) flooding

Both iterations have slightly reduced the flooding in Great Western – the flood extents are seen here, but the effect would translate to flood depths as well.

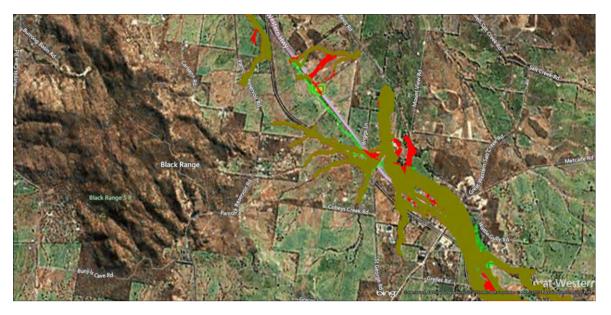
Figure 4: Comparison between iteration 2B design (green) and existing (red) flooding

In both iteration instances there is flood water running parallel to the highway from north to south above Concongella Creek, this is due to inadequate culvert capacity allowing the water to cross the road and should be addressed prior to design.
