MORDIALLOC FREEWAY PROJECT

Quarterly Construction Audit

Report 1, March 2020

Quarterly Construction Audit, March 2020

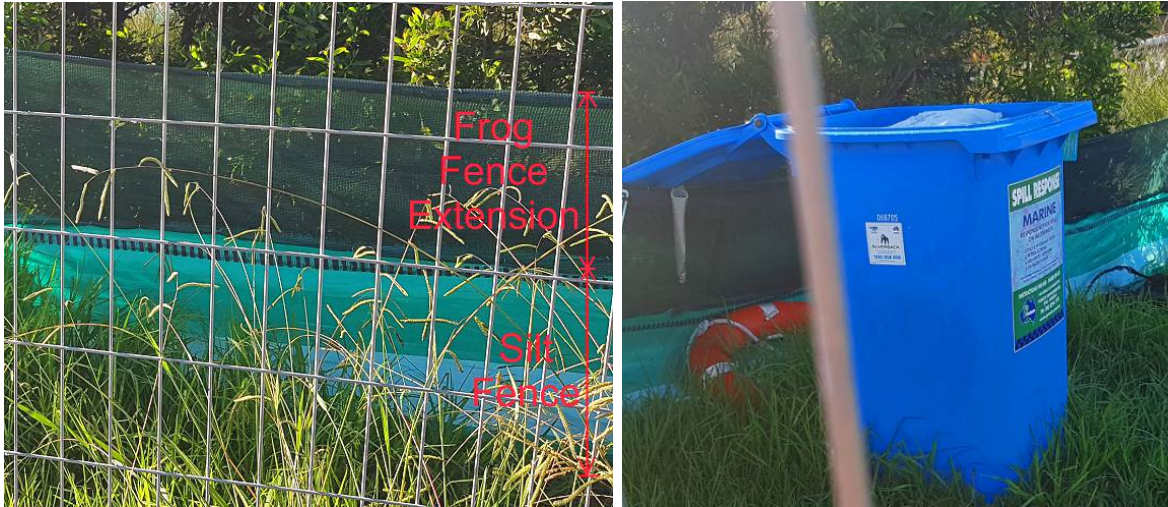
Left: Example of the combined sediment and frog fence south of Bowen Parkway
 Right: Marine spill kit in use around the waterways.

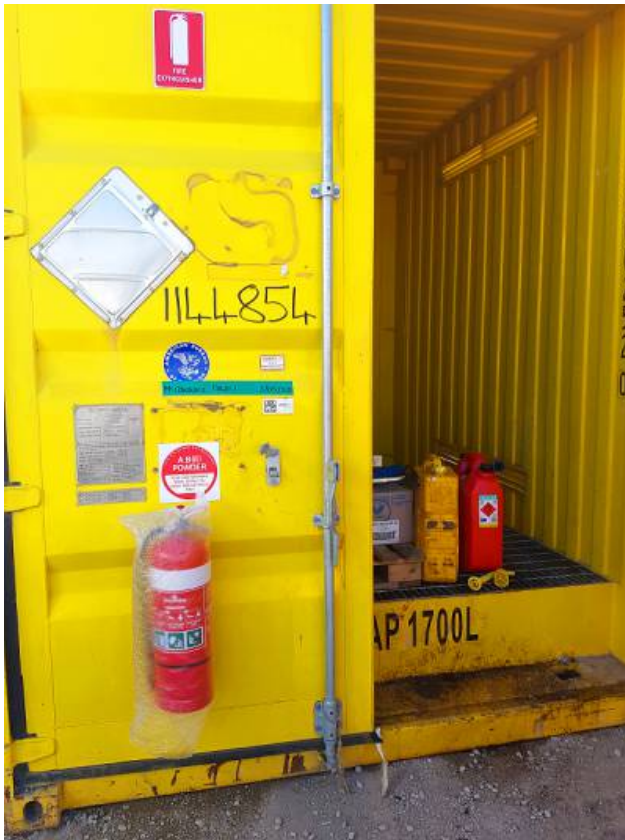
Left: The flammable goods container at the Governor Rd Compound. Note the missing DG diamond. Also note the close proximity of the fire extinguisher to the flammable materials. This would make it difficult to access the fire extinguisher in case of a fire.

- 10. A dangerous goods diamond label should be fixed to the front of the dangerous goods container at the Governor Road compound.**
- 11. Flammable gases and flammable liquids should not be stored in the same container. A dedicated flammable gas cabinet should be purchased.**
- 12. Fire extinguishers should not be stored inside Dangerous Goods containers and ideally, not on the container itself. Labelled fire extinguisher stations should be established approximately 2 m away from each Dangerous Goods container.**

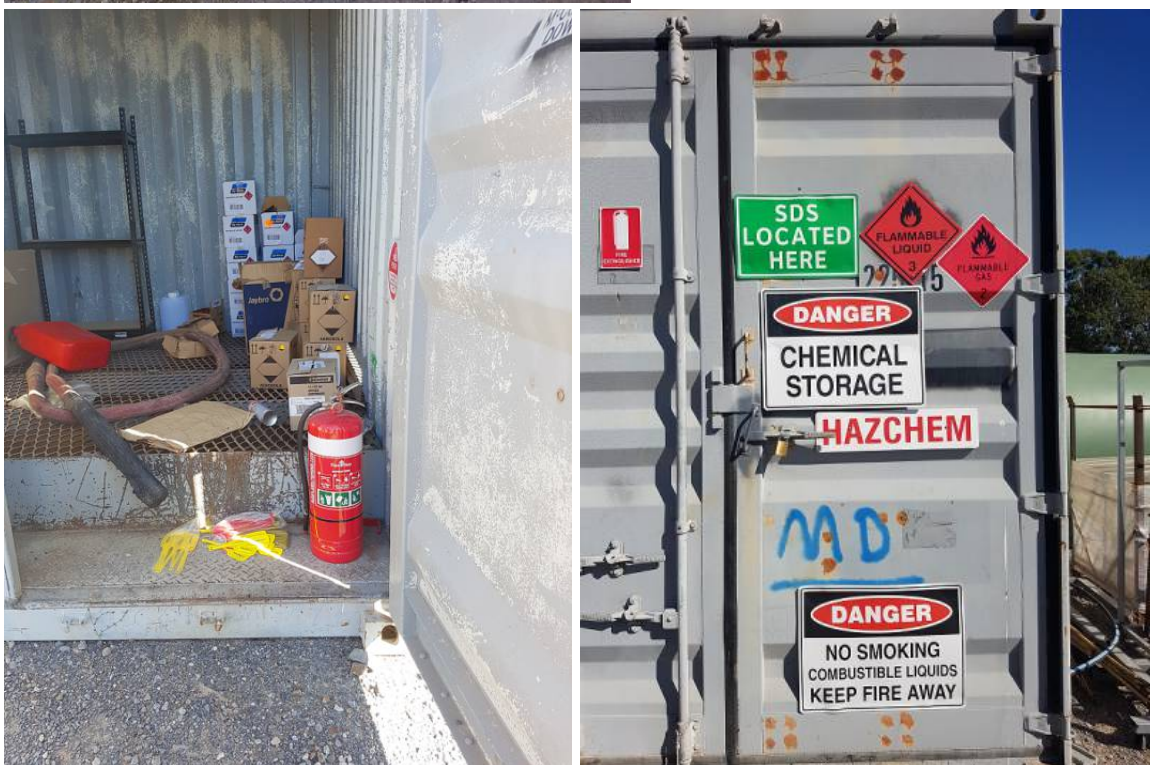
Left: Fire extinguisher inside the Dangerous Goods container at the Woodlands compound, making it impossible to retrieve in case of a fire in the container.

Right: The outside of the Dangerous Goods container at the Woodlands compound indicating that flammable gases and flammable liquids would be stored together, contrary to regulatory requirements that these materials be segregated. The container held boxes of pressure pack cans and several empty petrol jerry cans.

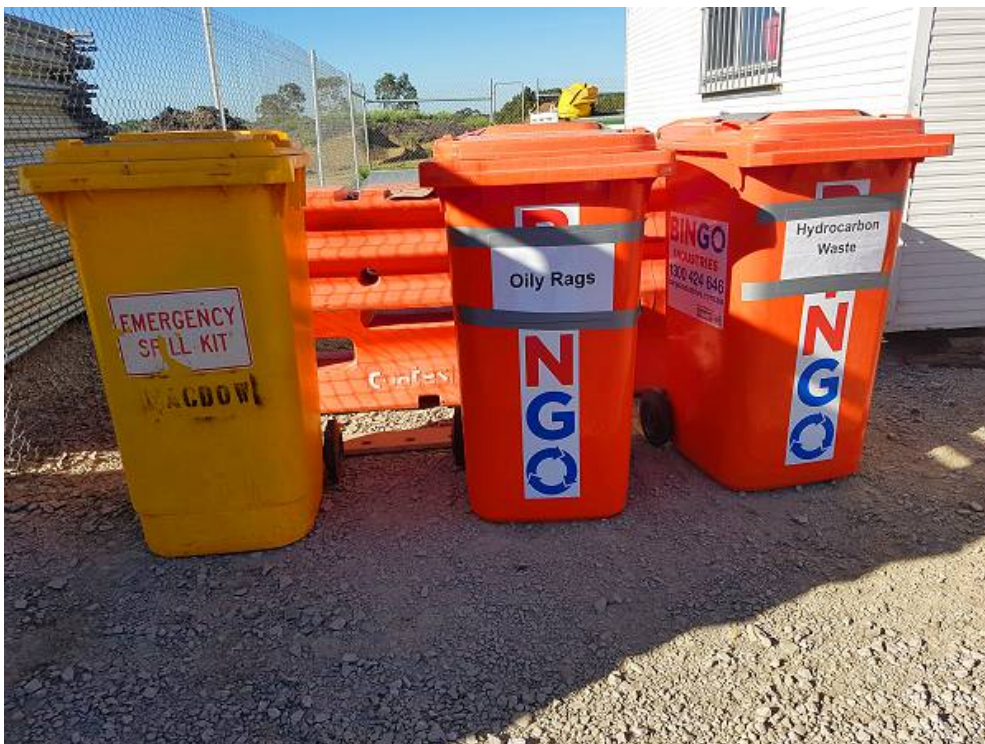
Above: A good example of well labelled and accessible waste bins and spill kits– Governor Road Compound.

13. The Project should review the labelling of waste bins and the availability of spill kits near to compound generator fuel tanks. The actions taken at the Governor Road compound could be used as an example of good practice.

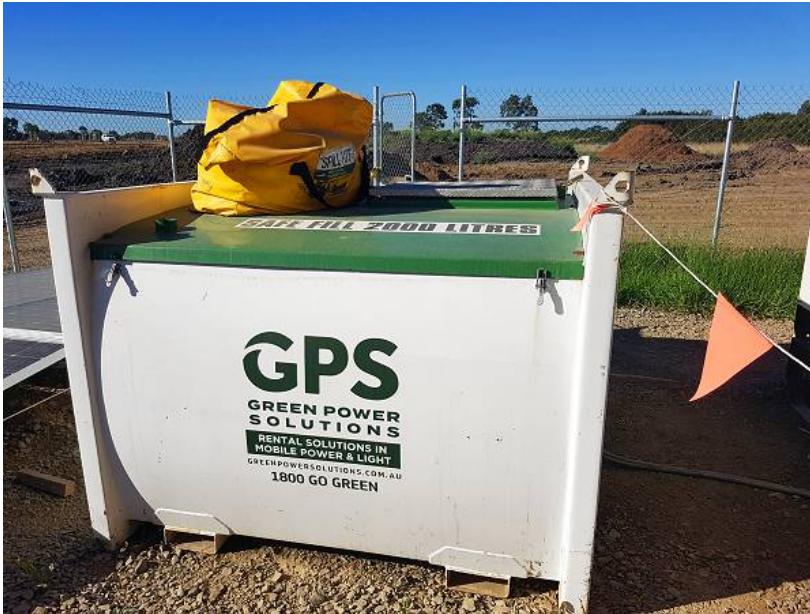
Left: Spill kit on the Governor Road generator fuel tank, ready for use in case of a spill during refueling.

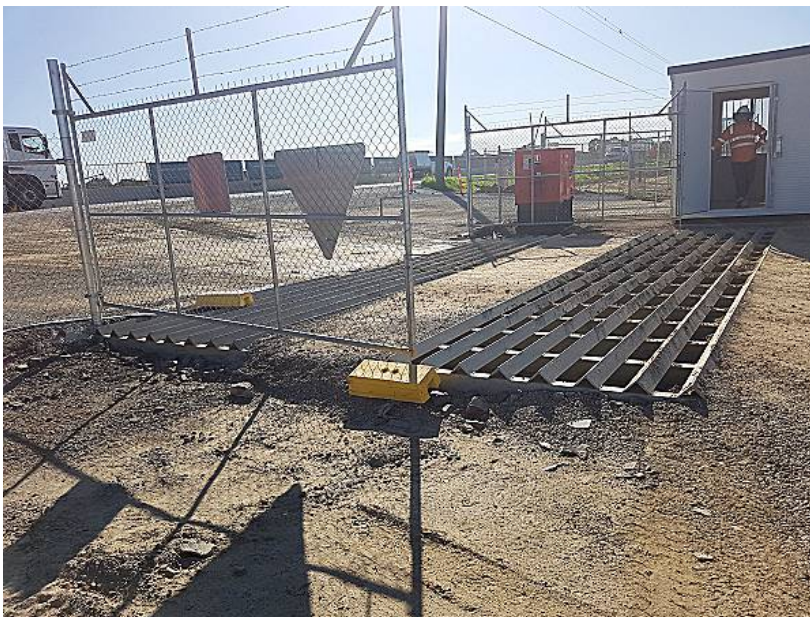
Left: Rumble Grid at exit of Governor Road compound.

It was noted during the inspection that truck drivers are required to leave their vehicles in an inspection area just prior to the site exit and inspect their vehicle to ensure no rocks have been caught between the dual tyres. However, it was also noted that a significant amount of

dust was on the roadway in front of the Governor Road exit. On average, 200 to 250 trucks per day reportedly pass through the site and this number has been as high as 400 truck movements per day. In many instances, the vehicles consist of both truck and trailer. The exit to the site is fitted with two rumble grids (refer to photograph above). However, observation found that the grids are too narrow and that that trucks are able to pass over each grid in less than one tyre rotation, which reduces the efficiency of cleaning the vehicles.

It was also found that the short section of road from the exit of the rumble grids to Governor Road was unpaved and loose. Reportedly, the site has attempted to stabilise this area, however, the trucks need to make a sharp turn onto Governor Road and the truck tyres very quickly break up the surface, which contributes to the dust carried by the trucks onto Governor Road. Street sweepers are in use, however, it appears their effectiveness is limited given the amount of dust transported onto the roadway by the large number of truck movements.

- 14. More effective truck cleaning facilities need to be installed at the Governor Road compound exit. A method needs to be developed and implemented so the trucks don't become recontaminated after cleaning, particularly the section intersecting Governor Road where the trucks begin their turn. Entry and exit points to other sections of the Project should also be reviewed for the same potential issues, the effectiveness of existing controls and the risk posed given the site specific circumstances.**

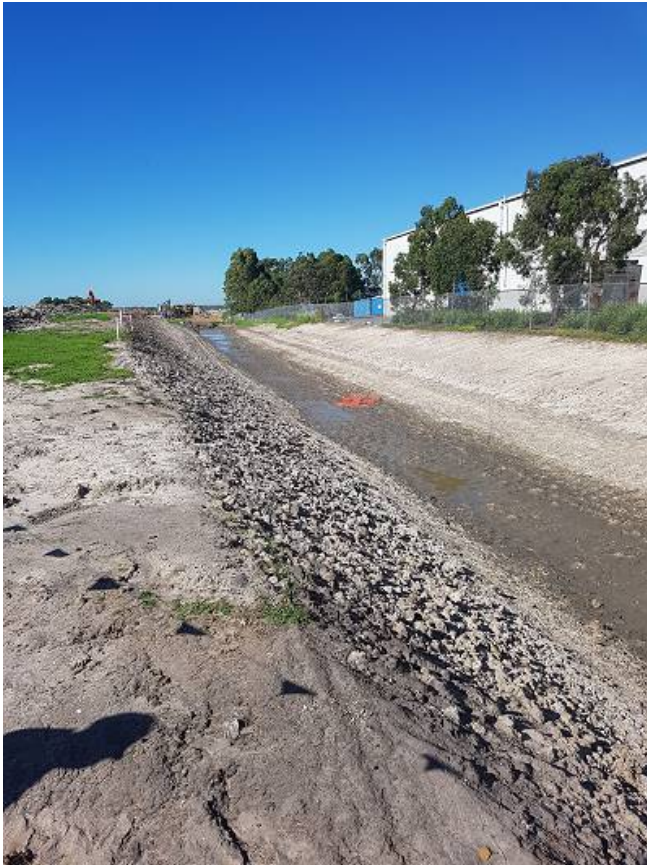
Left: An example of one of the large swales used to successfully contain storm water run-off during normal rain events over the summer period.

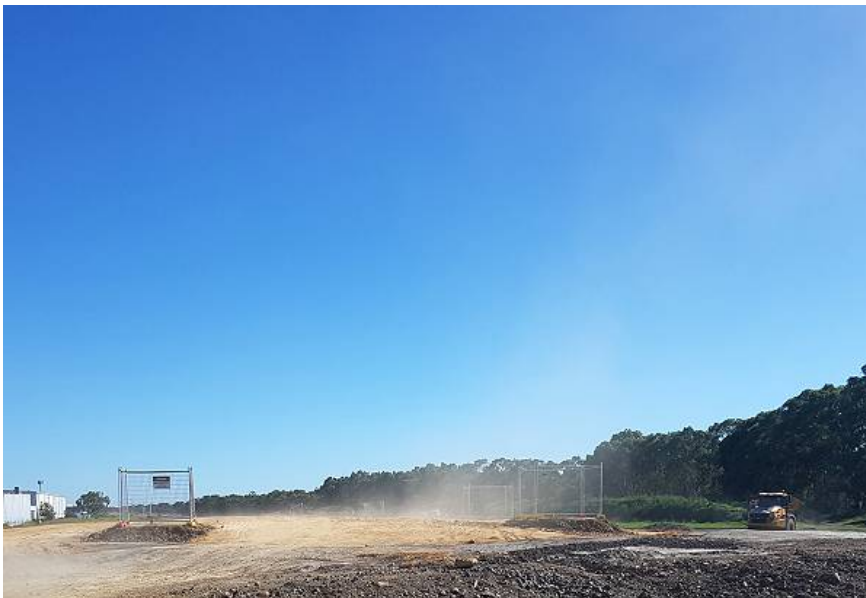
Left: Wind blown dust after a truck had passed – north of Park Way entrance. It was noted that the section of the access road south of the Park Way entrance appeared damp, while the Park Way entrance and the section north of the entrance appeared dry and truck movements generated significant dust.

- 15. The current use of the four water carts should be reviewed to determine if they could be scheduled to provide more effective and regular coverage of the Project site. Supervisors should also be requested to assess and report on the speed of heavy vehicles and if the speed appears excessive.**

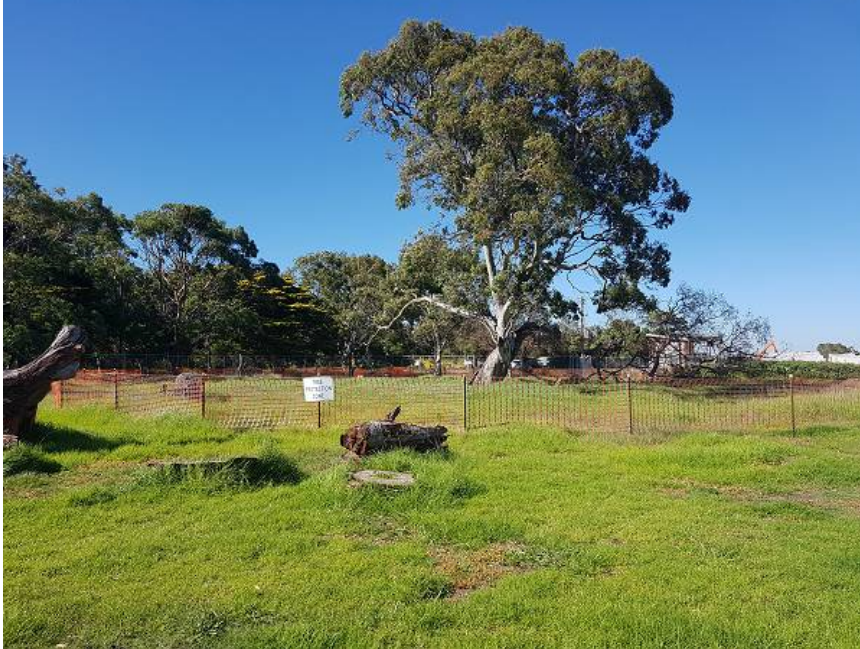
Left: Example of “No-Go” Zone fencing around a large gum tree west of the Parks Victoria compound.

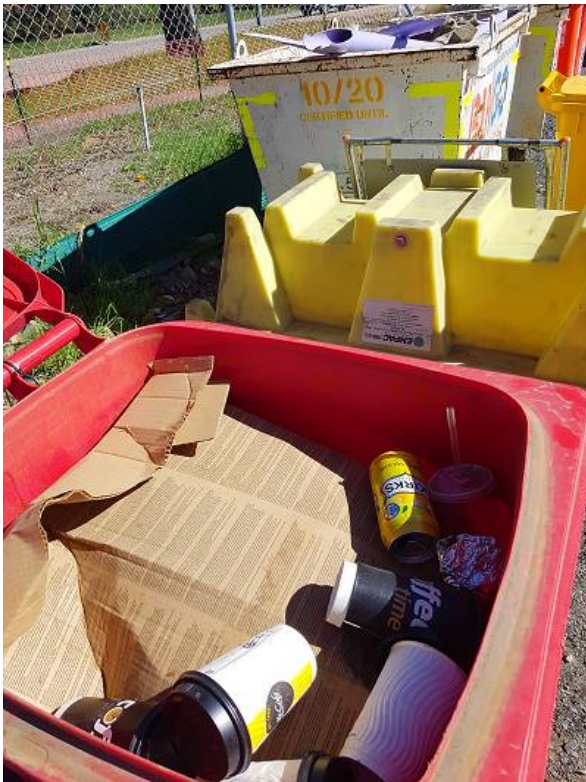
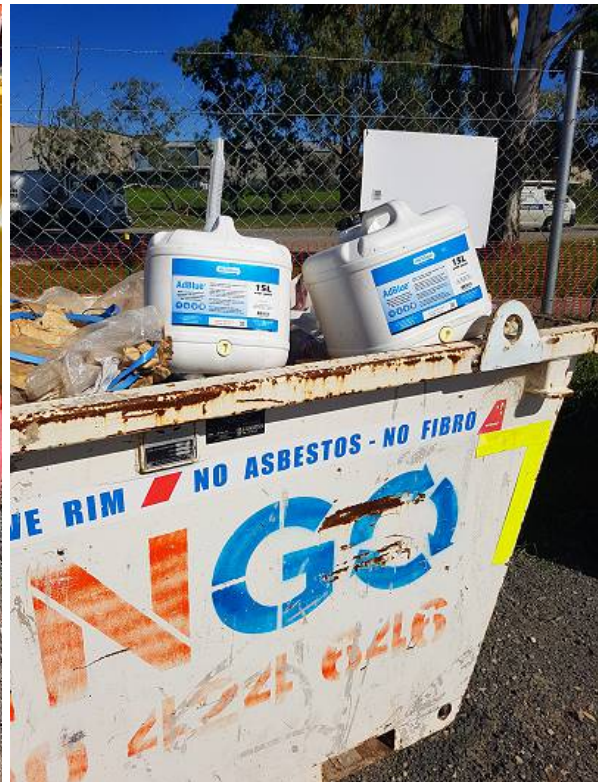
Left: Rubbish placed in spill kit container at the Woodland Drive compound. The general waste bin is in background, 2m away.

Right: Empty containers of a diesel fuel additive were in the general waste bin at the Woodland Drive compound. It is unclear if these containers should be treated as a general waste or a contaminated waste.

- 16. Toolbox sessions should be used to remind all employees and contractors that spill kits are not rubbish bins.**
- 17. The Project should obtain breakable ties and seal all spill kits. The daily inspections should then check any kit that has a broken seal, restock the kit if necessary and reseal the kit.**
- 18. The Project should check to see if empty Adblue diesel additive containers can be disposed of as general waste, or need to be disposed of as a contaminated waste.**

Recomm. No.	Type	Recommendation	Priority
18.	OI	The Project should check to see if empty Adblue diesel additive containers can be disposed of as general waste, or need to be disposed of as a contaminated waste.	B

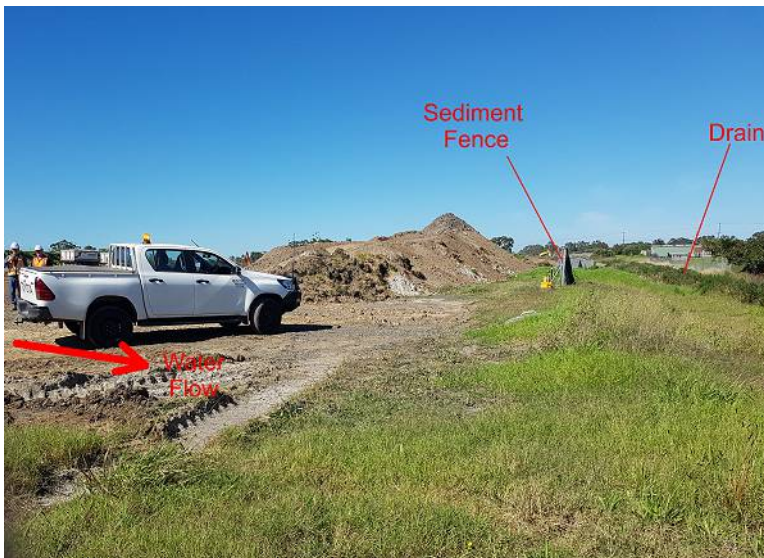
Left: A sediment fence has been installed down slope from a stockpile – south of Zone 1, Gate 4. However, the site slopes towards the west and sediment can be seen collecting along the edge of the grassed area. It would be prudent to extend the silt fence further north to ensure the drain running just outside the construction boundary is protected.

- 19. The sediment fence down slope from the stockpile south of Zone 1, Gate 4 should be extended northwards in order to prevent any run-off entering the nearby swale drain during heavy winter rains.**

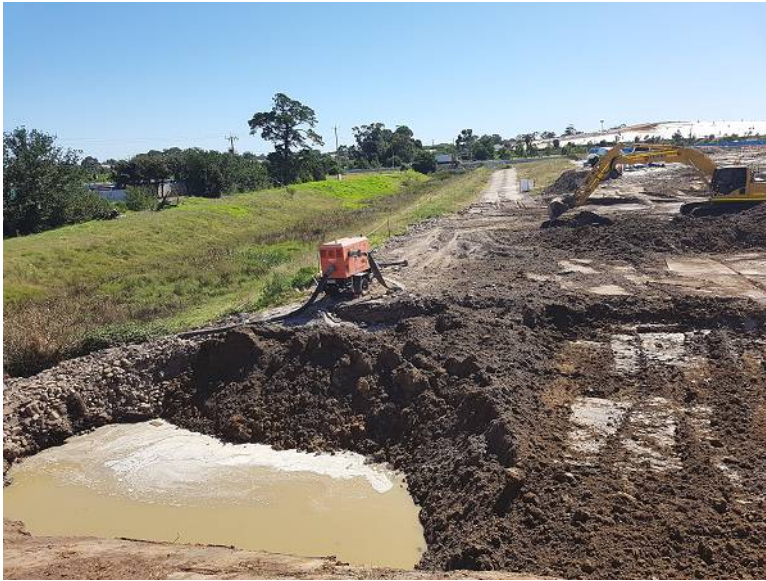
Left: Sediment laden water has collected in the western end of the blocked Old Dandenong Road Drain. This water should not be discharged off site without treatment, or it should be used on-site for dust suppression.

20. The Project should ensure the sediment laden water which has collected in the western end of the blocked Old Dandenong Road Drain should either be treated before it is discharged, or preferable, used on-site for dust suppression.

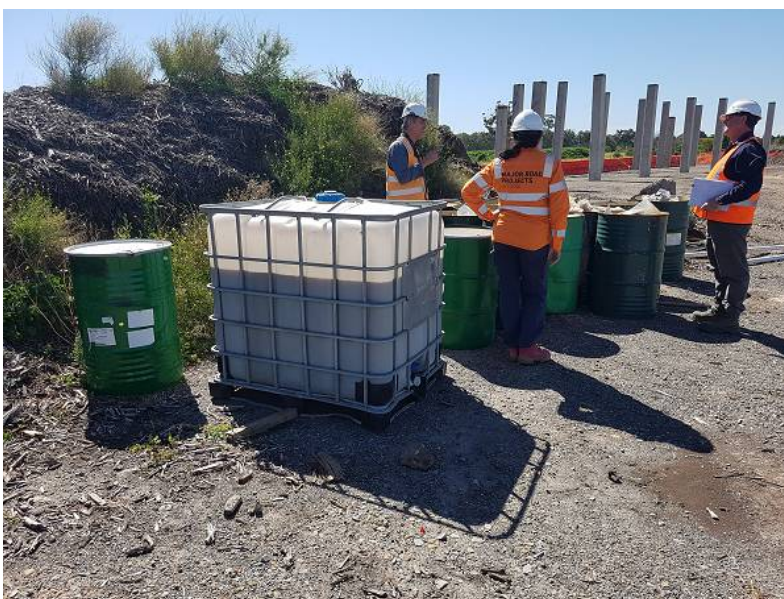
Left: Several 205L drums and a 1000L IBC container were found on the west side of the Landfill piling operations. They appear to be filled with drilling waste (mud and dirty water) and should be disposed of.
