North East Link Program – Central Package

IEA Six-Monthly Environmental Compliance Report – May to October 2022

A Report to the Minister for Planning

NEL-CNT-AAA-2990-EEE-REP-0001

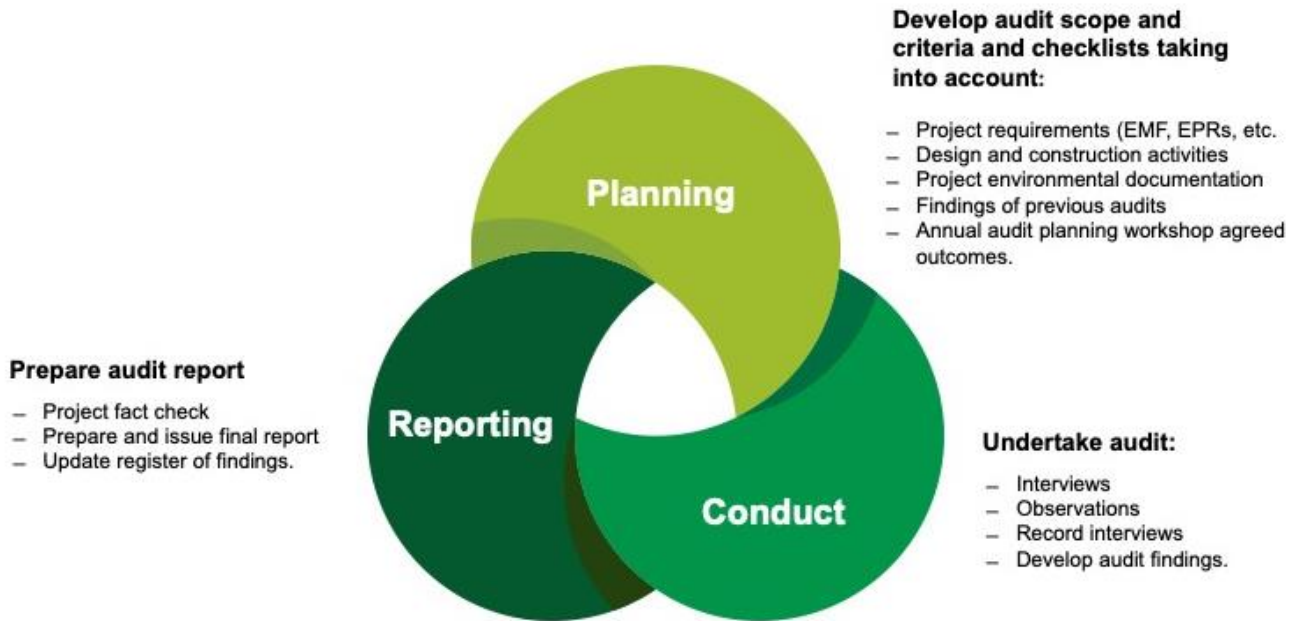
Figure 3: Audit process

The audit planning process for each environmental audit includes defining the objectives, scope, criteria, and additional information. The overall process for each audit is given in **Figure 3** below.

Each audit includes:

- Review of relevant Spark environmental records
- Interviews with relevant Spark environment and site personnel
- Observation of construction activities.

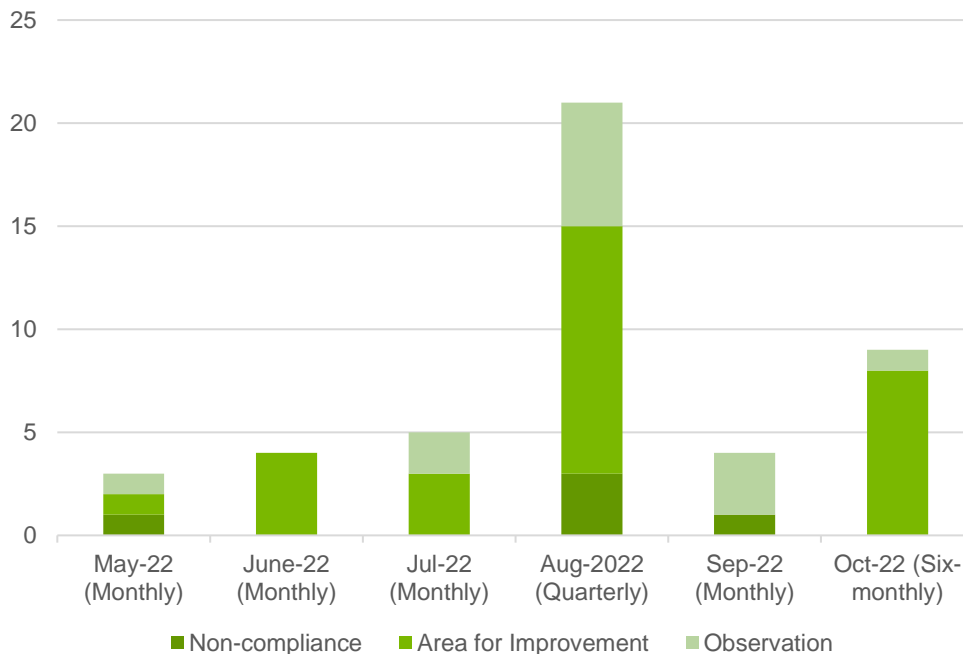
Figure 4: Audit findings by type and audit date (Project commencement to October 2022)

Most of the audit findings were raised in the August 2022 quarterly audit, which assessed compliance against the requirements of most of Spark’s environmental documentation, and the requirements of selected EPRs (see Figure 4).

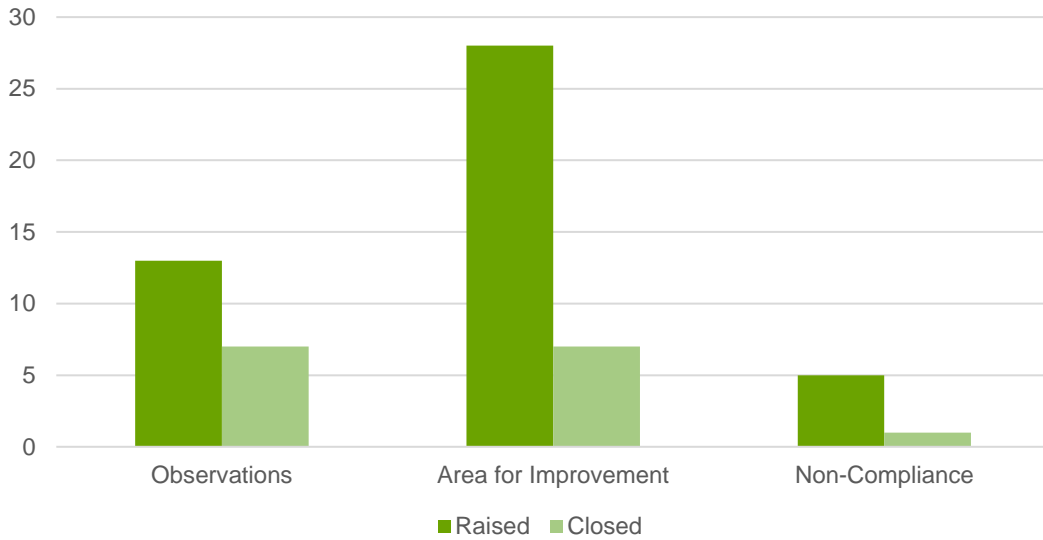
Figure 5: Cumulative audit findings raised and closed - Project commencement to October 2022

Spark D&C established corrective actions to address the audit findings. During the reporting period fifteen (15) findings were closed comprising of seven (7) Areas for Improvement, seven (7) Observations, and one (1) Non-compliance (see Figure 5).

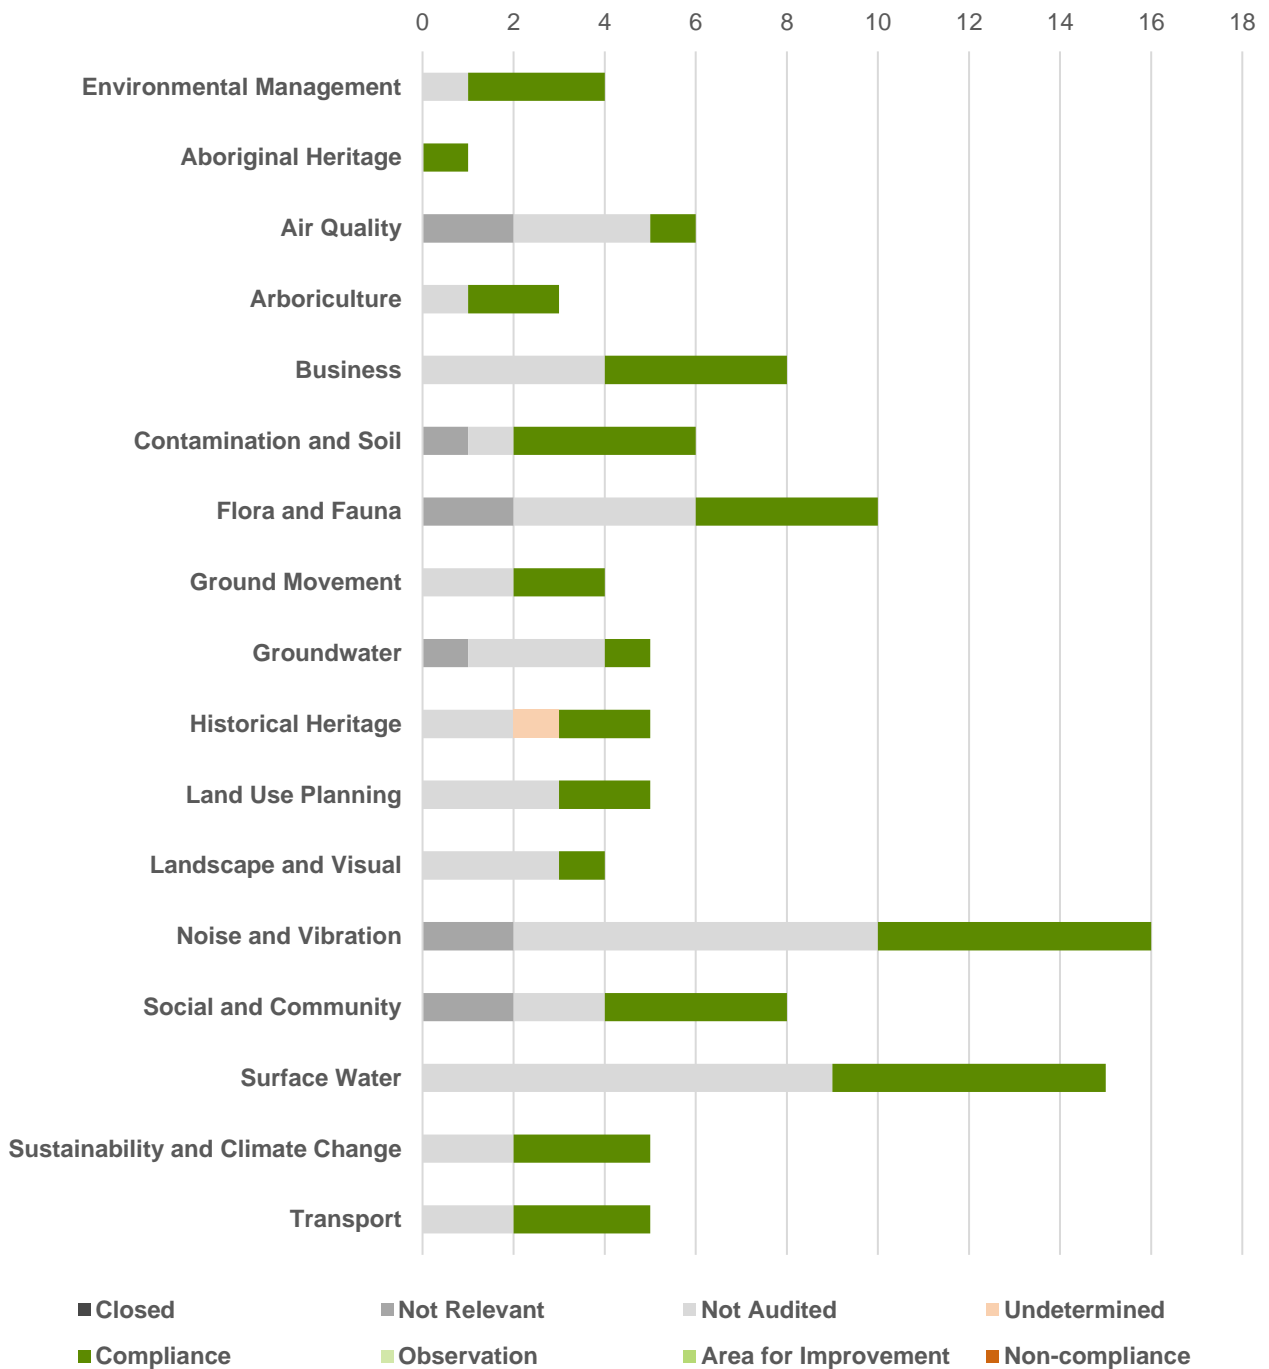
Figure 6: EPR audit findings by EPR category May - October 2022

As each EPR category includes several EPRs, some of these were not included in the audits in the reporting period. All environmental issues are audited through the audits of Management Plans.
