Calder Park Drive and Holden Road

LEVEL CROSSING REMOVAL PROJECT

000 - Multiple Sites **Victorian Grassland Earless Dragon Habitat Assessment - Calder Park Drive and Holden Road, Calder Park**

LXRP-LX14-000-0-00-PA-RPT-0005

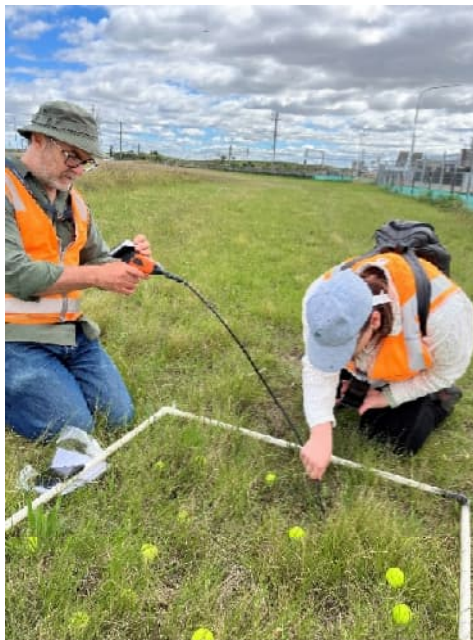
Plate 3 Habitat assessment and inspection of spider burrow, Banchory Grove Reserve (Dec 2023)

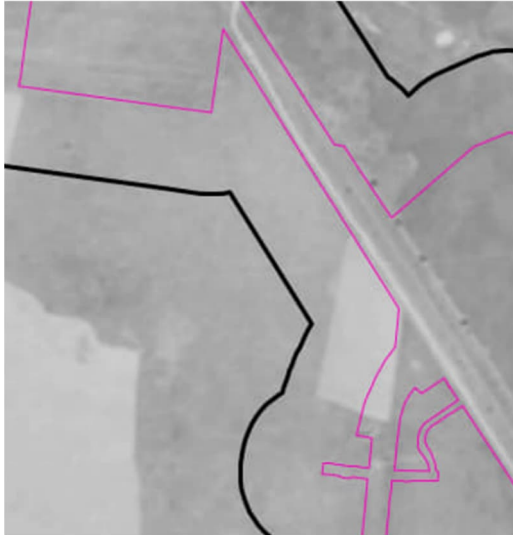
Figure 7 Close-up image of Banchory Grove Reserve in 1968, with division of cropping/grazing parcels evident

Banchory Grove Reserve appears to have been used for agriculture and potentially residential development. There is clear agricultural division in the 1968 image (Figure 7). Whereas in the 1991 imagery there is a large structure encircled by tracks in the north-east corner that is now the T-junction of Victoria Road and Calder Park Drive (Figure 10). This structure is absent in 1985 and 2001 imagery (Figures 8 to 11). It is possible that the temporary structure is related to the construction of the residential development to the south as there are connecting tracks/roads (e.g. building/sale office). There is also a small structure or possibly a dam in the south-east corner (adjacent to now Calder Park Drive) in the 1985 and possibly in the 1974 imagery (Figure 8, Figure 9).

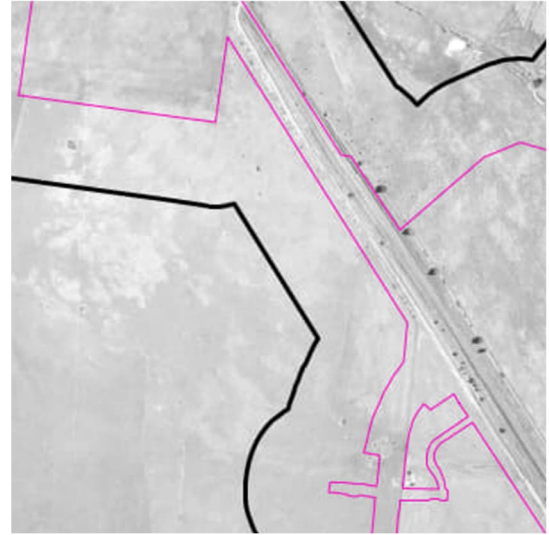
Figure 8 Close-up image of Banchory Grove Reserve in 1974

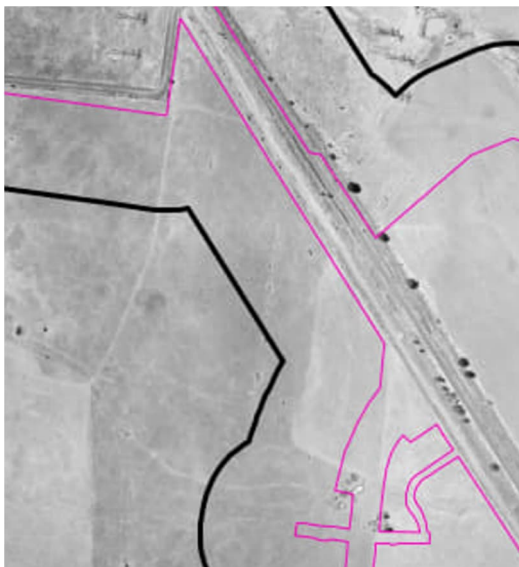
Figure 9 Close-up image of Banchory Grove Reserve in 1985, with a dam or structure in south-west corner

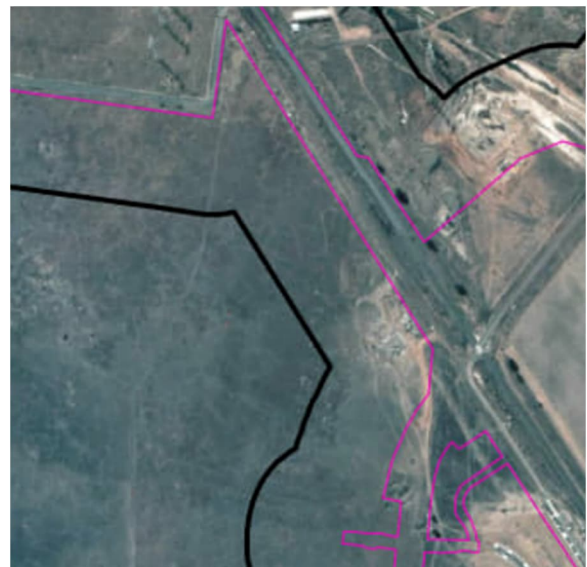
Figure 10 Close-up image of Banchory Grove Reserve in 1991, with large structure in north-east corner probably linked to the residential development in right-hand bottom corner of image

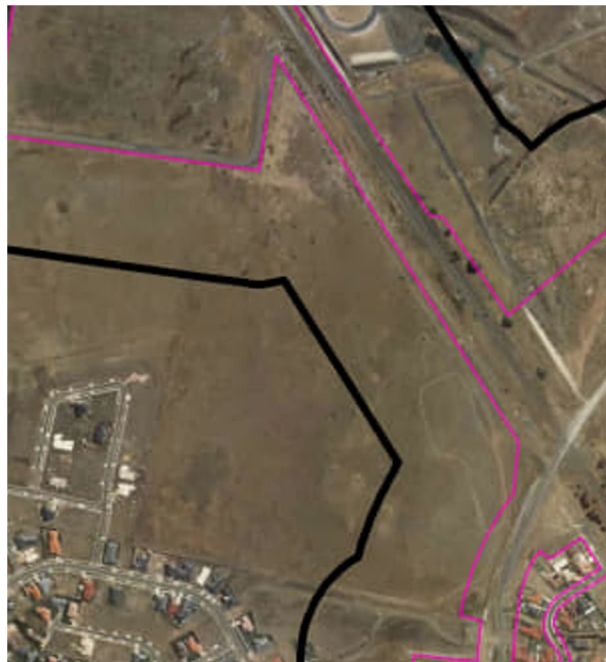
Figure 11 Close-up image of Banchory Grove Reserve in 2001, post protection, but with tracks from 1991 development in north-east corner and disturbance in south-east corner still evident

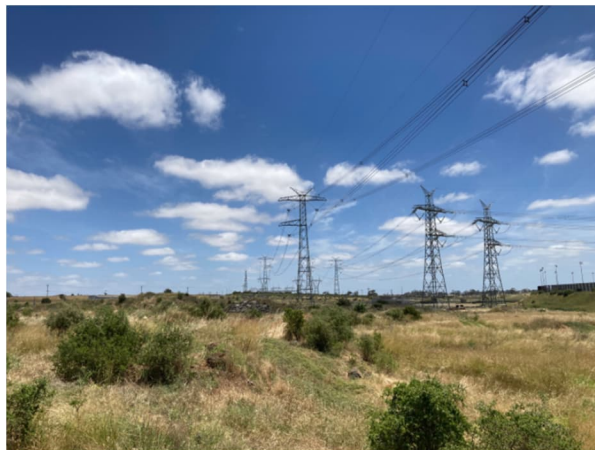
Plate 4 Highly degraded land from earth works associated with transmission line infrastructure and the thunder dome

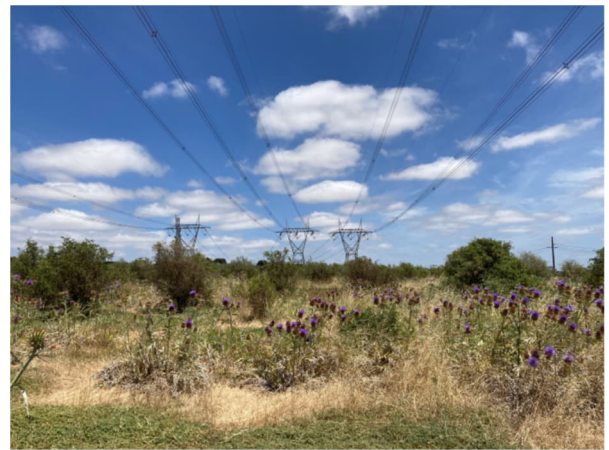
Plate 5 Ausnet paddock with significant transmission line infrastructure and dominated by African box thorn and Artichoke Thistle

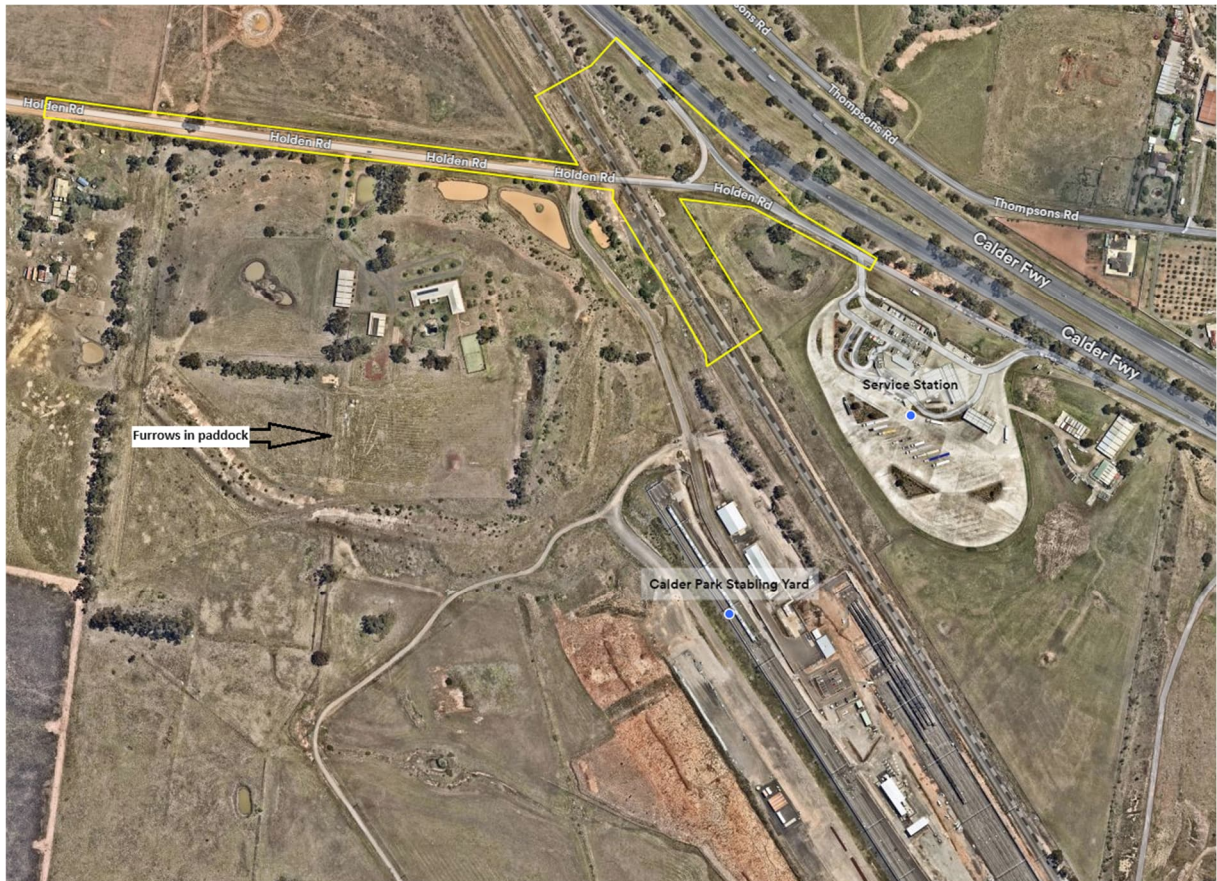
Figure 19 NearMap December 2023 – northern construction footprint (yellow line) (Holden Road)

Figure 19 is a 2023 NearMap image of the Holden Road level crossing area showing disturbance to the paddocks that are now the site of the Calder Park Stabling Yard, the service station development on the Calder Freeway and the road and rail network. Furrows can be seen in remaining paddocks. All of these features contribute to the isolate and degradation of the area.

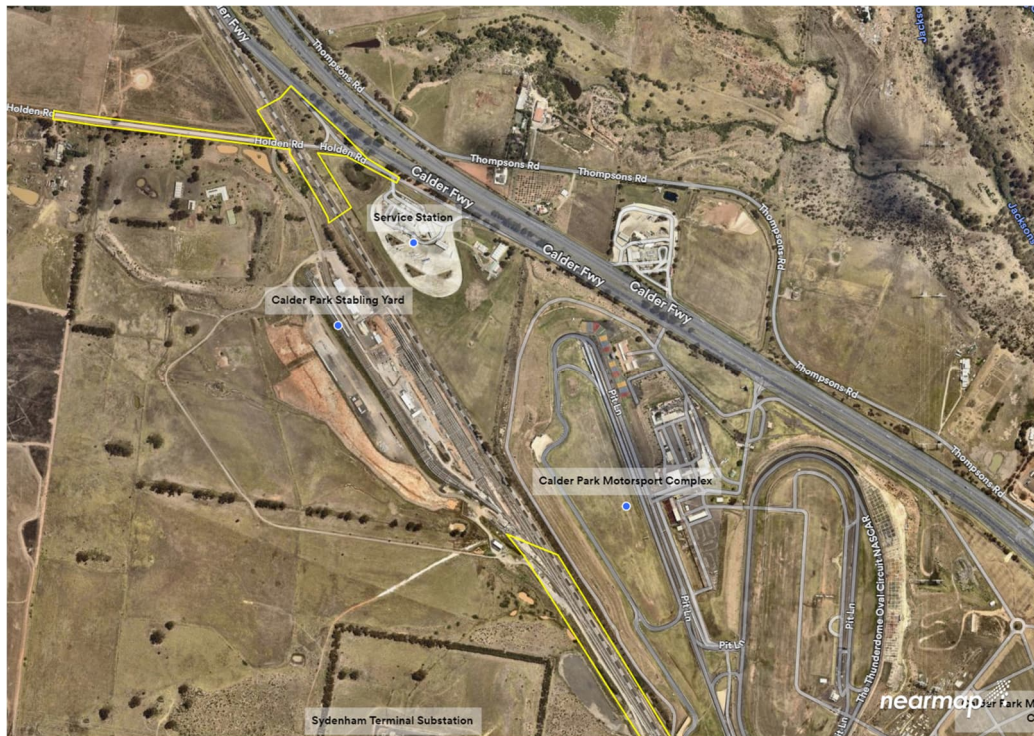
Figure 20 is a NearMap image from December 2023 of the northern section of the construction footprint that shows the disturbed and isolated environment of the rail corridor between the Calder Freeway outbound service station and the Calder Park Stabling Yards and the disturbed environment of the remaining landscape.

Figure 20 Northern construction footprint (yellow line) (Holden Road) in December 2023 (source: NearMap)

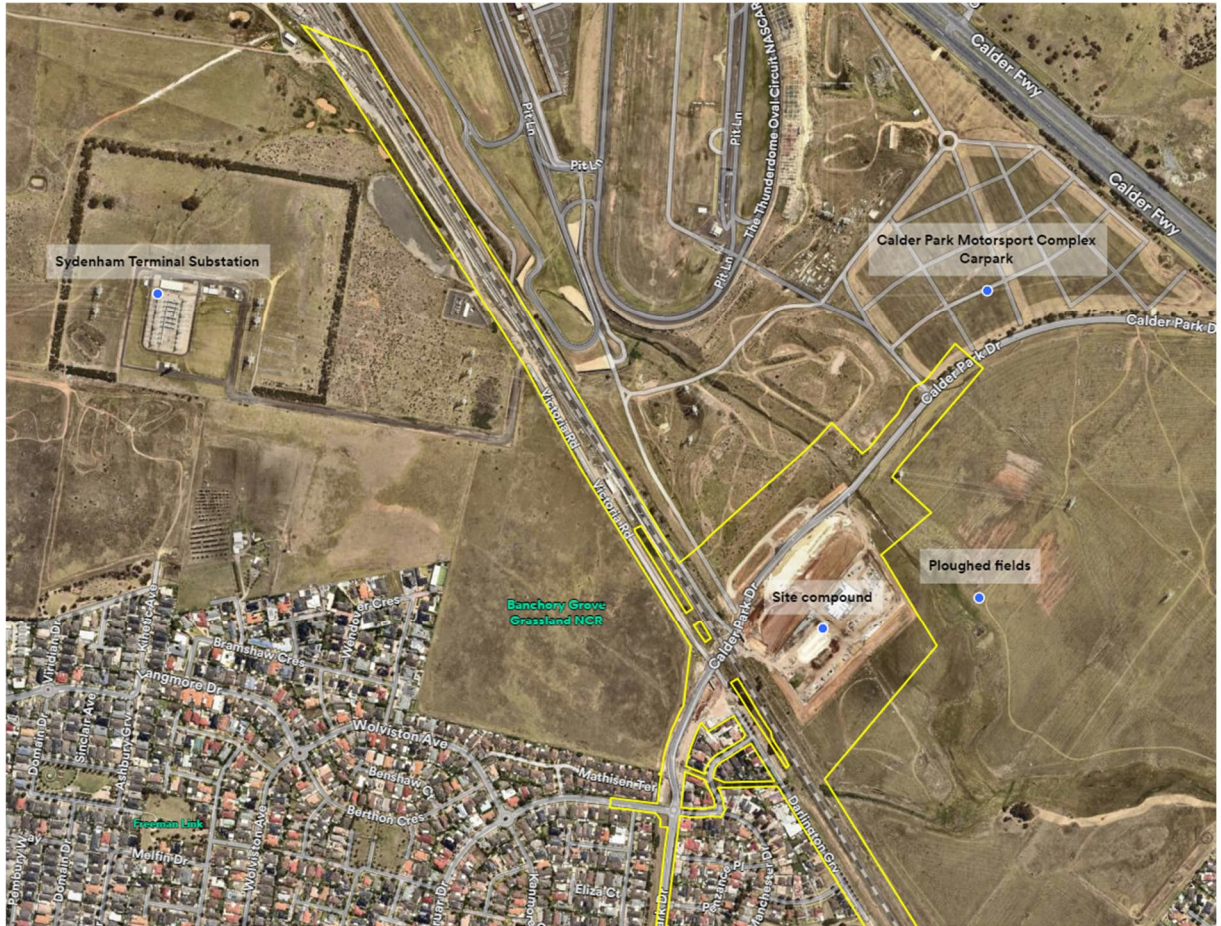
Figure 22 Southern construction footprint (yellow line) (Calder Park Drive) in December 2023 (Source: NearMap)

Figure 22 is a NearMap image from December 2023 of the southern section of the construction footprint shows the level of disturbance in the landscape. The slashed agricultural paddocks to the east of the rail and Calder Park Drive, the landfill and disturbed land associated with the Calder Park Motorsport Complex to the north of Calder Park Drive and the rail corridor, residential areas to the south, and the disturbed area in the east of Banchory Grove Reserve adjacent to the construction footprint.

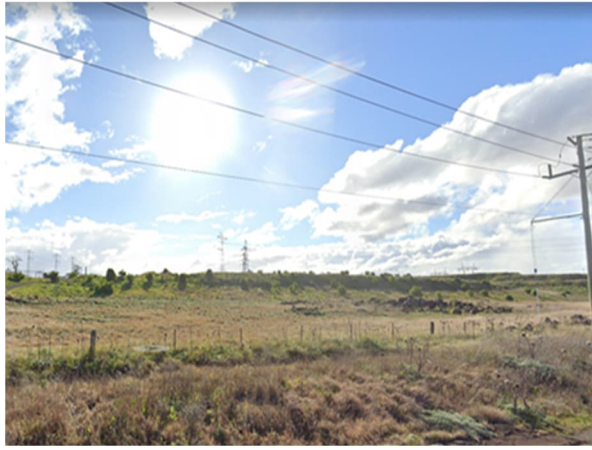
Plate 6 Former paddock north of Calder Park Drive and the site compound in the Calder Park Motorsport Complex property. Large earth bund and stockpiling of material can be seen. Area dominated high threat weeds.

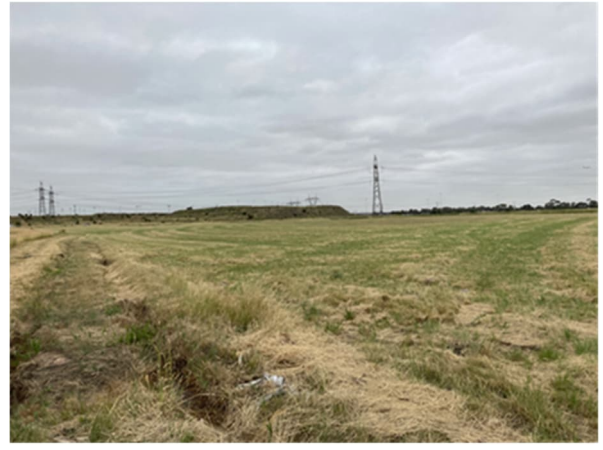
Plate 7 Location of site compound south-east of Calder Park level crossing. Paddock recently slashed and contains minimal sheltering habitat such as cracks, embedded and surface rock. Large earth bund north of Calder Park Drive can be seen in the background.

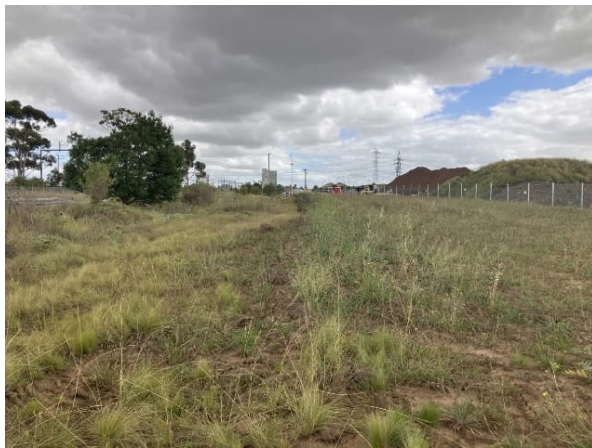
Plate 8 Former paddock and heavily weeded area between site compound and railway (Feb 2024)

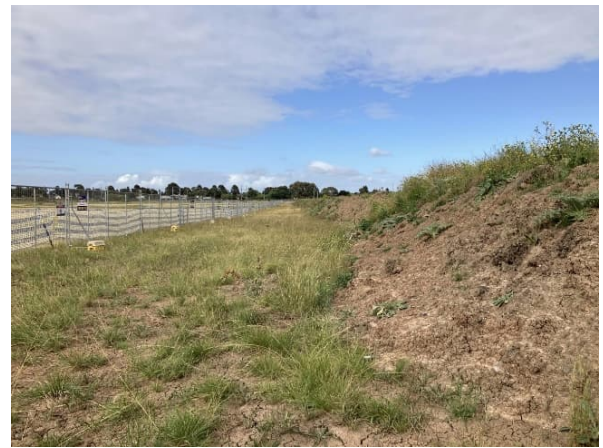
Plate 9 Former paddock southeast of site compound (Feb 2024)

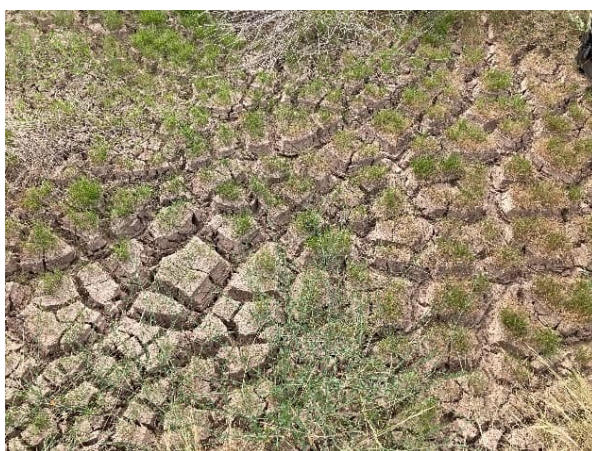
Plate 10 Soil cracking in former paddock southeast of site compound (Feb 2024)

Cracking in soil was minimal and not visible in many places due to high biomass (i.e., invasive species). Whereas cracking was high adjacent to the site compound possibly due to a long history of soil disturbance. A lot of rail ballast in the rail corridor indicates that these are not natural landforms. Large and small piles of rocks were artificial.

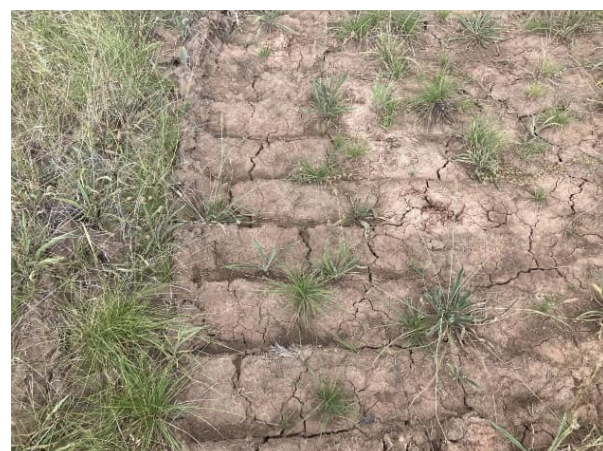
Plate 11 Vehicle tracks and other old and recent soil disturbance in former paddock southeast of site compound (Feb 2024)

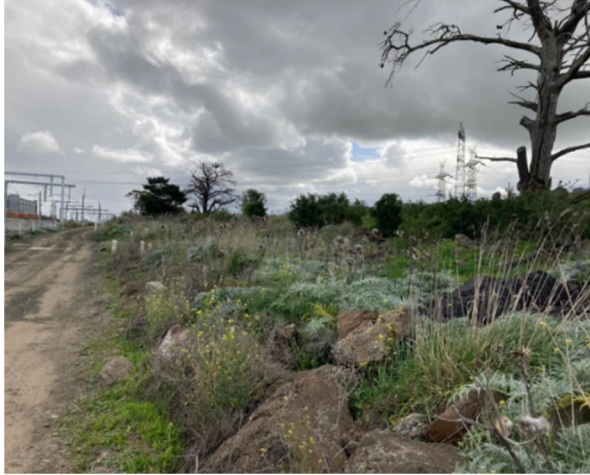
Plate 12 Past earth works within the rail corridor indicated by large rocks and weed infested earth bund

The rail corridor portion of the construction footprint has been substantially disturbed by rail construction works and ongoing maintenance. The corridor is narrow and dominated by weeds including introduced grasses and Artichoke thistle. Evidence of weed poisoning was observed during survey. The natural landform is disrupted by rock piles, rail ballast, earth piles, management tracks and illegally dumped rubbish alongside management tracks where accessible.

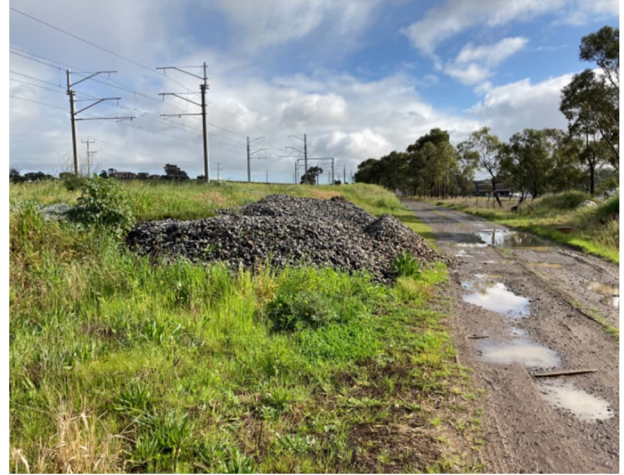
Plate 13 Material stock piling in the rail corridor

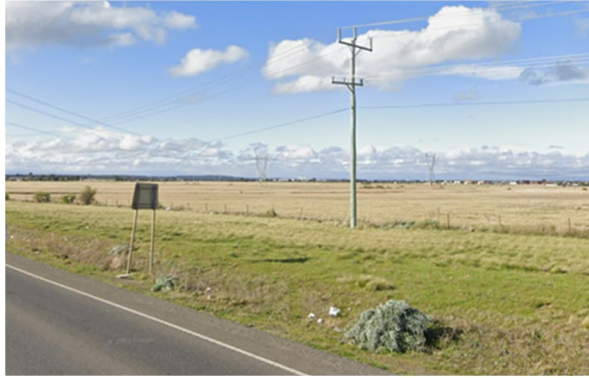
Plate 14 Roadside of Calder Park Drive contains minimal sheltering habitat such as cracks, embedded and surface rock

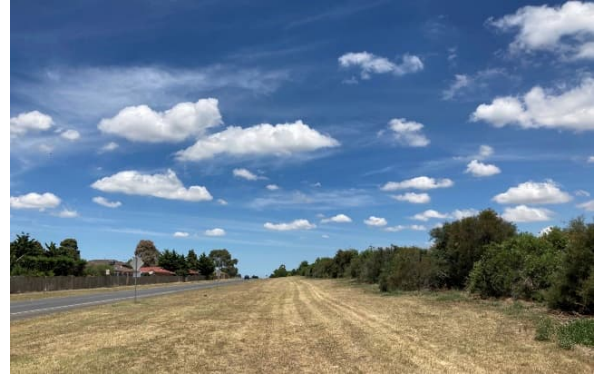
Plate 15 Roadside of Calder Park Drive south of Glenbruar Drive. Highly modified but retains required floristic cover for EVC Plains Grassland. Sheltering habitat such as cracks, embedded and surface rock absent.

Quadrat sampling during the species-specific habitat assessment noted that areas previously mapped as modified Plains Grassland south of Glenbruar Drive were not apparent at the time of survey (Plate 20). The quadrat survey was unable to sample sections of the Calder Park Drive roadside due to construction works and in February 2024 the entire verge being mown, however, sampling south of Glenbruar Drive in January 2024 indicates the roadside was dominated by *Bromus* sp. and *Chloris* sp. with only scattered tufts of Kangaroo Grass (*Themeda triandra*) (Plate 22, Plate 23). Kangaroo Grass was the only native species observed and within the quadrats most often constituted 1-5%, with maximum being 10%.

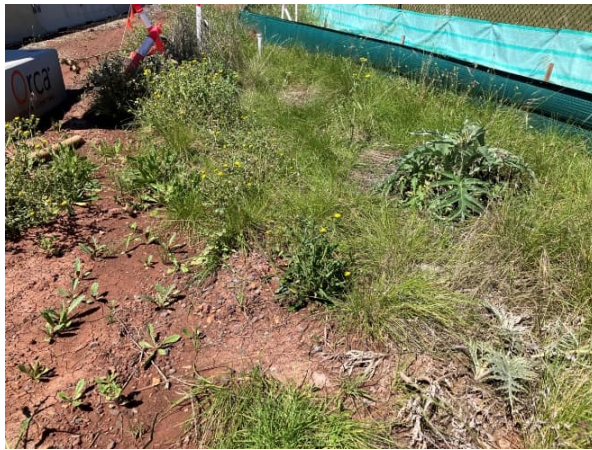
Plate 16 Calder Park Drive roadside south of level crossing – HZ3 area of high weed cover (January 2024)

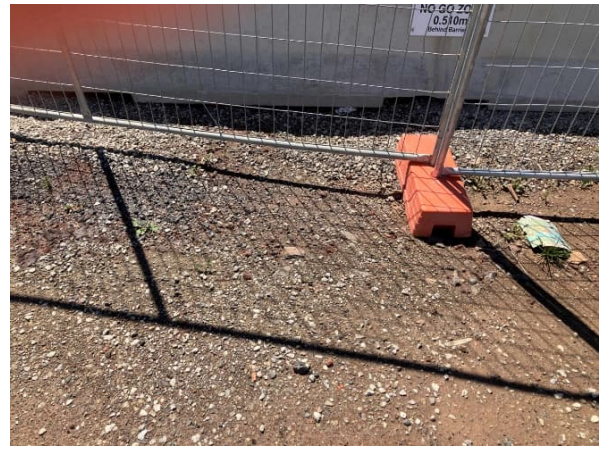
Plate 17 Calder Park Drive roadside south of level crossing – area of HZ14 highly disturbed (January 2024)

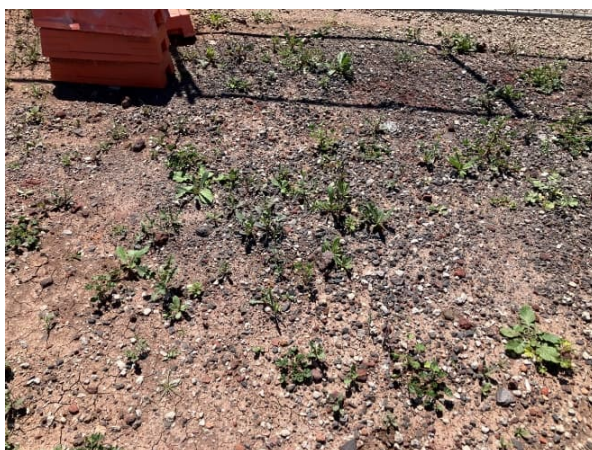
Plate 18 Calder Park Drive roadside south of level crossing – area of HZ14 highly disturbed (January 2024)

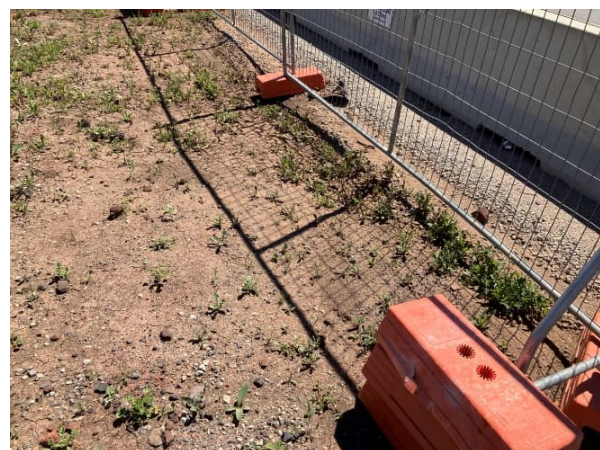
Plate 19 Calder Park Drive roadside south of level crossing – area of HZ14 highly disturbed (January 2024)

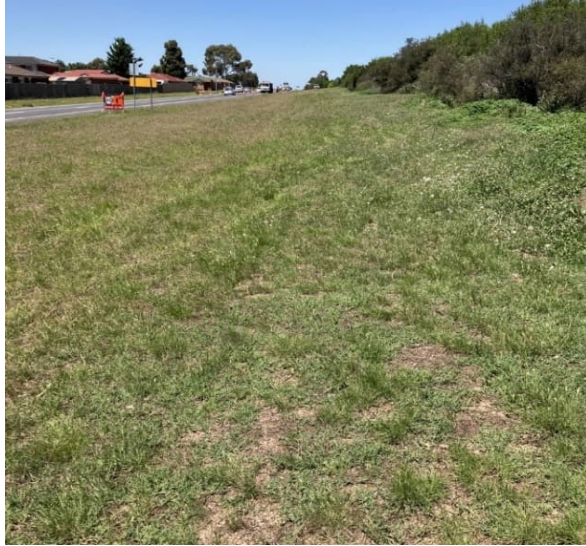
Plate 20 Calder Park Drive roadside south of Glenbuar Drive – HZ15 area of highly modified EVC Plains Grassland (January 2024)

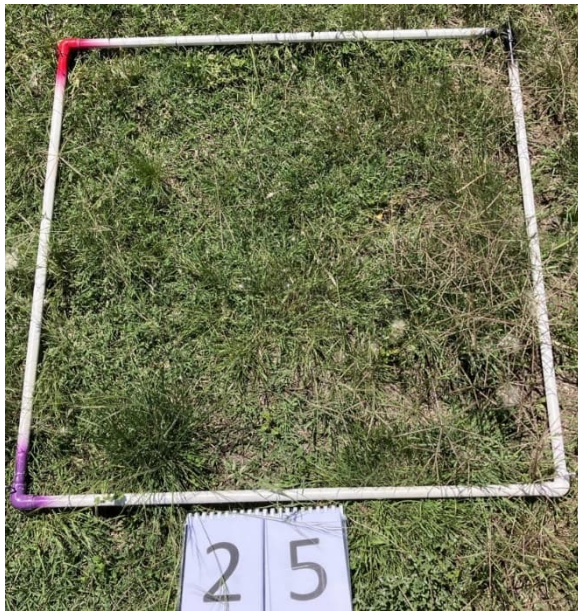
Plate 22 Quadrat sampled on Calder Park Drive roadside south of Glenbuar Drive – HZ15 area of highly modified EVC Plains Grassland, *Chloris* sp. dominates and *Themeda triandra* 1-5% (January 2024)

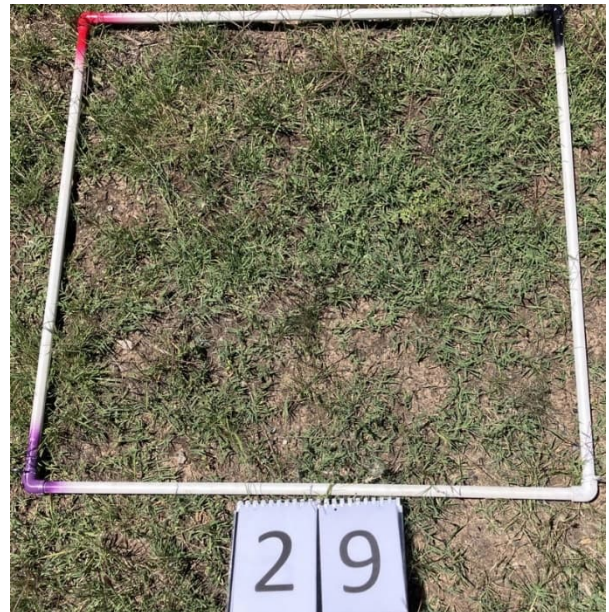
Plate 23 Quadrat sampled on Calder Park Drive roadside south of Glenbuar Drive – HZ15 area of highly modified EVC Plains Grassland, *Chloris* sp. dominates and *Themeda triandra* 1-5% (January 2024)

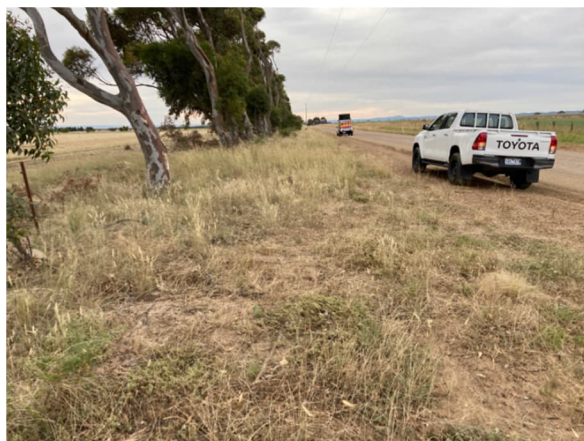
Plate 24 Low quality native grassland vegetation along Holden Road

Holden Road is unsealed and the roadside is narrow and appears to be less regularly slashed than Calder Park Drive. Most of the roadside is exotic grasses with some planted Sugar Gums. Some small patches of low-quality native grassland occur along the roadside (Plate 24). These areas are mostly re-colonised areas of Wallaby Grass and Spear Grass (*Austrostipa* spp). Quadrats in a patch identified during previous ecological assessments for the Project as potential Striped Legless Lizard habitat were dominated by Chilean Needle-grass and Serrated Tussock (*Nassella* spp.), rubbish and road rubble (Plate 25, Plate 26).

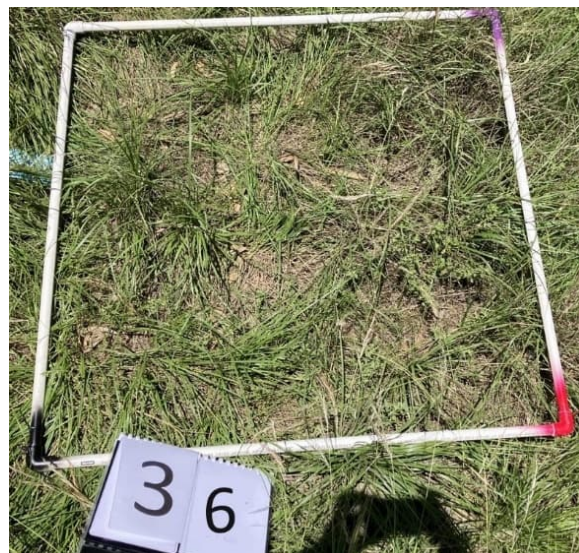
Plate 25 Quadrat along Holden Road previously identified as potential Striped Legless Lizard habitat. *Nassella* spp. was the dominant grass with rubbish and road rubble evident, 1-5% *Themeda triandra* cover

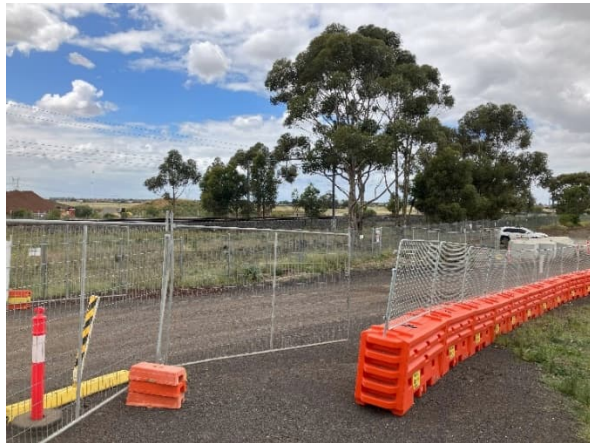
Plate 27 Biosite 3551 within the the rail corridor south of Calder Park Drive with planted Sugar Gums (Feb 2024)

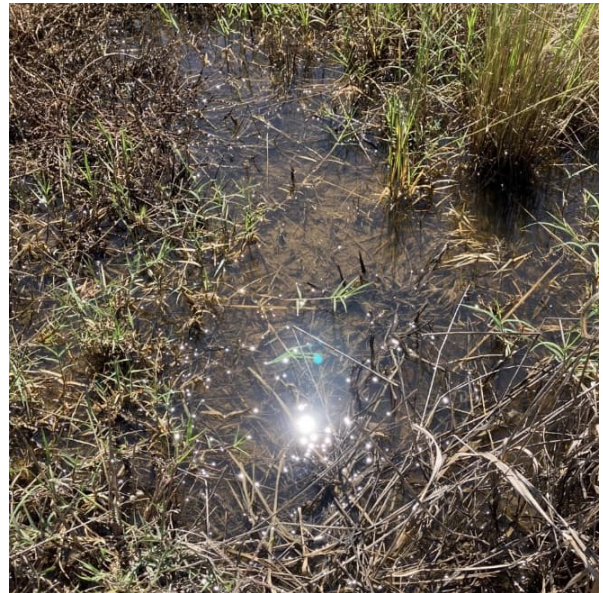
Plate 28 Pooled water in biosite 3551 near Calder Park Drive with tadpoles, Common Eastern Froglet (*Crinia signifera*) heard calling

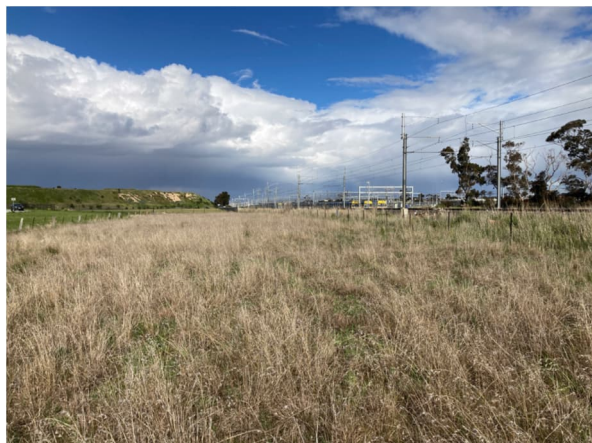
Plate 30 Biosite 8499 within the the rail corridor dominated by Kangaroo Grass located in Project area approximately 150 m south of the construction footprint (Holden Road level crossing construction footprint)

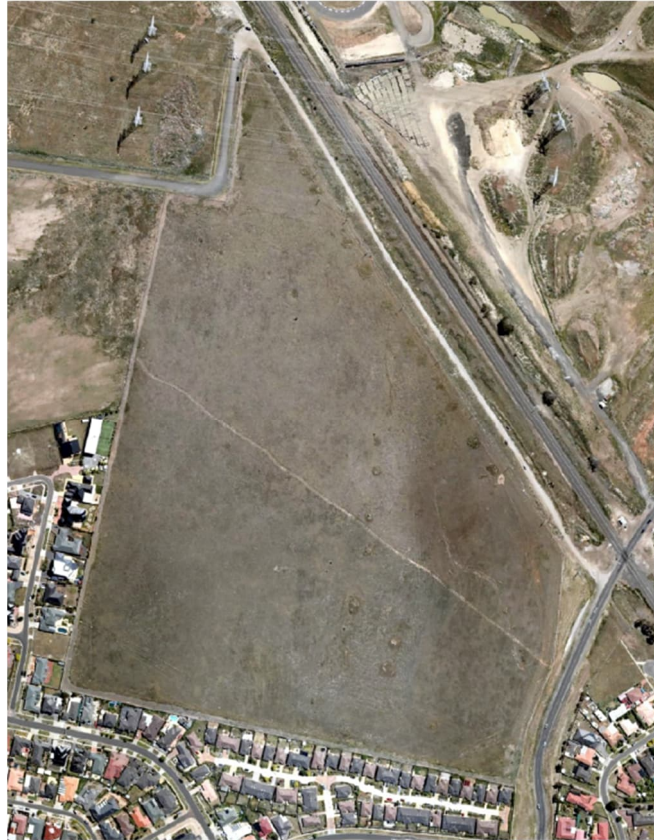
Figure 24 Aerial imagery of Banchory Grove Reserve with cleared area and vehicle tracks evident (NearMaps 2024)

Wheel ruts were clear within the strip/track, but a few arthropod burrows were found in the maintenance strip away from the ruts and one was occupied by a wolf spider (Plate 43). Part of the surveyed area had been previously mapped as NTGVVP during vegetation assessments for the Project, but the area no longer appears to support extensive cover of native species, inter-tussock spaces, arthropod burrows, soil cracks and rocks for the Victorian Grassland Earless Dragon. For a more detailed description of VGED habitat within Banchory Grove Reserve see Appendix C.

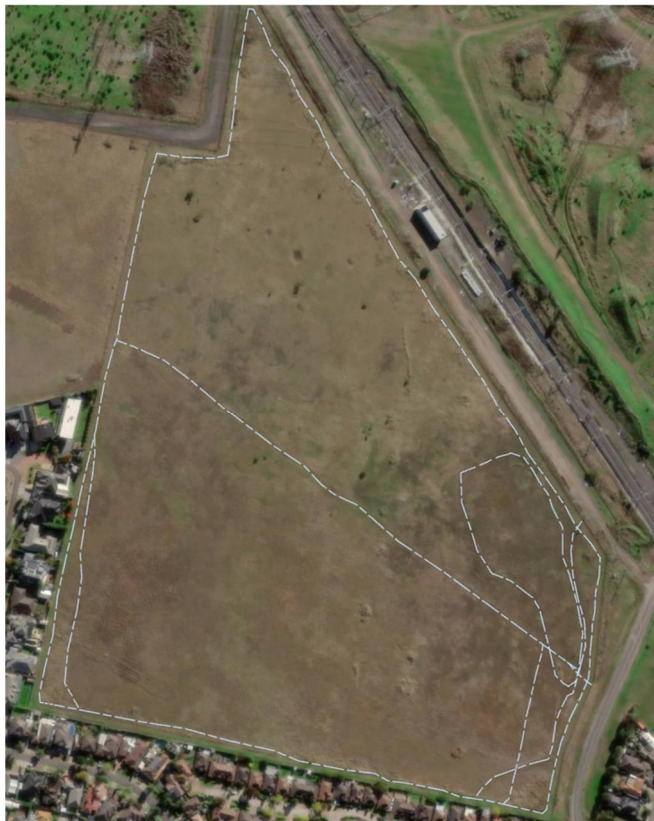
Figure 25 Aerial imagery of Banchory Grove Reserve with vehicle tracks highlighted (ArcGIS 2024)

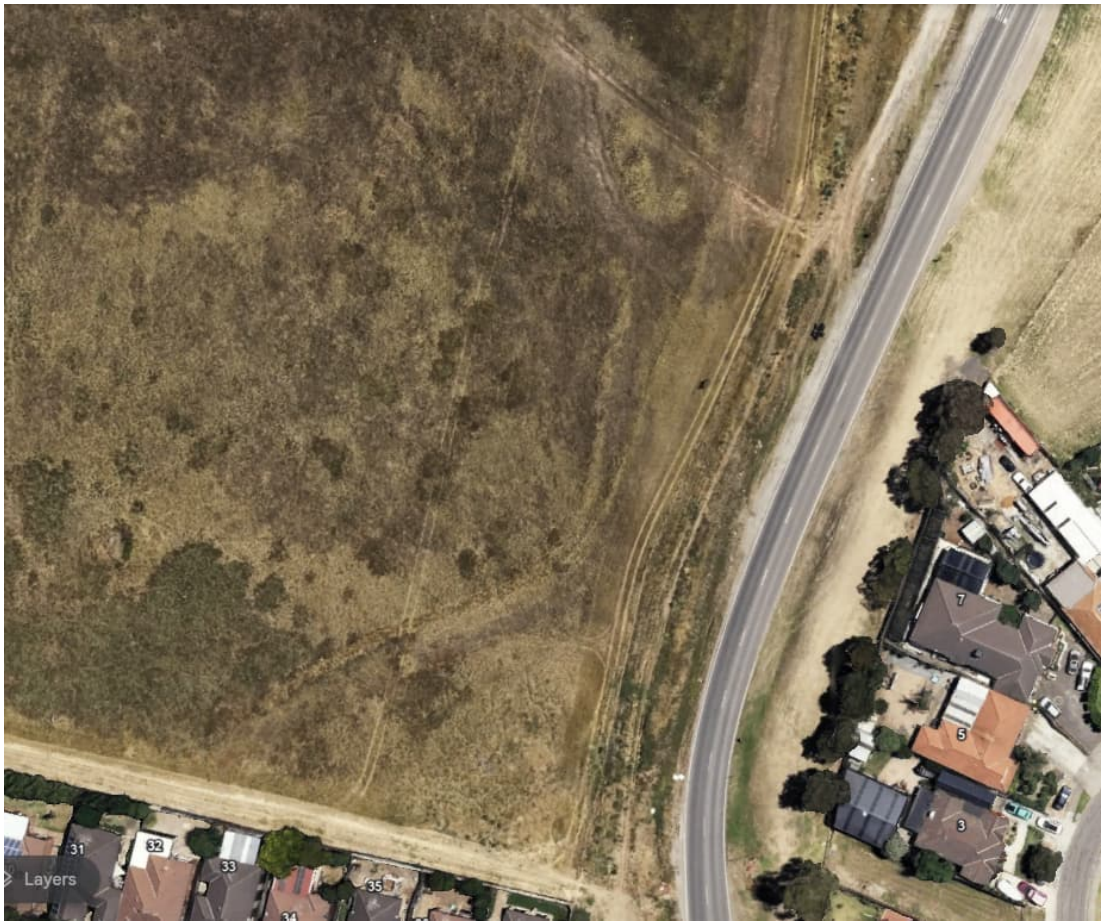
Figure 26 Google Earth (2021) clearly showing several maintenance tracks and cleared areas, vehicle ruts evident

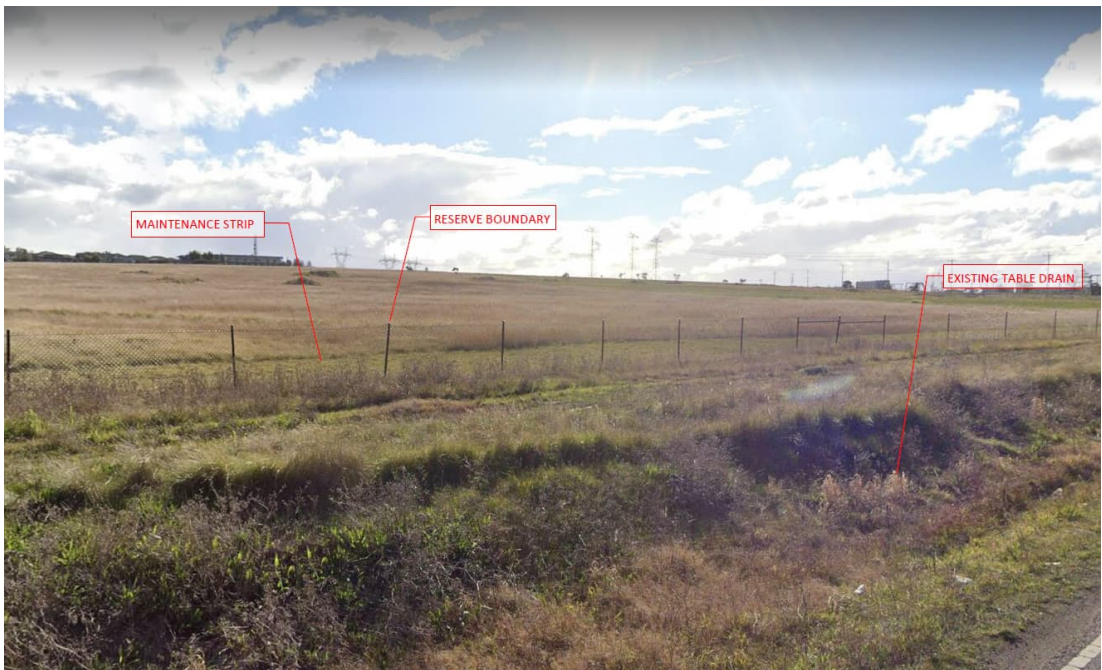
Figure 27 Banchory Grove Reserve boundary with slashed maintenance strip visible (Source: Google streetview image captured July 2021 in SMEC 2023a)

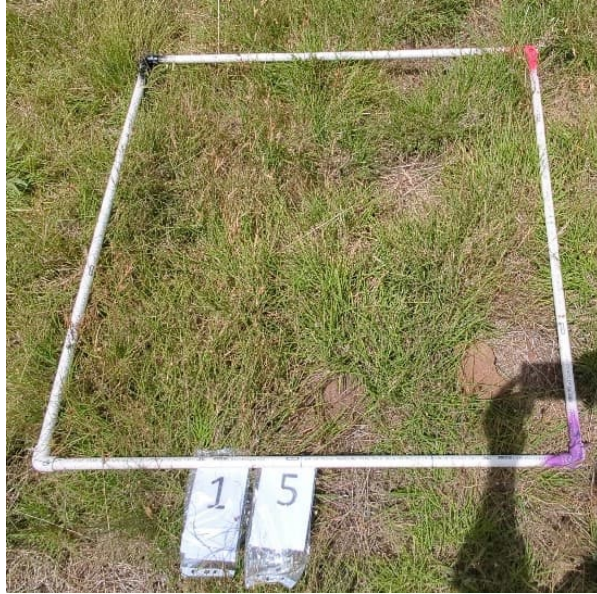
Plate 32 Western section of Banchory Grove Reserve; much higher ground, good coverage of Kangaroo Grass, scattering of embedded rocks

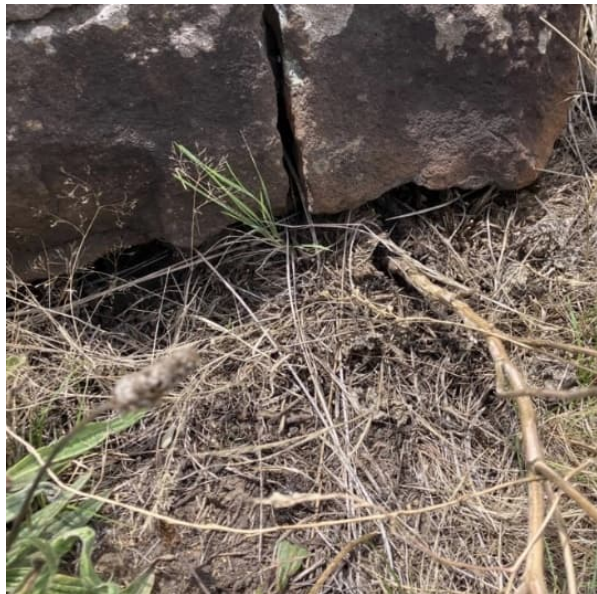
Plate 34 Burrows beneath natural rock formation on higher ground west of Banchory Grove Reserve. Unoccupied.

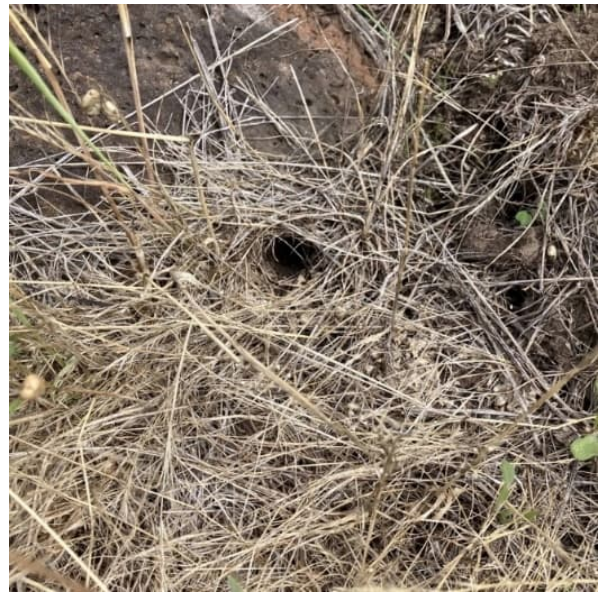
Plate 35 Well-maintained burrow on the higher ground in the west of Banchory Grove Reserve. Scope did not detect any occupants.

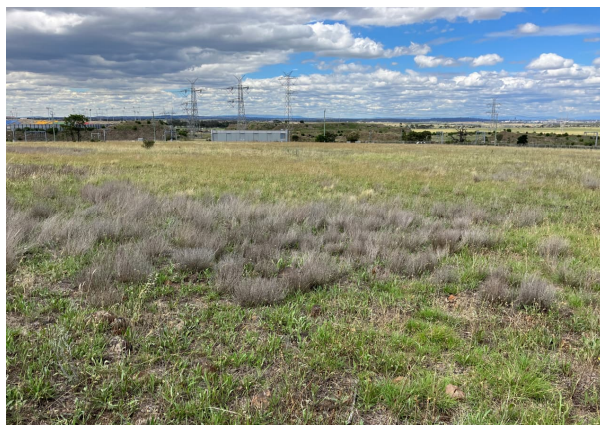
Plate 36 Western area of Banchory Grove Reserve supports native grassland patches but also still open areas dominated by forbs (Dec 2023)

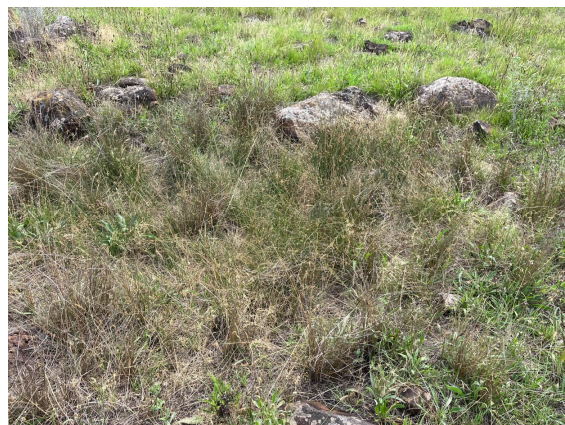
Plate 37 Western area of Banchory Grove Reserve supports more rock than the eastern area (Dec 2023)

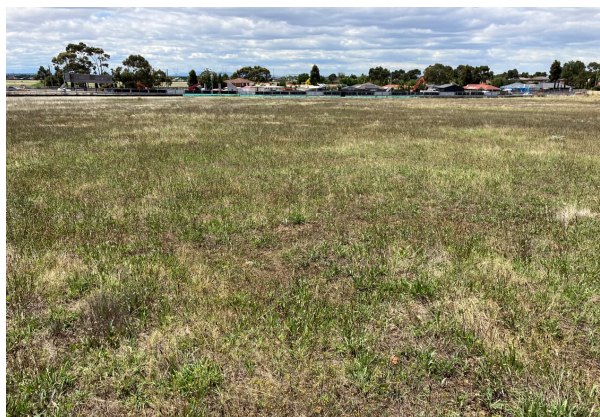
Plate 38 Central area of Banchory Grove Reserve viewed east supports extensive open areas dominated by forbs (Dec 2023)

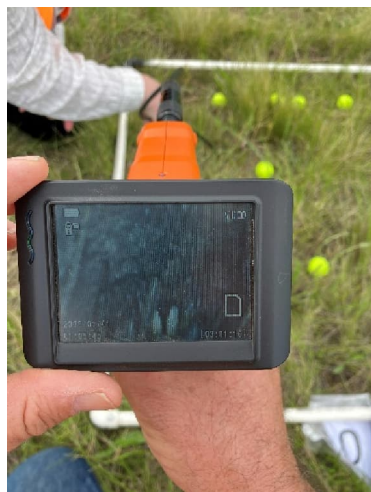
Plate 43 Wolf spider in burrow in maintenance strip next to vehicle track on eastern boundary in Banchory Grove Reserve (December 2023)

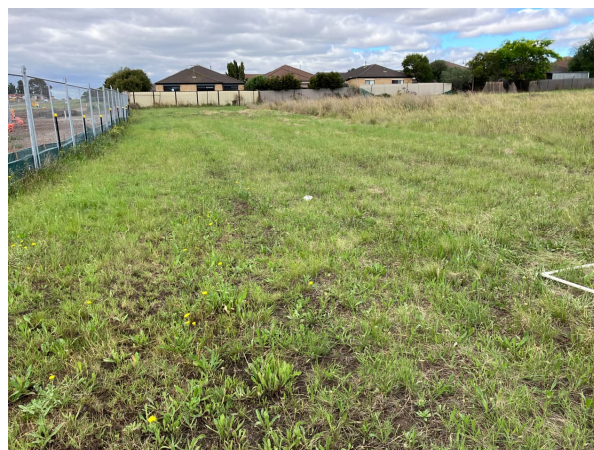
Plate 46 Quadrat surveyed along edge of eastern maintenance strip in Banchory Grove Reserve with high coverage of forb weeds, no burrows few cracks and no rocks and high dead grass cover (Dec 2023)

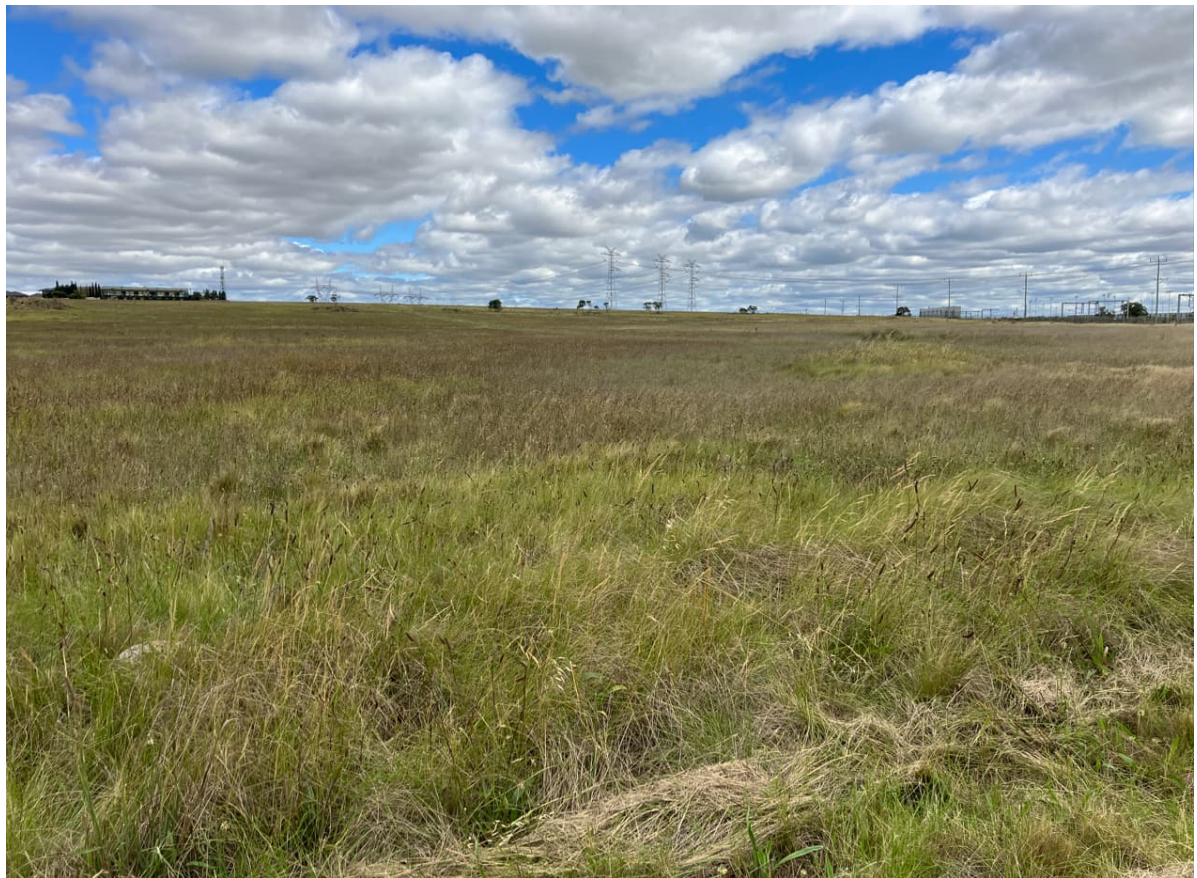
Plate 48 View of Banchory Grove Reserve from south-east corner showing rising to the north-west (Source: Google Maps streetview)

Banchory Grove Reserve slopes from west to east with the lowest point of Banchory Grove Reserve adjacent to Calder Park Drive and therefore the study area. The cross sections in Figure 37 illustrate the slope at three locations across Banchory Grove Reserve with the highest elevation in the west and a fall of approximately 16 to 20 m from west to east. The landform of Banchory Grove Reserve is also apparent in the street view image in Plate 48.

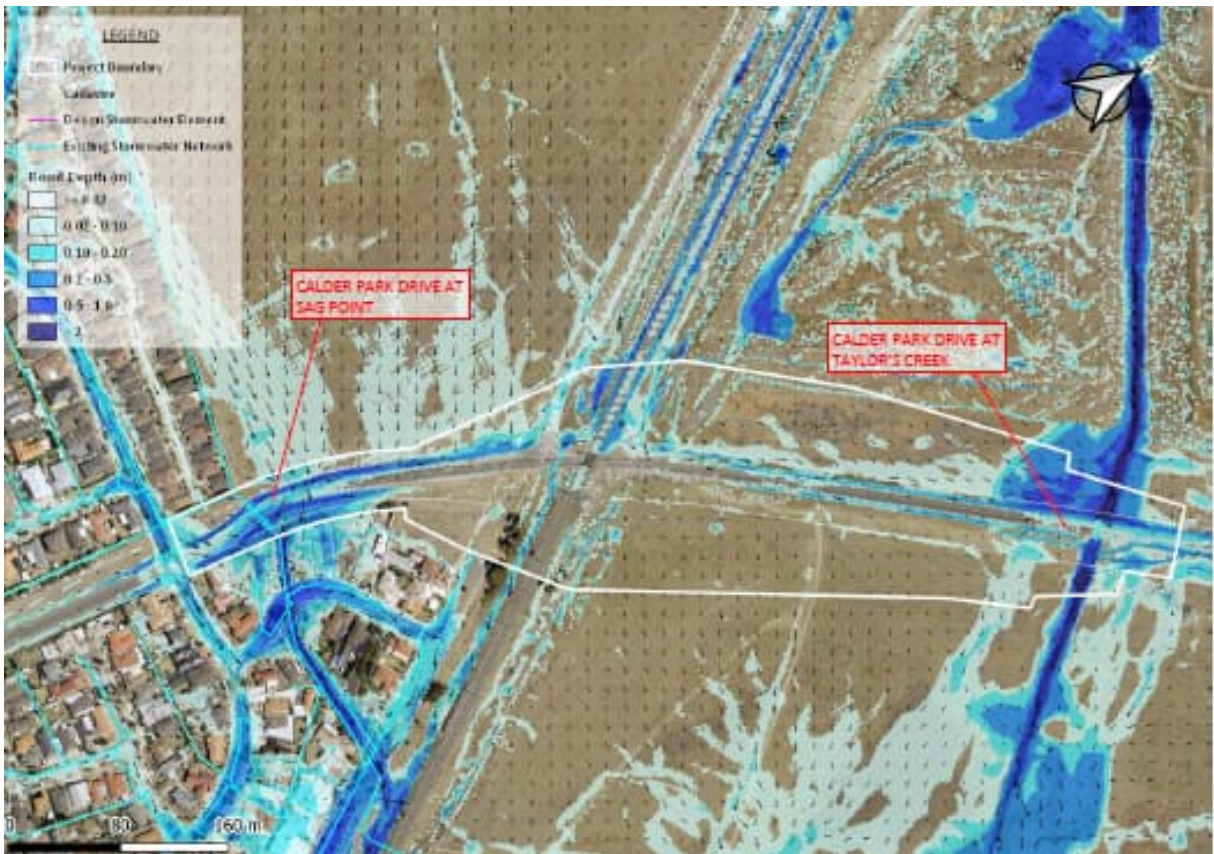
Figure 29 Drainage network

Topography grades to the south-east of the level crossing on Calder Park Drive with a local Council drainage network in the south (Figure 29). The drainage network in the south extends from the south-east corner of Banchory Grove Reserve and discharges to the Victoria Street Drain (AECOM-GHD JV 2022b).

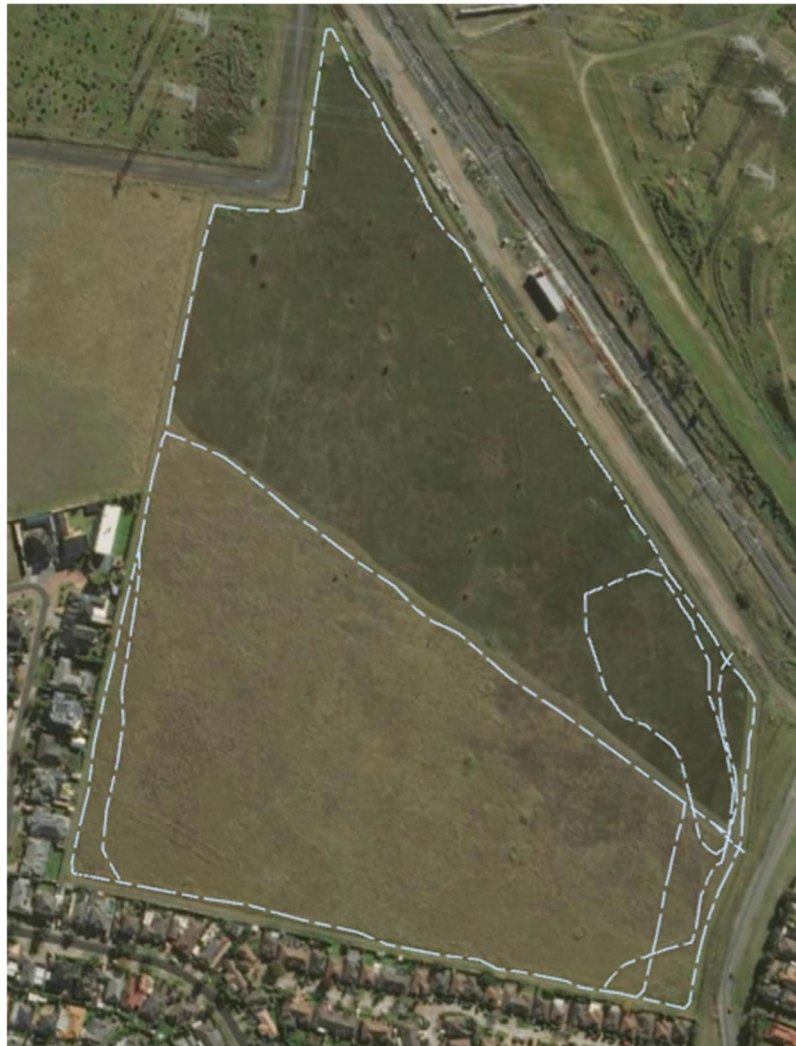
Figure 31 Image of Banchory Grove Reserve from 2022 showing the burnt north section (ArcGIS WMTS Service 2022)

World Imagery from ArcGIS Pro (2022) shows that the north of the maintenance track has clearly been burnt in Banchory Grove Reserve (Figure 31). That area is visibly a different vegetation colour in the Google Street view image below, from 2021 (Figure 32).
