Calder Park Drive and Holden Road

LEVEL CROSSING REMOVAL PROJECT

000 - Multiple Sites **Victorian Grassland Earless Dragon Habitat Assessment - Calder Park Drive and Holden Road, Calder Park**

LXRP-LX14-000-0-00-PA-RPT-0005

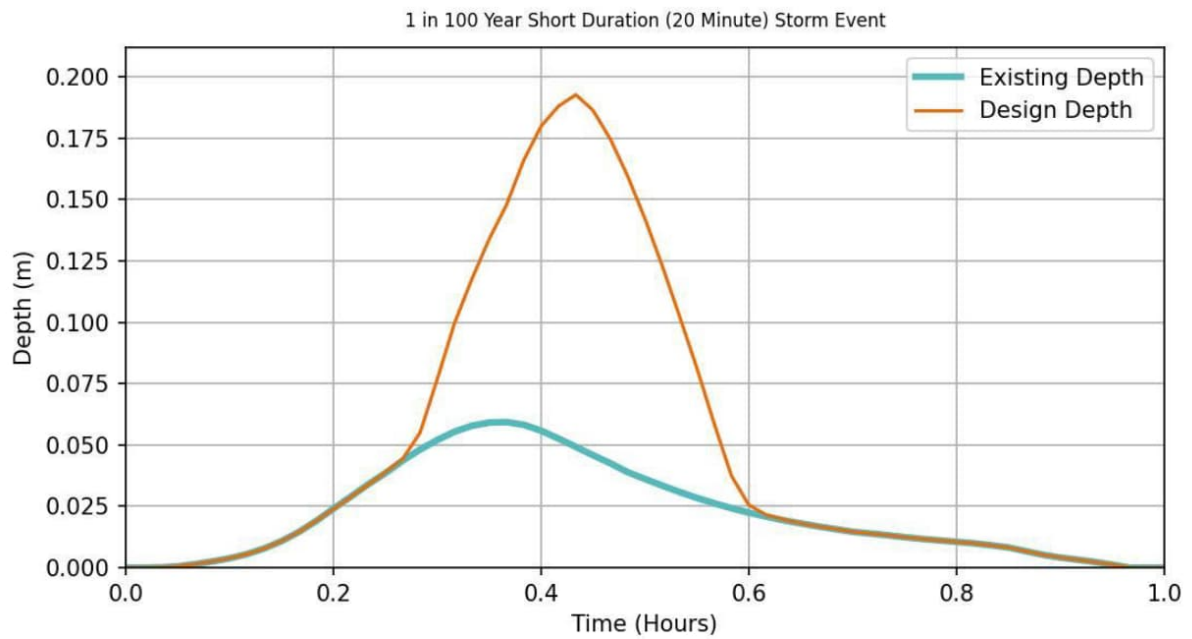
Figure 40 ARI short duration (20 minute) event existing and design condition (Source: Figure 22 in SMEC 2023a)

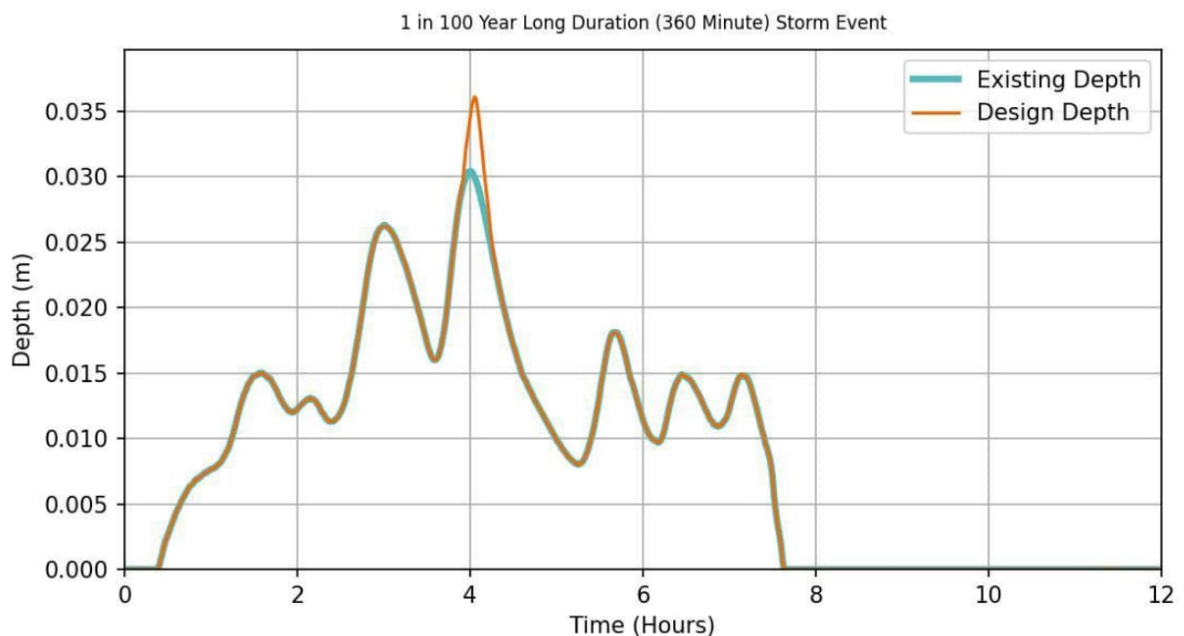
Figure 41 ARI long duration (360 minute) event existing and design condition (Source: Figure 26 in SMEC 2023a)

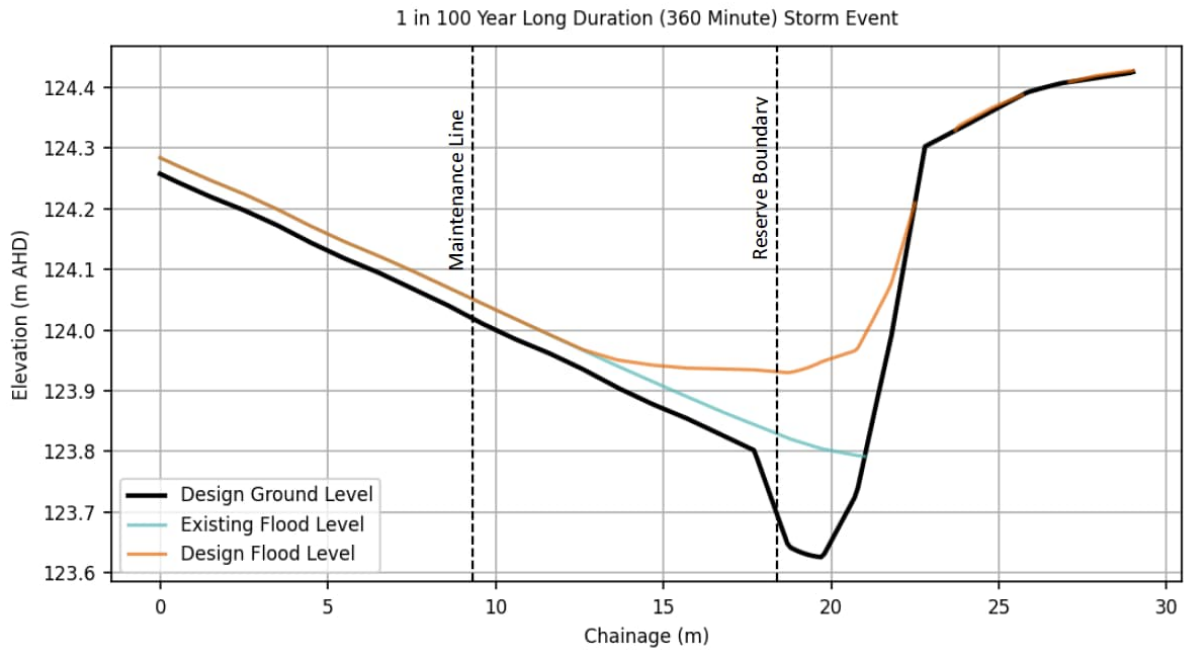
Figure 42 ARI long duration (360 minute) event existing and design condition by distance (Source: Figure 16 in SMEC 2023a)

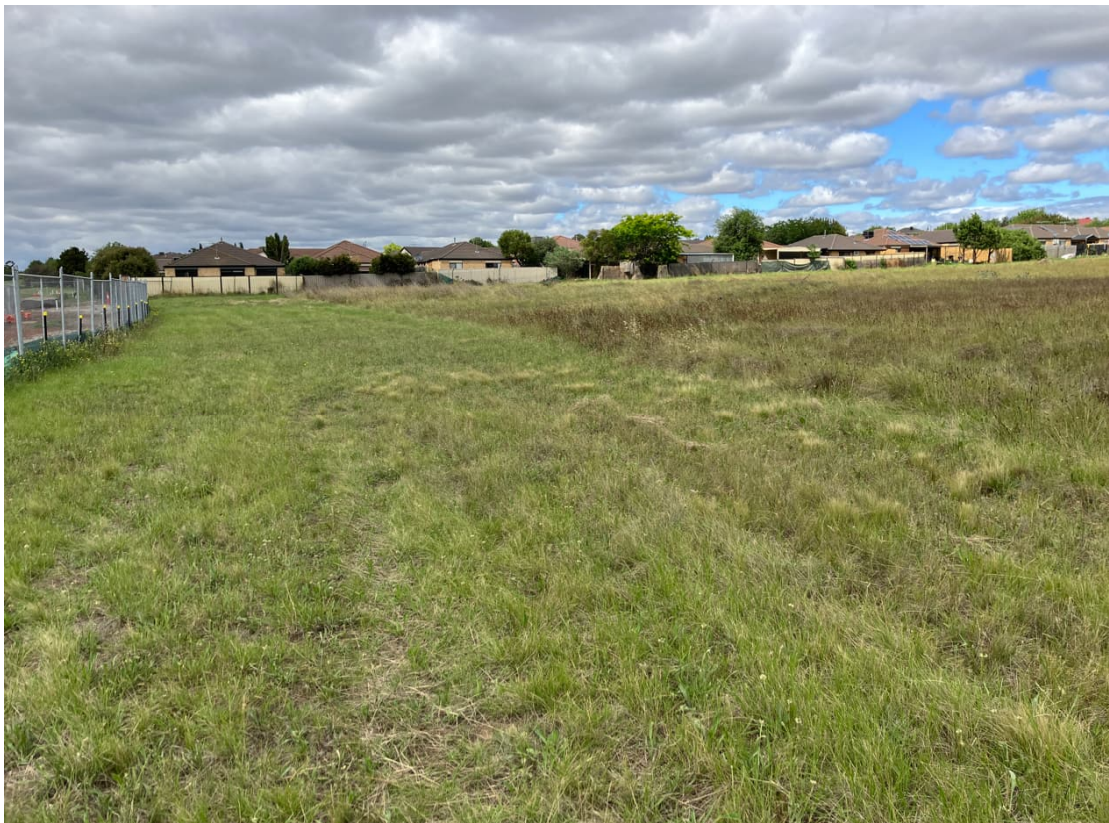
Figure 43 Area affected by afflux in the eastern area of Banchory Grove Reserve (Dec 2023)

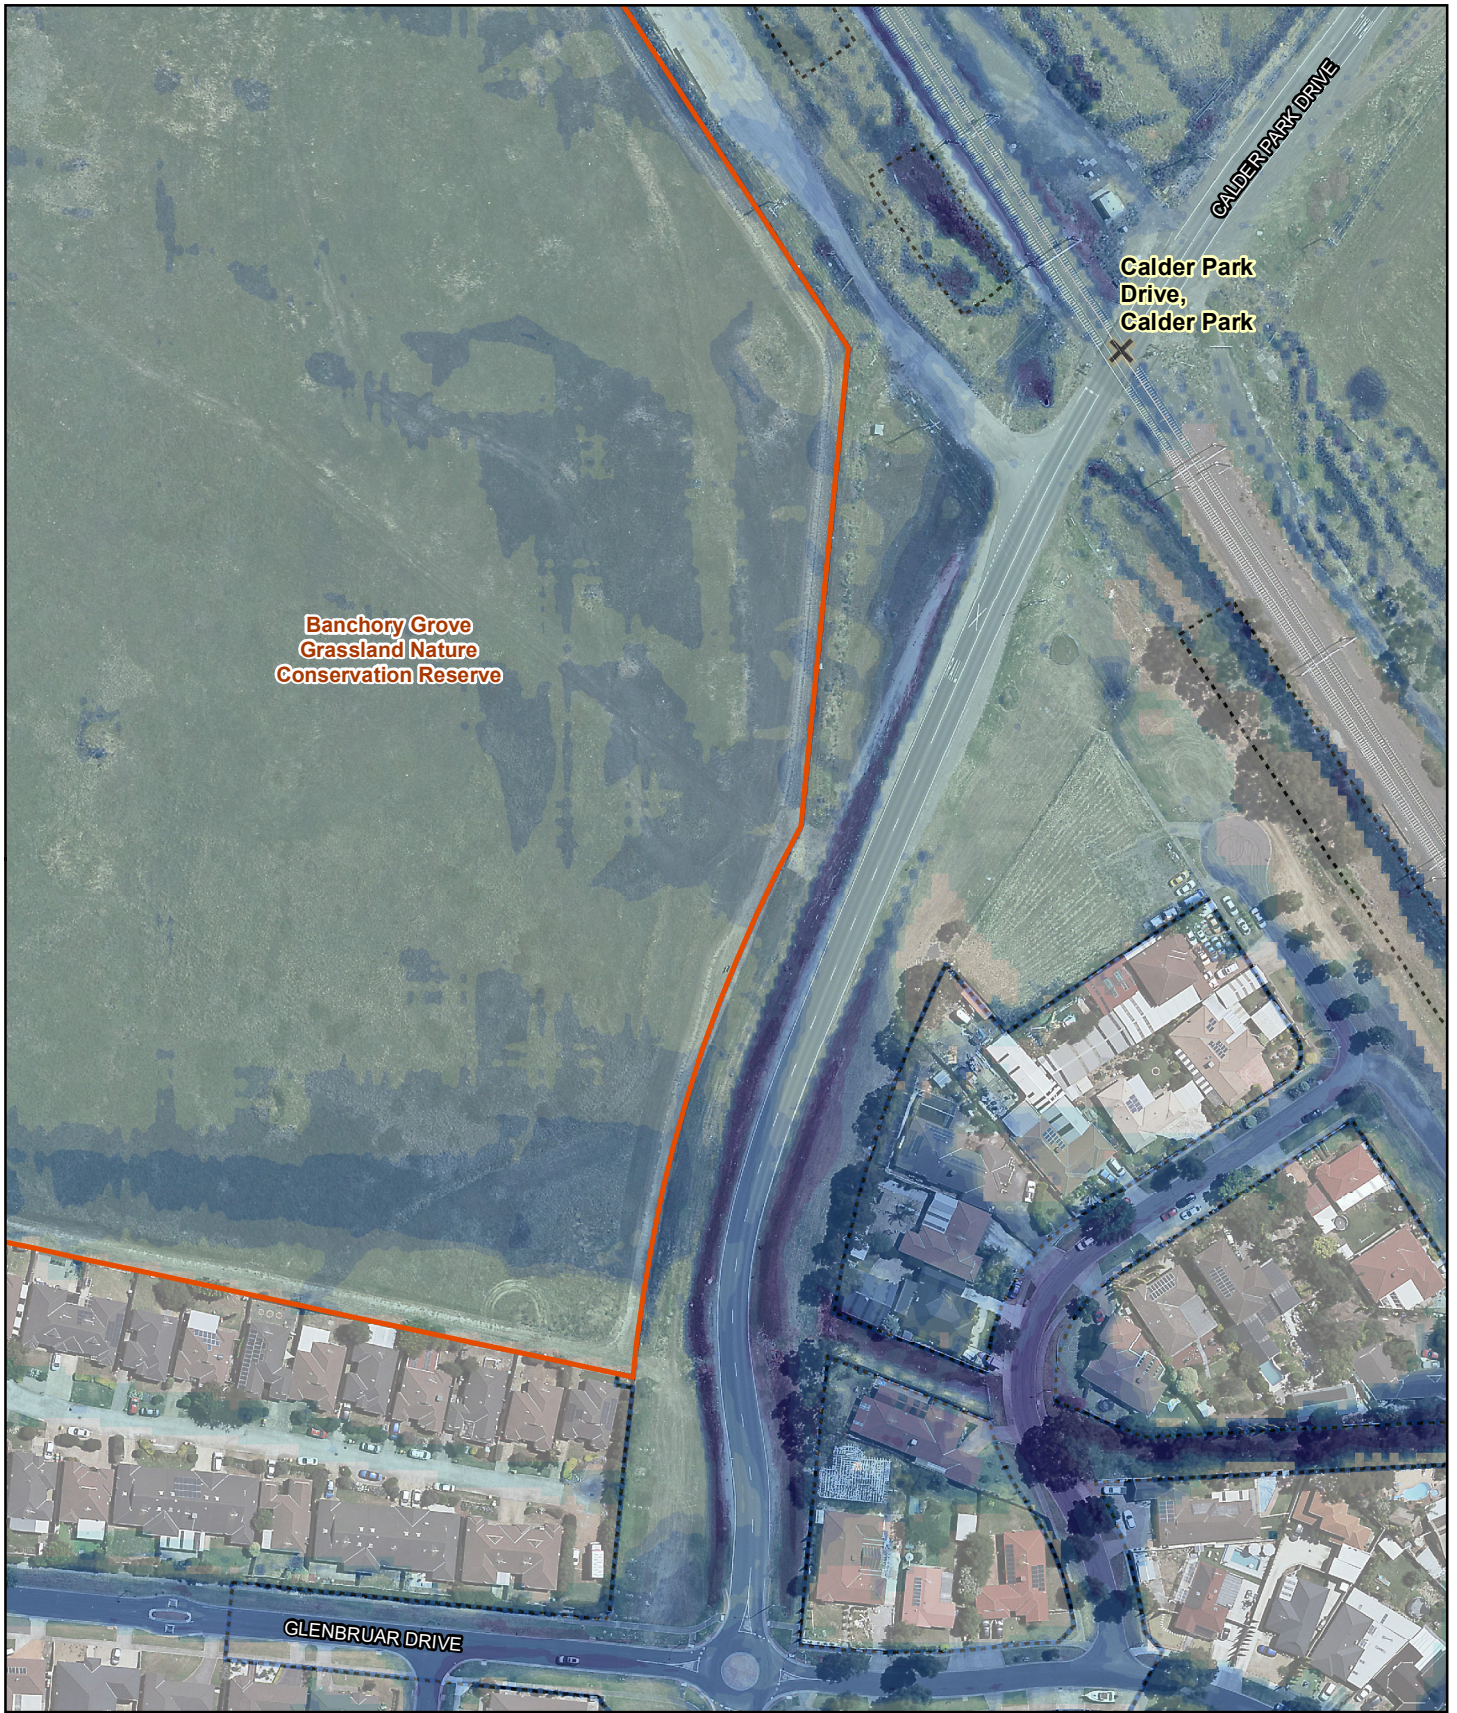
Calder Park Drive and Holden Road
Base Condition
1% AEP Short Duration
Figure 44

Figure 44 Calder Park Drive and Holden Road Base Condition 1% AEP Short Duration

However, for completeness (and given the analysis had already been undertaken as part of the impact assessment), analysis of flood modelling is included in Appendix D and Figures 44 to 48 to outline how change in drainage associated with the Project may affect Banchory Grove Reserve.

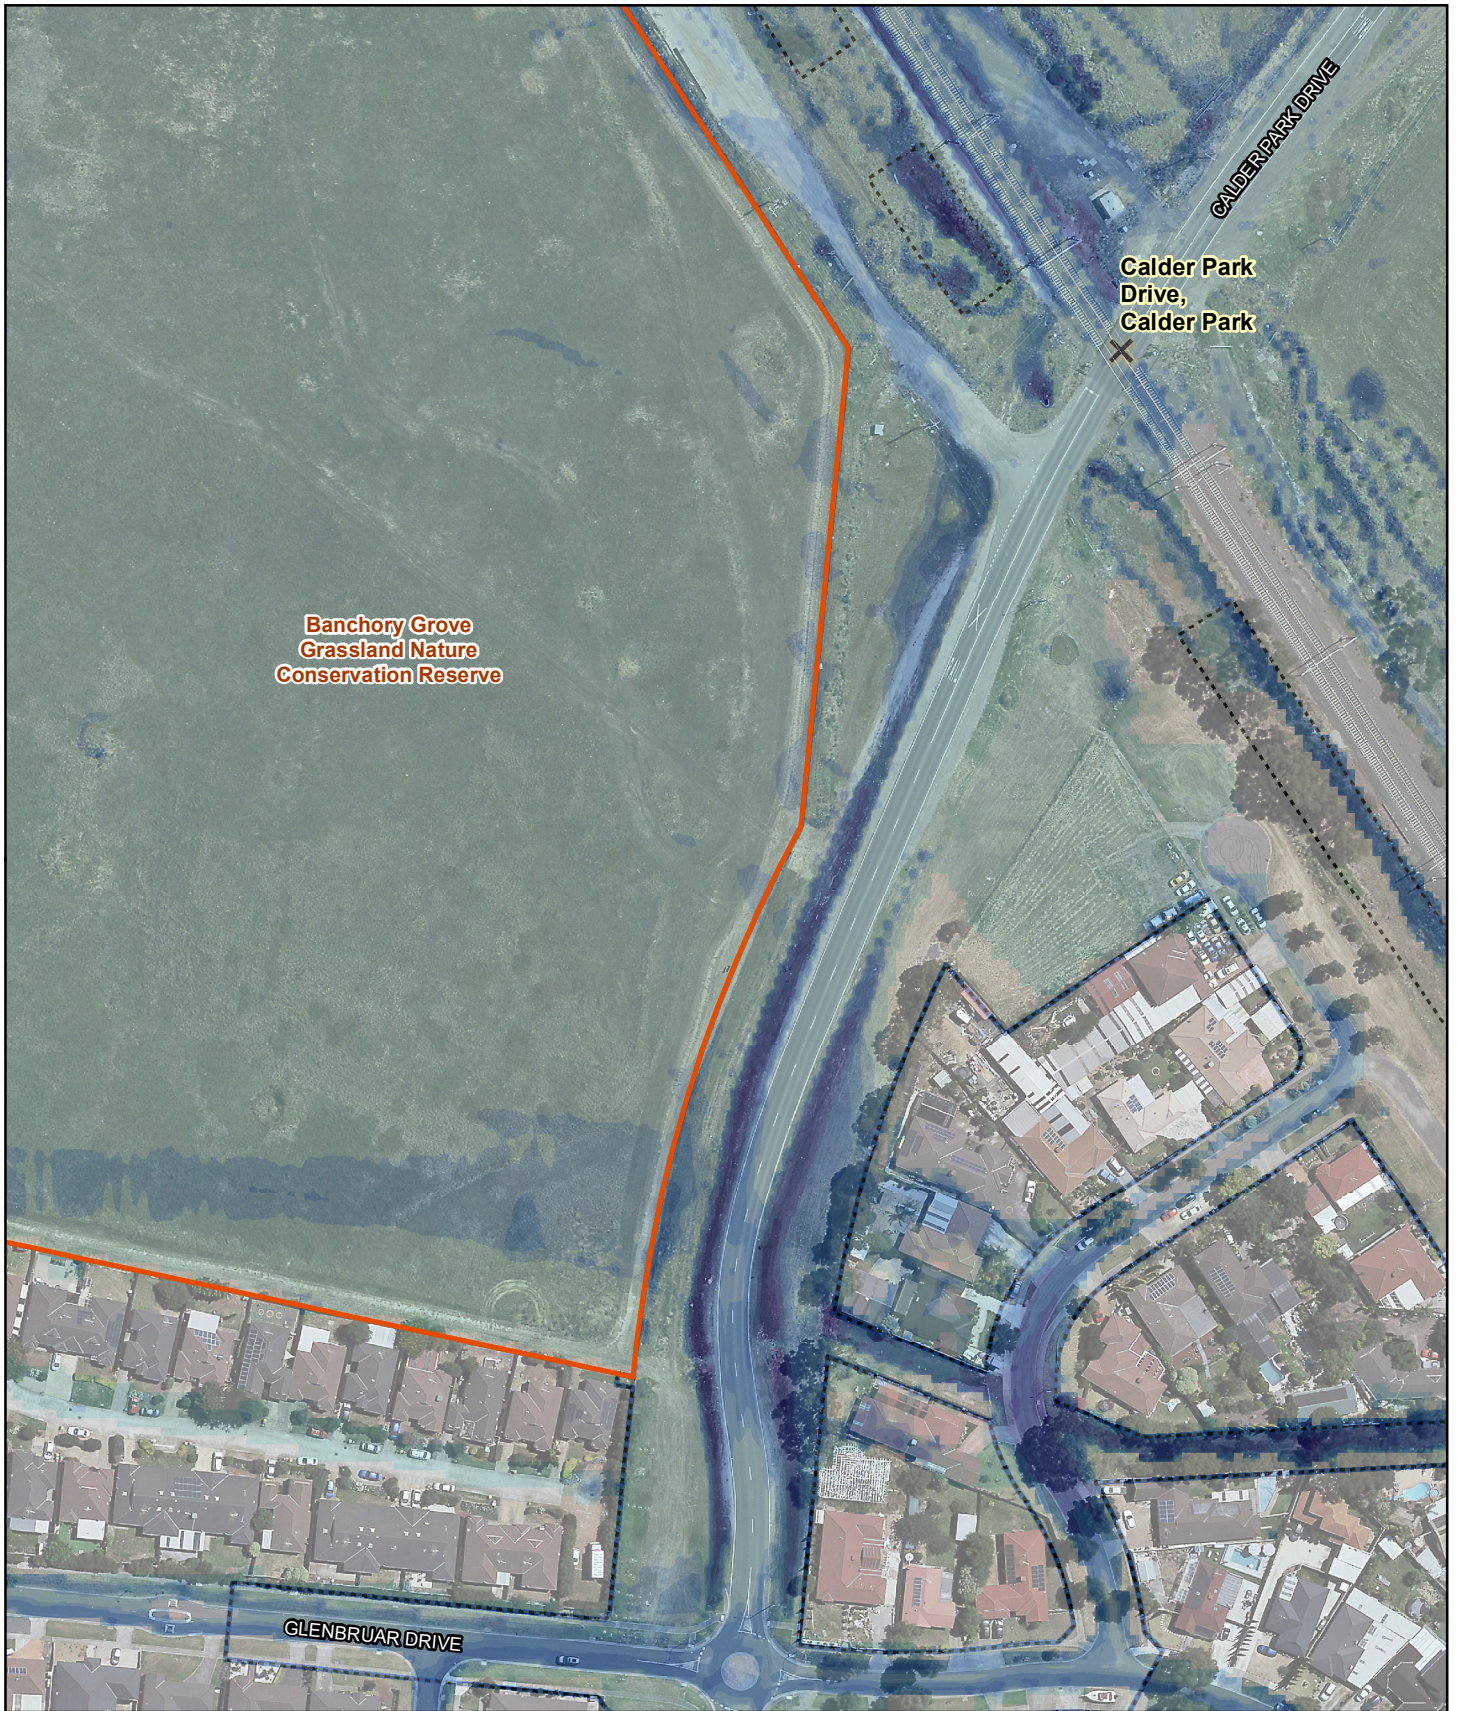
Calder Park Drive and Holden Road
 Base Condition
 1% AEP Long Duration
 Figure 45

Figure 45 Calder Park Drive and Holden Road Base Condition 1% AEP Long Duration

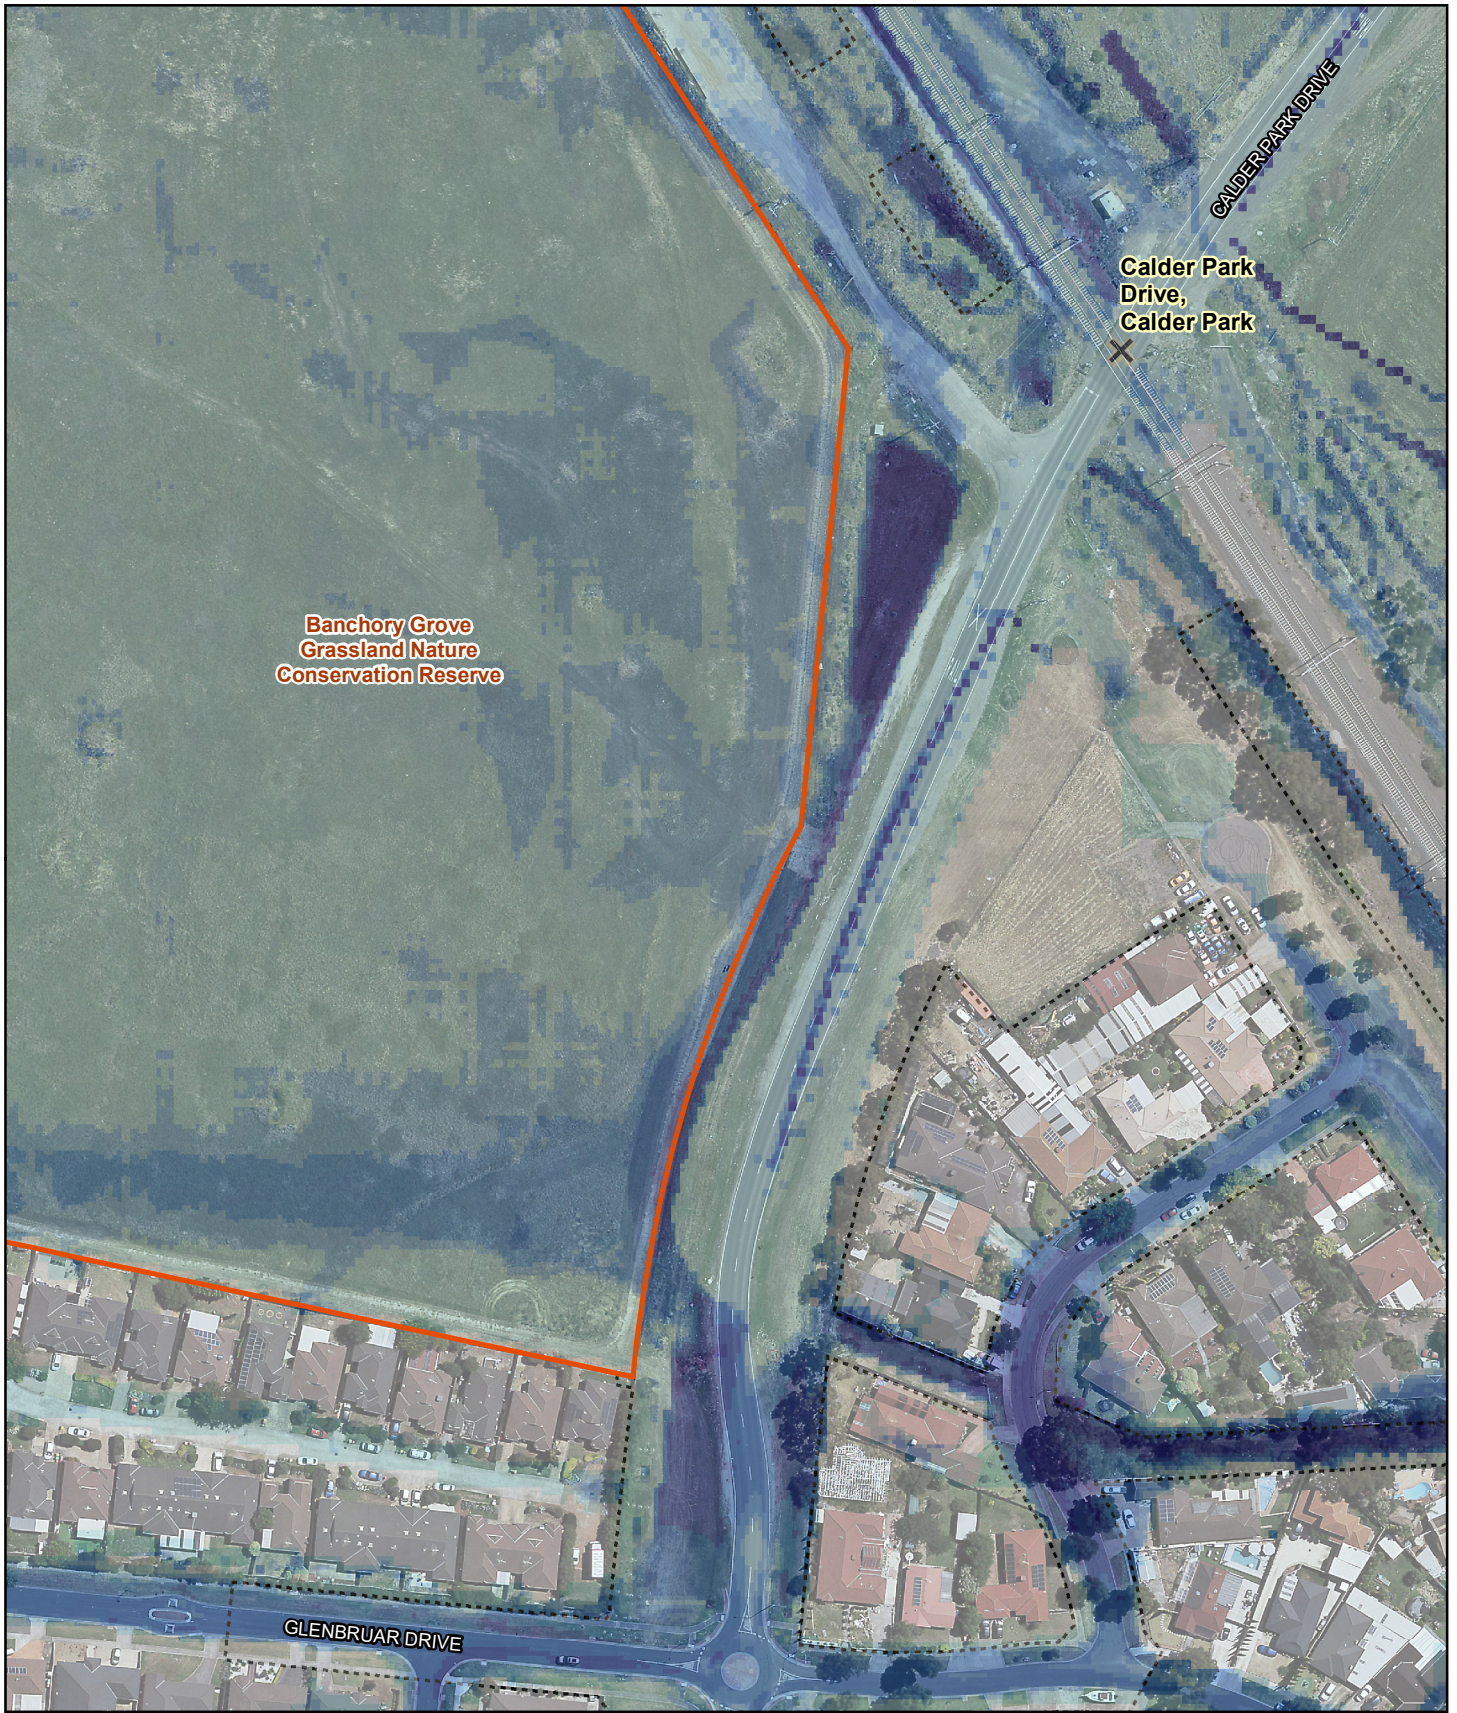
Calder Park Drive and Holden Road
 Design Condition
 1% AEP Short Duration
 Figure 46

Figure 46 Calder Park Drive and Holden Road Design Condition 1% AEP Short Duration

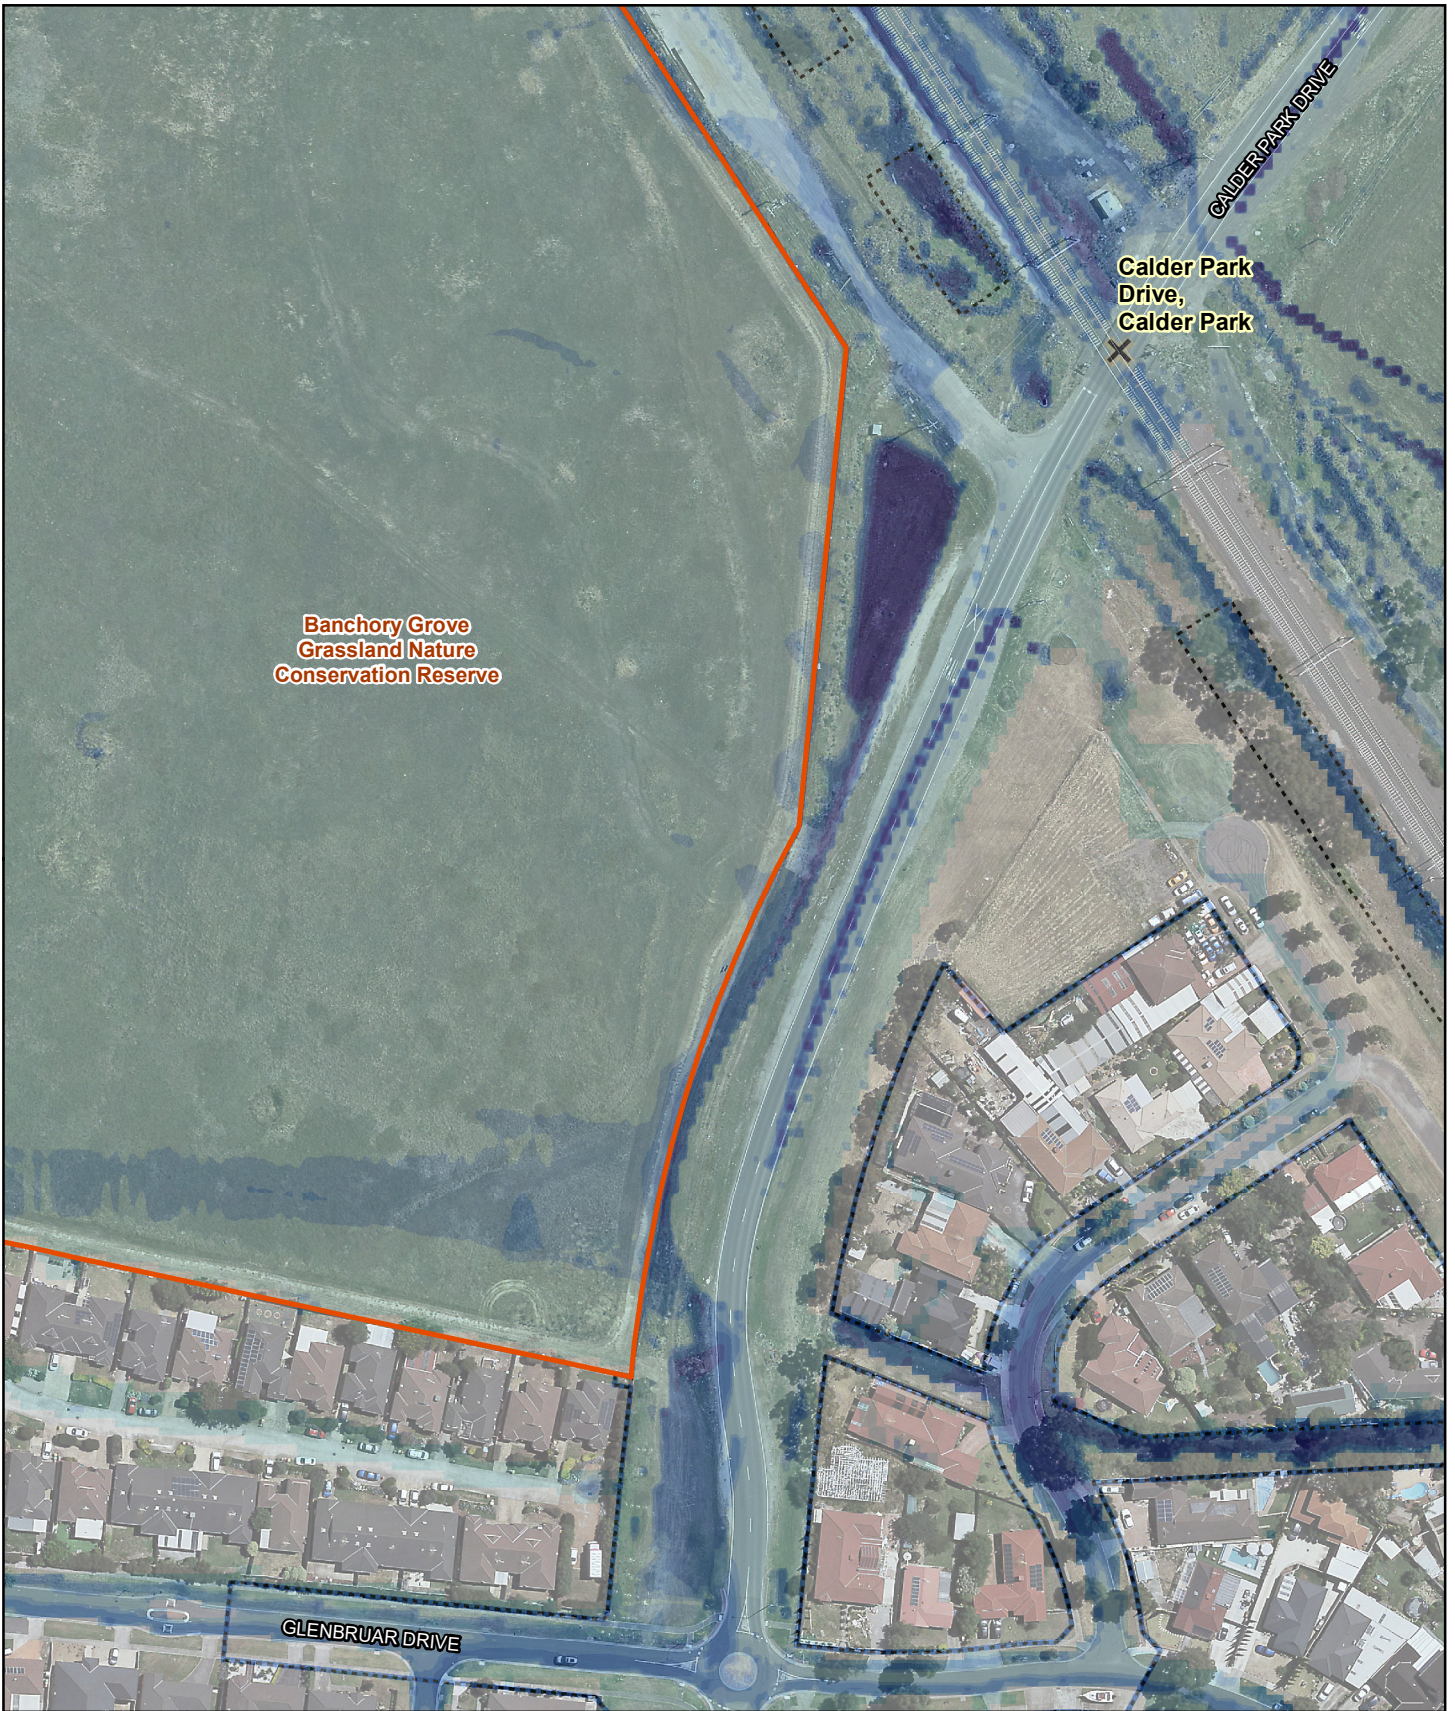
Calder Park Drive and Holden Road
Design Condition
1% AEP Long Duration
Figure 47

Figure 47 Calder Park Drive and Holden Road Design Condition 1% AEP Long Duration

Whilst this change represents a change in the peak flood level it is a continuation of the existing conditions experienced along the eastern boundary (i.e., inundated, unsuitable habitat). The afflux area appears to be entirely within the maintenance and vehicle track or adjacent areas subject to previous soil disturbance and scalping based on aerial imagery (Figure 47, Figure 48).

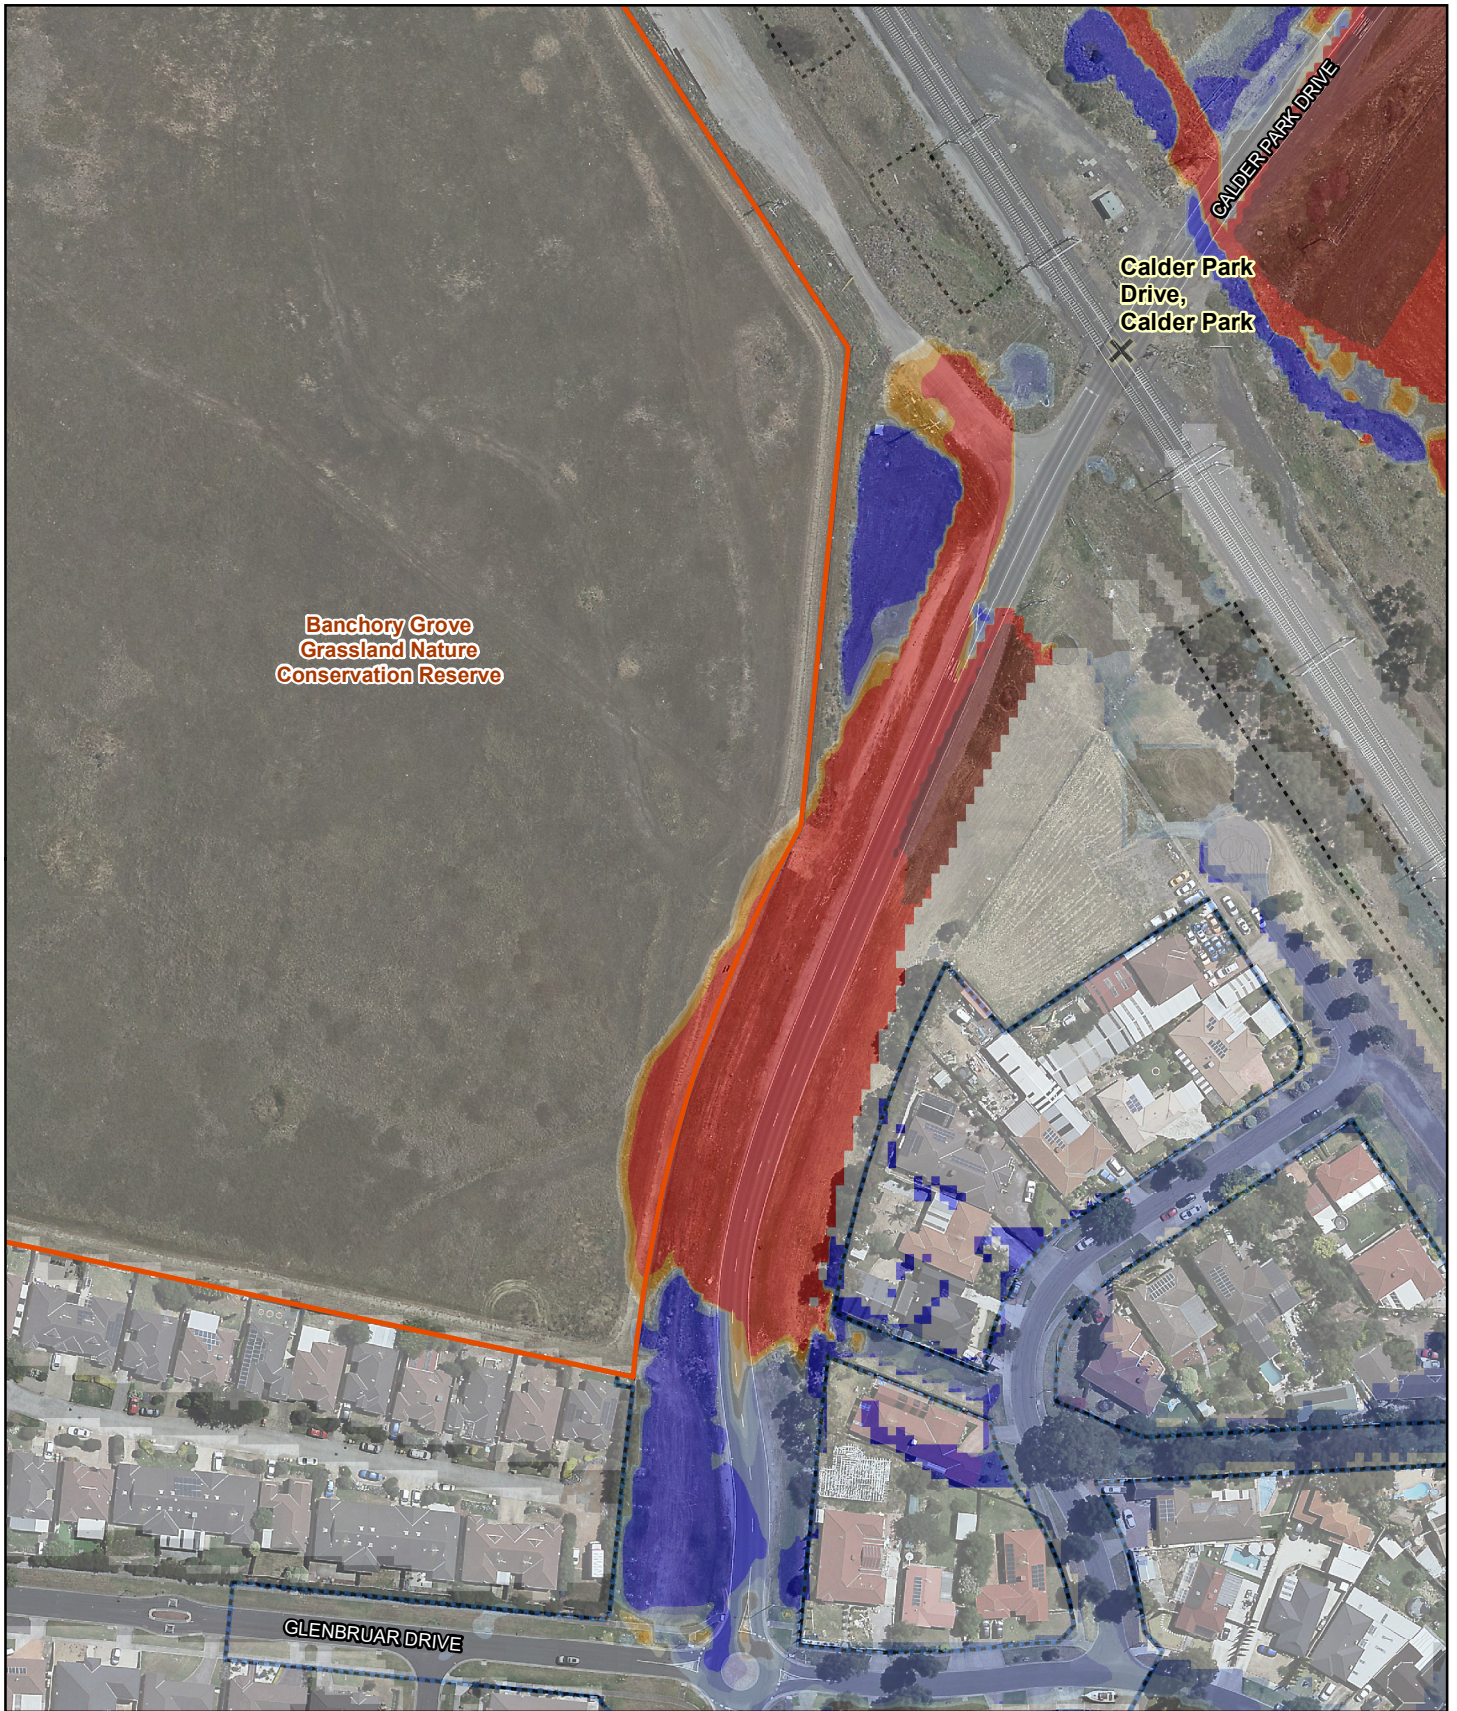
Calder Park Drive and
Holden Road
AEP1% Afflux
Short Duration
Figure 48

Figure 48 Calder Park Drive and Holden Road AEP1% Afflux Short Duration
