# **NORTH EAST LINK PROJECT**

**North East Link Environment Effects Statement**

**Technical report L – Aboriginal cultural heritage**

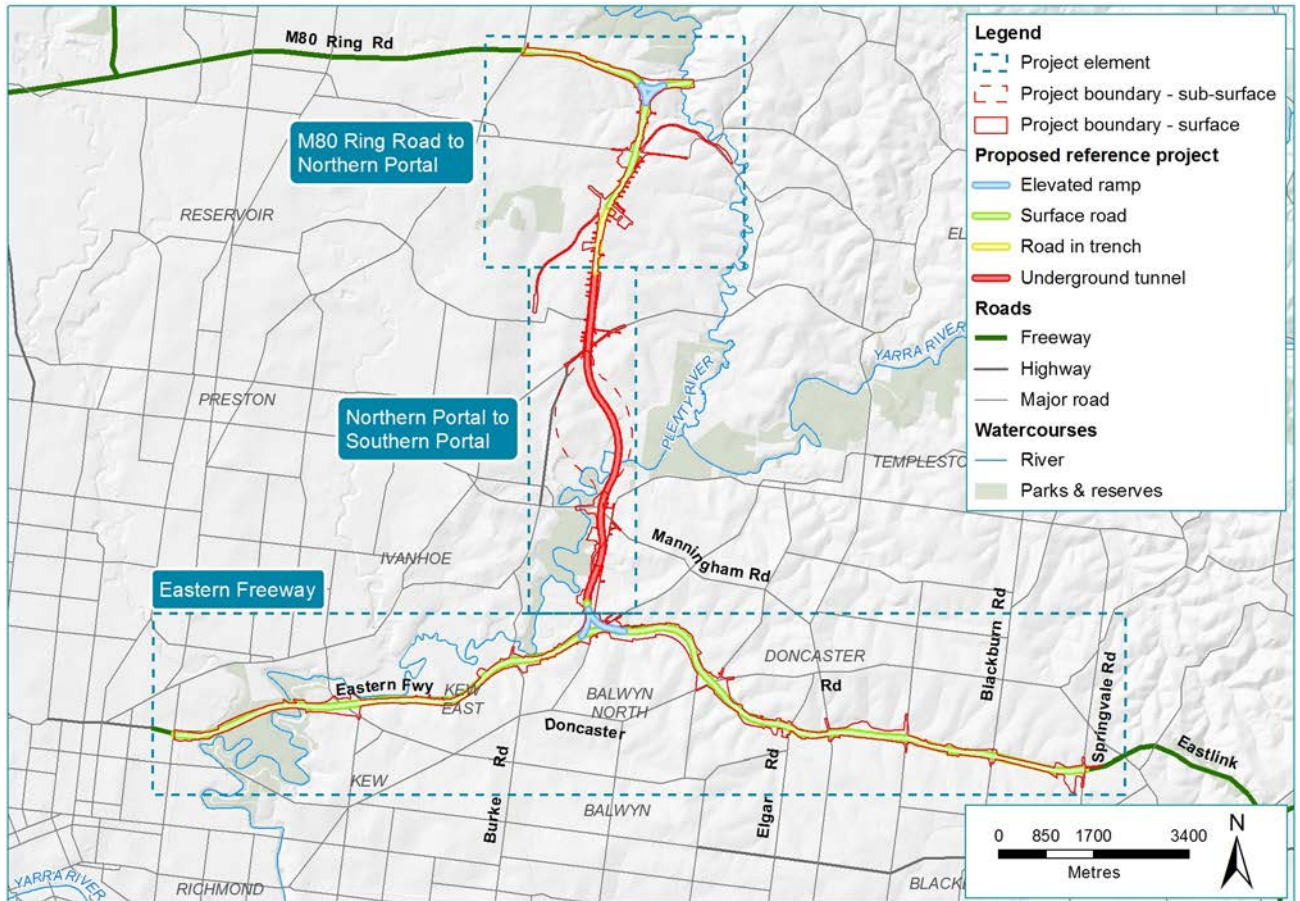
Figure 3-1 Overview of North East Link

The project would also improve existing bus services from Doncaster Road to Hoddle Street through the Doncaster Busway and as well as pedestrian connections with the bicycle network through connected shared use paths from the M80 Ring Road to the Eastern Freeway.

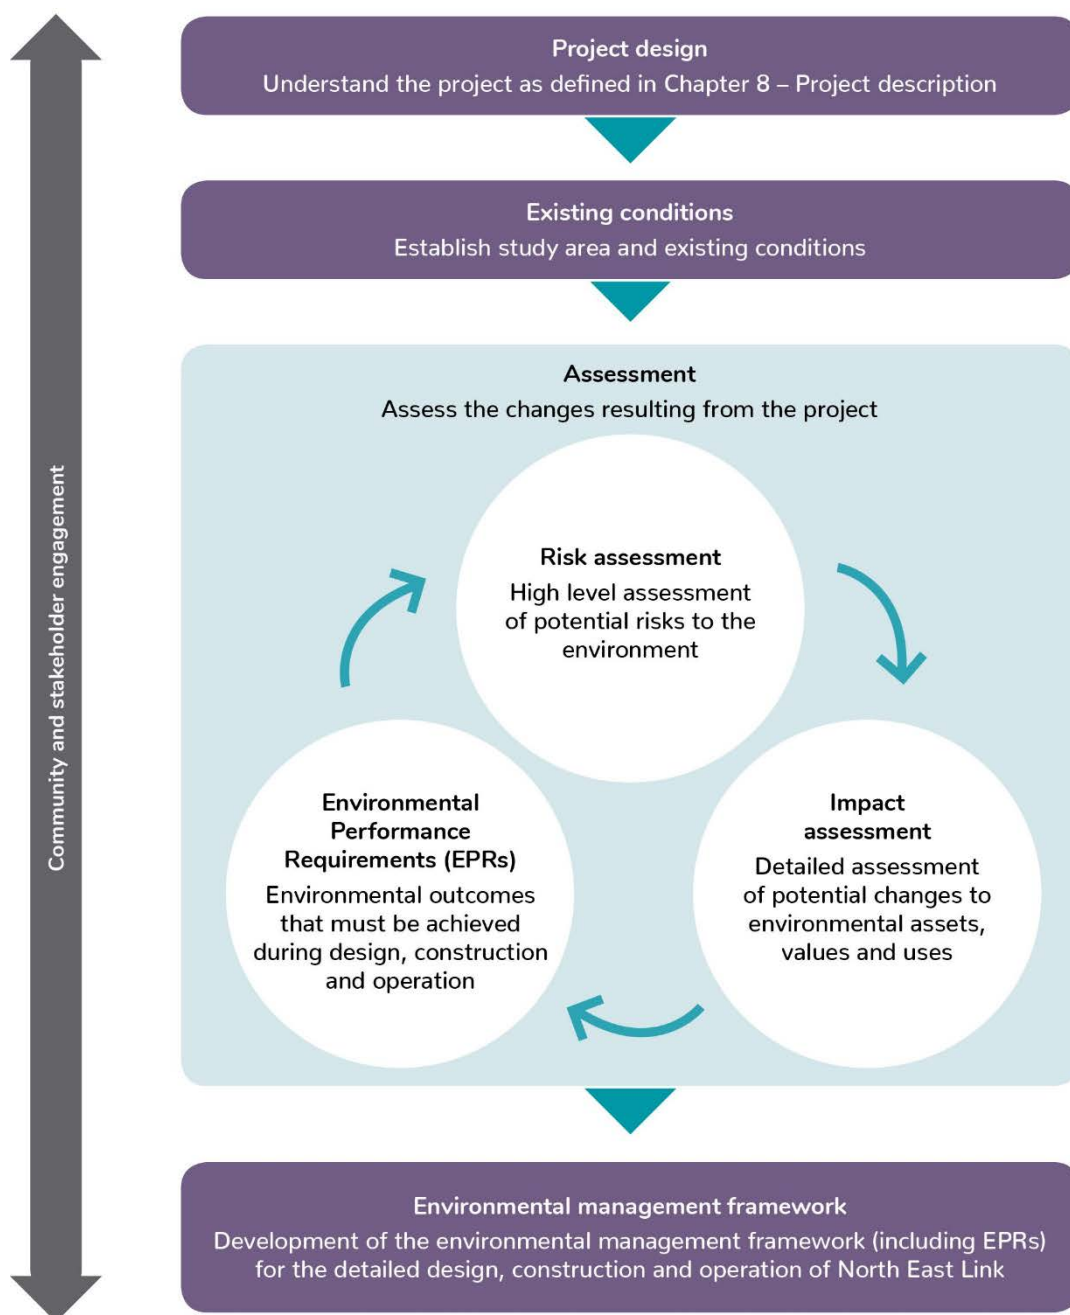
Figure 5-1: Overview of assessment method

This section describes the method that was used to assess the potential impacts of North East Link. A risk-based approach was applied to prioritise the key issues for assessment and inform measures to avoid, minimise and offset potential effects. Figure 5-1 shows an overview of the assessment method.

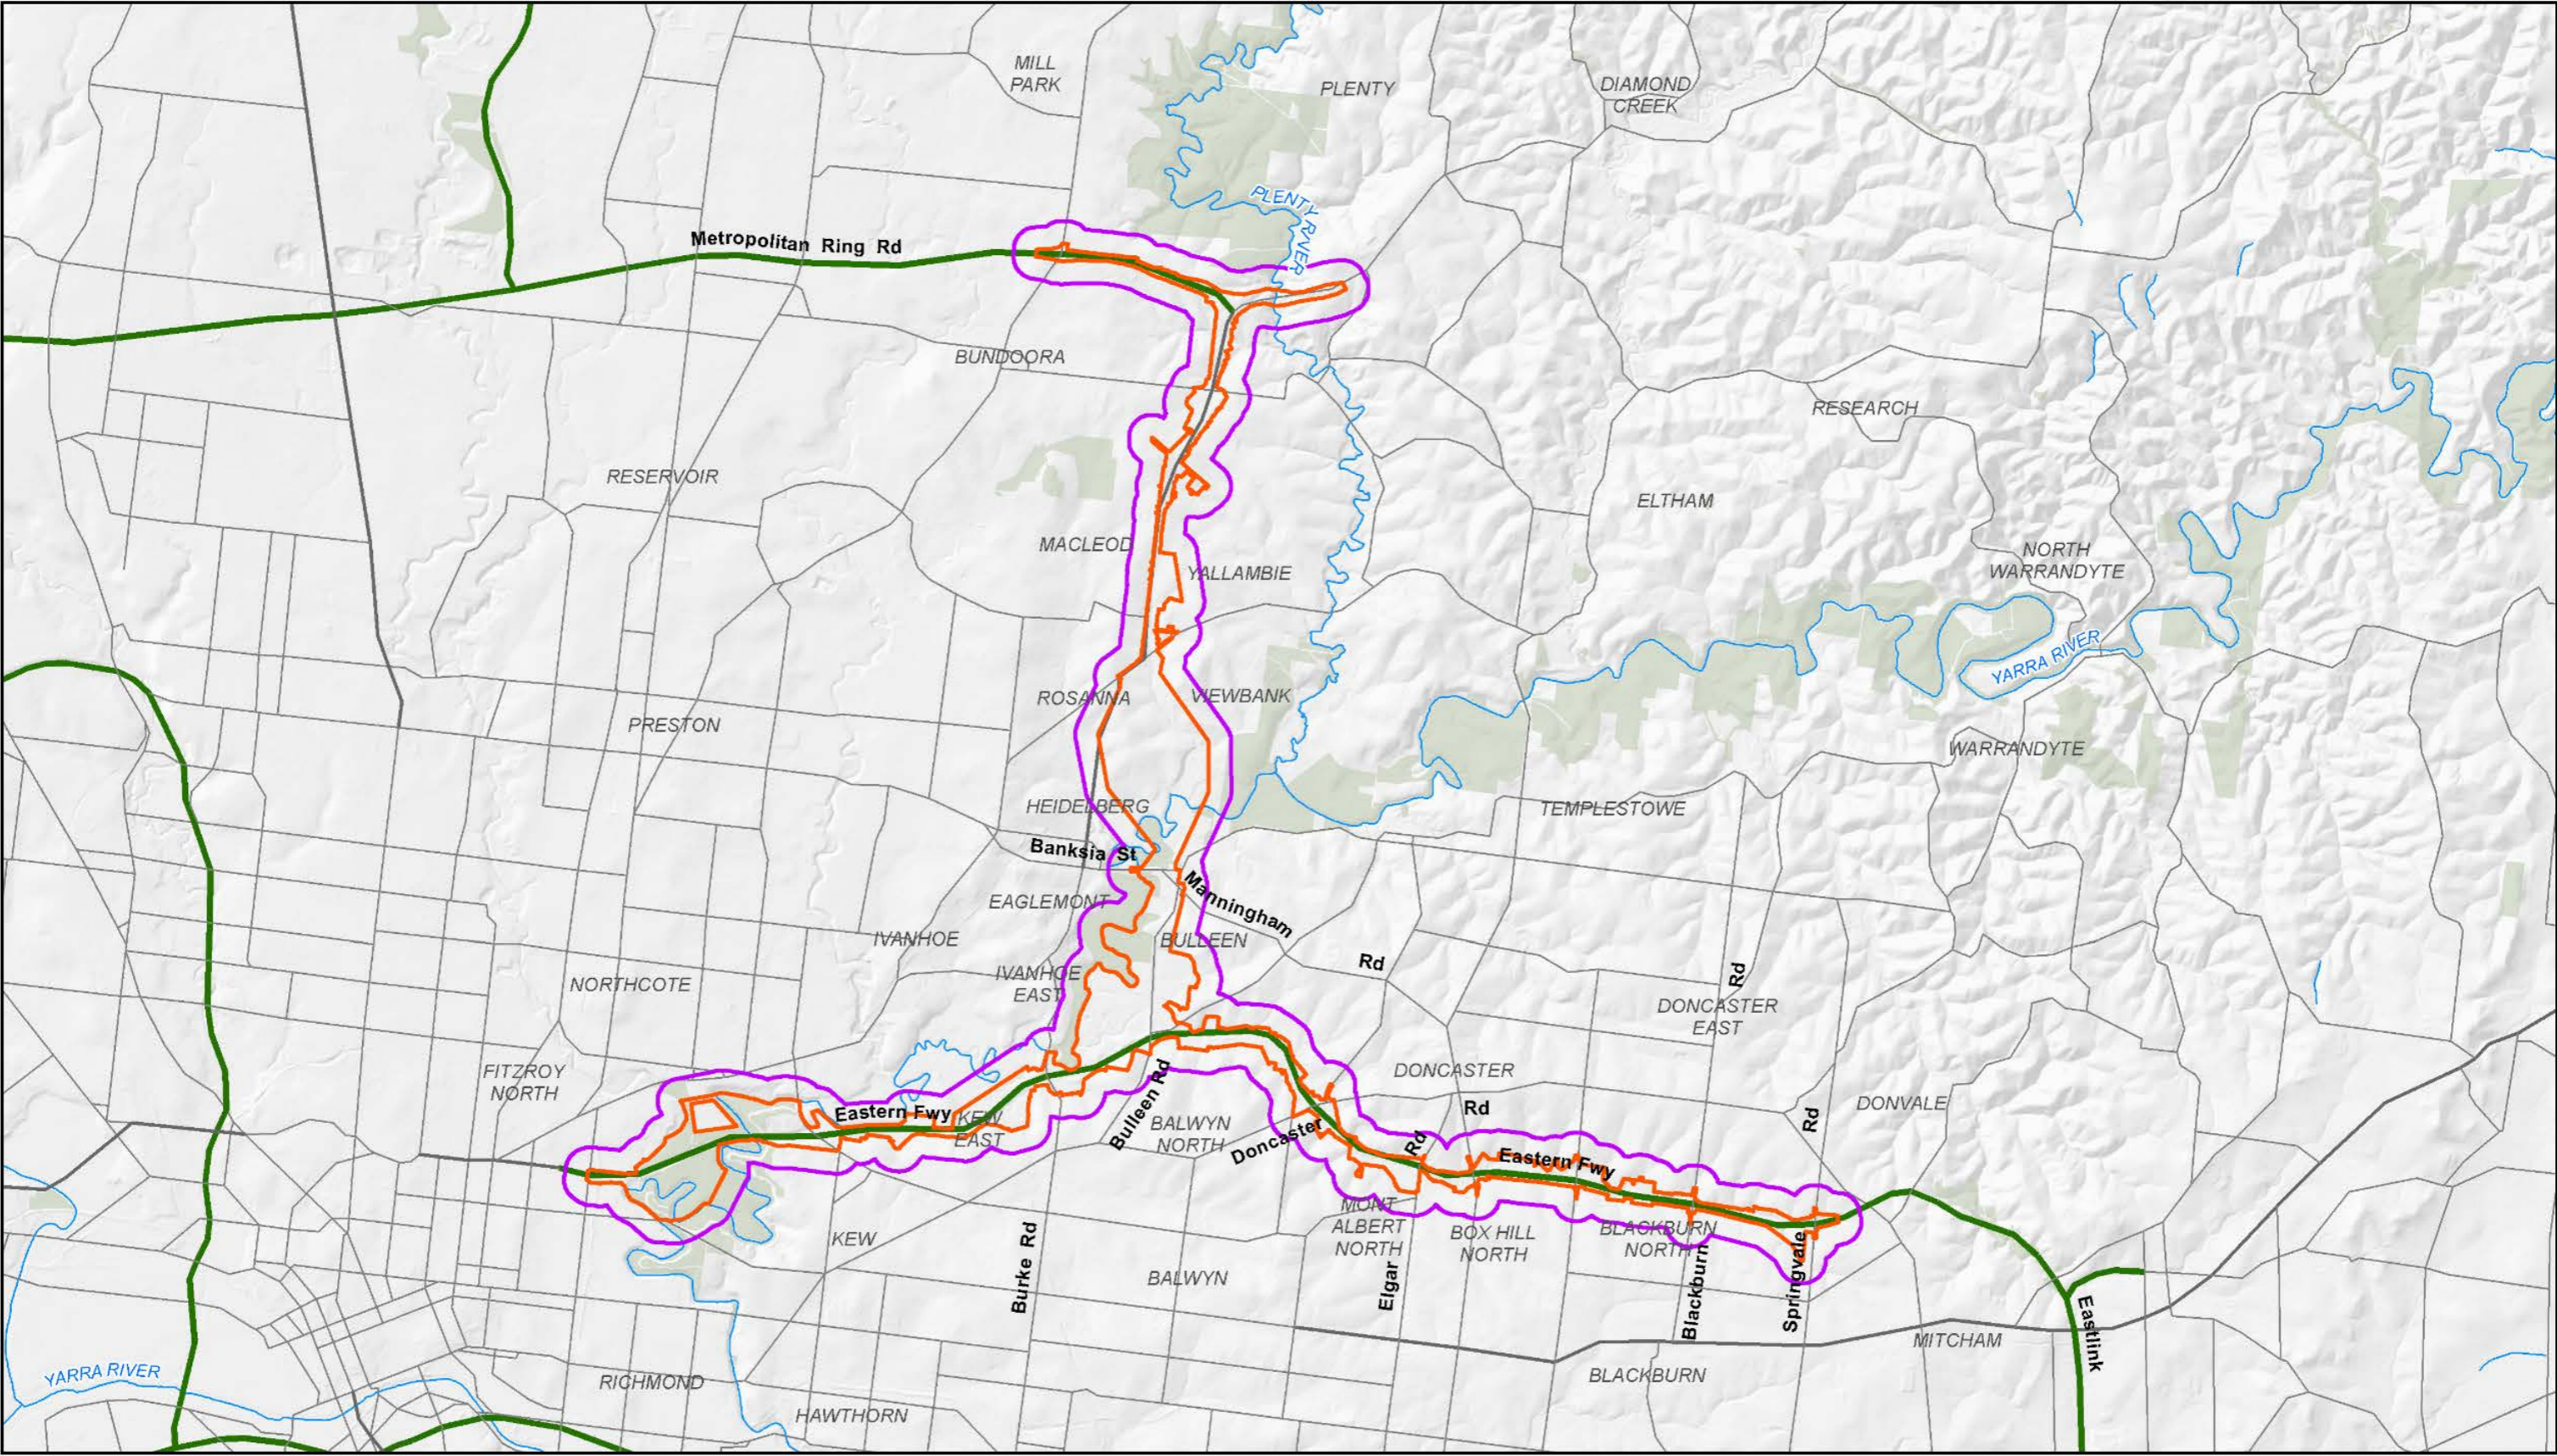
The study area for the Aboriginal heritage impact assessment is based on the project area established by NELP for the reference project. A 300-metre buffer has been added to the project area to act as a broad geographic region for the preparation of this assessment and the Cultural Heritage Management Plan (CHMP). The study area is shown in Figure 5-2. The report has assessed impacts within this area.

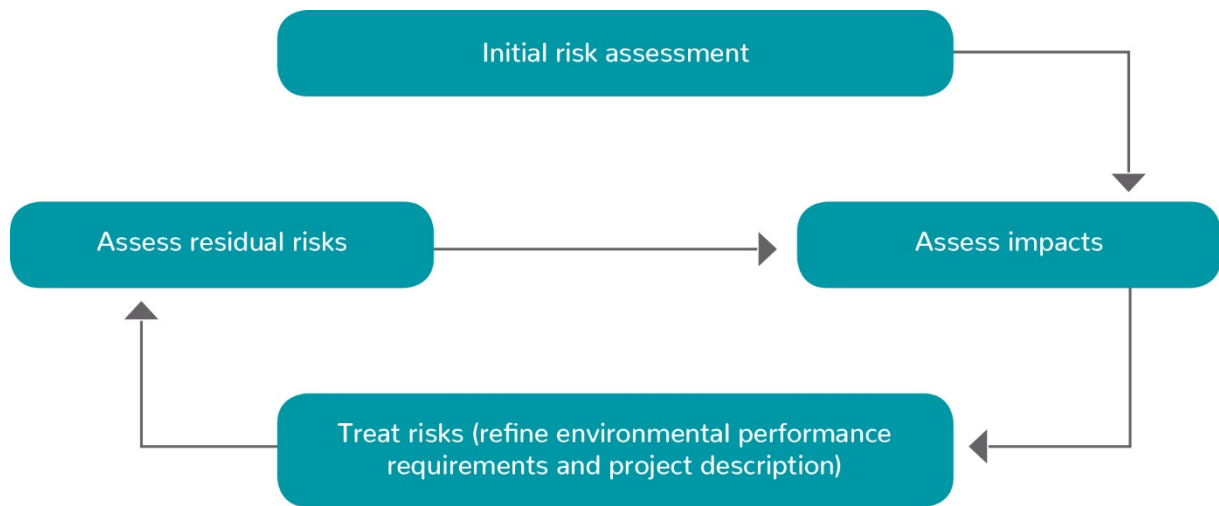
**Figure 5-3: Risk-based approach**

While there are clear steps in the risk process, it does not follow a linear progression and requires multiple iterations of risk ratings, pathways and EPRs as the technical assessments progress. Demonstrating this evolution, a set of initial and residual risk ratings and EPRs are produced for all technical reports. Figure 5-3 shows this process.
