MAJOR ROAD PROJECTS VICTORIA

TECHNICAL REPORT K - CONTAMINATED LAND IMPACT ASSESSMENT

Yan Yean Road Upgrade – Stage 2: Kurrak Road to
Bridge Inn Road

15 JULY 2020

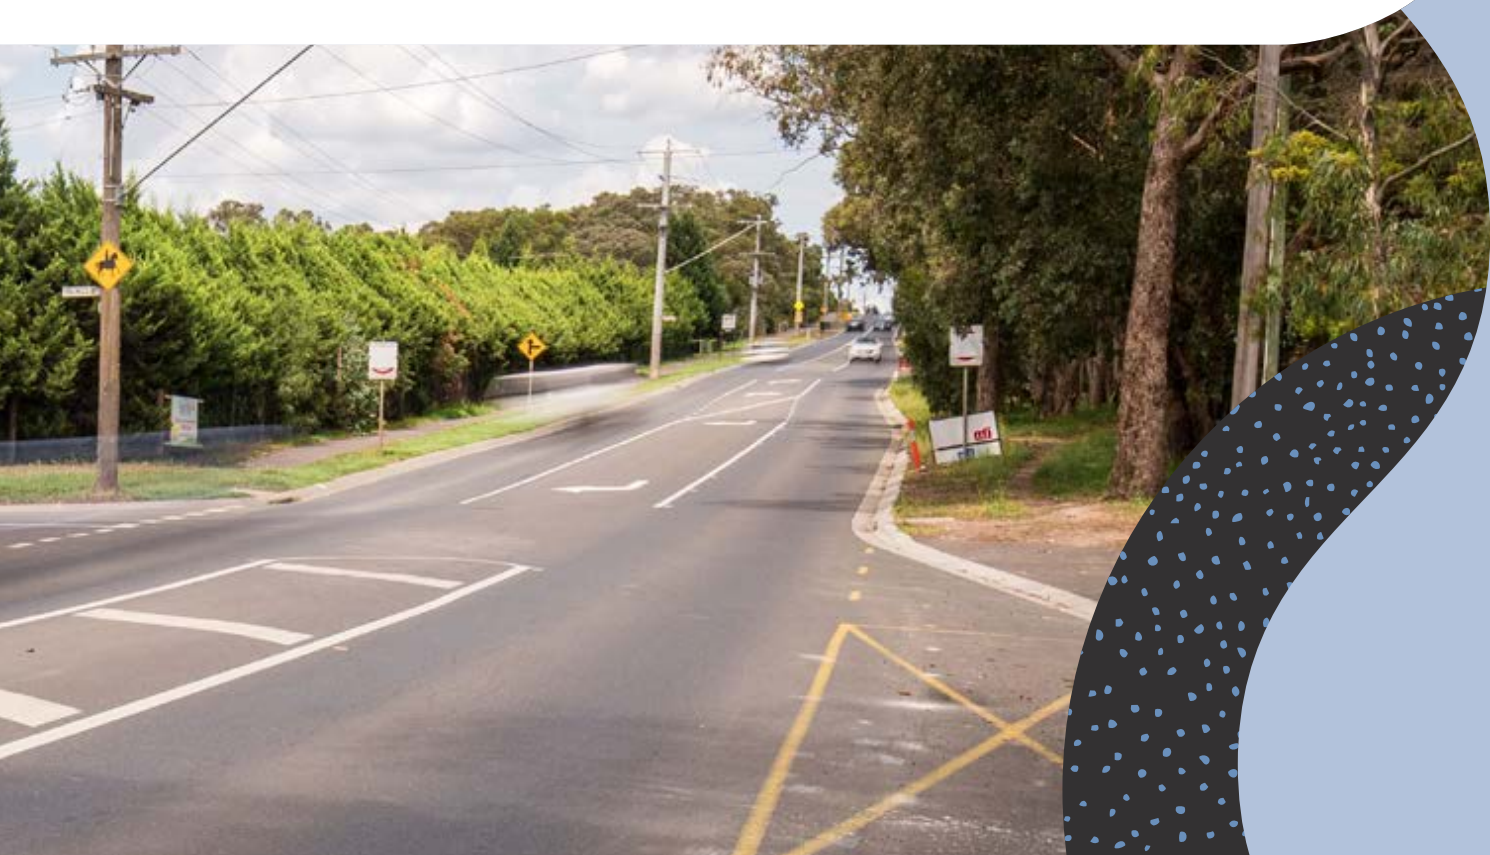
Figure 5.1 Project area

The design also seeks to limit impacts to existing properties, local accesses and trees along Yan Yean Road. The existing road alignment has been retained due to constraints around the topography and land uses adjacent to the road corridor. The exception is at the Bridge Inn Road intersection, which would be shifted to the north east to retain two River Red Gums (referred to as the Doreen River Red Gums) and two businesses. The project area is shown in Figure 5.1 and key components of the Project are shown in Figure 5.2.
