APPENDIX 1:
ABORIGINAL CULTURAL HERITAGE REPORT – STANDARD
ASSESSMENT

WESTERN HIGHWAY DUPLICATION: ARARAT TO STAWELL: STANDARD ASSESSMENT REPORT

CULTURAL HERITAGE MANAGEMENT PLAN NUMBER: 11819

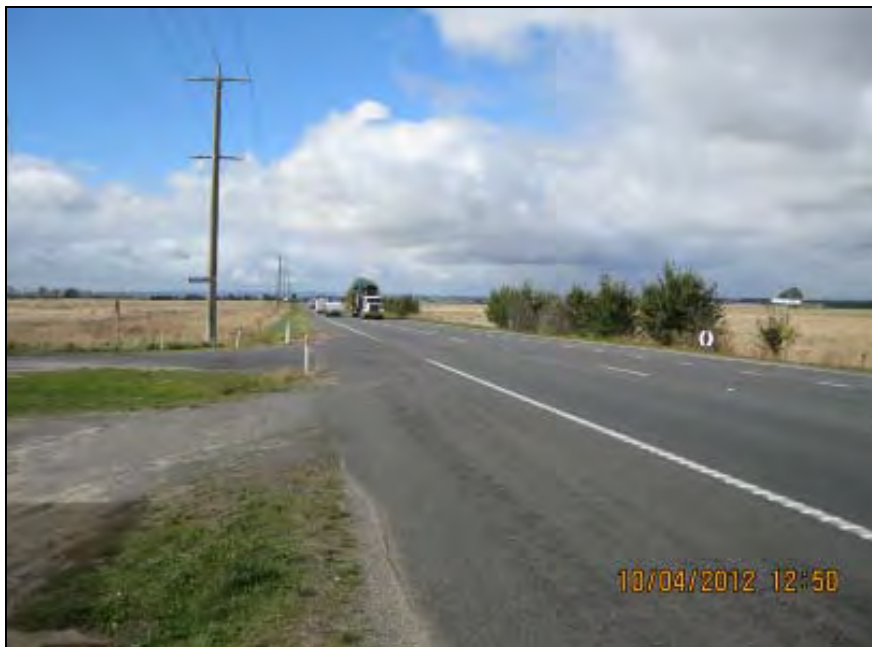
The following photos give an indication of the likely impact on the surface of the land and buried former land surfaces. These photos are taken from section 1a and 1b of the Western Highway Project between Ballarat and Beaufort.

Figure 1: Image of Western Highway where duplication works are yet to commence

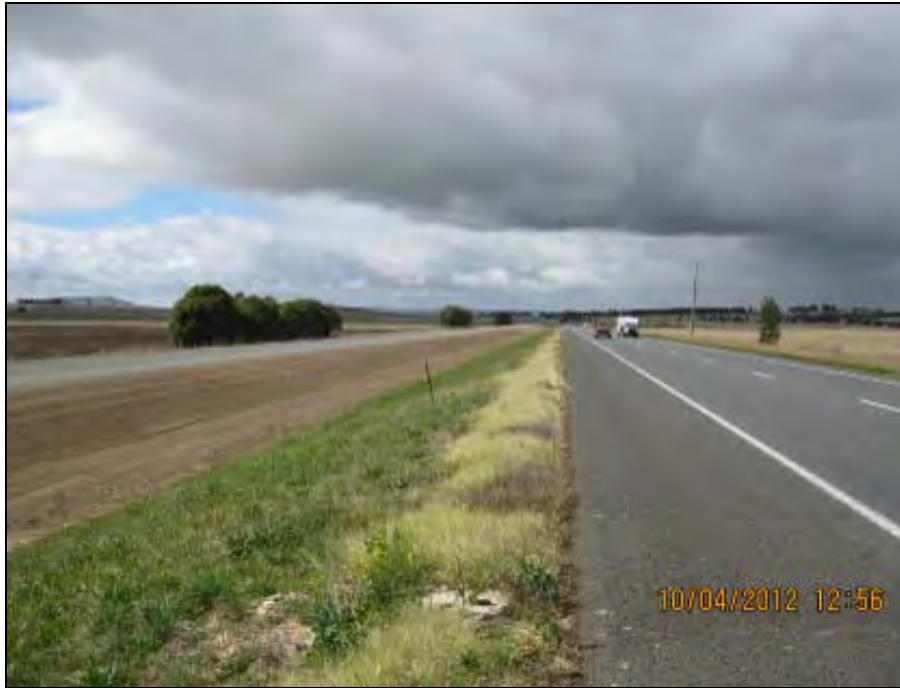
Figure 2: On the left side of this photo the duplication works can be seen being undertaken, on the right of the photo is the existing Western Highway (please note these works are occurring south of the current activity area under an already approved CHMP)

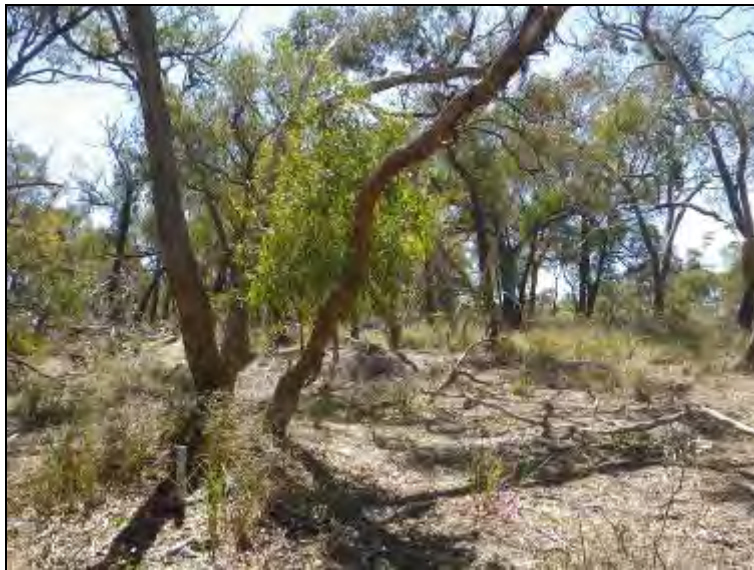
Figure 8: Example of ground surface visibility within a road reserve to the north of the Western Highway.

Weather conditions during the survey ranged from cool and sunny to cool and cloudy with a temperature range over the five days from 24° to 32° Celsius. Ground surface visibility across a majority of the activity area was extremely poor (<5%) due to dense grass and leaf litter cover. However, some ground surface exposures were noted, and these were primarily due to stock movement, ploughing and road construction. In these areas ground surface visibility increased to approximately 40%. The activity area incorporates the existing road reserve of the Western Highway, as well as portions of side roads and privately owned properties either side of the road reserves. A large number of trees were present within the road reserves of the Western Highway. However, a majority of these trees were either introduced species or immature native trees. Only a small number of mature native trees of an appropriate age to be Pre-European were identified during the survey.

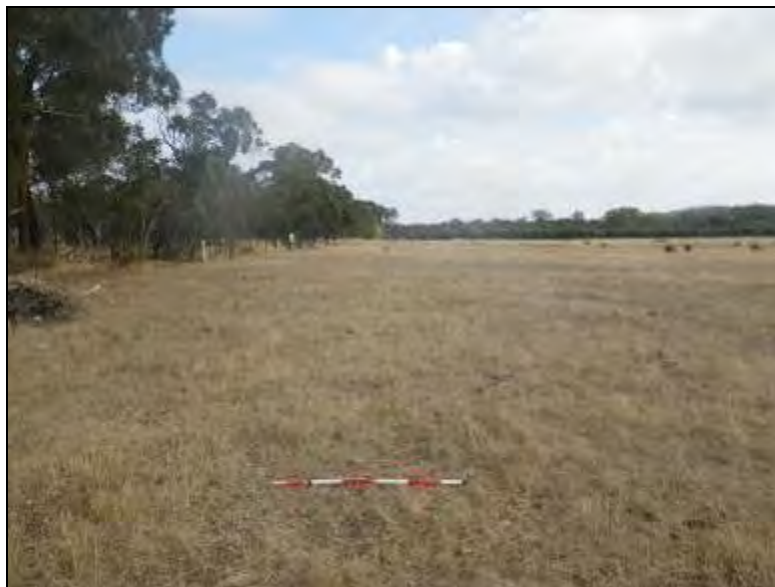
Figure 9: Example of ground surface exposure within the paddocks throughout the activity area.

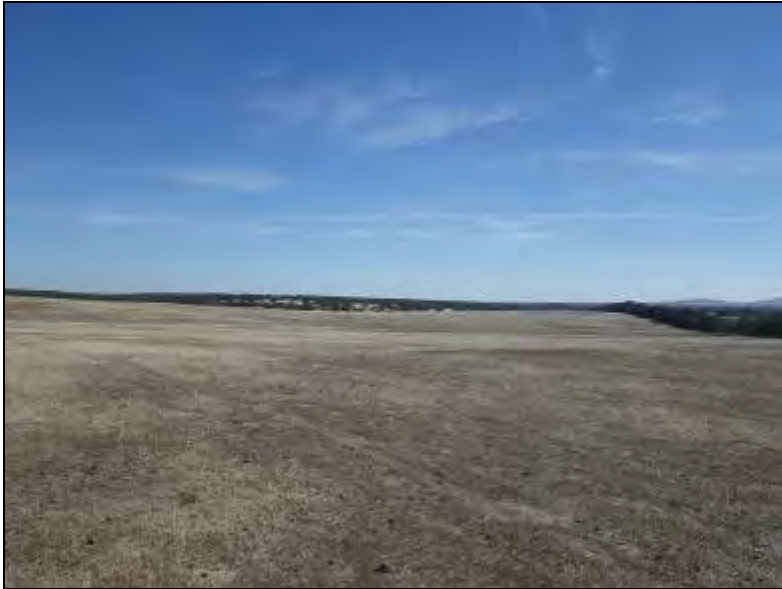
Figure 10: View of the paddock within the activity area to the east of the Western Highway facing north.

A total of approximately 5% of the activity area was effectively surveyed due to limitations imposed by ground surface visibility. The physical environment of the activity area was dominated by a flat to slightly undulating plain in the south from Ararat up to Stawell. The plain in the south near Ararat is dissected by a number of unnamed waterways and Concongella Creek. Concongella Creek was found to cut through the transect on a number of occasions. These waterways typically followed a north-east to south-west course originating from Concongella Creek to the north east of Stawell.

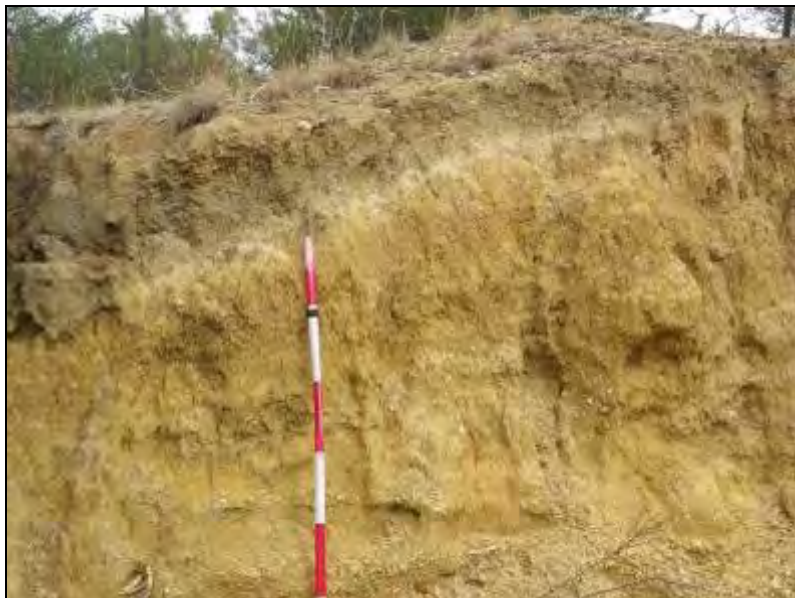
Opportunistic observations of the sediment profile of Concongella Creek revealed medium brown sandy silt overlaying a light brown sandy sediment overlaying a light brown and yellow sandy sediment with loose irregular rocky inclusions.

Figure 11: View of the sediment profile exposure on the western wall of Concongella Creek (exact location not recorded). Photo taken facing south.

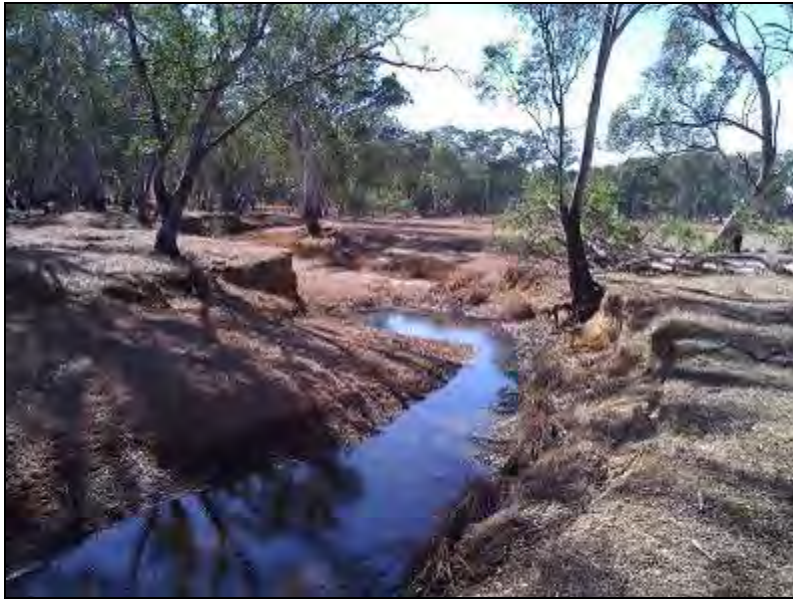
Figure 12: View of the sediment profile exposure on the western wall of Concongella Creek located within the original activity area. Located 10 m south of Kimburra Road 1. Photo taken facing south.

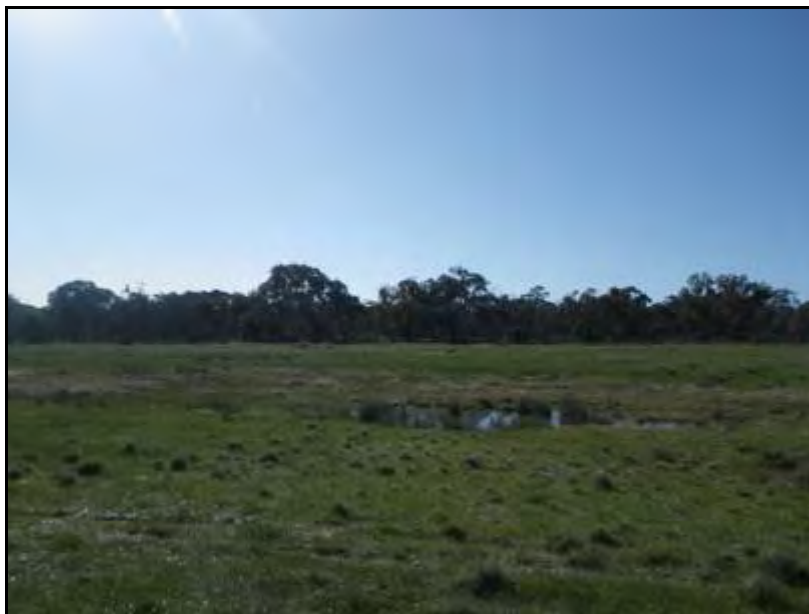
Figure 13: Two small soaks located to the north-west of Loddon Road in additional survey area stage 1. Photo taken facing east.

A number of other waterways, including soaks, were recorded throughout much of the activity area (see Figure 13).

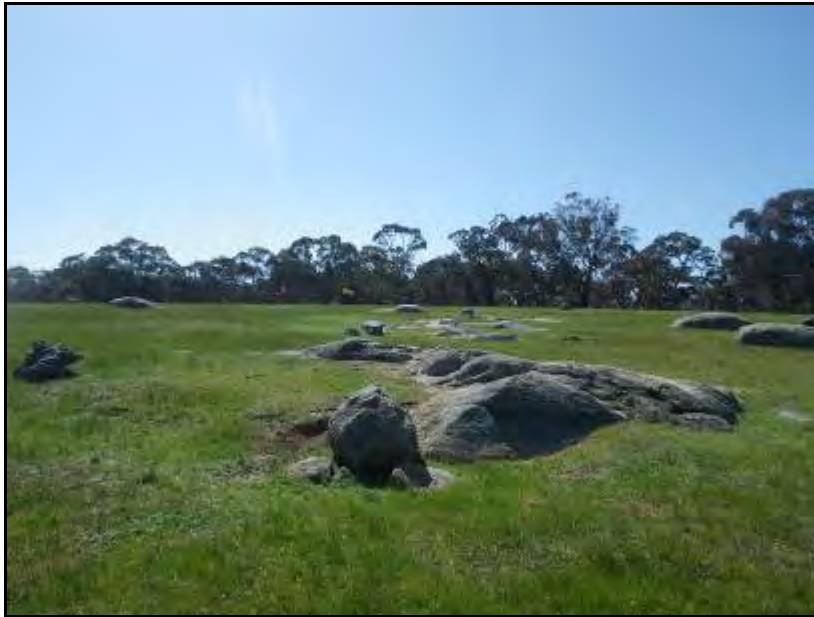
A large stony rise with granite outcrops (see Figure 14) was recorded between St George Road and the rail line and within 500 m north-east of a waterway. No artefacts were observed on the surface of the area, but it is considered to be moderately to highly sensitive.

Figure 14: Large stony rise with granite outcrops was observed between St George Road and the rail line in Stage 2 of the additional survey area. Photo taken facing north-east.

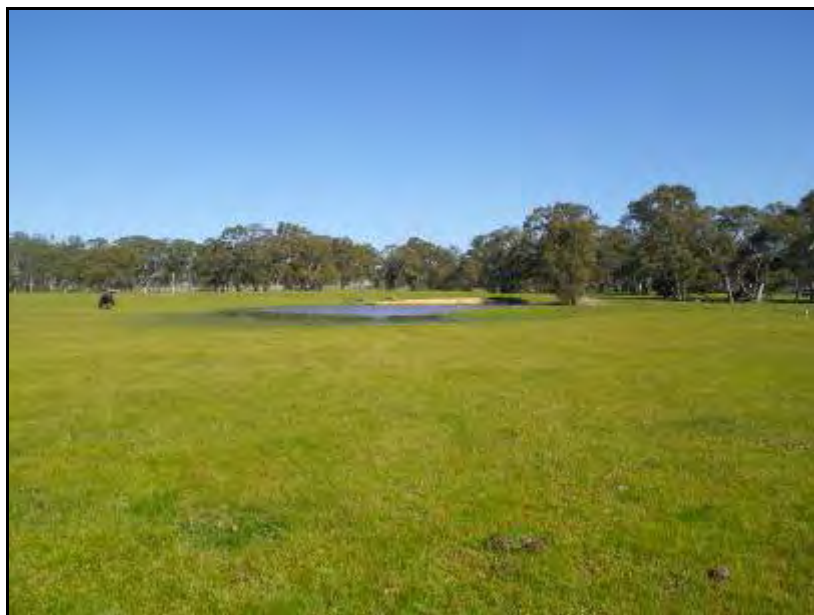
Figure 15: An example of the many dams throughout the activity area. Photo taken facing south-east.

A number of dams were also prevalent throughout many of the properties surveyed (see Figure 15 and 16).

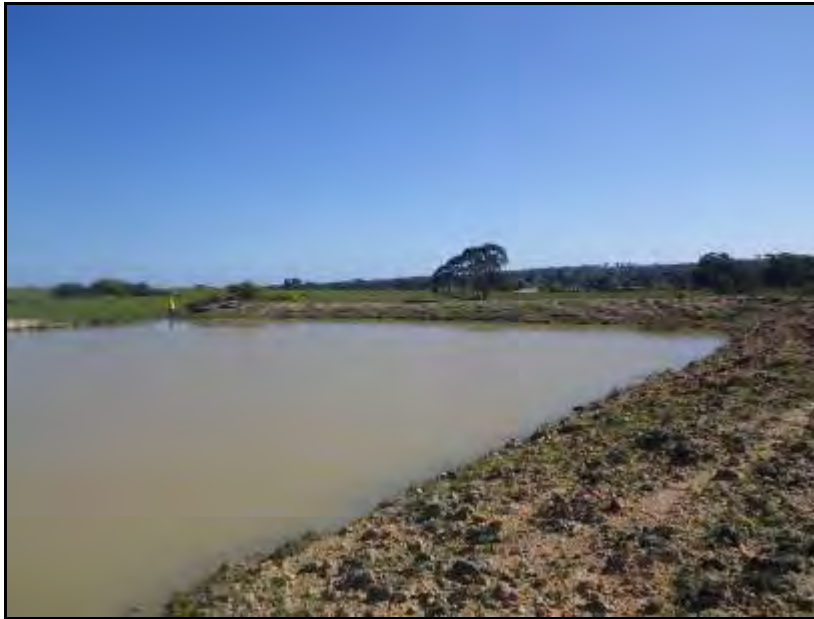
Figure 16: Example of large dam within the activity area alignment. Photo taken facing north-west.

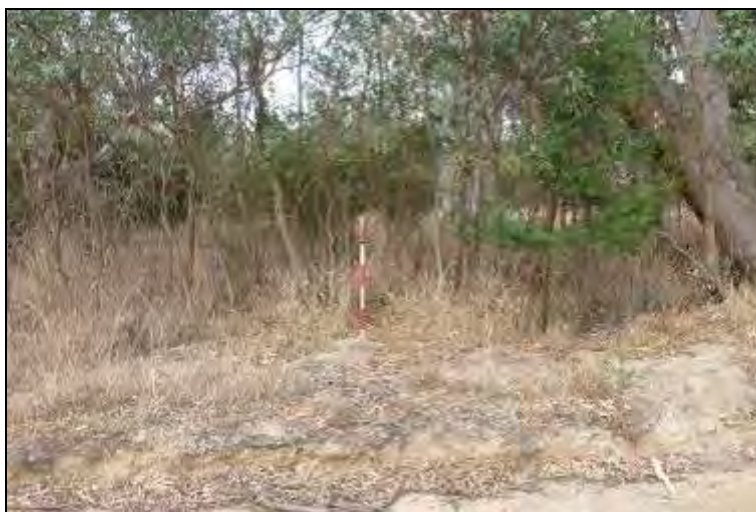
Junction Bridge 1 and 2 are scar trees located 50m apart, 10m west of the Western Highway and 150m north of Old Brewery Road. Neither tree could be identified in the nearby landscape, which is most likely due their recent removal.

Figure 17: Location of Junction Bridge 1. Photo taken from the Western Highway facing west.

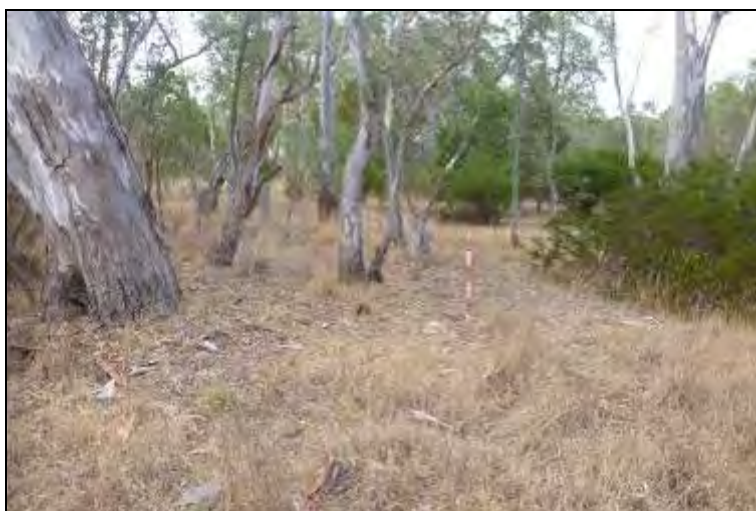
Figure 18: Location of Junction Bridge 2. Photo taken from the Western Highway facing west

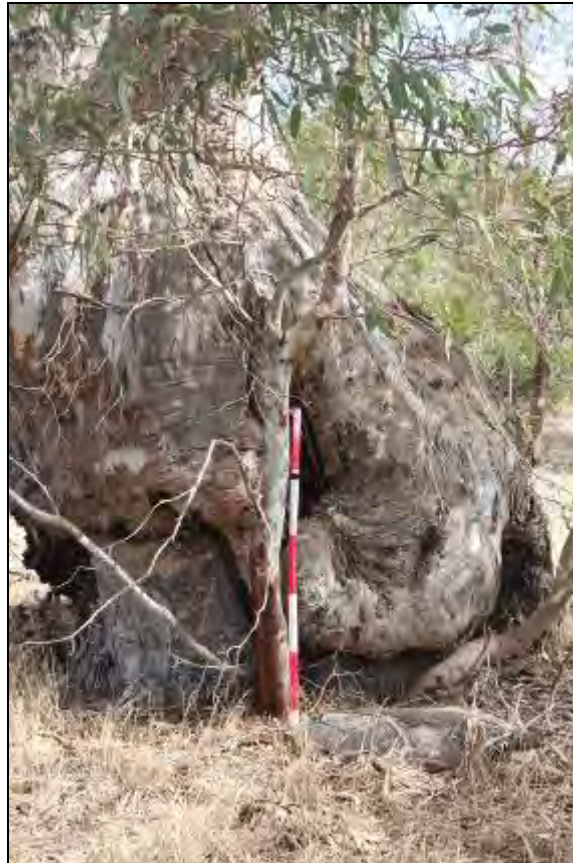
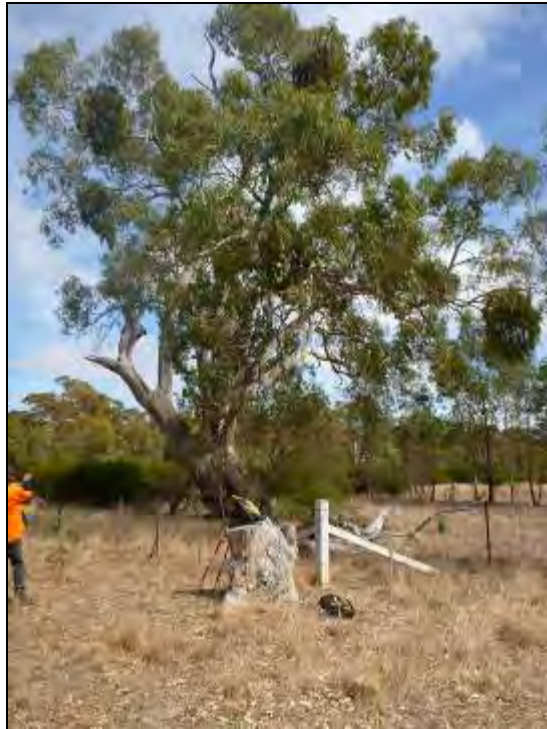
Armstrong ST 2 is a scar tree site and considered an ethnographic site as identified by Frank Douglas (Barengi Gadjin representative). The site is located 100m east of the Western Highway and 500m north of Garden Gully road. The site is surrounded by a fence that sits approximately 10m from the tree's base. The scarred tree seems to be in good health.

Figure 19: Photo of Armstrong ST 2. Photo was taken facing north-east and shows the tree's scar.

Figure 20: Photo of Armstrong ST 2. Photo taken facing north-east and shows the full extent of the tree.

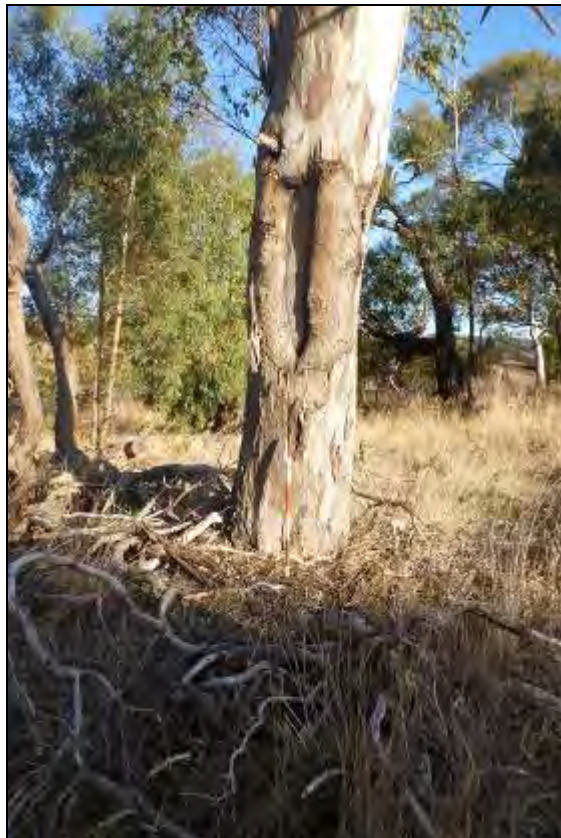
Armstrong ST 3
VAHR: 7423-0738
 [REDACTED]

Armstrong ST 3 is a scar tree site and is located 600m south of Kimburra road, 20m east of the Western Highway and has Concongella Creek running 200m to the east. The tree seems to be in good health and seems undisturbed.

Figure 21: Photo of ST 3. Photo taken facing north-east.

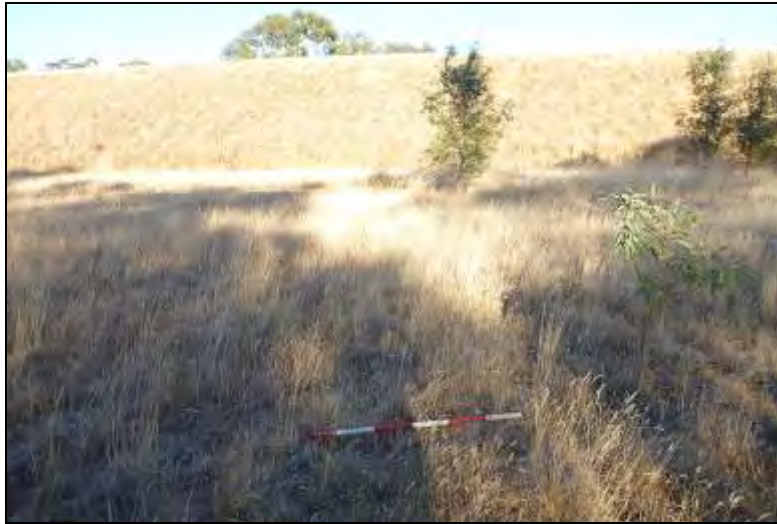
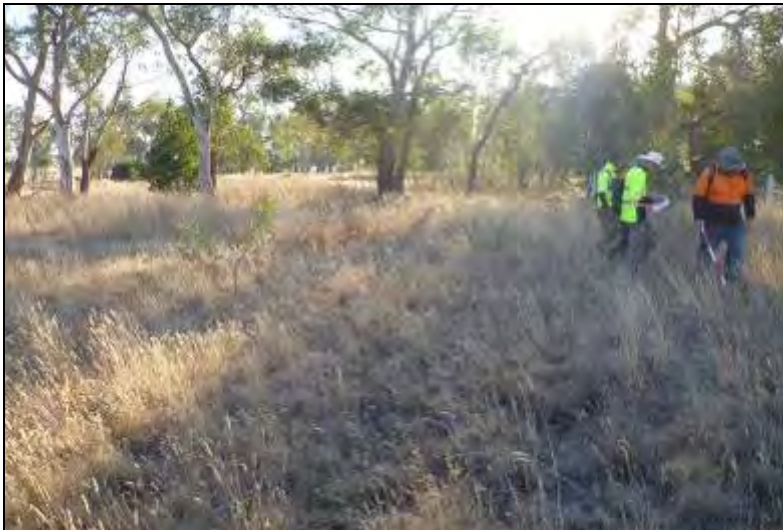
Armstrong SS 1
VAHR: 7423-0734

Armstrong SS 1 is a surface scatter site located 600m south of Kimburra road, 50m west of the Western Highway and has Congongella Creek running 230m to the east. The surface scatter could not be identified due to poor ground visibility. This site may have undergone disturbance due to the close proximity to the highway.

Figure 22: Location of Armstrong SS 1. Photo taken facing east.

Figure 23: Location of Armstrong SS 1. Photo taken facing west.

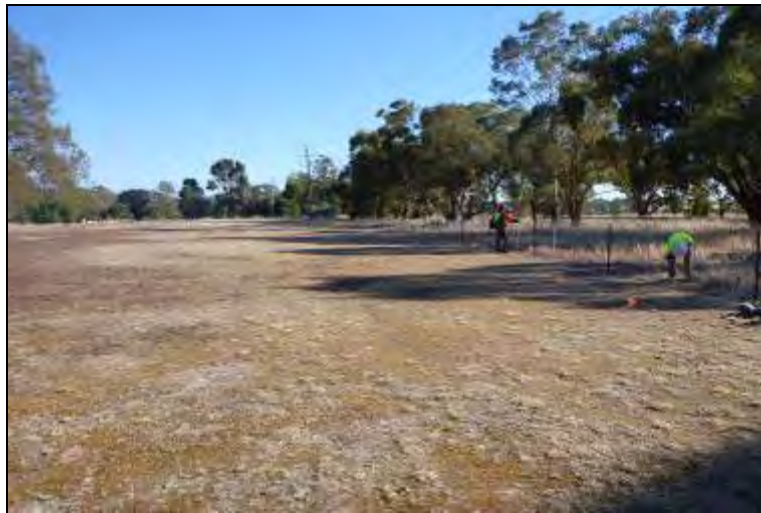
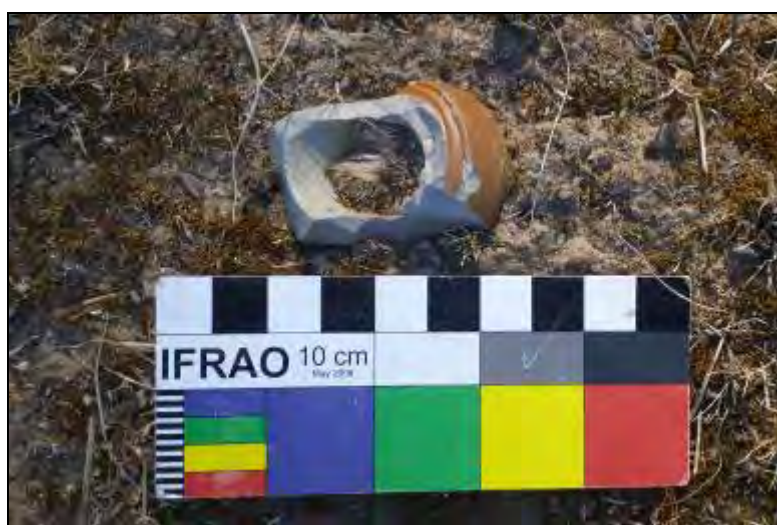
Kimburra Road 1 is a surface scatter comprising two ceramic and four glass flaked pieces. The site was located 10m north of Concongella Creek and 50m south of Kimburra Road. The scatter was located on flat terrain with a relatively higher ground visibility of 20%. The surface scatter continued for 20m north of Concongella Creek. The site is likely to extend westward outside the survey corridor. The site was situated on private property which has been previously impacted by land clearance and animal trampling.

Figure 24: Location of Kimburra Road 1. Photo was taken from Concongella Creek looking north across the site.

Figure 25: Example of one of the flaked ceramic pieces located at Kimburra Road 1.

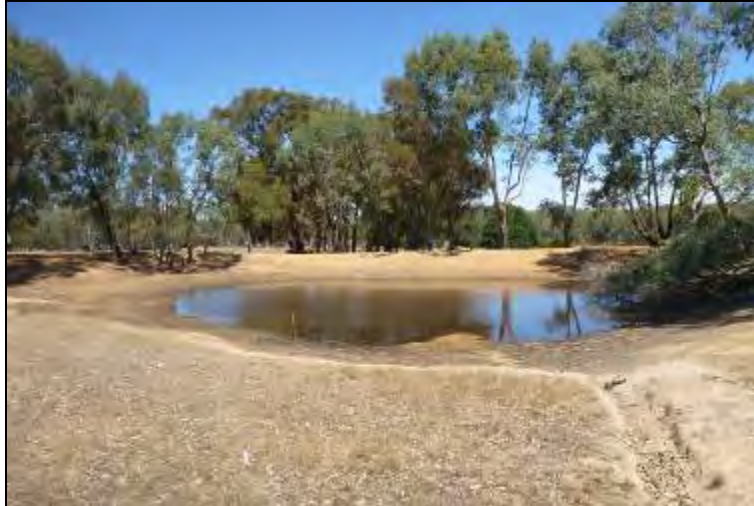
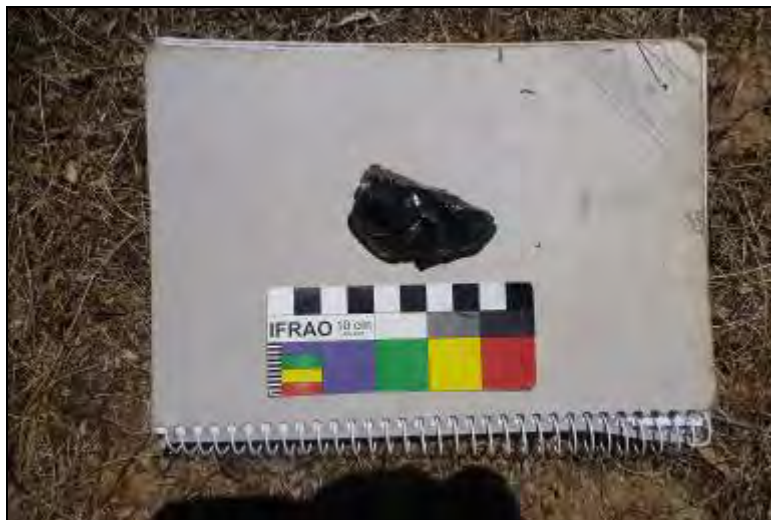
Wattle Gully Road 1 is an isolated artefact composed of one glass flake found on the surface. The site was located at the base of the banks of an unnamed artificial waterway used to supply water to the private property's dam. The property was located east of Great Western heading north from the Western Highway.

Figure 26: Location of Wattle Gully Road 1. Photo taken facing south.

Figure 27: Close up image of flaked glass which composes Wattle Gully Road 1.

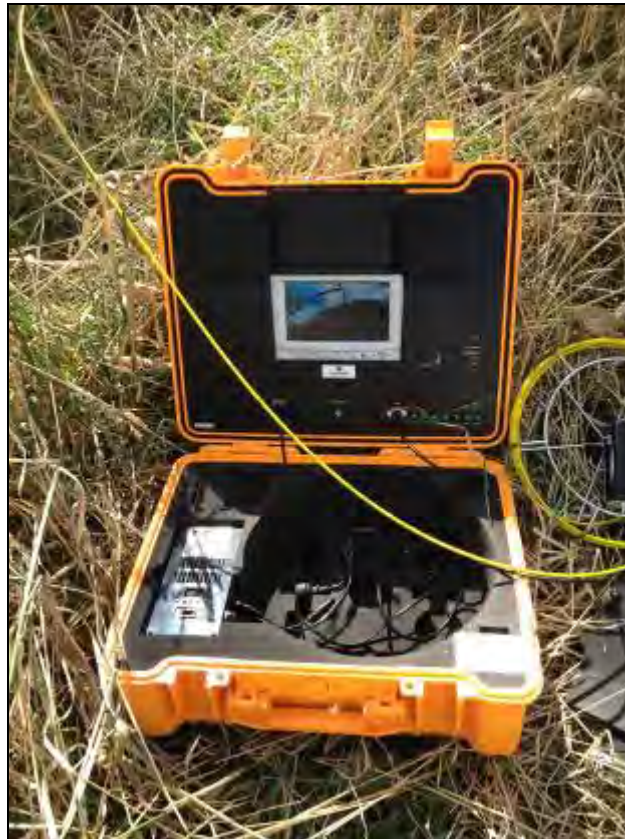
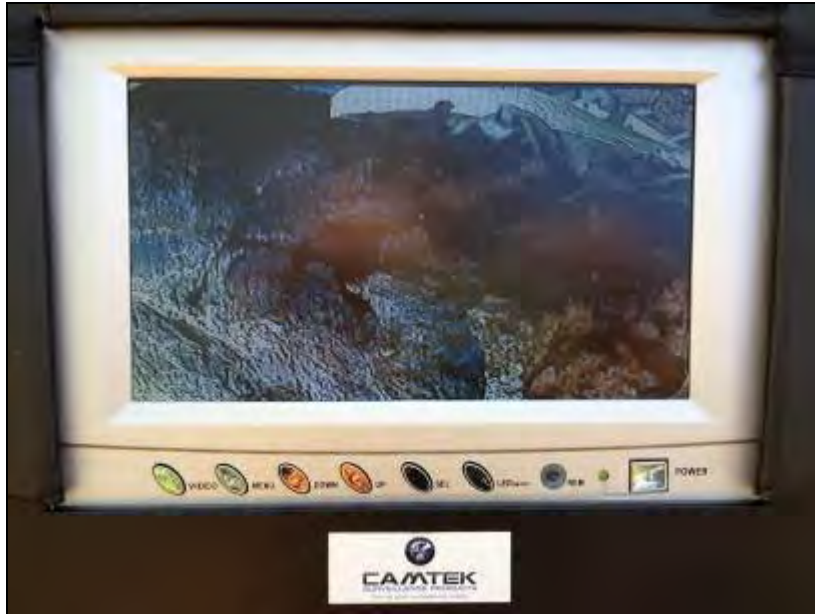
There was no evidence of human burials or mortuary goods within any of the hollow trees inspected within the activity area.

Figure 28: Endoscope equipment used for climbing hollow tree inspections

Figure 29: An example of the type of image produced using the endoscope at the base of the hollows. Note the clarity of the image - wood grain and leaves are clearly visible

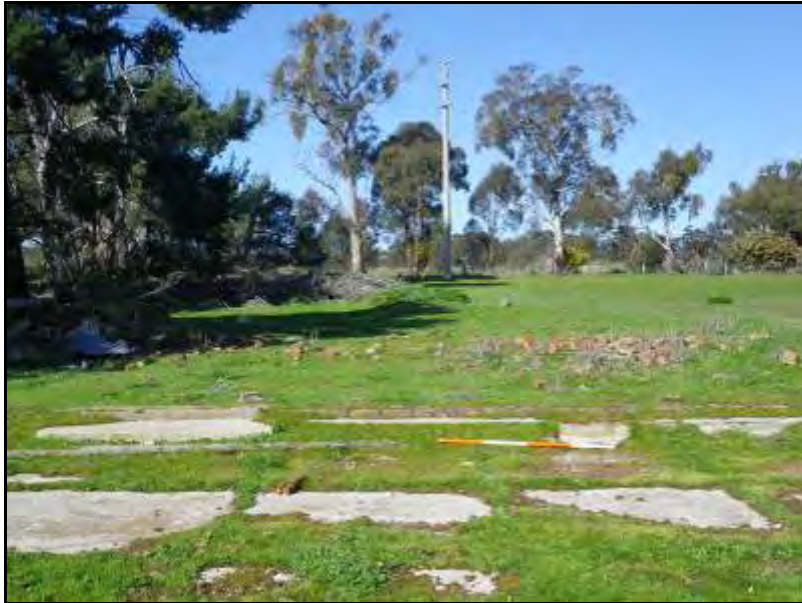
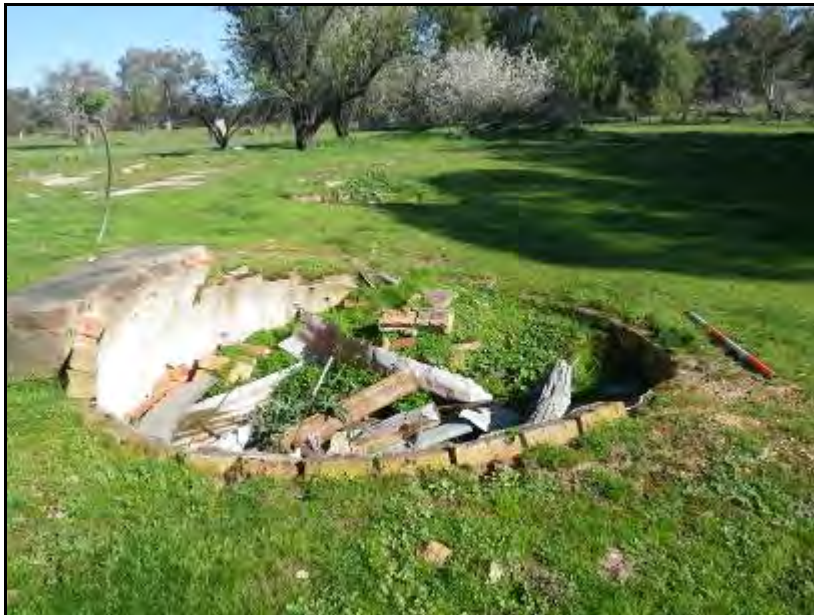
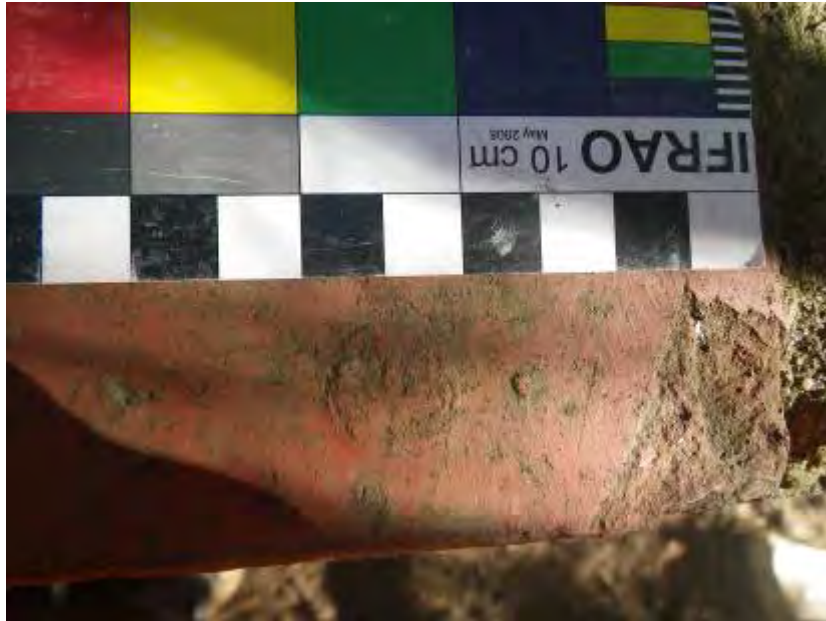
The foundations and well associated with a historic homestead (H7423-0061 Armstrong No. 2; see Figure 31) were recorded. The historical well was quite small (see Figure 32) and had a diameter of approximately 2 m; the well was capped and located directly north in a paddock neighbouring the homestead. Markers mark was recorded on one of the bricks (see Figure 33).

Figure 30: Historic Homestead H7423-0061 Armstrong No. 2. Photo taken facing north-east.

Figure 31: Ruins of a brick-lined well associated with H7423-0061 Armstrong No. 2. Photo taken facing north-east.

Figure 32: Makers mark on one of the bricks associated with the well (H7423-0061 Armstrong No. 2).

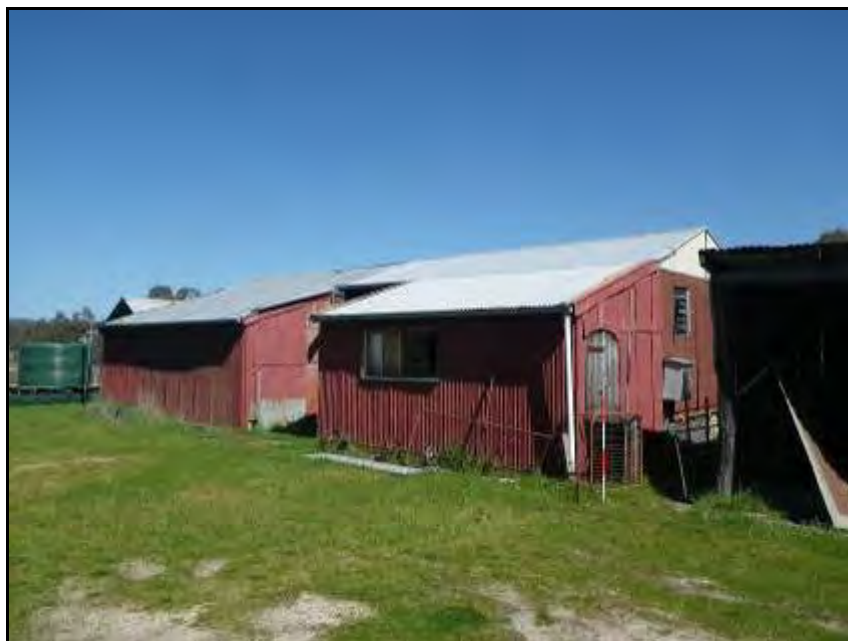
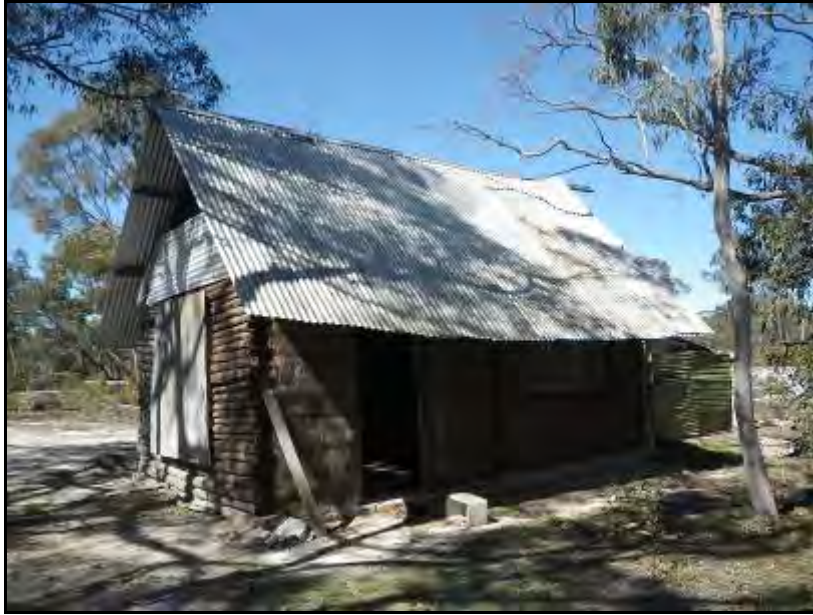
An historic shearing shed and squatters hut was observed near Panrock-Reservoir Road (see Figures 34 and 35), but is located just outside of the current activity area boundary. The shearing shed had an equipment shed and shearers quarters / lunchroom attached, while the squatters hut appears to have had modern additions which may be associated with kids setting up a place to spend time.

Figure 33: Historic shearing shed near Panrock-Reservoir Road. Photo taken facing south-west.

Figure 34: Squatters Hut located near Panrock-Reservoir Road. Photo taken facing east.
