North East Link Program – Central Package

IEA Six-Monthly Summary Environmental Compliance Report – May to October 2024

A Report to the Minister for Planning

NEL-CNT-AAA-2990-EEE-REP-0005

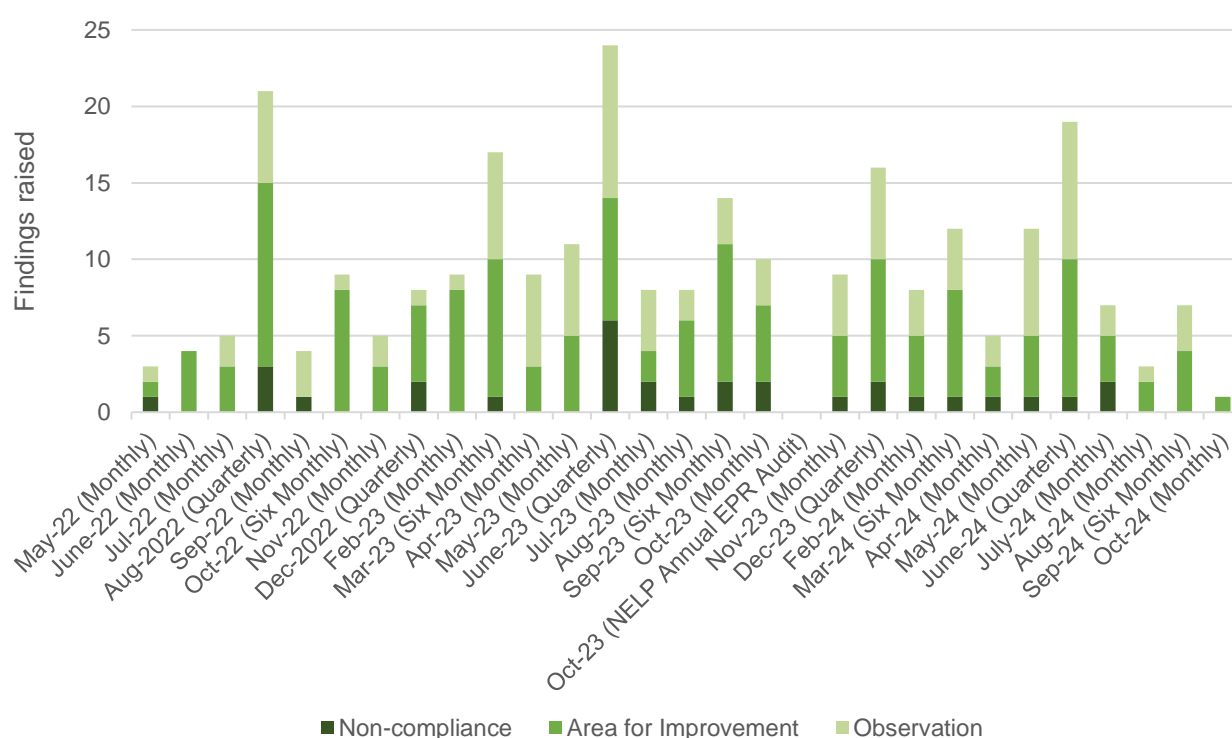
Figure 4: Audit findings by type and audit date (Project commencement to October 2024)

Most of the audit findings were raised in the June 2024 quarterly audit, which assessed compliance against the requirements of most of Spark's environmental documentation (see Figure 4).

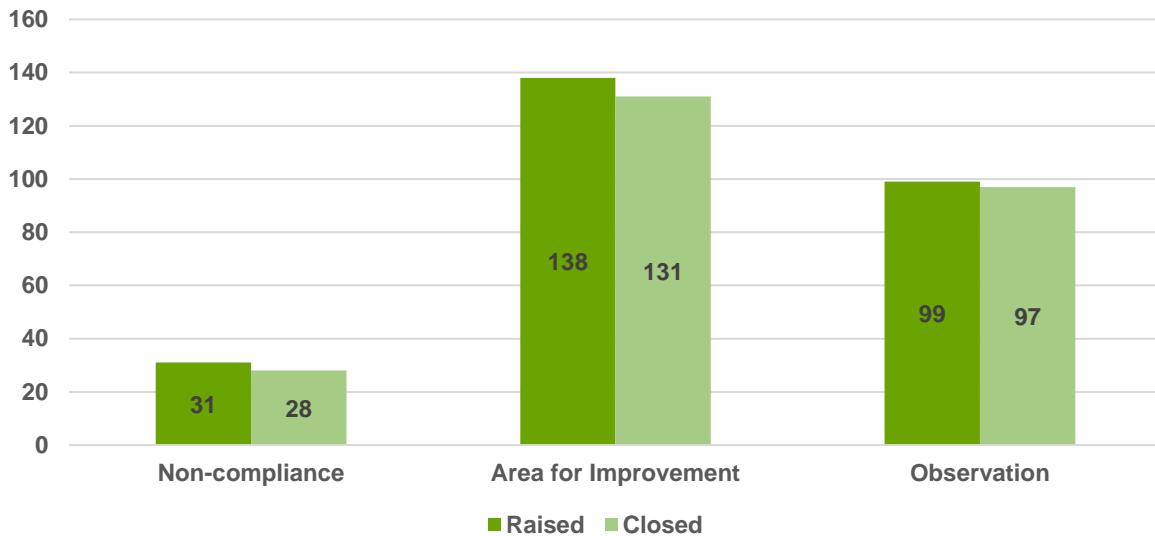
Figure 5: Cumulative audit findings raised and closed - Project commencement to October 2024

Spark D&C established corrective actions to address audit findings. Fifty-eight (58) findings were closed during the reporting period. Twelve (12) findings remained open at the end of the reporting period. (See Figure 5).

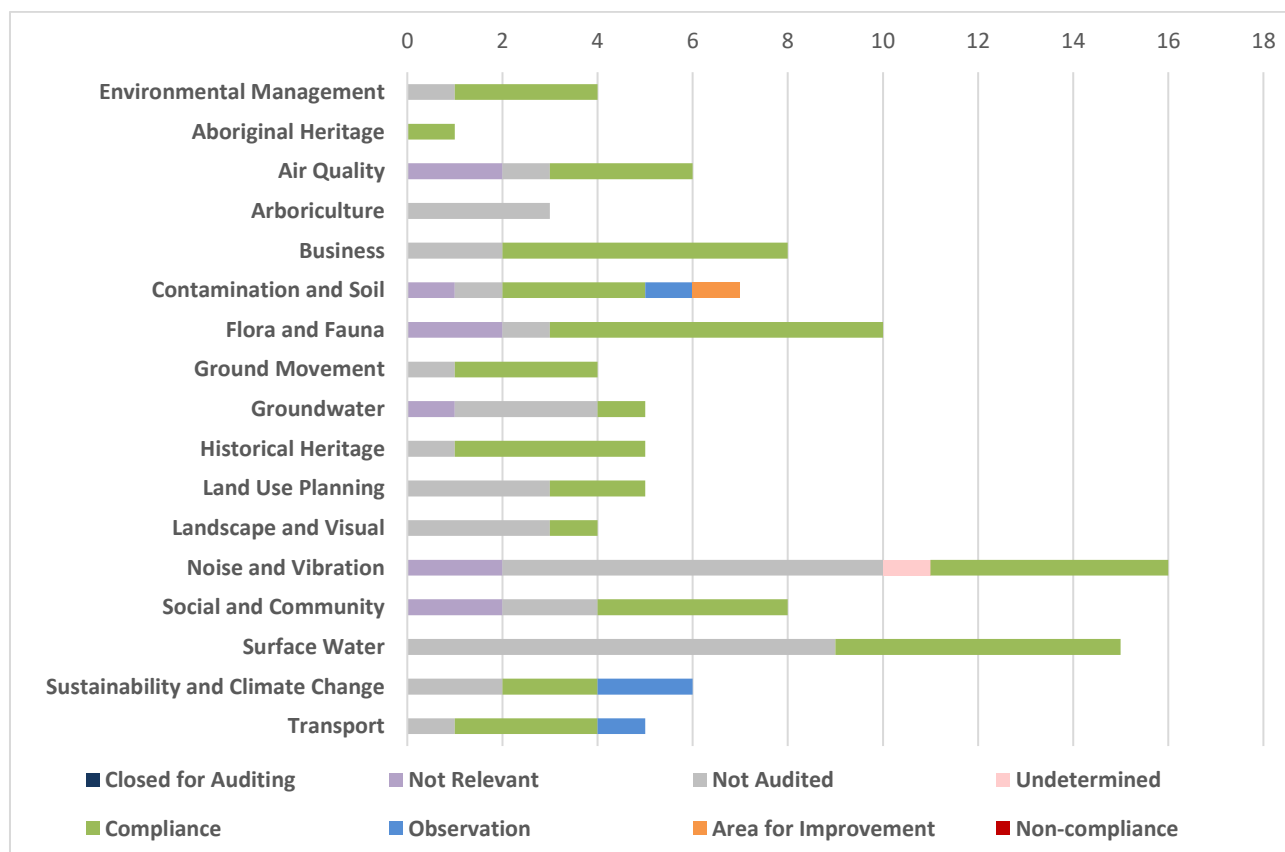
Figure 6: EPR audit findings by EPR category May to October 2024

Figure 6 shows the distribution of EPRs in each of the categories noting which were audited, and the status of compliance for the reporting period. In addition to the five findings, Figure 6 also shows the compliance rating for EPR NV15 was set as U (or Undetermined) as Spark was continuing with the design process required to meet the EPR's requirements. Further, only EPRs relevant to the design and construction underway during the reporting period were included in the audit schedule for the period. Further, not all EPRs have equally detailed requirements, and there are different numbers of EPRs in each EPR category. The number of EPRs audited does not directly reflect the relative weight of environmental management requirements

As each EPR category includes several EPRs, some of these were not included in the audits in the reporting period. All environmental issues are audited through the audits of Management Plans.

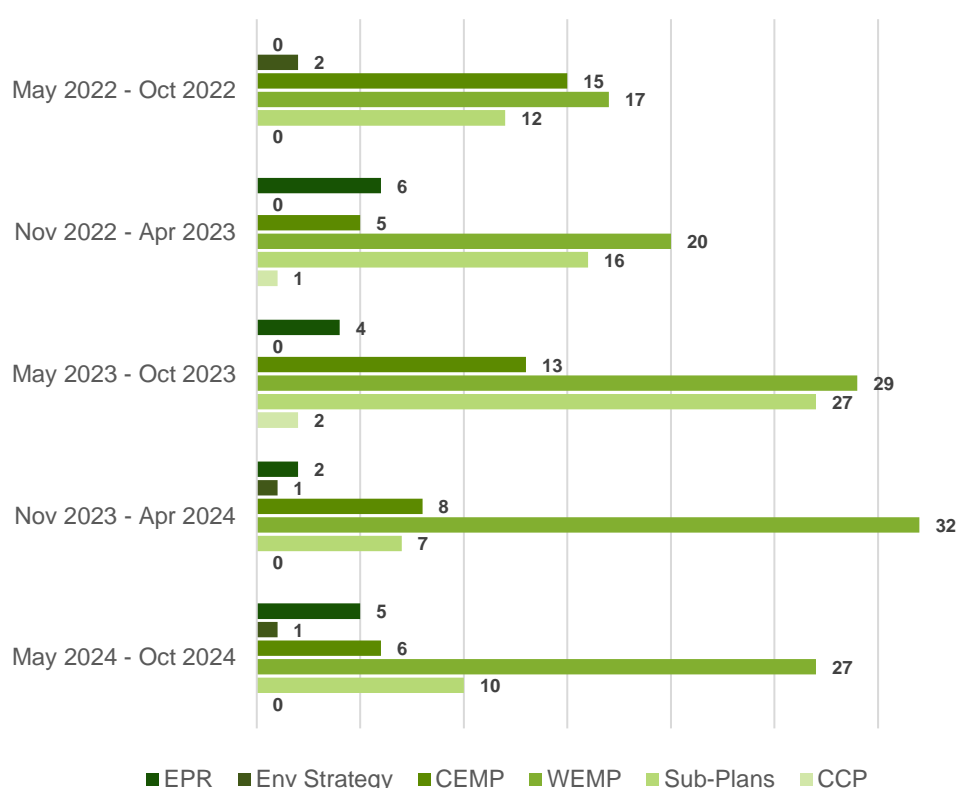
Figure 7: Audit findings by reporting periods

The audit findings trends over the reporting periods show that Spark's documented environmental management arrangements have improved to reflect actual environmental management processes, and Spark's implementation of these processes has improved. The number of audit findings against the process documents (Environment Strategy, CEMP, and Sub-Plans) has decreased (see Figure 7). Findings against the WEMPs, which largely manage on ground environmental controls, also decreased compared to the previous reporting period. The number of WEMP-related findings may correspond with the increased scope and complexity of construction activities. However, the findings also note the need for Spark to further establish commensurate environmental controls.

The number of findings against the WEMPs has decreased from previous reporting period (see Figure 7). However, the findings also note the need for Spark to further develop commensurate environmental controls. Spark has not demonstrated that these on-ground controls are always effective.
