North East Link Program – Central Package

# IEA Six-Monthly Summary Environmental Compliance Report – November 2024 to April 2025

NEL-CNT-AAA-2990-EEE-REP-0006

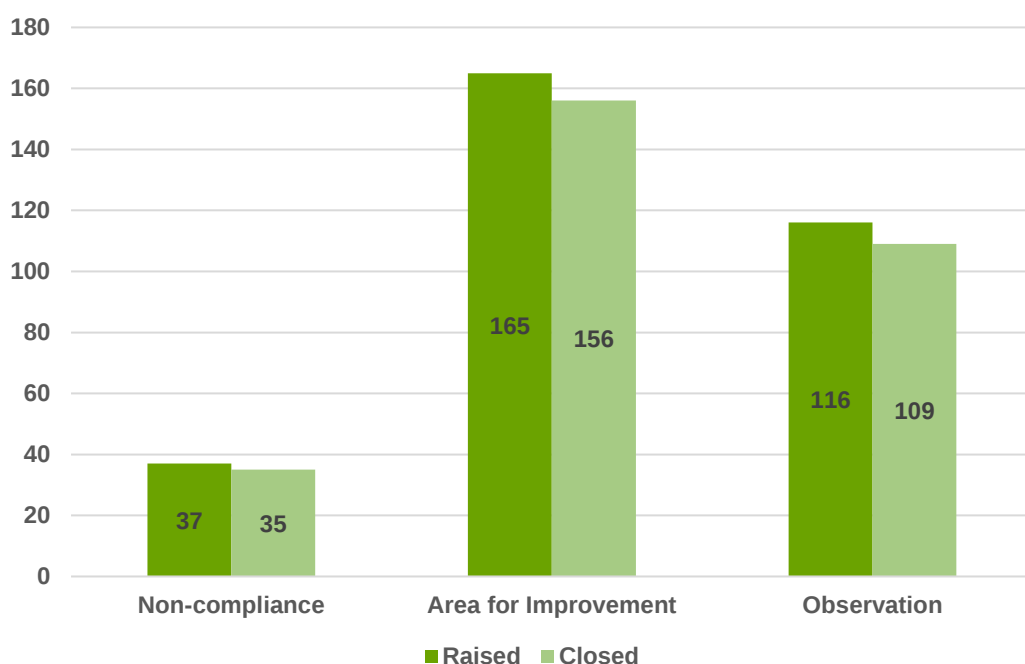
Figure 6: Cumulative audit findings raised and closed - Project commencement to April 2025

Spark D&C established corrective actions to address audit findings. Forty-four (44) findings were closed during the reporting period. Eighteen (18) findings remained open at the end of the reporting period. (See Figure 6).
