14. Cultural Heritage

14.1 Introduction

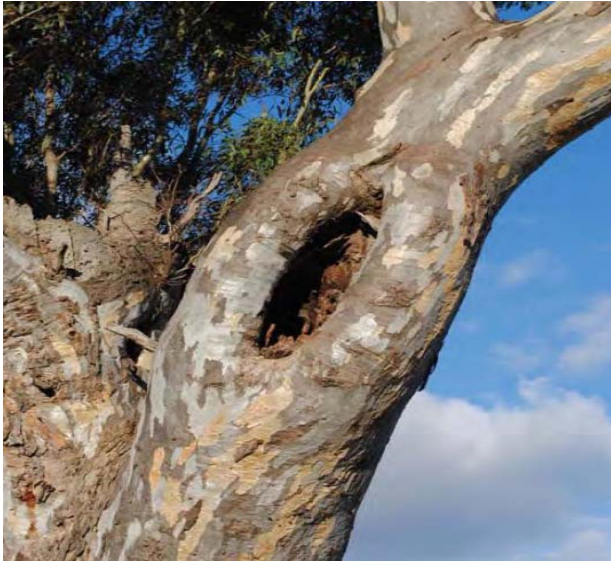
Hollow Tree

A total of eight hollow bearing trees were assessed for their potential as mortuary trees by a qualified arborist. One tree was considered to require further inspection (a flexible camera was used to look inside the hollow to confirm whether there were human remains or grave goods). No human remains or grave goods were recorded within the hollow inspected.

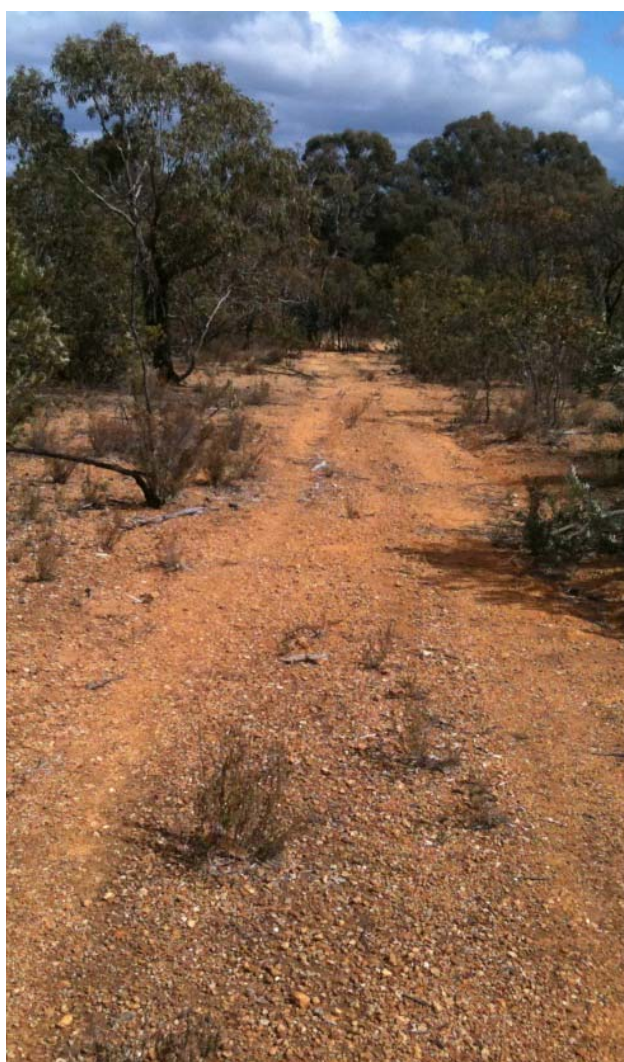
***Great Western Lead Mine (Source: ALA)***

Registration Type	Registration Number	Place/Site Name	Description	Significance
Heritage Inventory & DSE listed	H7423-0027	Former Great Western Lead Mine	Narrow band of intensive sinkings (shafts and small mounds) along an old cement lead. Very scrubby but workings are undisturbed and do provide an appreciation of the nature of this type of gold mining.	Local
Heritage Inventory	H7423-0060	Armstrong No. 1	Ruins comprising a ruined structure, marked by stone wall foundations and possible stone hearth with a possible outbuilding and a raised circular structure with a central depression	Local
Heritage Inventory	H7423-0061	Armstrong No. 2	House ruins with remnant cistern and garden.	Local
Heritage Inventory	H7423-0062	Garden Gully Road Ruin	Unable to be located during comprehensive site surveys between Sep. 2011 and Feb. 2012. Site previously recorded as a ruinous structure, marked by the remains of a stone fireplace with stones set in mud mortar. There a few scattered handmade bricks.	Local
