EDITHVALE AND BONBEACH  
LEVEL CROSSING REMOVAL PROJECTS  
**ENVIRONMENT EFFECTS STATEMENT**

EES TECHNICAL REPORT C  
**Acid Sulfate Soils and Contamination**

LXRA-LX31-00-HZ-EES-0001

February 2018

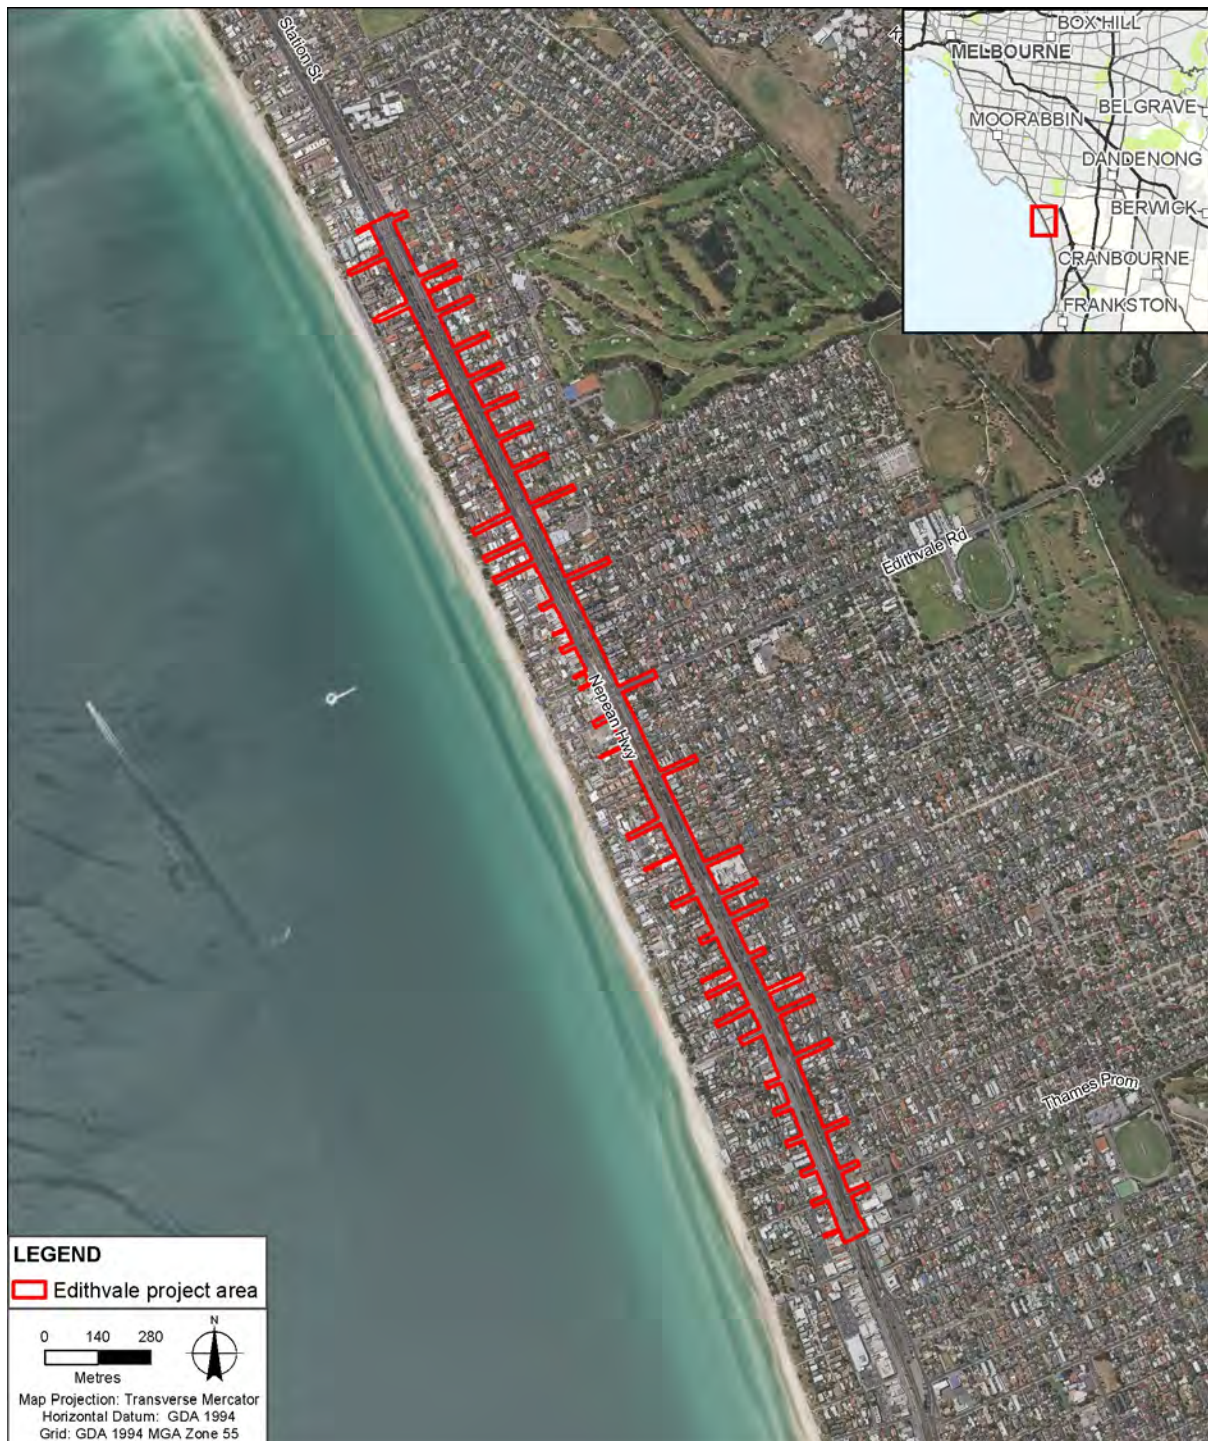
Figure 1 Edithvale project area

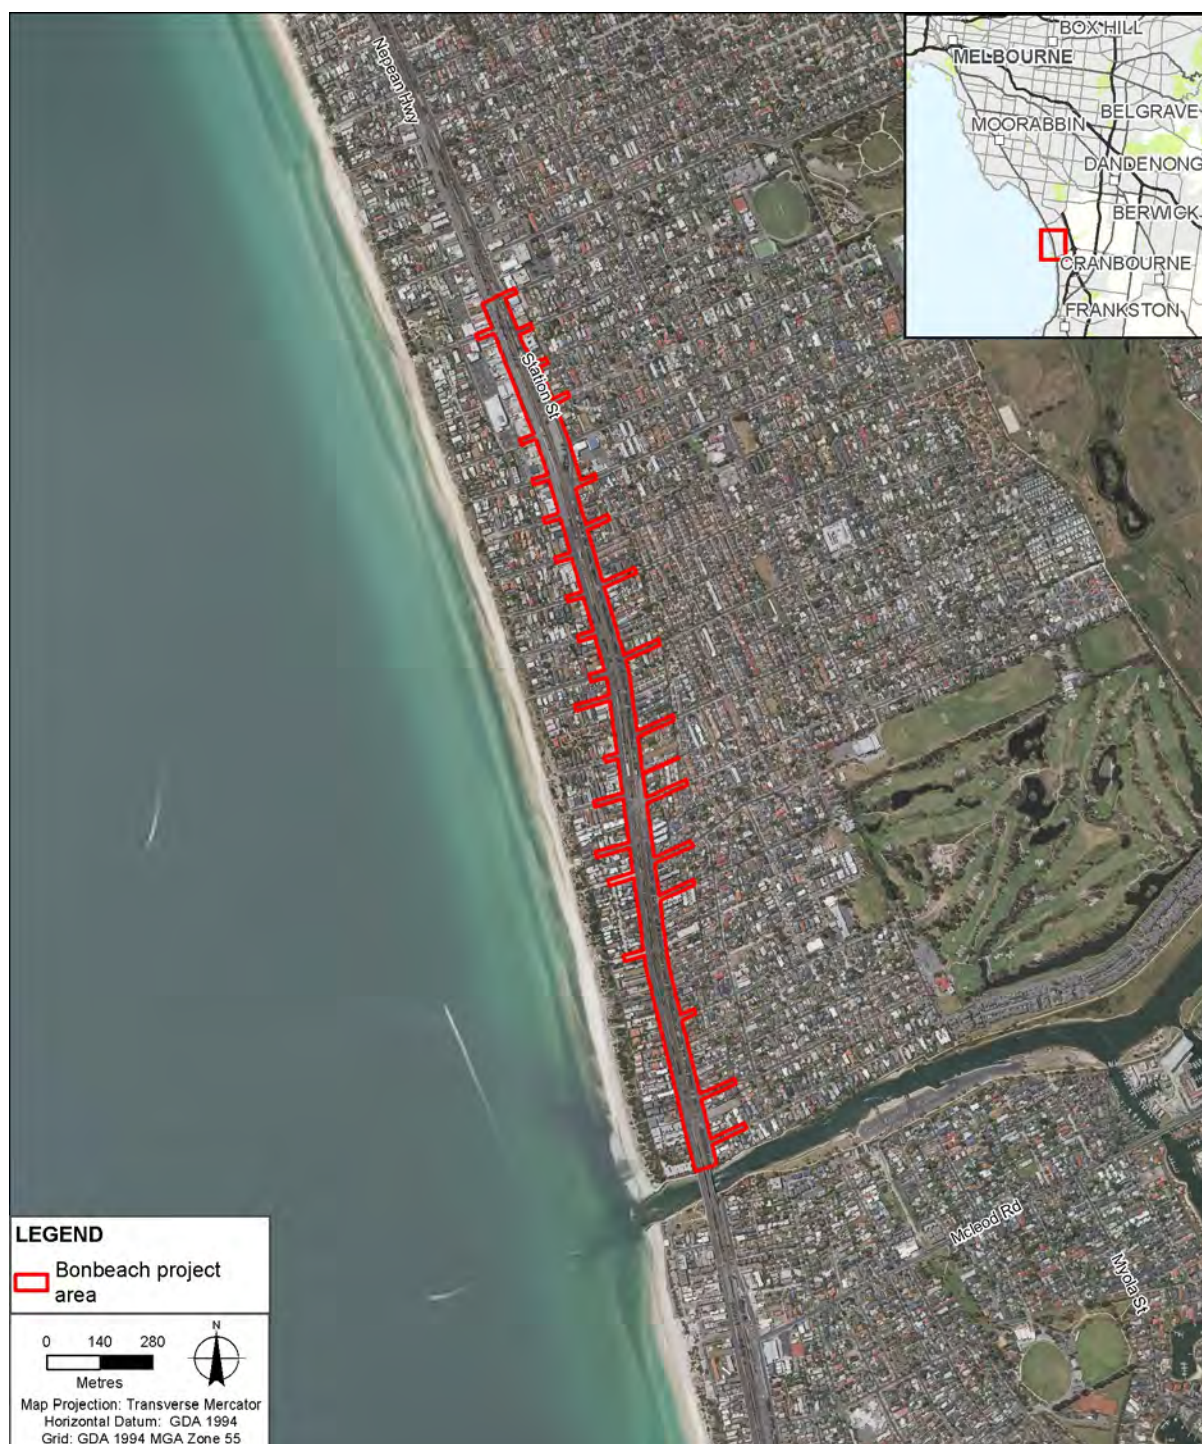
Figure 2 Bonbeach project area

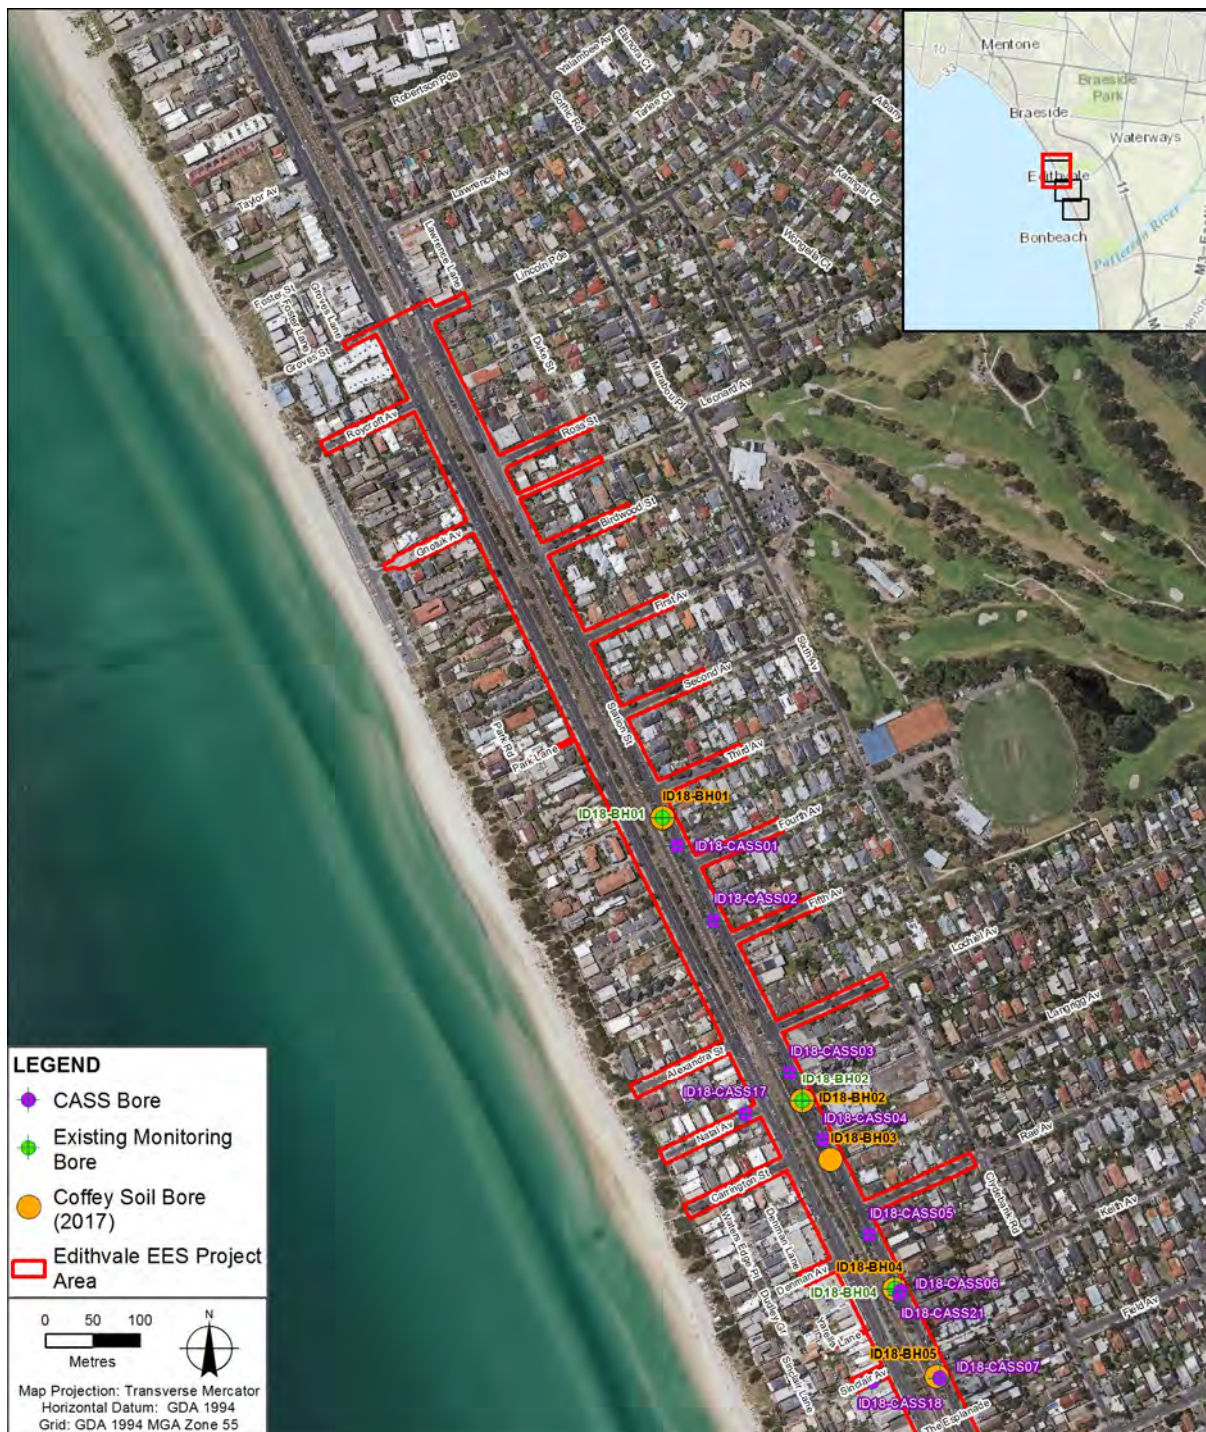
Figure 4 Location of CASS boreholes, historical boreholes and groundwater monitoring locations - Edithvale (Page 1 of 3)

Figure 4 Location of CASS boreholes, historical boreholes and groundwater monitoring locations - Edithvale (Page 2 of 3)

Figure 4 Location of CASS boreholes, historical boreholes and groundwater monitoring locations - Edithvale (Page 3 of 3)

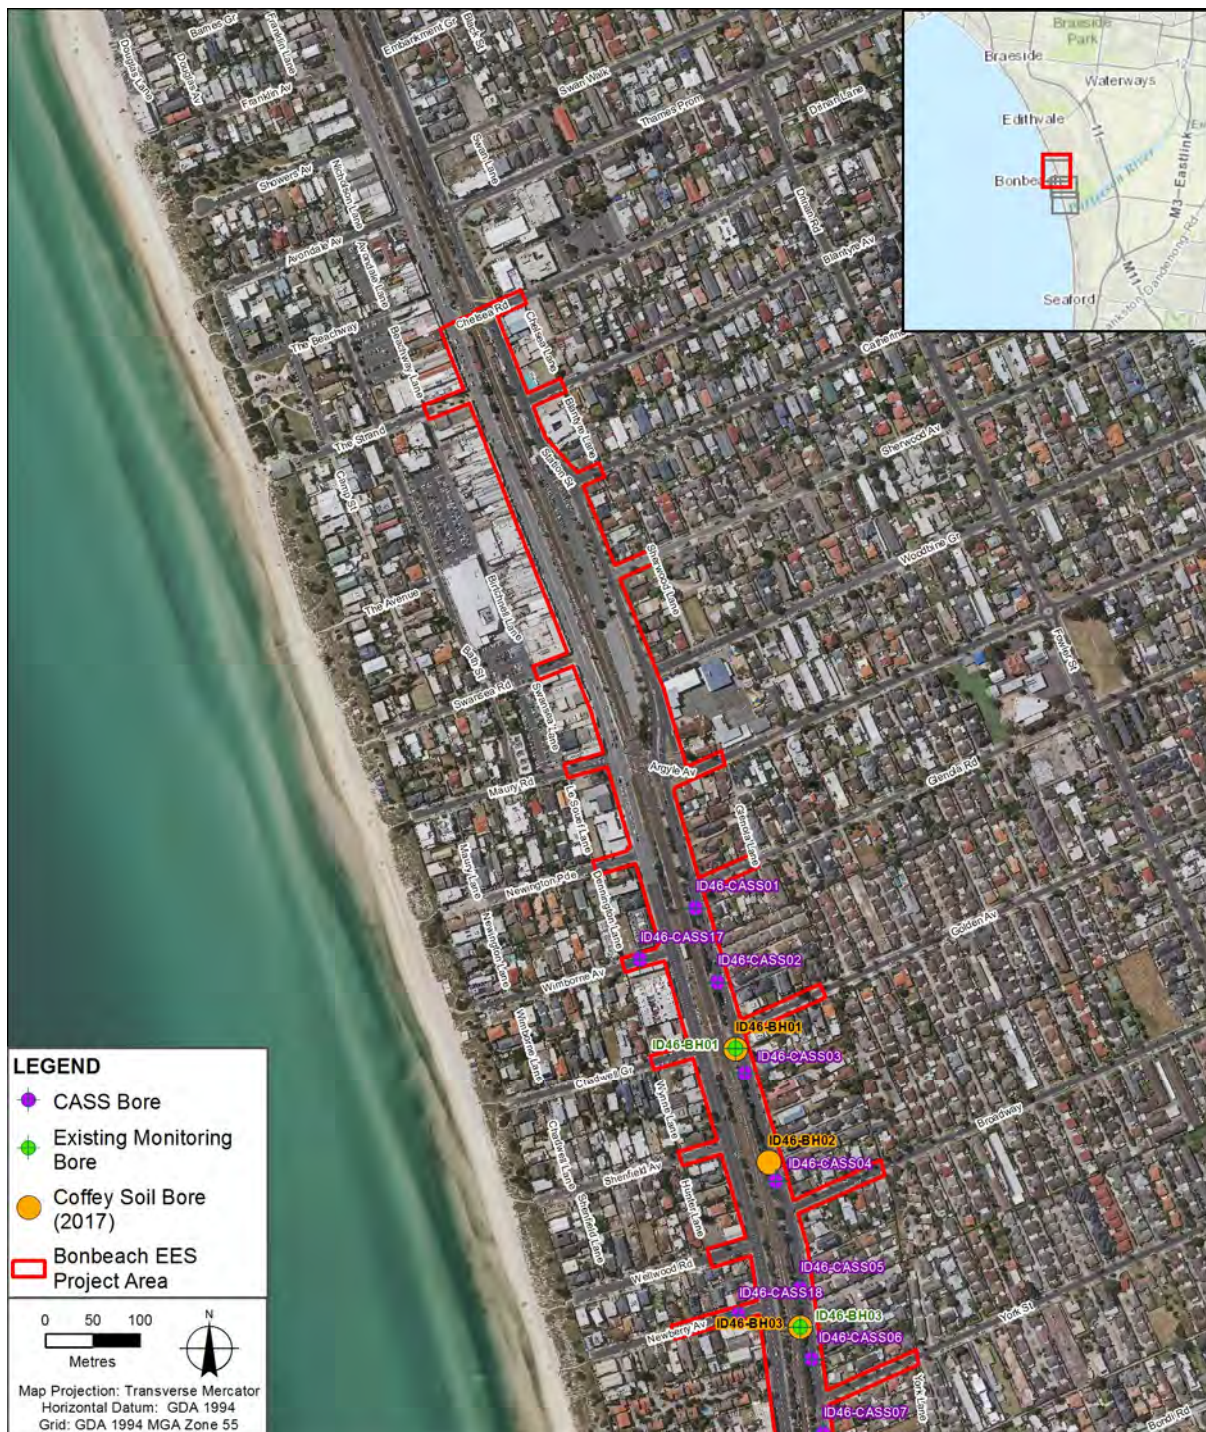
Figure 5 Location of CASS boreholes, historical boreholes and groundwater monitoring locations – Bonbeach (Page 1 of 3)

Figure 5 Location of CASS boreholes, historical boreholes and groundwater monitoring locations – Bonbeach (Page 3 of 3)

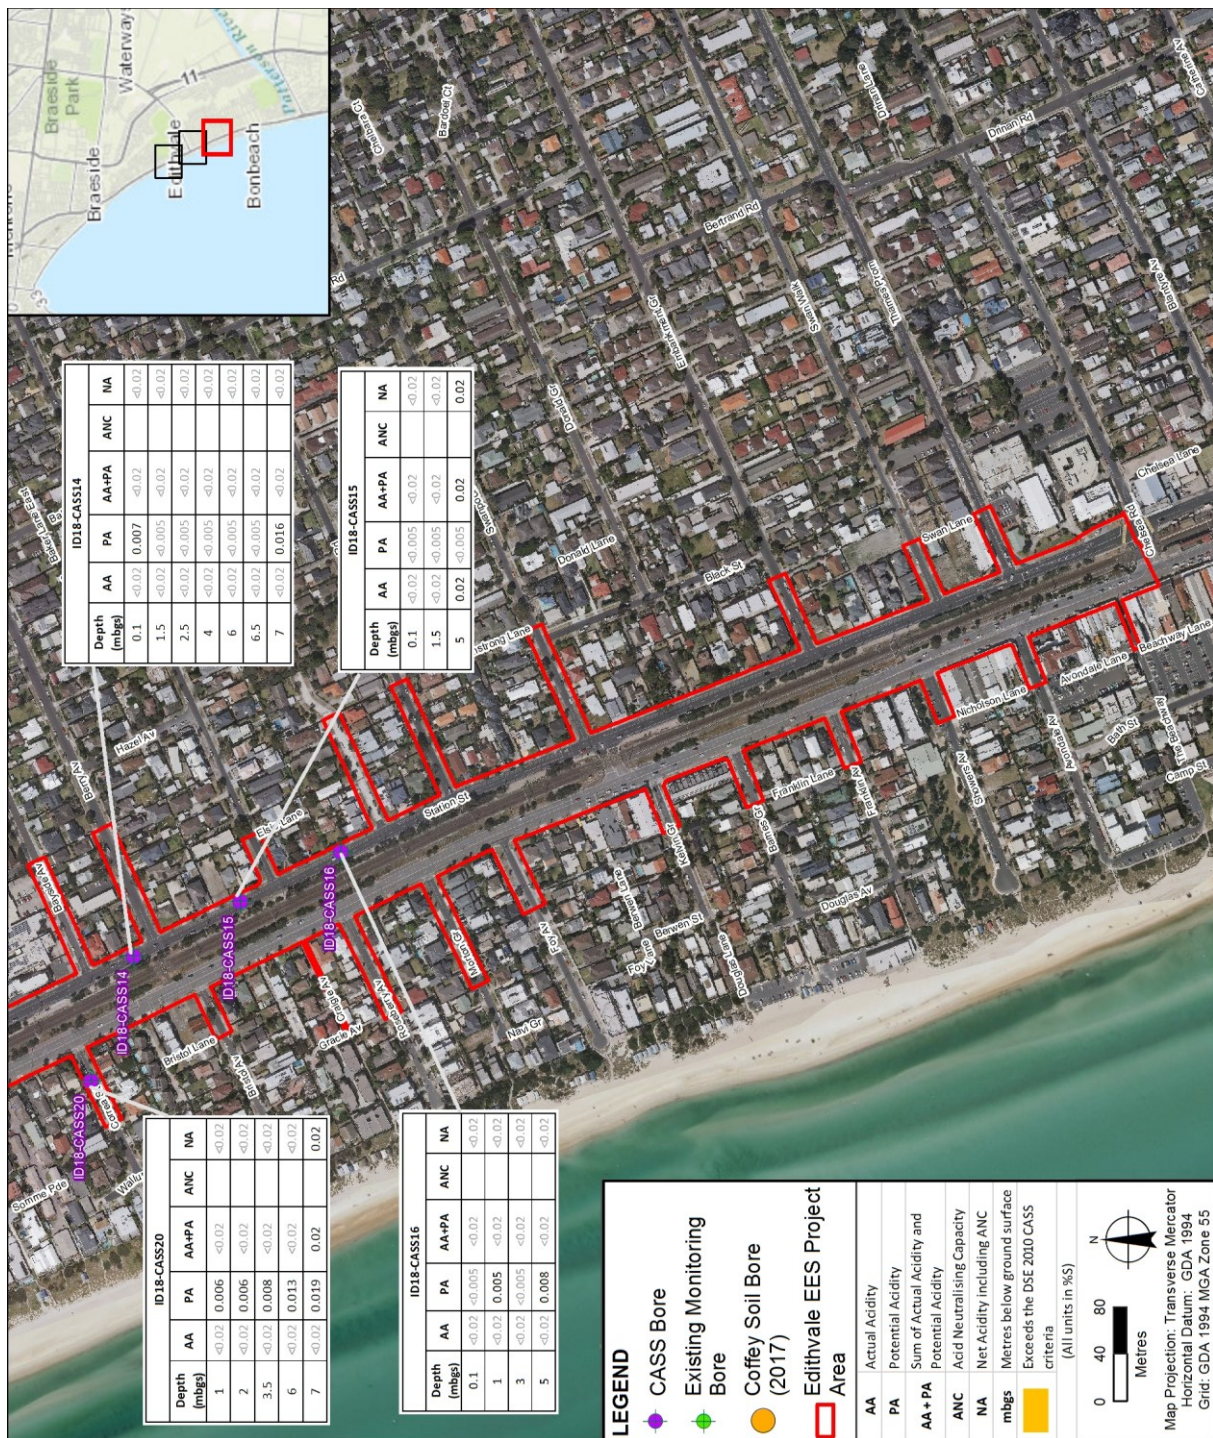
**Figure 7 Edithvale CASS Soil and Groundwater results (Page 1 of 3)**

**Figure 7 Edithvale CASS Soil and Groundwater results (Page 3 of 3)**

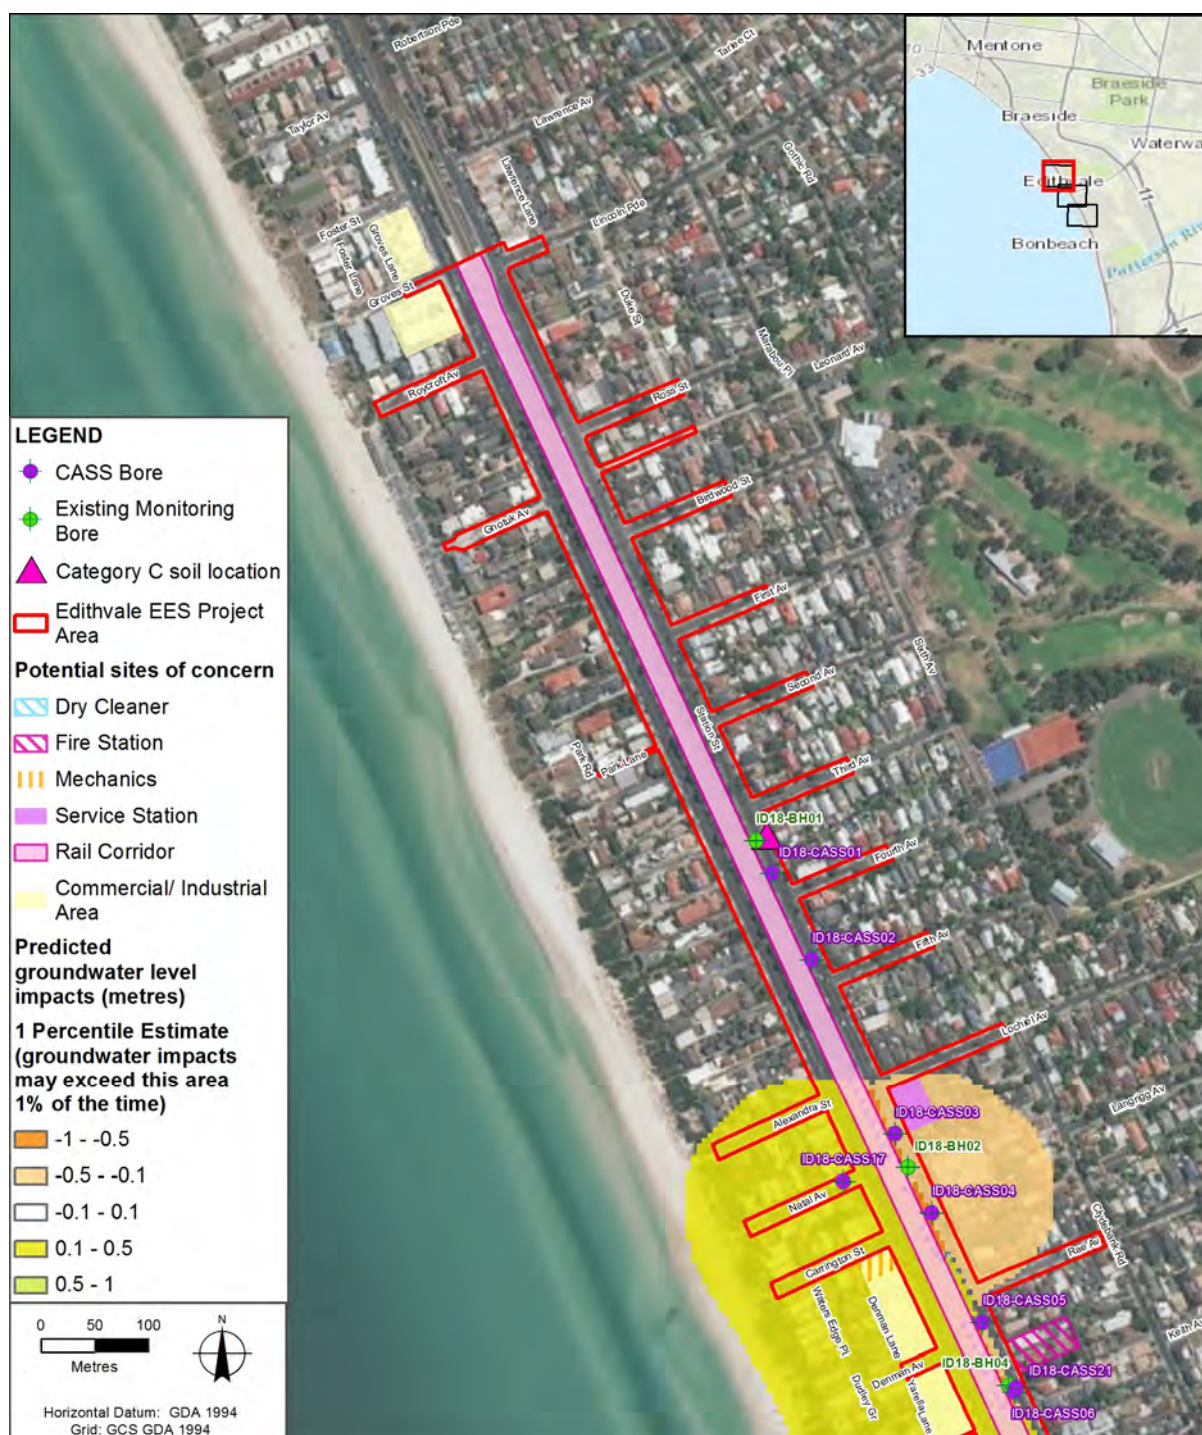
Groundwater modelling with the installation of sub-surface infrastructure predicted a significant reduction in the magnitude of drawdown and mounding during both construction and operation. Groundwater modelling with the installation of sub-surface infrastructure predicted a maximum groundwater drawdown of up to 0.2 metres within 80 metres of the rail trench, and groundwater mounding to be up to 0.2 metres within 50 metres of the rail trench. Comparatively, the 'no mitigation' scenario predicted groundwater drawdown of up to 1.4 metres within 50 metres of the rail trench, and groundwater mounding of up to 0.9 metres within 50 metres of the rail trench.

Figure 21 PSOCs and predicted groundwater mounding/drawdown after installation of passive horizontal trench (Page 2 of 3)

Figure 21 PSOCs and predicted groundwater mounding/drawdown after installation of passive horizontal trench (Page 3 of 3)

The sub-surface infrastructure would reduce both the magnitude of groundwater level change (from drawdown or mounding) and the extent of the area affected (Figure 21). It would not mitigate changes as a result of the diversion of groundwater along the cut-off wall. The PSOCs within the reduced area of groundwater change would include two operating service stations, a mechanics, a dry cleaners, a mower sales/service centre and the Edithvale fire station, and the identified PFAS contaminated groundwater in the vicinity of the Edithvale fire station. As such, the combination of the reduction in the extent of drawdown and mounding, as well as the reduction in the number of PSOCs within the area of impact, results in the likelihood of contaminant migration reducing from almost certain to highly probable. If contaminant plume migration were to occur, the implementation of groundwater monitoring, management and mitigation plans (**EPR\_GW3**, **EPR\_CL4** and **EPR\_CL5**) would provide early detection of impacts as a result of contamination plume migration and develop appropriate mitigation measures.
