APPENDIX 1:
ABORIGINAL CULTURAL HERITAGE REPORT – STANDARD
ASSESSMENT

WESTERN HIGHWAY DUPLICATION CULTURAL HERITAGE MANAGEMENT PLAN: FIERY CREEK TO ARARAT: STANDARD ASSESSMENT REPORT

CULTURAL HERITAGE MANAGEMENT PLAN NUMBER: 11812

Report Date: 30 March 2012

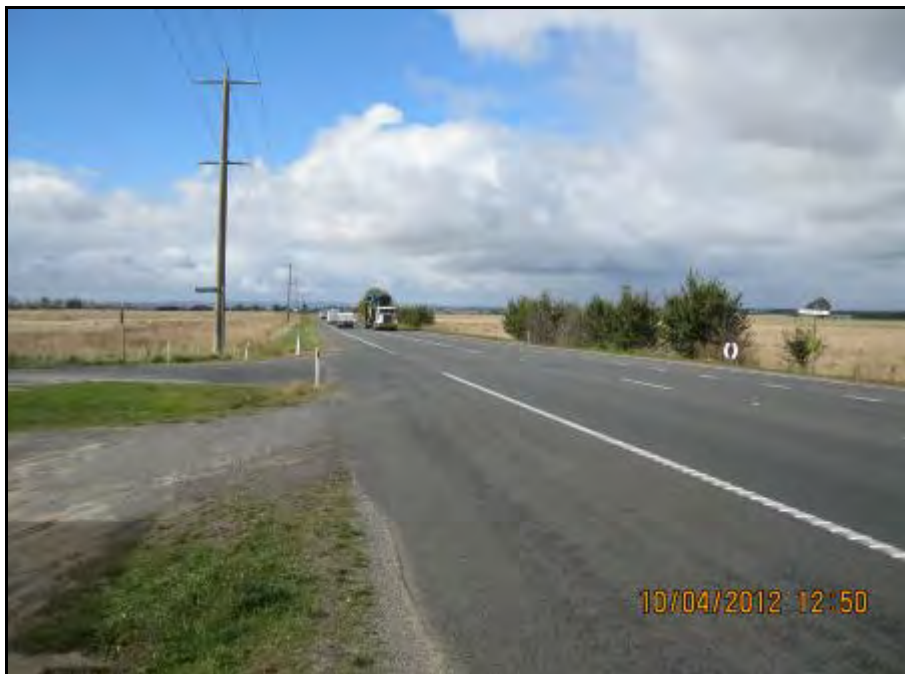
The following photos give an indication of the likely impact on the surface of the land and buried former land surfaces. These photos are taken from section 1a and 1b of the Western Highway Project between Ballarat and Beaufort.

Figure 1: Image of Western Highway where duplication works are yet to commence

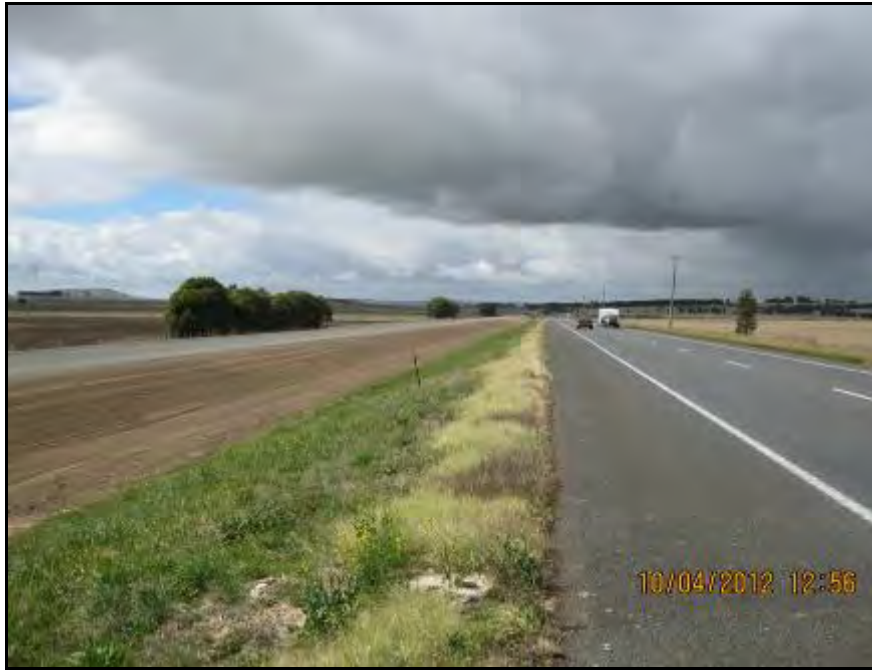
Figure 2: On the left side of this photo the duplication works can be seen being undertaken, on the right of the photo is the existing Western Highway (please note these works are occurring south of the current activity area under an already approved CHMP)

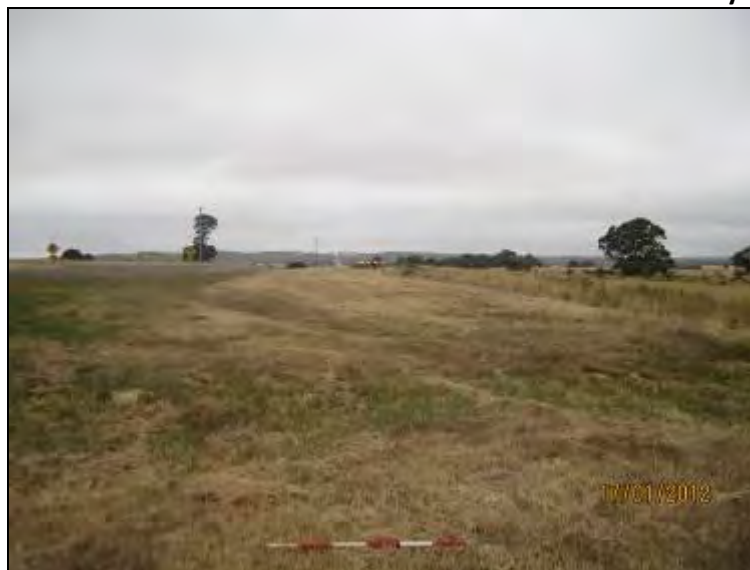
Figure 8: South-east view towards Fiery Creek from Western Highway road easement. Note the lack of ground visibility (0%) and the earthworks associated with the construction of the highway itself

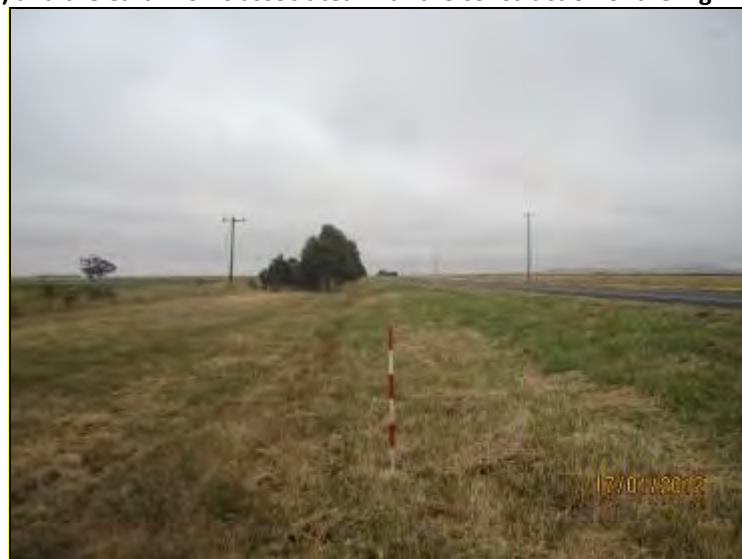
Figure 9: North-west view from highway easement. Note the dense ground cover with zero visibility and the generally flat alluvium landform on the left of the photo

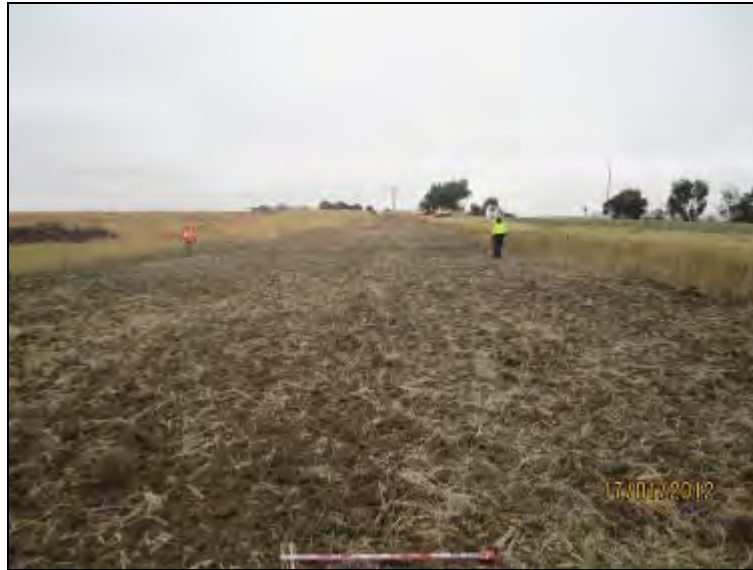
Figure 10: North-west view across ploughed area north-west of Fiery Creek (south side of highway). Note the high ground visibility ~90%

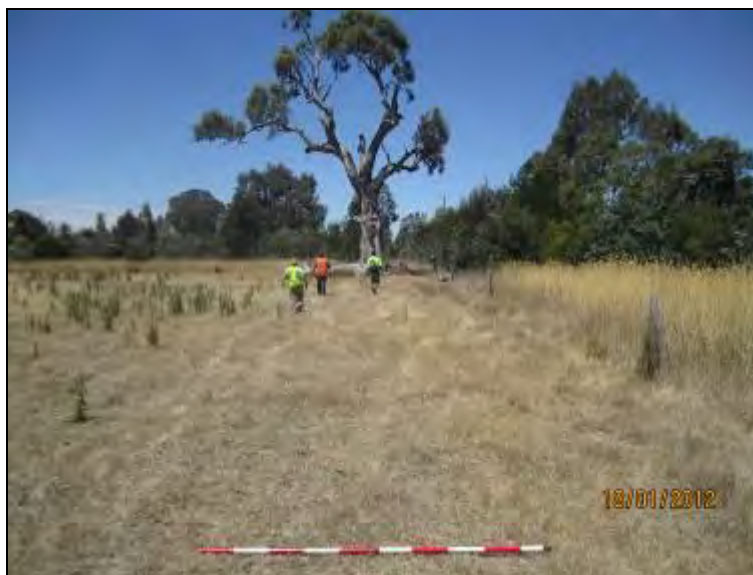
Stage 2 included a short stretch from Goulds Lane to Middle Creek (Map 5) and encompassed both sides of the highway. The only obvious relief within this survey unit was provided by the creek itself. Due to the dense grass cover, ground surface visibility was less than 1%.

Figure 11: East view of transect conditions in stage 2. Note the dense grass cover.

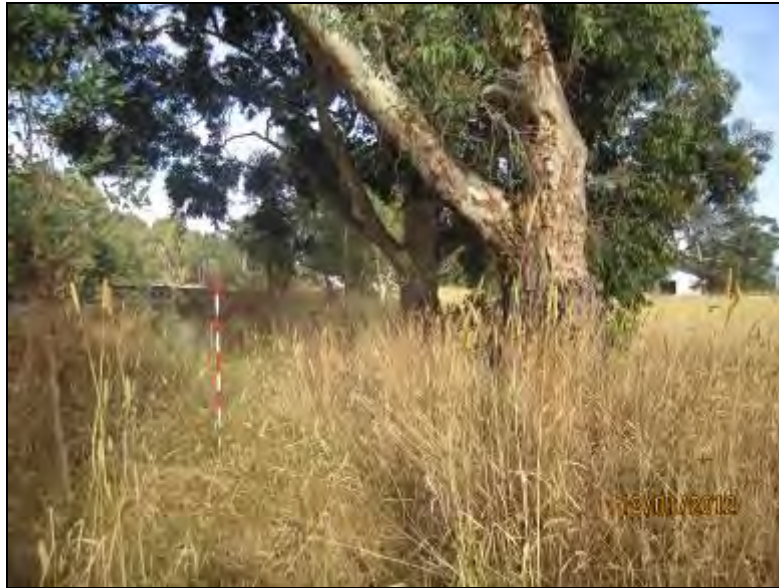
Stage 3 included the area from Middle Creek to Middle Creek Road (Map 5) and again included both sides of the highway. In common with stage 2, the only obvious relief within this survey unit was provided by the creek itself. Due to the dense grass cover, ground surface visibility was less than 1%.

Figure 12: West view of Western Highway road easement: note the dense ground cover

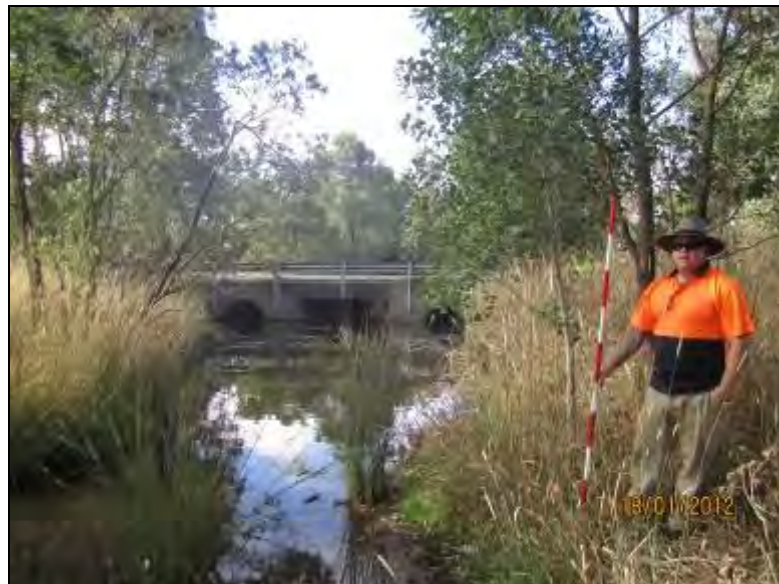
Figure 13: South view of Middle Creek and Middle Creek bridge on the highway

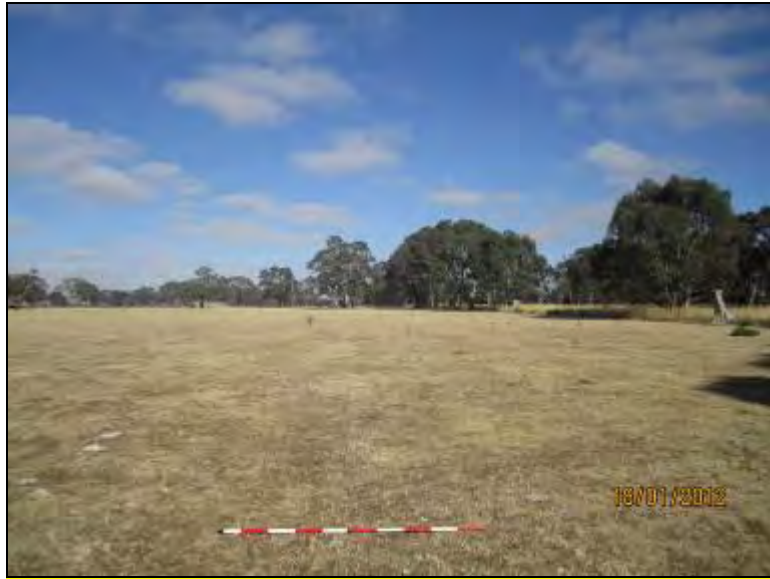
Stage 4 began at Middle Creek Road and continued until Woodnaggerak Road. The landscape was again flat with minor relief provided by Charliecombe Creek along the north edge of the activity area.

Figure 14: North view of stage 4: note the flat landscape and the dense grass cover

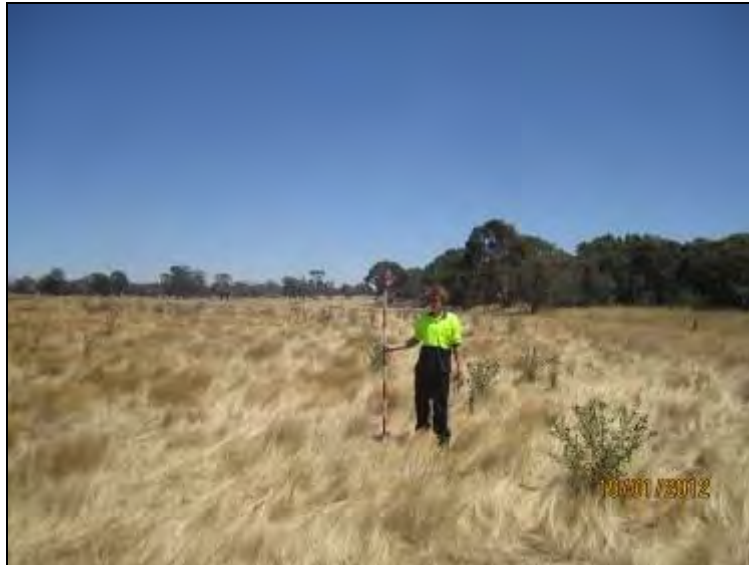
Stage 5 started from Woodnaggerak Road and continued until Mile Post Lane (Map 6). The main point of interest here is that the landscape changes during the course of this transect: the area around Charliecombe Creek is the approximate start of the changes. The landscape grades from a relatively flat plain with minimal relief and begins to take on more relief, the activity area here lying at the base (foothills) of Mount Buangor, the summit of which is located just over six kilometres to the north. The relief therefore is largely controlled by a change in geology from volcanics to granites and sandstones which form a prominent chain of plateaus land form that rise above the adjacent alluvial drainage systems, namely Mt Cole, Mt Buangor and Mt Langi Ghiran. The summits of these are located to the north of the activity area: the foothills of these elevated plateaus form part of the landscape of the activity area. Although the initial changes are gradual in this stage, the relief increases as one moves in a north westerly direction, with Charliecombe Creek showing some two metres of incision, with a coarse sandstone with iron bands exposed in the stream bed. The soil profile revealed a sandstone bedrock stream bed overlain by a yellow brown coarse sandy clay (B subsoil horizon) overlain by a light grey to yellow silty sand to sandy loam (A horizon).

Figure 15: West view immediately west of the start of stage 5; note the change in landscape

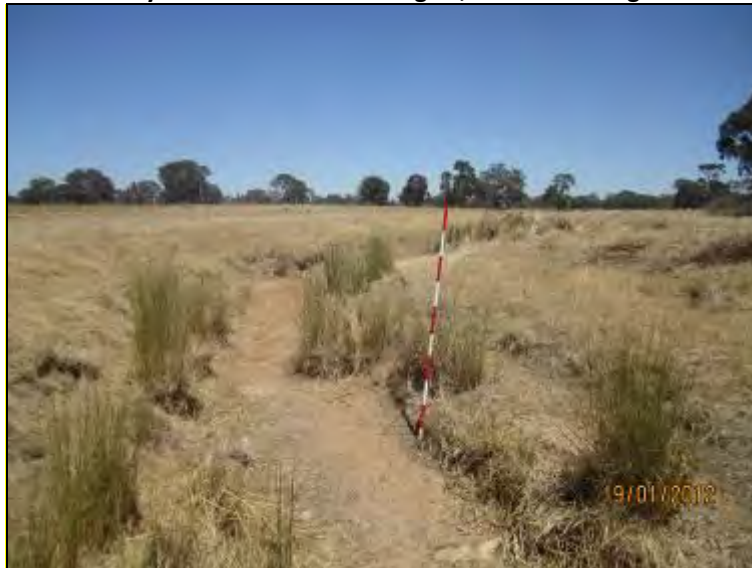
Figure 16: South-west view of start of granitic landscape

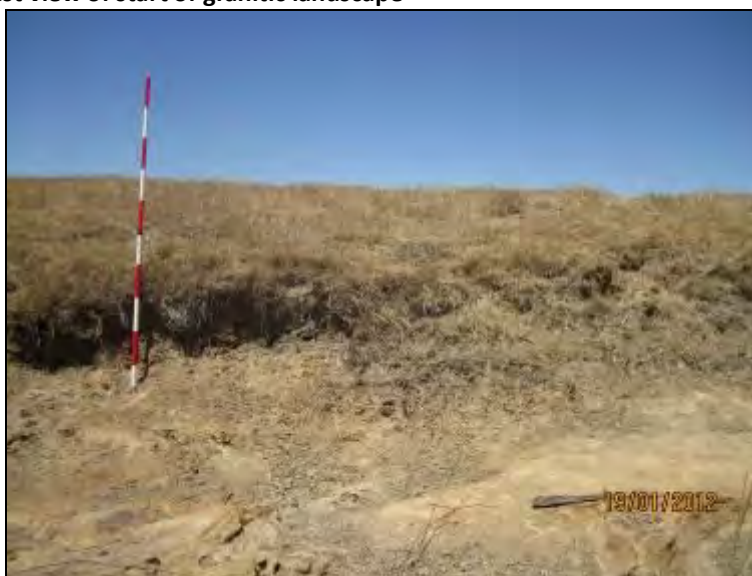
Figure 17: South view of Charliecombe Creek soil profile

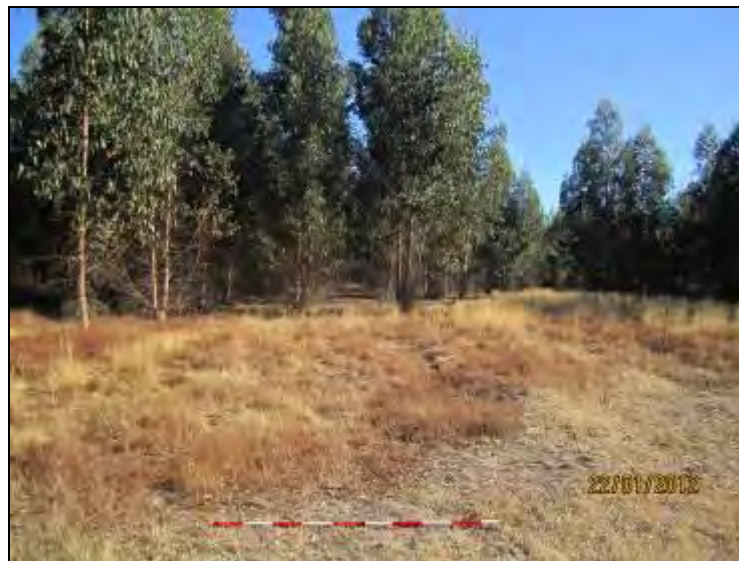
Stage 7 began at Anderson Road, continuing on until Peacock Road. The section of the activity area in stage 7 is located to the north of the current highway alignment and for the first time splits into two options (north is identified as option 1, south route as option 2; refer Map 6). The entire stage here was located within the confines of a forestry plantation: the landscape is very disturbed. Ground visibility varied: a dense ground cover was noted on areas on the edge of plantations themselves, which was in the order of 20% exposure, rising to 40% exposure between the tree plantation rows themselves. The average ground visibility was in the order of 15%. One creek bed and soil profile was recorded at the north-west corner of this stage. The basal unit was a grey mottled yellow light clay (possibly a B2 subsoil horizon) overlain by a grey silty clay with gravels (B1 subsoil), itself overlain by a yellow fine sandy silt with gravel lenses (A horizon).

Figure 18: North view across forestry plantation

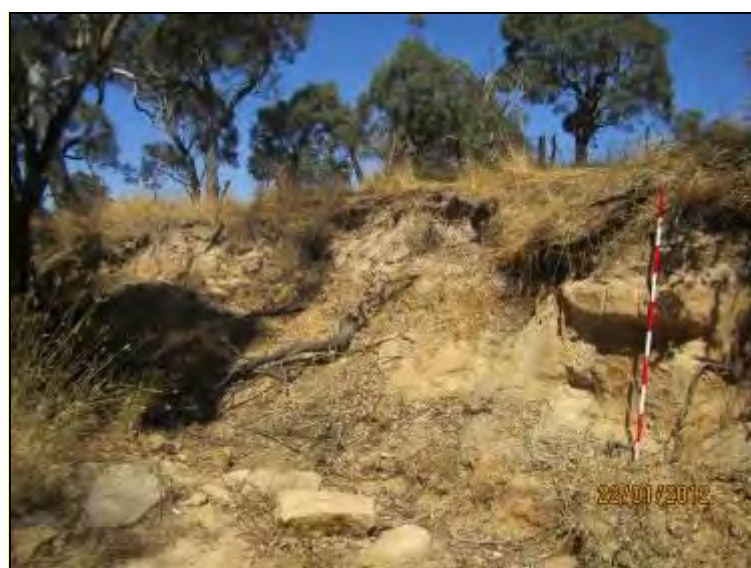
Stage 8 continued the two route options to the north of the current highway alignment located between Peacocks Road and the Buangor-Ben Nevis Road. Open woodland across gently inclined relief, with the occasional residual rises made up the landscape. The landscape also traversed two creeklines, again forming the majority of the relief. Ground visibility was a challenge, being in the order of ~1%. Localised erosion of grass cover was noted around creeklines, where visibility was around 60%: this was however less than 5% of the activity area.

Figure 20: South-west view of creek section on west side of Peacocks Road

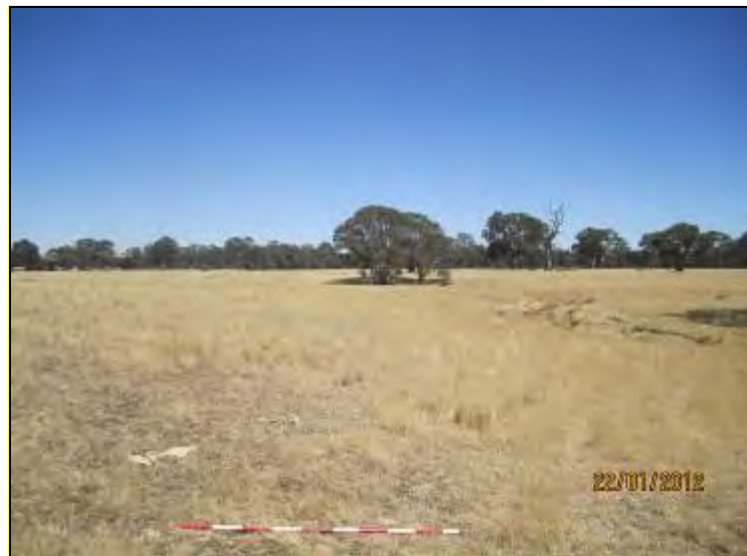
Figure 22: West view across the landscape of stage 8

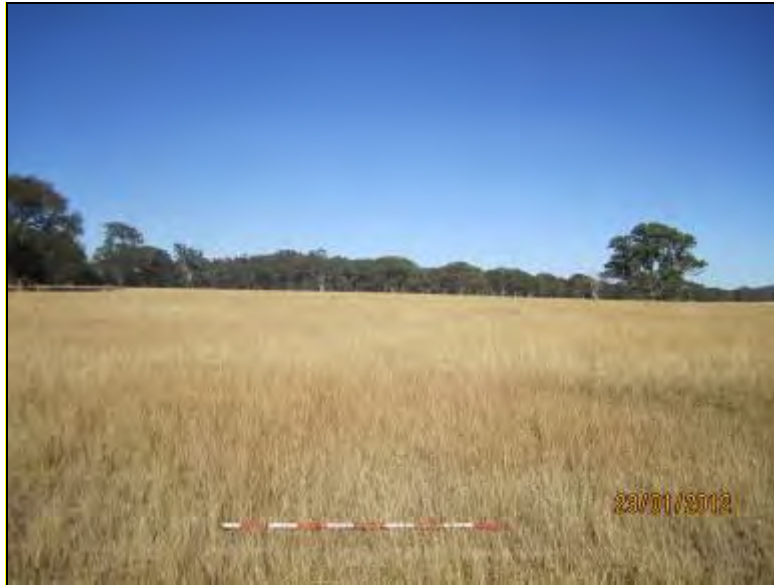
Stage 9 covered a short stretch from the Buangor-Ben Nevis Road to Gravel Route Road: the two route options (north and south; refer Map 6 and Map 7) come together within this stage and cross-over one another immediately west of Gravel Route Road (i.e. stage 10). Stage 9 is essentially an extension of the landforms and conditions noted across the majority of stage 8, excluding creek and plantation landforms. Ground visibility was in the order of ~5% meaning effective coverage was less than 5% of the activity area here.

Figure 23: West view across the extremely low relief landscape of stage 9

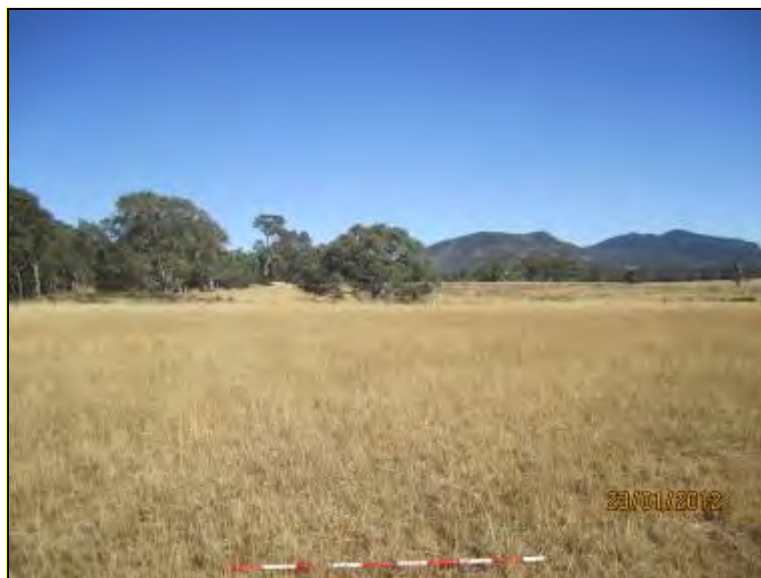
Stage 10 of the transects sees the two route option change: the north route (option 1) of stages 8 and 9 now crosses the highway and railway track and subsequently continues parallel to the rail line; the 'south' route (option 2) of stages 8 and 9 continues alongside and parallel to the current alignment of the highway (refer Map 7). The landscape across this stage sees increasing relief and different slope forms appear and several first and second order creeks are traversed. This stage is located between Gravel Route Road and Pope Road.

Figure 24: West view across stage 10

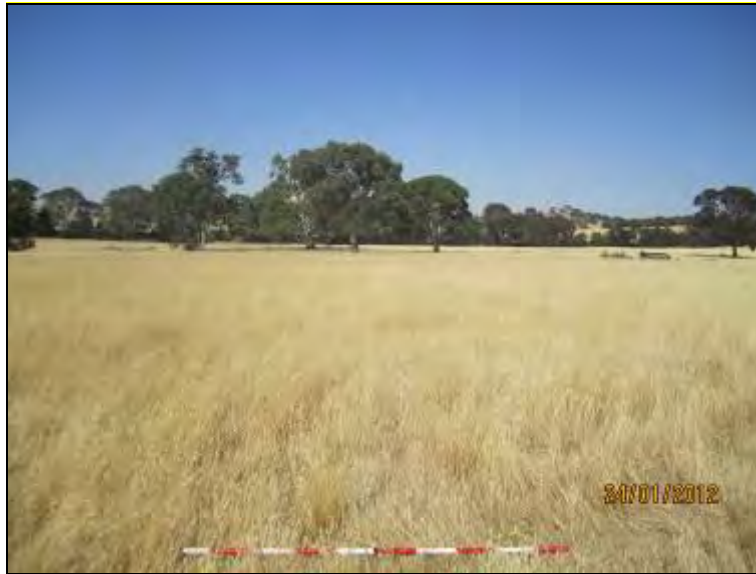
This part of the landscape crosses into low relief landform patterns and for the first time a variety of slope forms and elevations appear. The various route options cross creeklines, but also traverse crests and ridgelines for the first time.

Figure 25: South-west view across Option 3

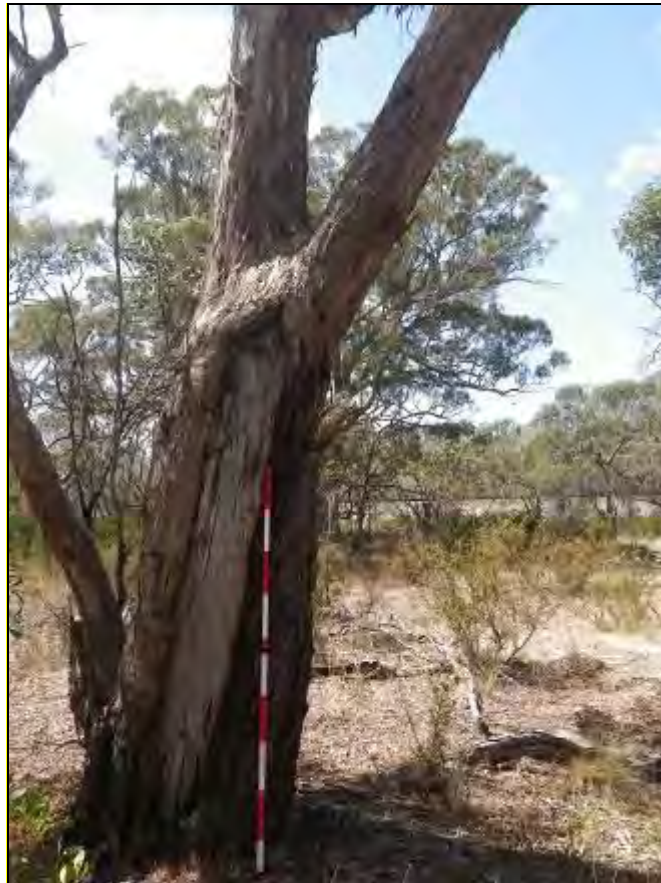
LG/ST 23 is a previously recorded living scarred tree. Large scar measuring 2.4m length by 0.34m width, 2.7m girth. 10m from drip line of canopy to base of tree. Extensive regrowth, which may obscure the greater scar sleeve. Historic axe marks towards base of scar. Tree is located approximately 250m south east of Langi Ghiran Picnic Ground Rd, north of the Western Hwy.

Figure 26: View of scar tree LG/ST

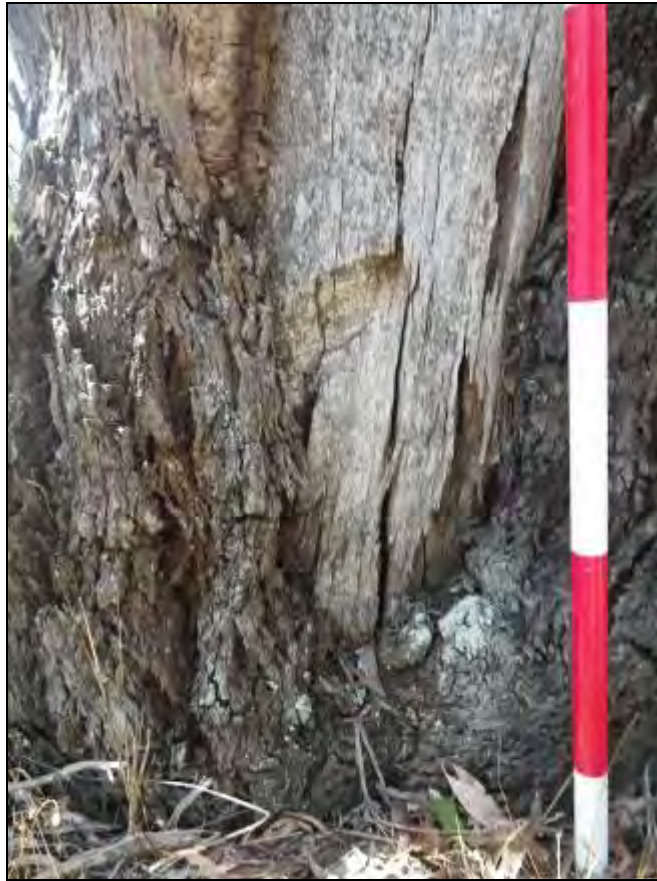
Figure 27: Close up view of base of scar on scar tree LG/ST

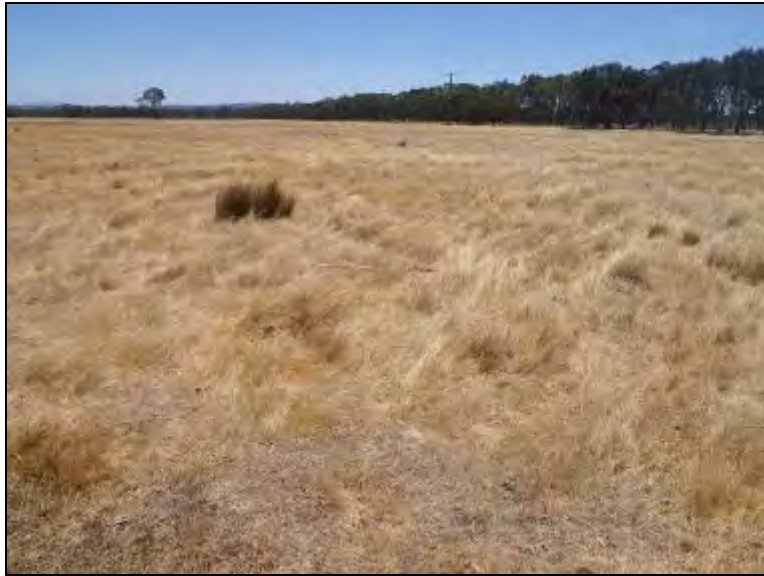
Site Name: Gorinn 1
VAHR 7523-0001

Gorinn 1 is a previously recorded earth feature that has been greatly affected by previous and current land use, as well as bioturbation by way of rabbit damage. The earth feature resembles a low relief mound that is almost unrecognisable. The site was originally recorded in 1976 and was noted to have been in poor condition at that time. The site comprises a rocky (Basalt) mound thought to be of anthropomorphic origin. The mound measures approximately 3m across and some 20cm in height. The site is located within a paddock, southeast of the Hillside Rd and Western Hwy intersection. The site occupies a heavily grassed area with almost no ground surface visibility, except for the crest of the mound itself.

Figure 28: View of Gorinn 1, mound featured in foreground

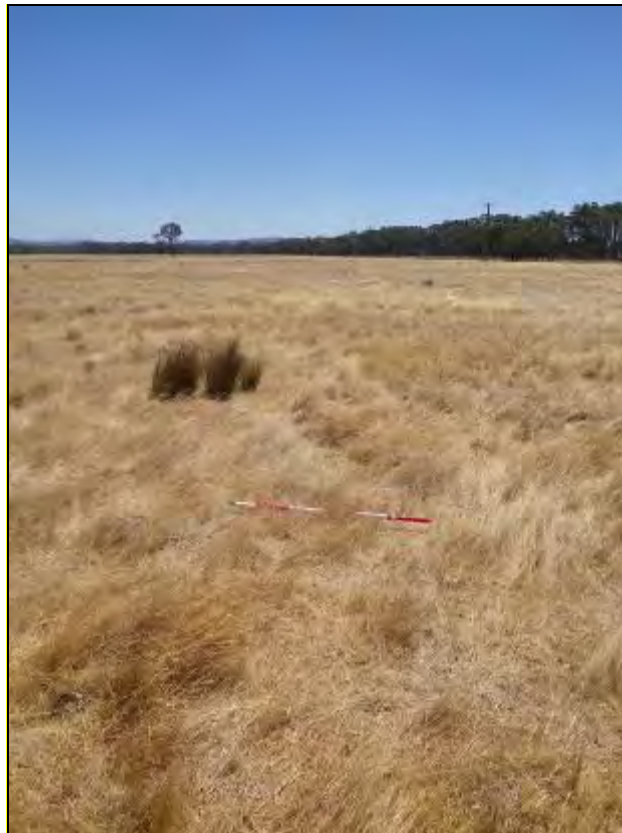
Gorinn 2 is also a previously recorded earth feature (mound), the site could not be clearly identified during the inspection. This is most likely due to the extensive damage that has been inflicted on the site by way of previous and current land use as well as rabbit burrowing. The site was originally located adjacent to Gorinn 1 in the 1976 assessment. However, no evidence of this site remains at present.

Figure 29: View of location of Gorinn 2. Not site unable to be visually identified during the survey.

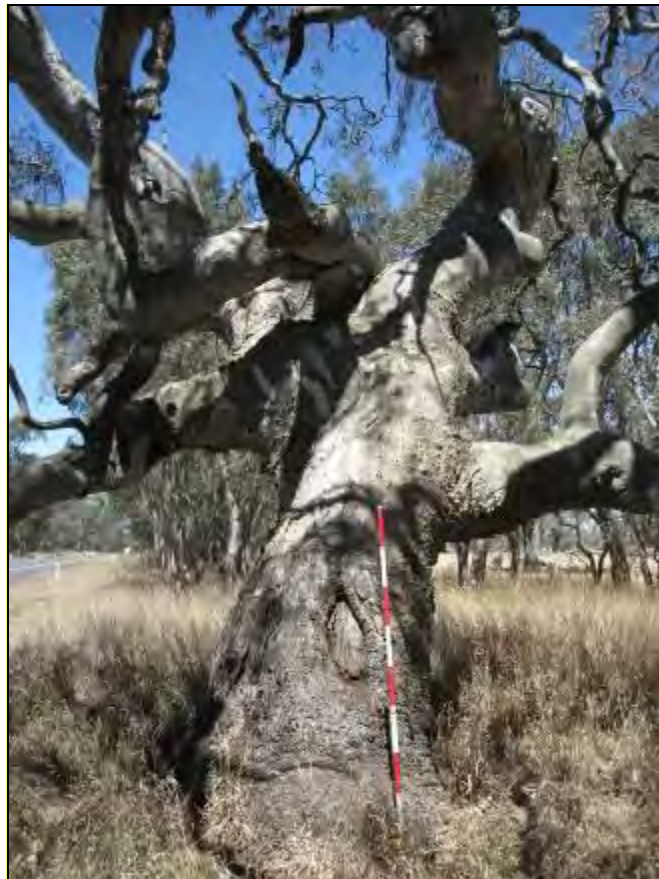
The scar itself is broadly lenticular in form with regrowth altering its shape, where once it would have probably been more oval in form. The scar dimensions are: (length) 0.46m by (width) 0.22m by (depth) 0.11m, where the diameter at the middle of the scar is 4.16m. The height from ground level to the base of the scar is 1.14m. The size and form suggest a shield.

Figure 30: Western Highway Scarred Tree 1. East view of scarred tree: note the degree of regrowth around the scar, particularly at the apex where branches are growing out immediately above the scar

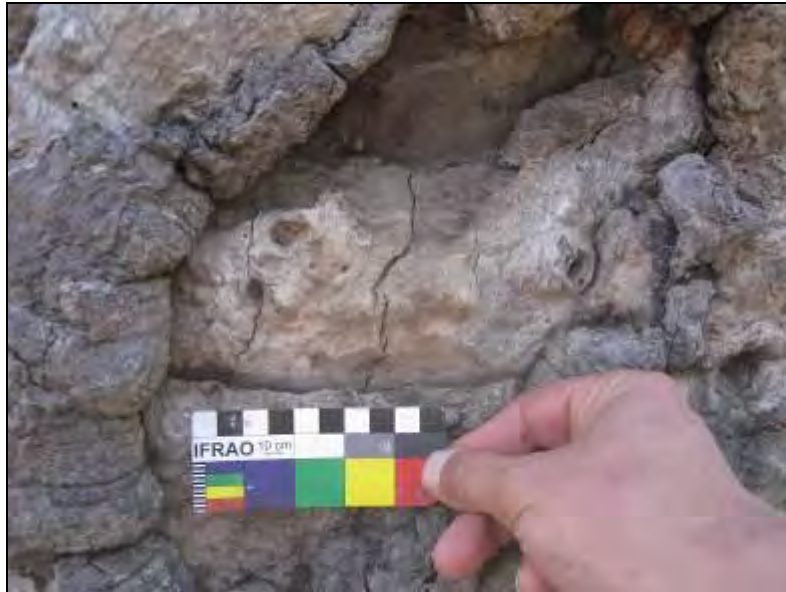
Figure 32: Detail view of toe hold tree scar 1: the blade cut is 0.09 m

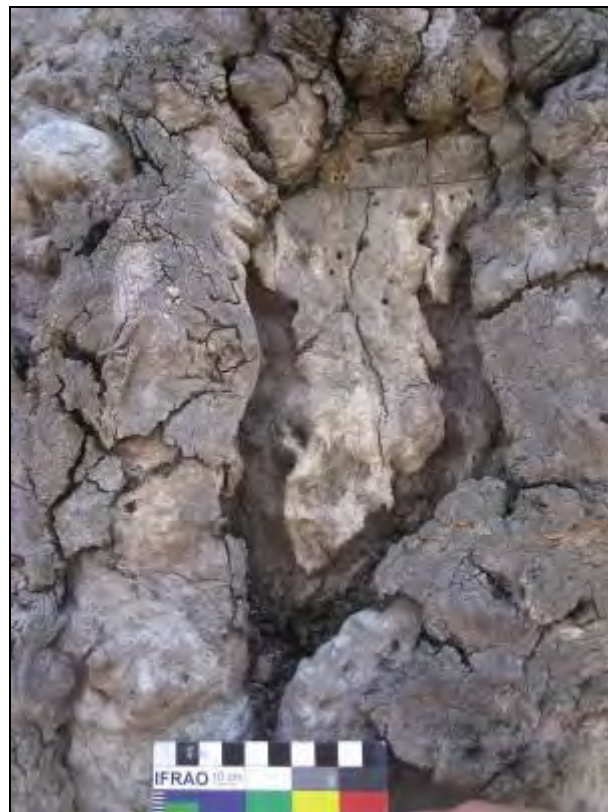
Figure 33: Detail view of toe hold scar tree 2, the blade cut is 0.15 m

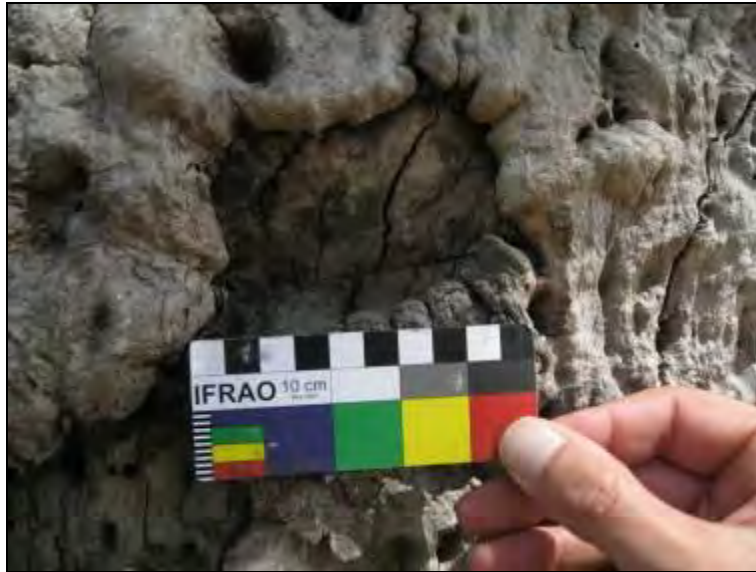
Figure 34: Detail view of toe hold tree scar 3: the blade cuts are 0.07m and 0.08 m

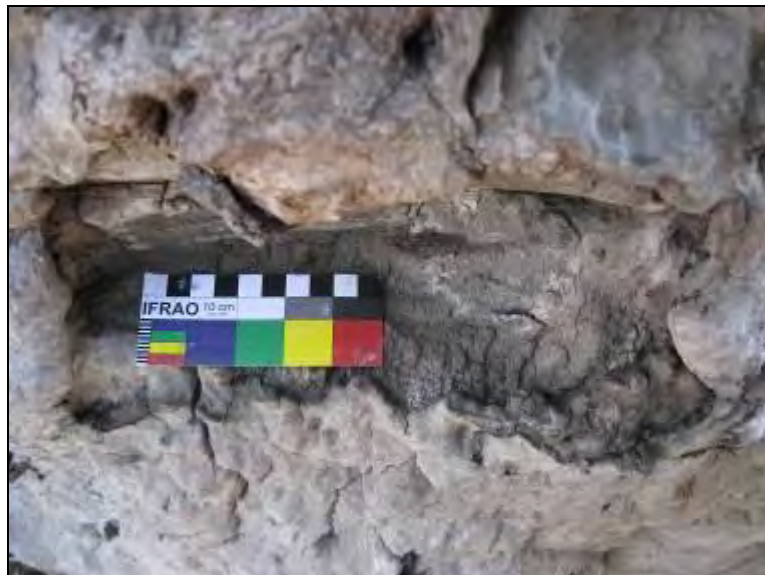
Figure 35: Detail toe hold tree scar 4: the blade cuts are 0.20 m and 0.09 m

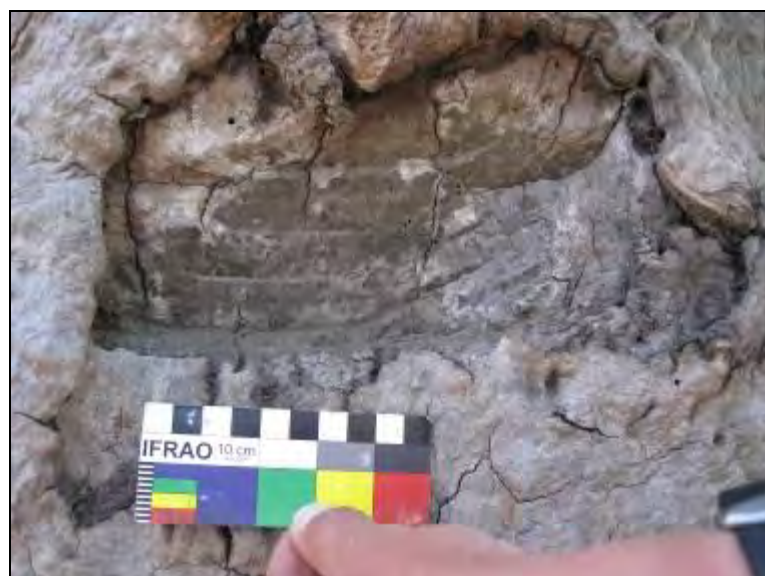
Figure 36: Detail view of toe hold tree scar 5 : the blade cut is 0.09 m

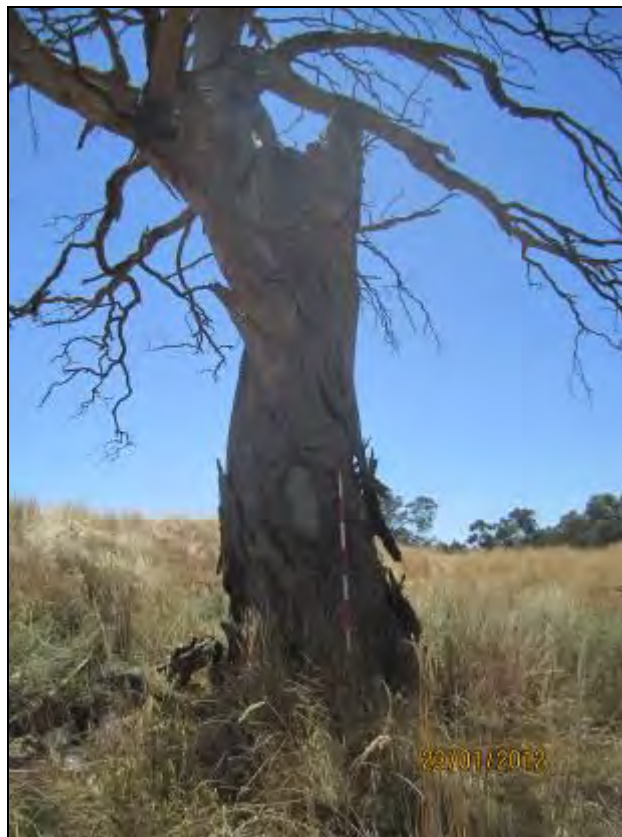
The scar is a small oval shape. The base of the scar is located 1.30m above the ground surface and measures (length) 0.70m by (width) 0.30m by (depth) 0.24m. The diameter of the tree is 4.54m. The size and form (noting that it is heavily overgrown) suggest a shield.

Figure 37: North-east view of Western Highway Scarred Tree 4

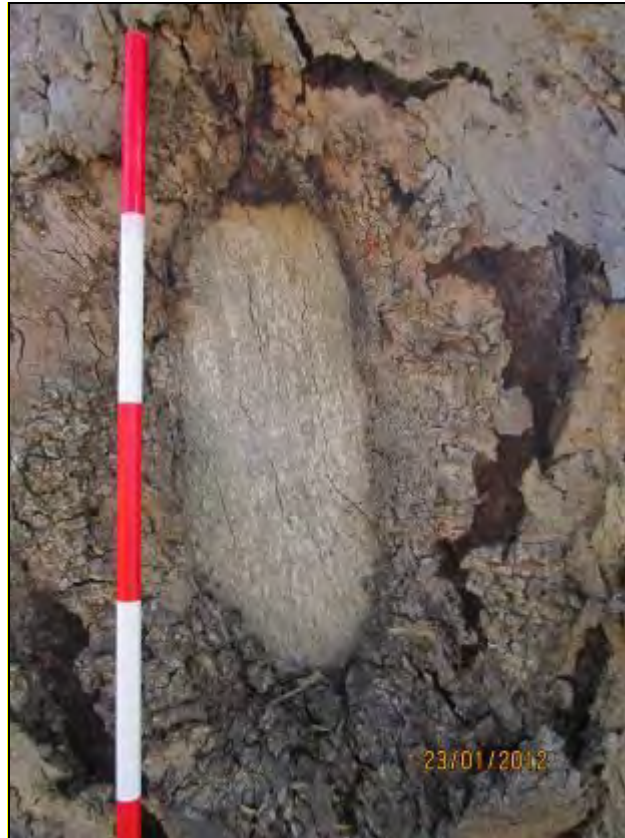
Figure 38: Detail of the regrowth around the scar

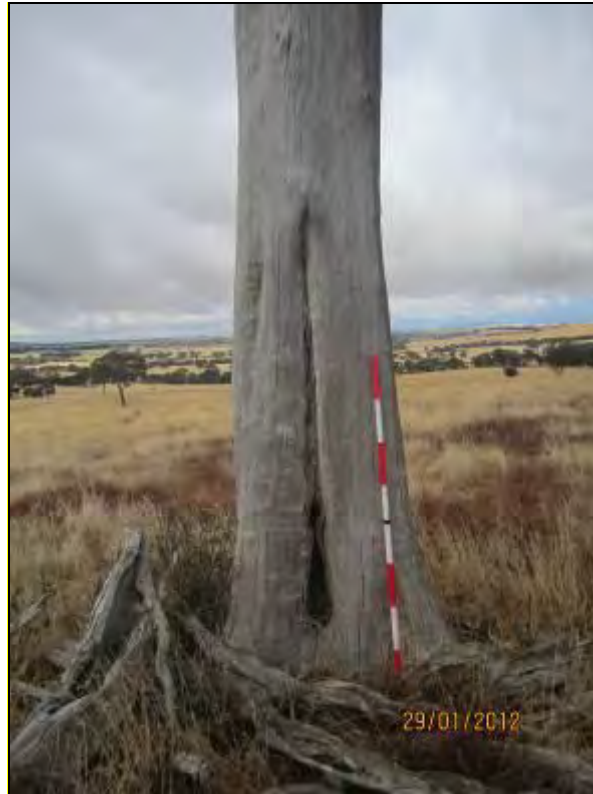
Western Hwy 5 is a dead standing scarred tree with extensive (almost complete) regrowth. Girth measured to 3.8m; the original canopy size is unknown, and small hollows feature towards upper limbs. The tree on which the scars were identified was a mature *Eucalypt sp.* The scar is located on the trunk and is orientated west. Regrowth is advanced around the complete perimeter of the scar, particularly at the apex where a knot is forming.

Figure 39: View of Western Highway 5

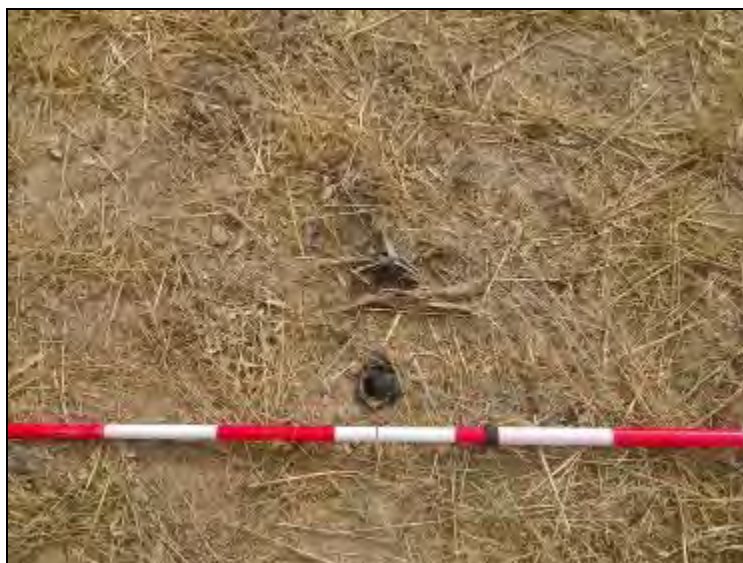
Western Hwy is a surface artefact scatter situated on a levee terrace, in the paddock southeast of the Hopkins River, adjacent to Dobie Rd. Numerous artefacts were encountered, which comprised milky quartz, silcrete, and opaque green knapped bottle bases. The site is defined by the extent of the levee ridge, which runs roughly north-south outside the activity area.

Figure 40: Surface of Western Highway 7

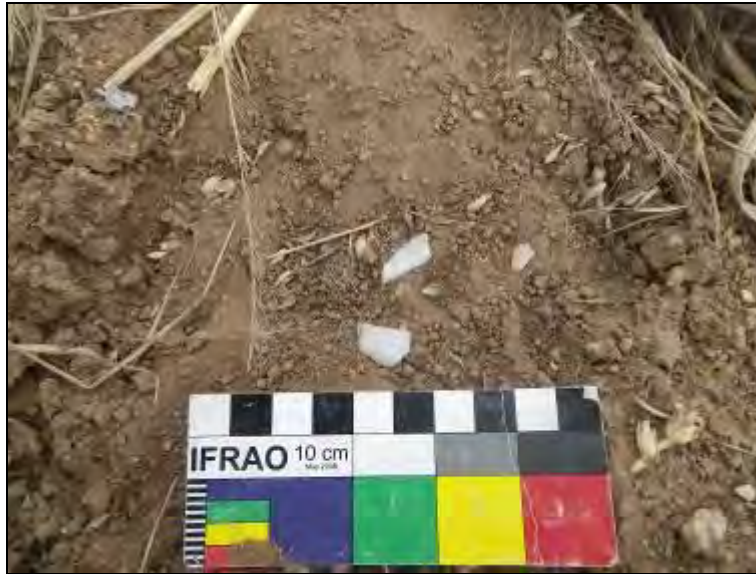
Figure 41: Quartz artefacts on the surface of Western Highway 7

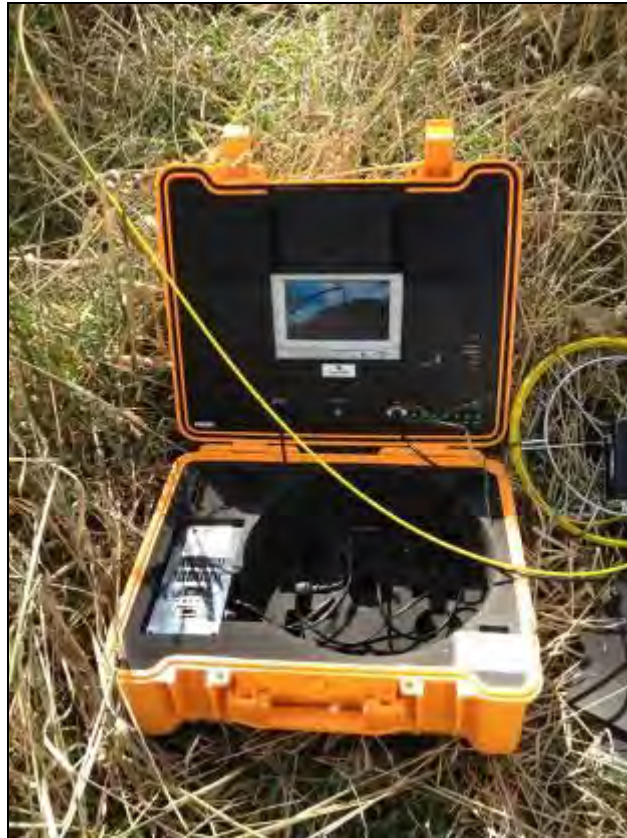
Figure 42: Endoscope equipment used for climbing hollow tree inspections

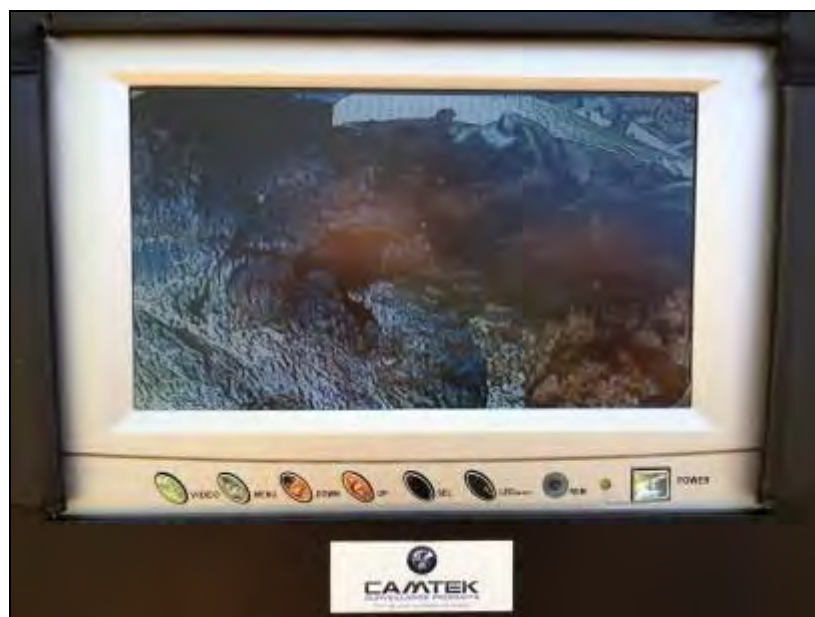
There was no evidence of human burials or mortuary goods within any of the hollow trees inspected within the activity area.

Figure 43: An example of the type of image produced using the endoscope at the base of the hollows. Note the clarity of the image - wood grain and leaves are clearly visible
