North East Link Program – Central Package

IEA Six-Monthly Summary Environmental Compliance Report – May to October 2025

A Report to the Minister for Planning

NEL-CNT-AAA-2990-EEE-REP-0007

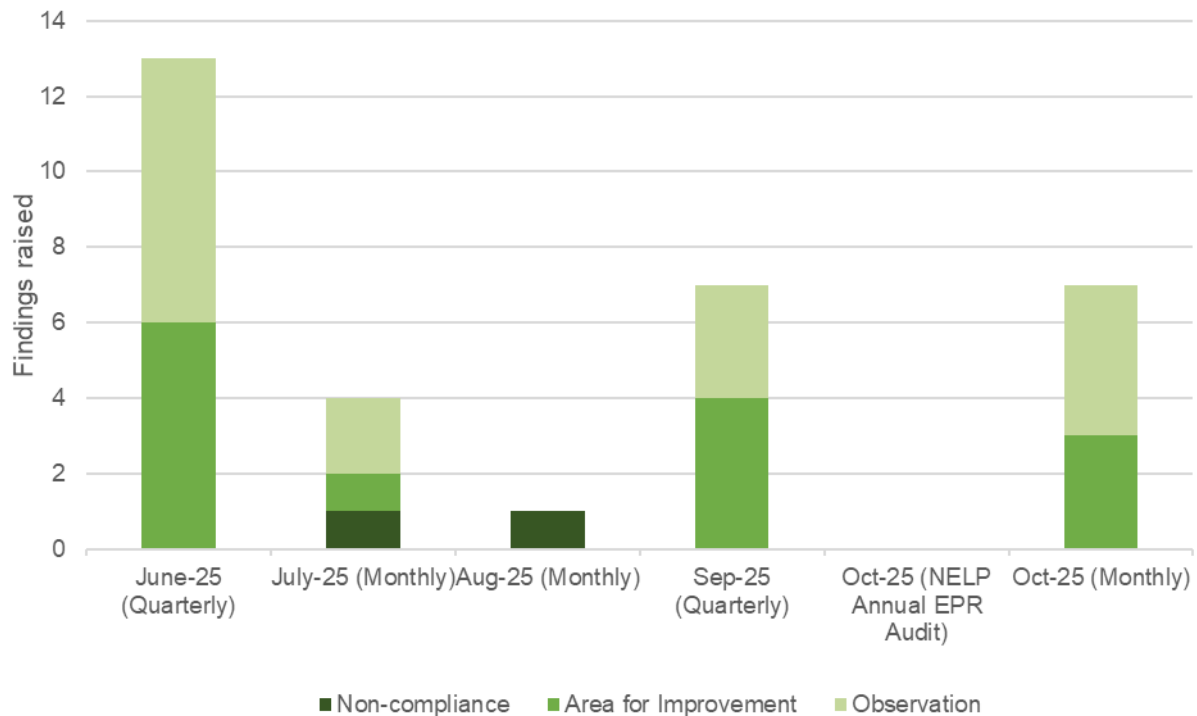
Figure 4: Audit findings by type and audit date during the reporting period

The highest number of audit findings were raised in the June 2025 quarterly audit (see Figure 4)

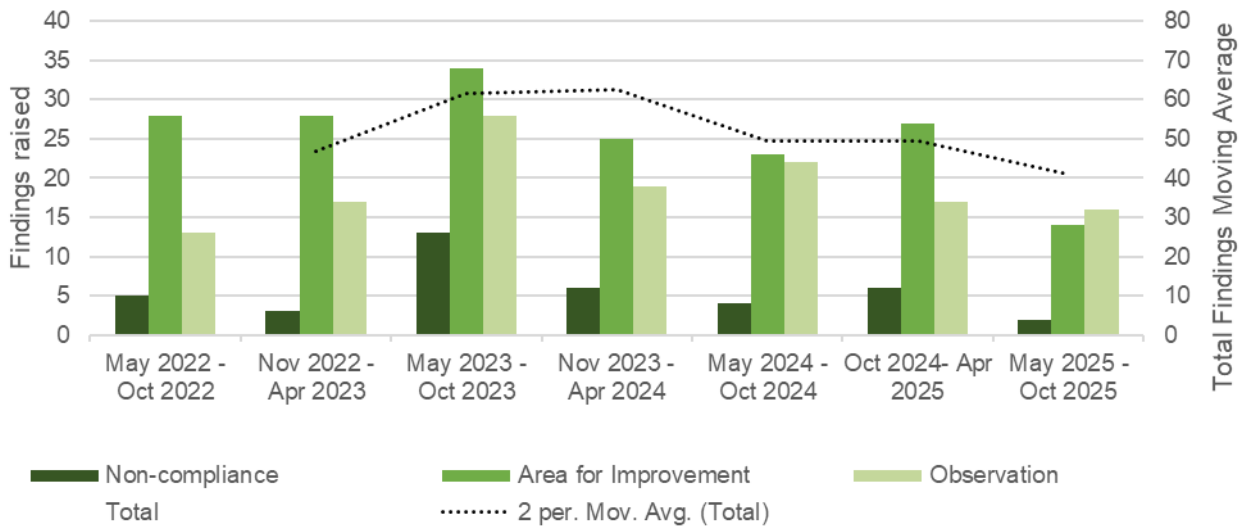
Figure 5: Audit findings by classification and reporting period Project commencement to October 2025.

The overall number of audit findings raised in this reporting period has decreased compared to the last reporting period. This is demonstrated by the moving average determined over two reporting periods (i.e. average of the first and second reporting periods, second and third reporting periods, third and fourth reporting periods, and so on) (see Figure 5).

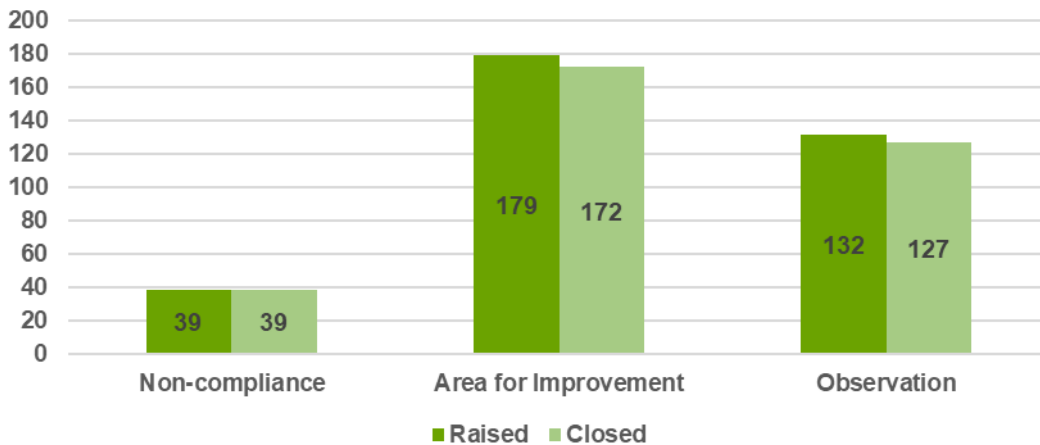
Figure 6: Cumulative audit findings raised and closed - Project commencement to October 2025

Spark D&C established corrective actions to address audit findings. Thirty-eight (38) findings were closed during the reporting period. Twelve (12) findings remained open at the end of the reporting period. (See Figure 6).

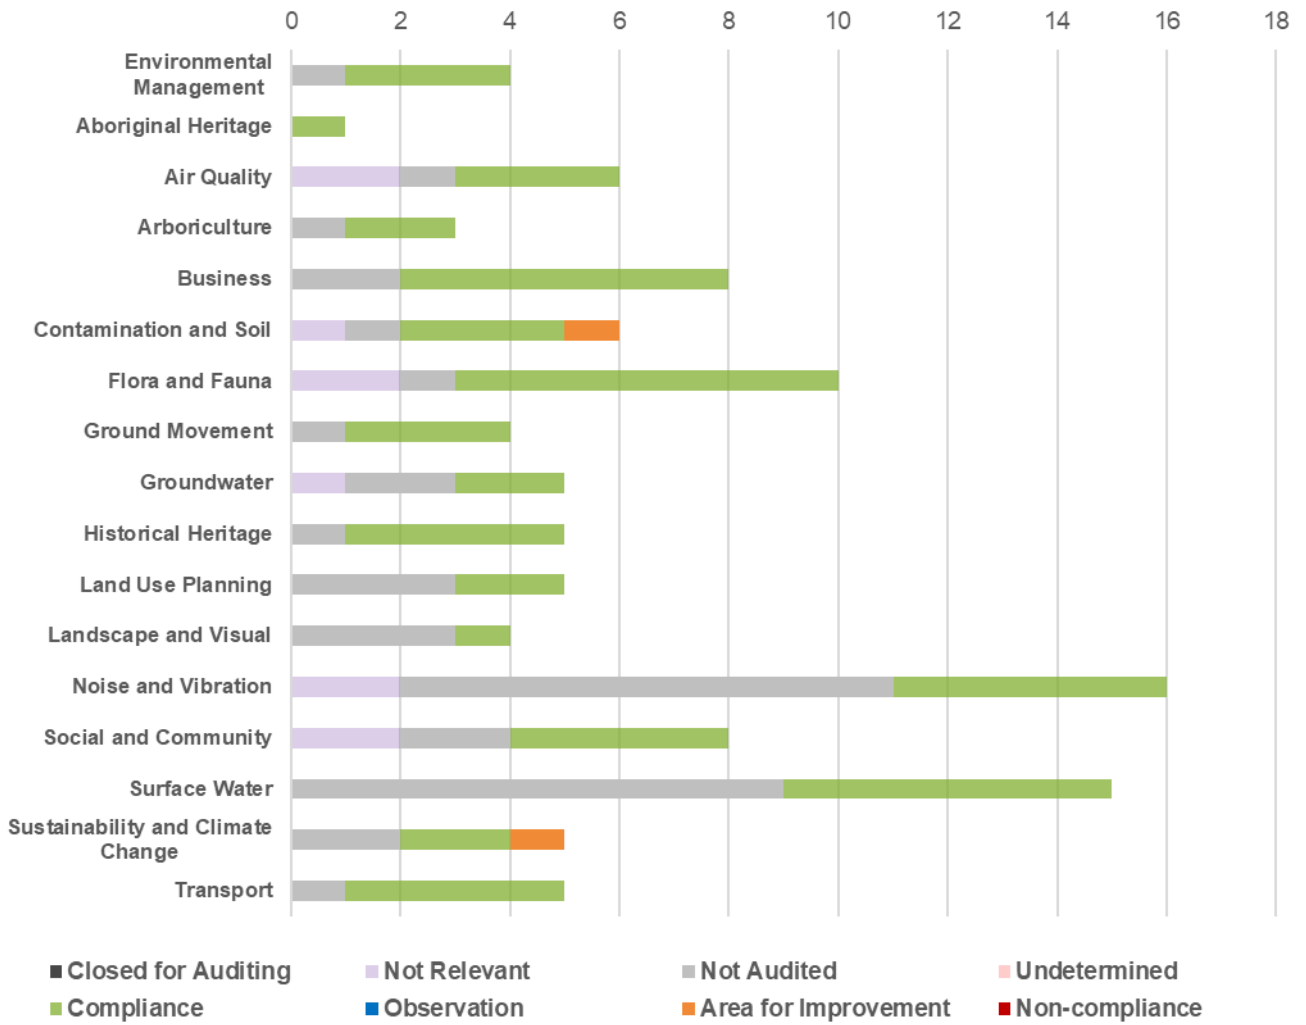
Figure 7: EPR audit findings by EPR category May to October 2025

Figure 7 shows the distribution of EPRs in each of the categories noting which were audited, and the status of compliance for the reporting period. Only EPRs relevant to the design and construction underway during the reporting period were included in the audit schedule for the period. Not all EPRs have equally detailed requirements, and there are different numbers of EPRs in each EPR category. The number of EPRs audited does not directly reflect the relative weight of environmental management requirements.

As each EPR category includes several EPRs, some of these were not included in the audits in the reporting period. All environmental issues are audited through the audits of Management Plans, even if the environmental aspect is not included in the EPRs in scope for the audits.

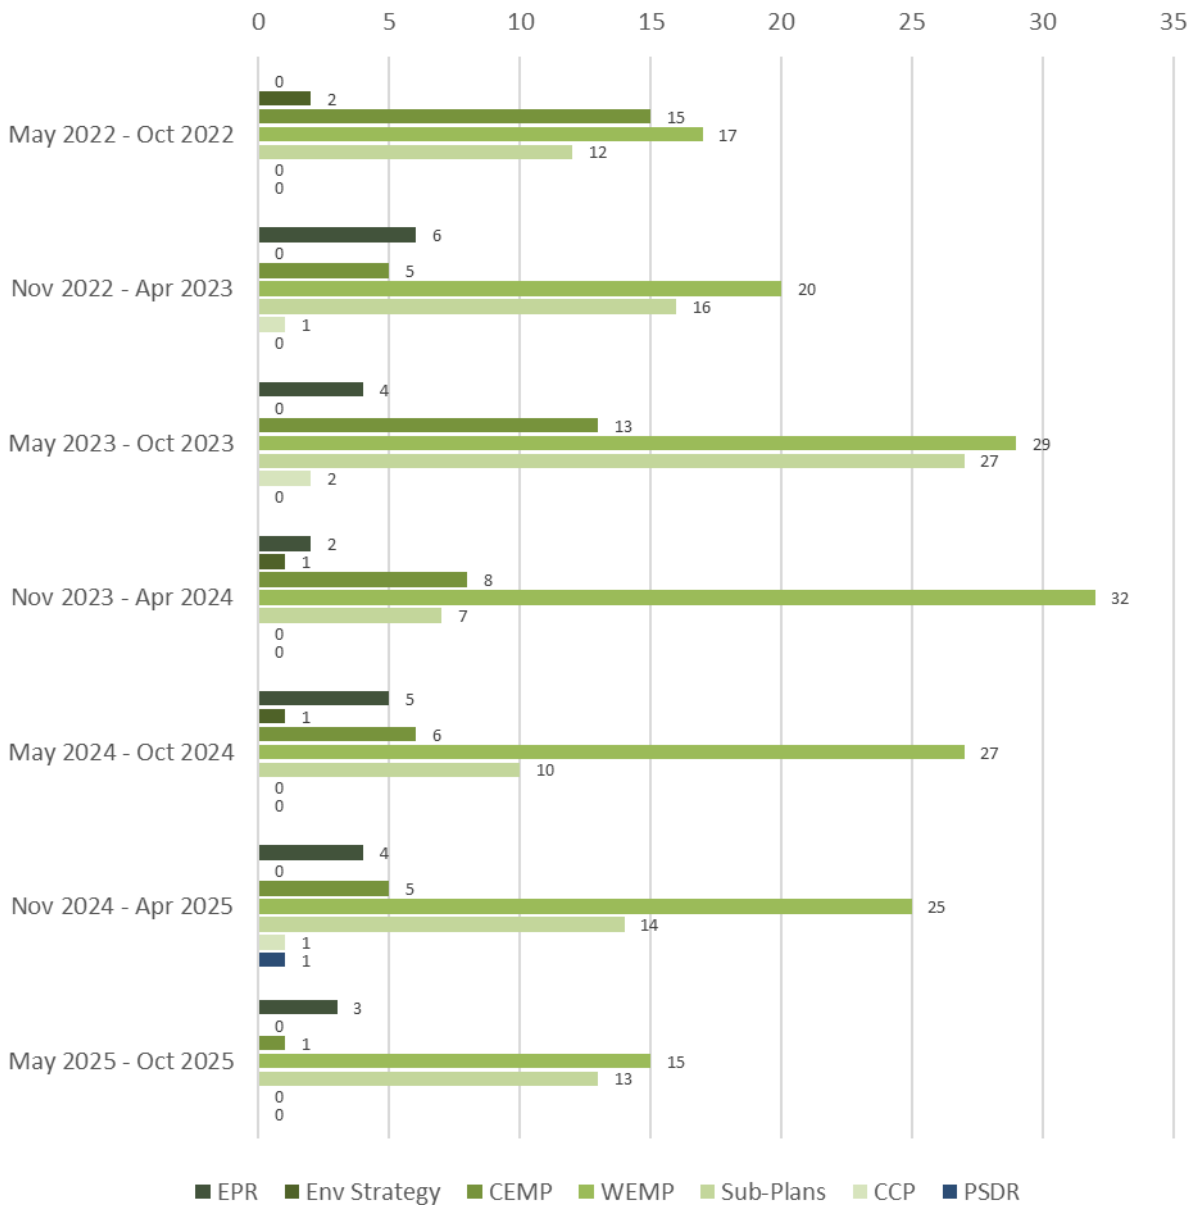
Figure 8: Audit findings by reporting periods

However, the findings also note the need for Spark to further establish commensurate environmental controls and maintain these controls for effectiveness. The number of findings related to water management on site, and to mud tracking on to roads adjacent to the construction sites indicate that Spark requires additional focus on these environmental aspects.
