Annual EPBC Act Approval Compliance Report

North East Link Program

EPBC Approval: 2018/8142

Reporting Period: 18 May 2022 – 18 May 2023

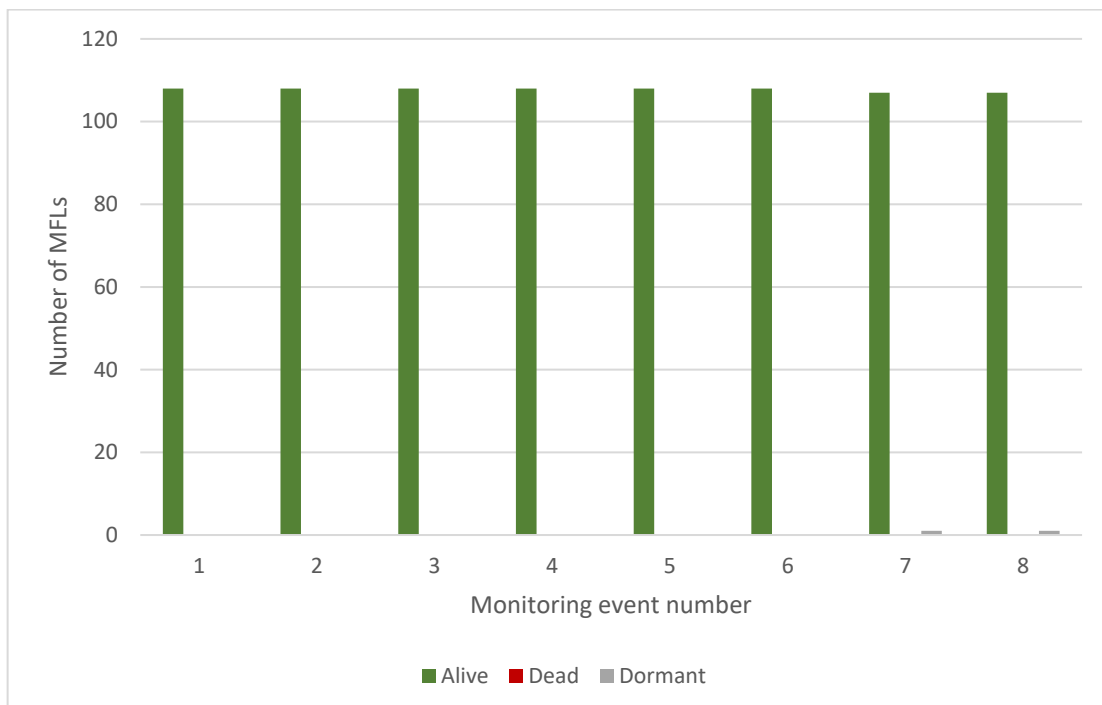
Figure 3 MFL survivorship in Cherry Street Reserve between August to December 2022

As at Event 8 (the most recent data captured by this report) the survival rate of the MFLs at Cherry Street Reserve is 99% (107 MFLs) (Figure 3; Appendix C). It is strongly suspected that the final MFL is alive and was missed due to biomass growth making it difficult to find the individual. It will not be recorded as dead unless it is not found for another year.

The survivorship of the MFLs has remained high over the course of the monitoring program. Only in Event 7 and Event 8 have any of the MFLs not been recorded as present. However, it has been a different MFL plant not recorded each time, suggesting that the issue is finding the plant, not that the plant has not survived. Figure 3 shows the number of “missing” plants which were not found during surveys but not considered dead at this point.

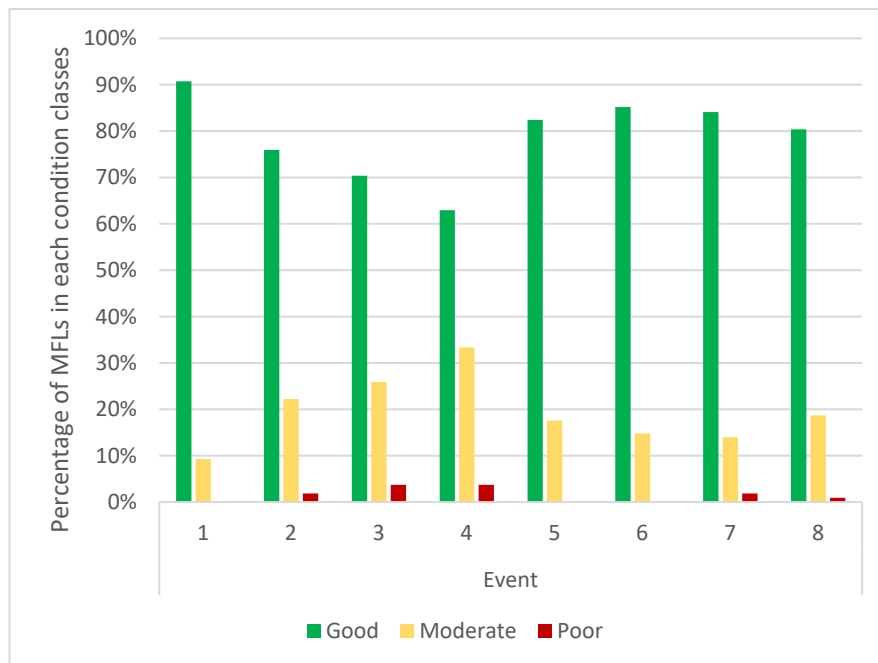
Figure 4 MFL condition in Cherry Street Reserve between August to December 2022

The health of the MFLs started off high after being translocated from the nursery (Figure 4). The proportion of plants with good health (>70% green leaves) decreased over the next 4 weeks to a low of 63%. In September, the proportion of good condition plants increased to 82% and stayed at 80% or above through to December.

The proportion of plants in poor condition (<30% green leaves) has remained low, only increasing to 4% at the end of August before decreasing again.

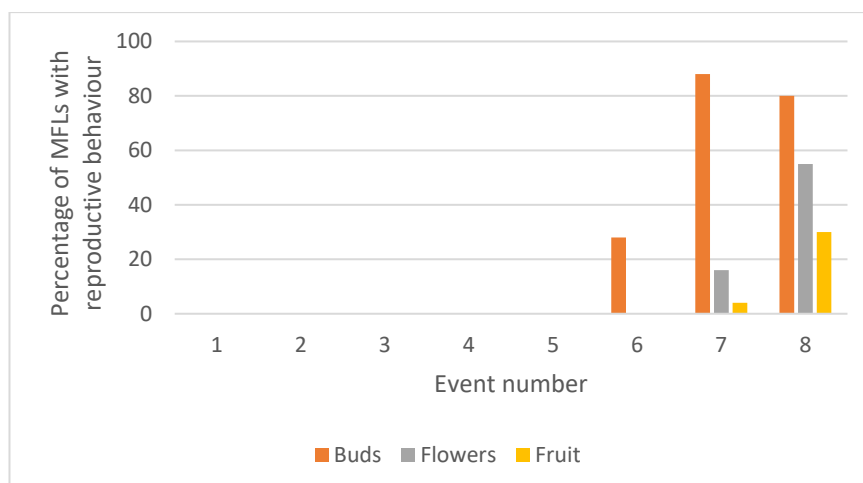
Figure 5 MFL buds, flowering and fruiting percentages from August to December 2022

October was the first time any inflorescences were observed, with 25.9% of plants (28 plants) with at least one inflorescence. This is in line with the MFLs expected flowering period. This increased in November with 89% of MFLs showing some stage of reproduction (buds, flowering or fruiting) and then decreased slightly in December with 87% of MFLs in some stage of reproduction (Figure 5). The high proportion of plants displaying some stage of reproductive behaviour is a good sign of Matted Flax-lily health.

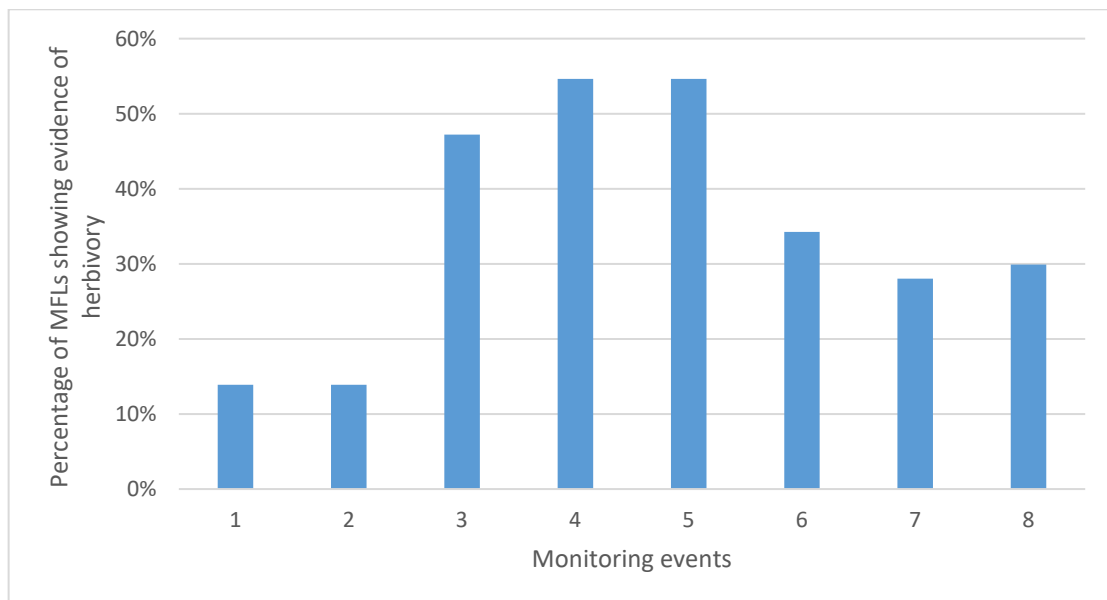
Figure 6 The percentage of MFLs impacted by herbivory

After the initial translocation there were signs of herbivory with leaves of many MFLs being chewed across the reserve (Figure 6). However, since then there has been little evidence of continued herbivory stress on the plants. This will be monitored over the life of the program in case conditions change.

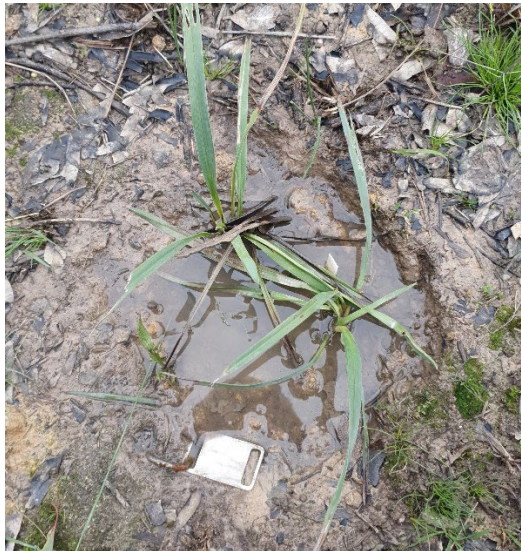
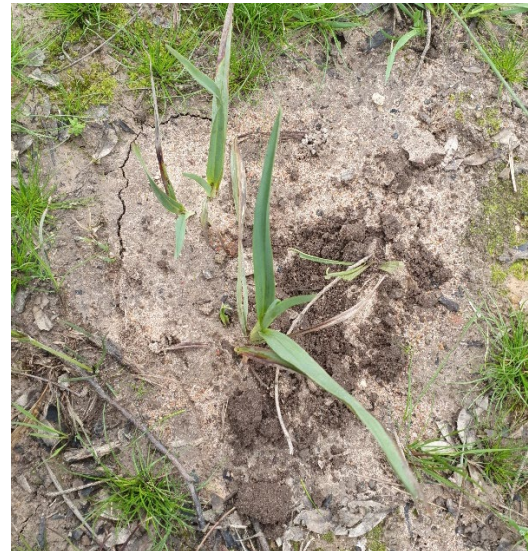
Waterlogging is a threat to MFLs with some plants in the east side of the reserve having their soil washed away and water pooling at the base of the plants (Plate 1). Corrective actions have been taken including adding soil near the base of plants to ensure water is unable to pool around the root zone. At the completion of monitoring Event 8 no MFLs have an active risk of waterlogging stress. Ongoing monitoring will continue to check for this stress.

Plate 1 Matted Flax-lily from Event 3 (1a) waterlogged due to soil washing away and recent rain. The same Matted Flax-lily during Event 5 (1b) after soil has been added back to the base of the plant.

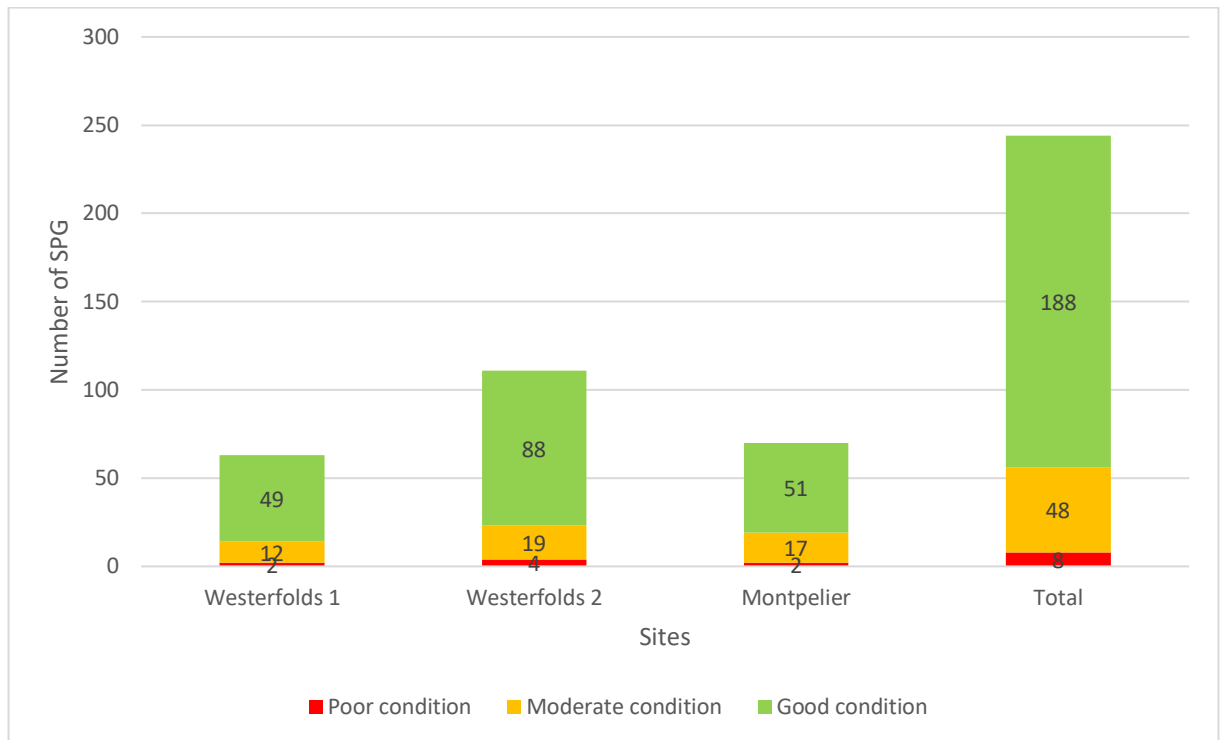
Figure 2 Condition of SPG across the three recipient sites: Fourth quarterly survey March 2023

In March 2023 surveys found that 244 SPGs (74.3%) were alive (Figure 2). Of the 244 living SPGs, 188 (77%) were in good condition. The proportion of good condition plants has steadily increased over the course of the year from 53% of plants in August 2022 to 77% in March 2023. Reasoning for the increased number of plants in good condition is probably due to seasonality. The spring/summer season provided optimal conditions for the SPGs to put on new growth and grow taller (average height increased from 68.6 cm in August 2022 to 155.9 cm in March 2023). One plant had some form of reproduction in the Montpelier reserve. This is encouraging; and it is expected, a greater proportion of plants will likely show some form of reproduction in the future as they age.

Across the three sites, 48 individuals (20%) were in moderate condition and 8 (3%) in poor condition. Eighteen (18) of 262 SPGs were dead or missing (7%). These rates are within the expected range for in situ plantings. No herbivory, notable environmental stress or disease was observed during the March 2023 monitoring.

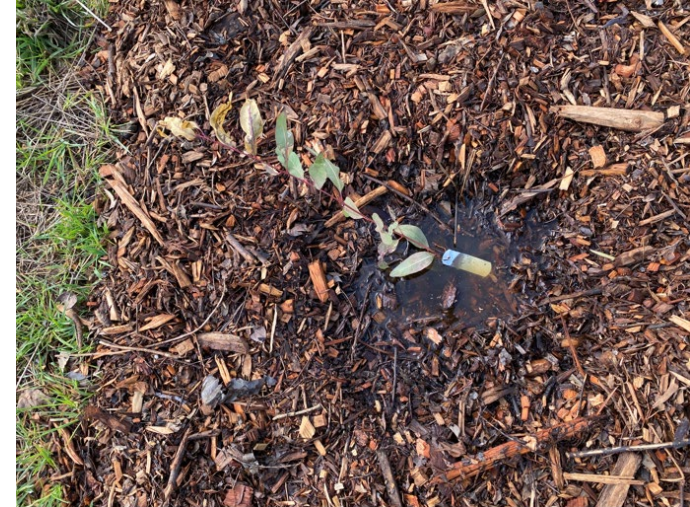
Correctly planted SPG, which has been submerged due to the heavy rainfall event

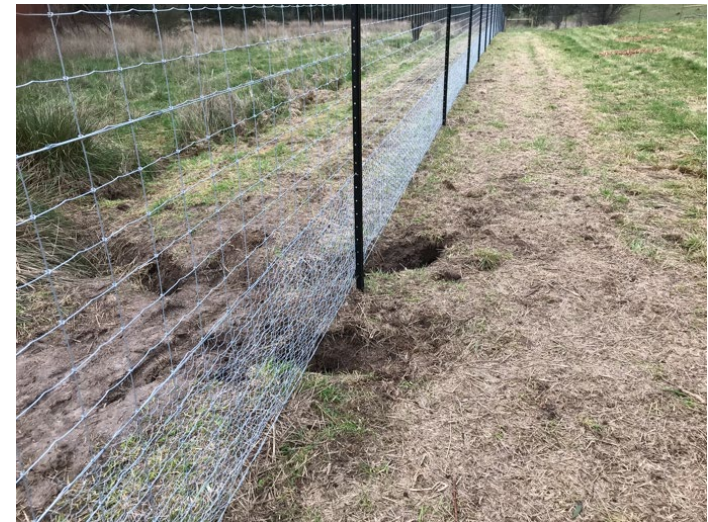
Wombat burrow which has been closed off from the outside.
