**SUBURBAN  
RAIL LOOP**

# **Air Quality Monthly Report**

## **Tunnels South**

## **Tunnels North**

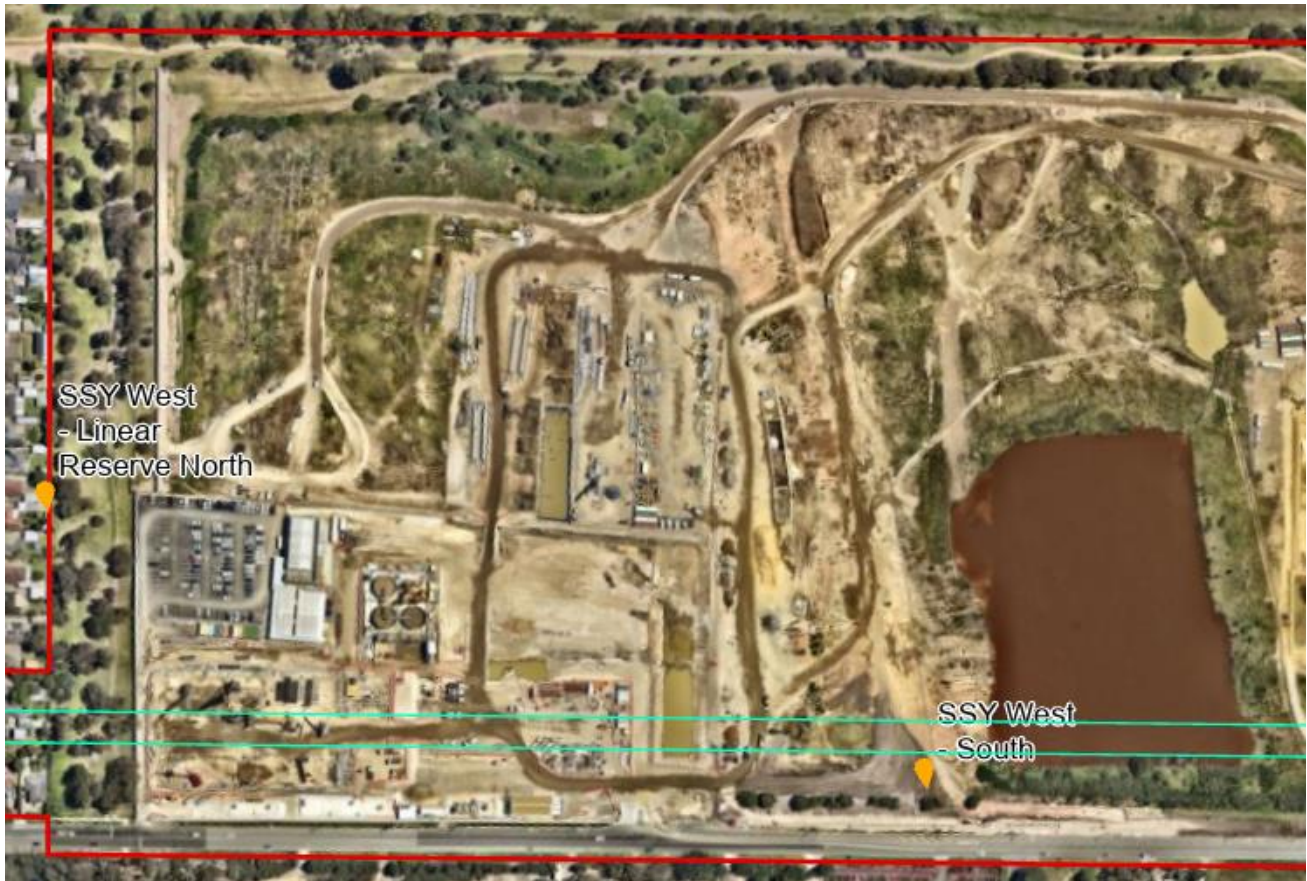
Figure 3: Train Stabling Facility West site air quality monitoring stations

The SSY West – North monitor was removed from site this month, as monitors at the Linear Reserve North and South locations provide sufficient coverage of current construction activities.

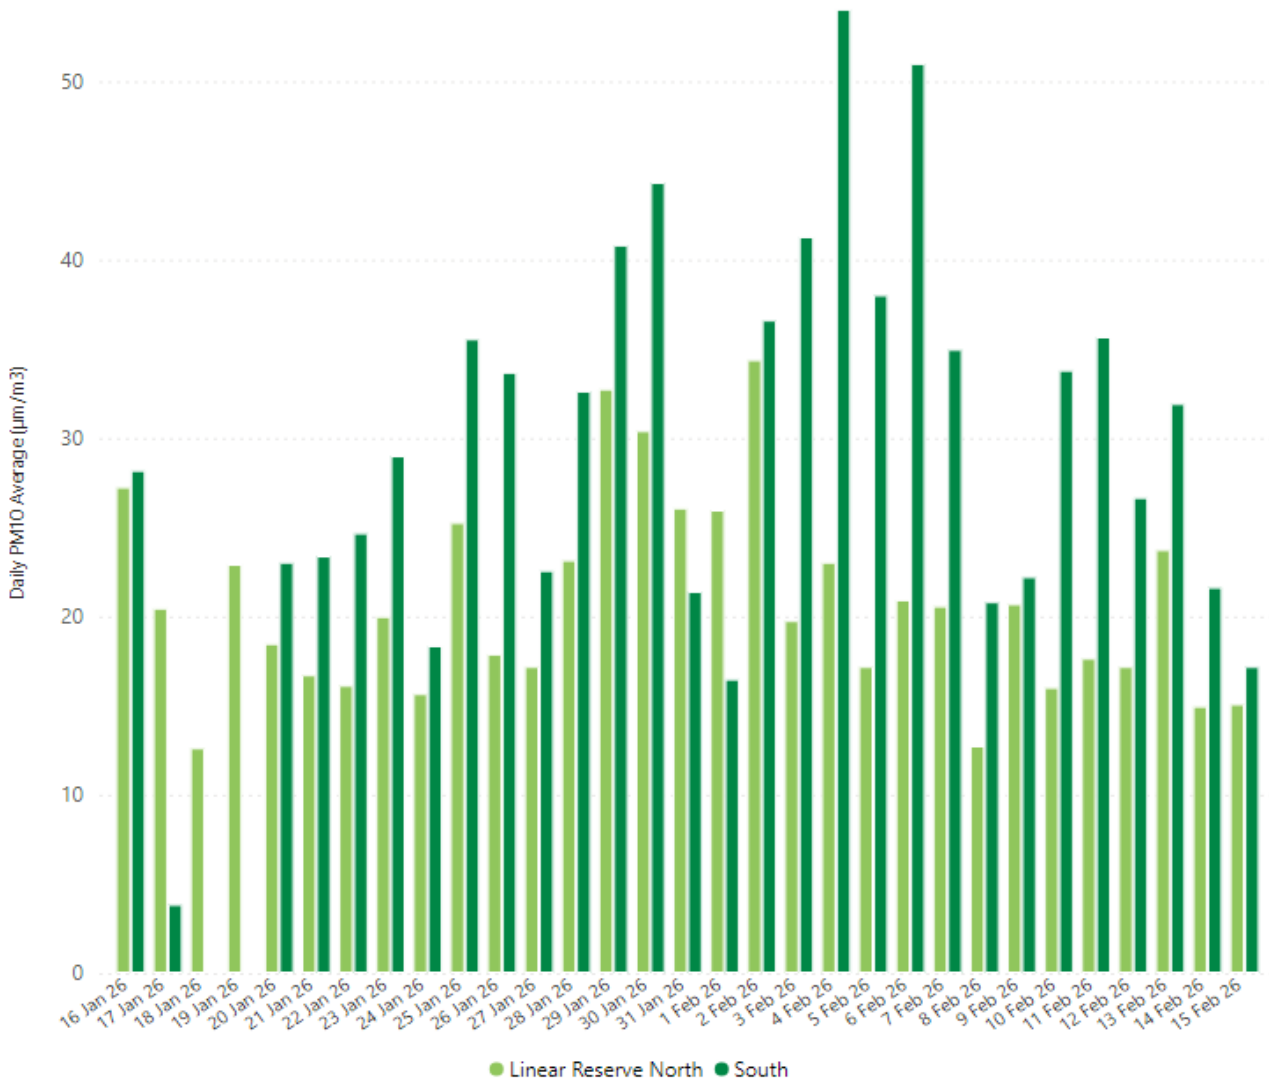
**Figure 4: Daily Averages PM<sub>10</sub> Results at Train Stabling Facility West**

Two elevated daily average PM<sub>10</sub> events above 50 µg/m<sup>3</sup> occurred at the South monitor during the reporting period. Visual inspections confirmed ambient weather conditions and external dust sources were contributing to elevated readings. Dust management measures were confirmed to be active and sufficient for the activities on site.

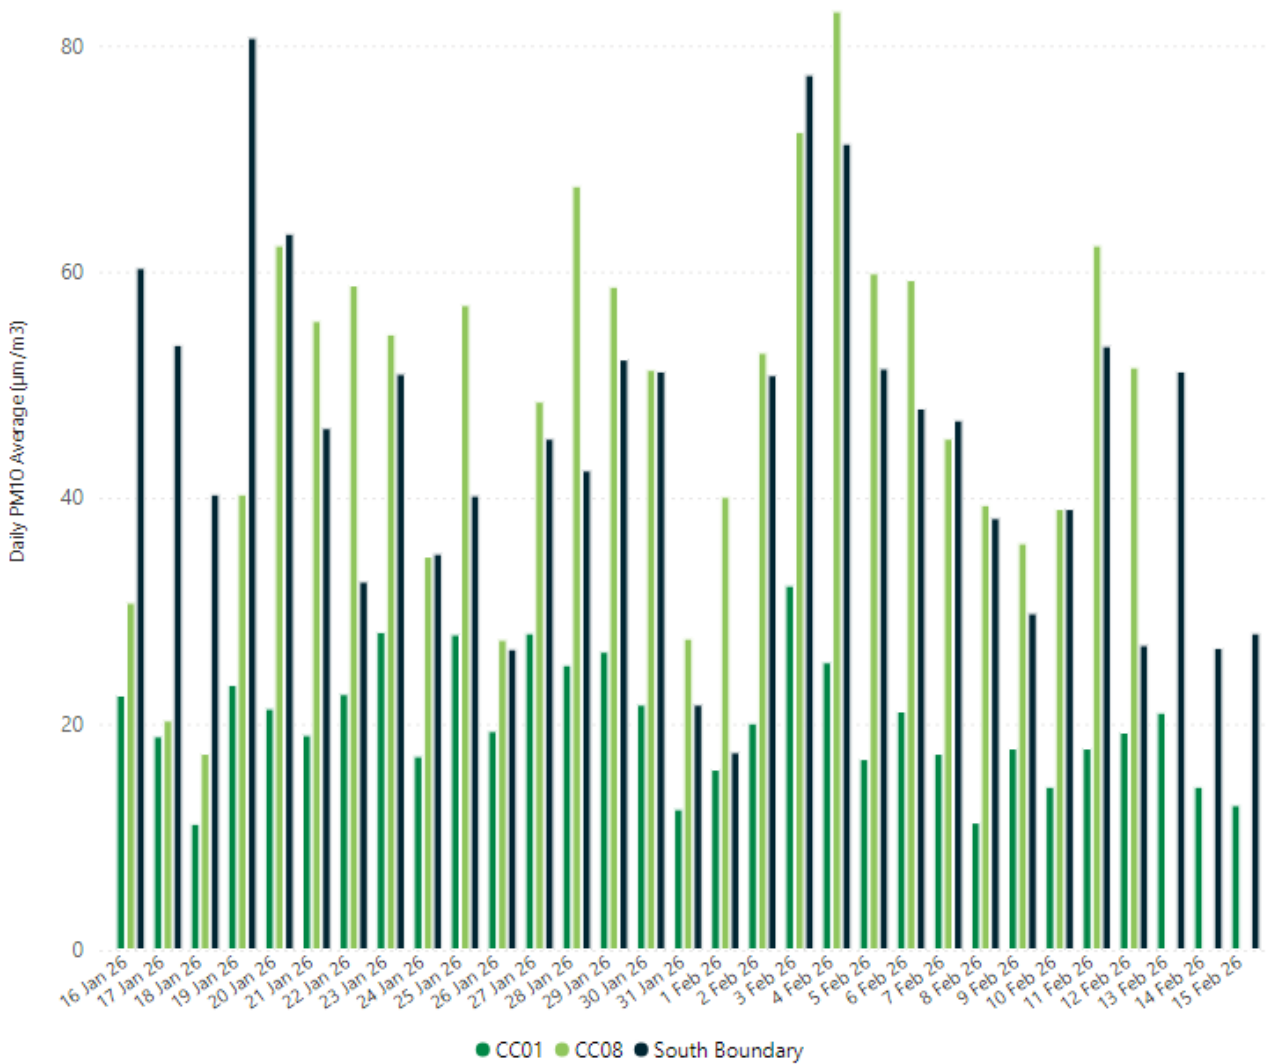
Figure 6: Daily Averages PM<sub>10</sub> Results at Clarinda TBM Launch Site

The CC08 monitor was offline from 13 February 2026 onwards due to technical issues. Monitor has since been replaced on 24 February 2026.

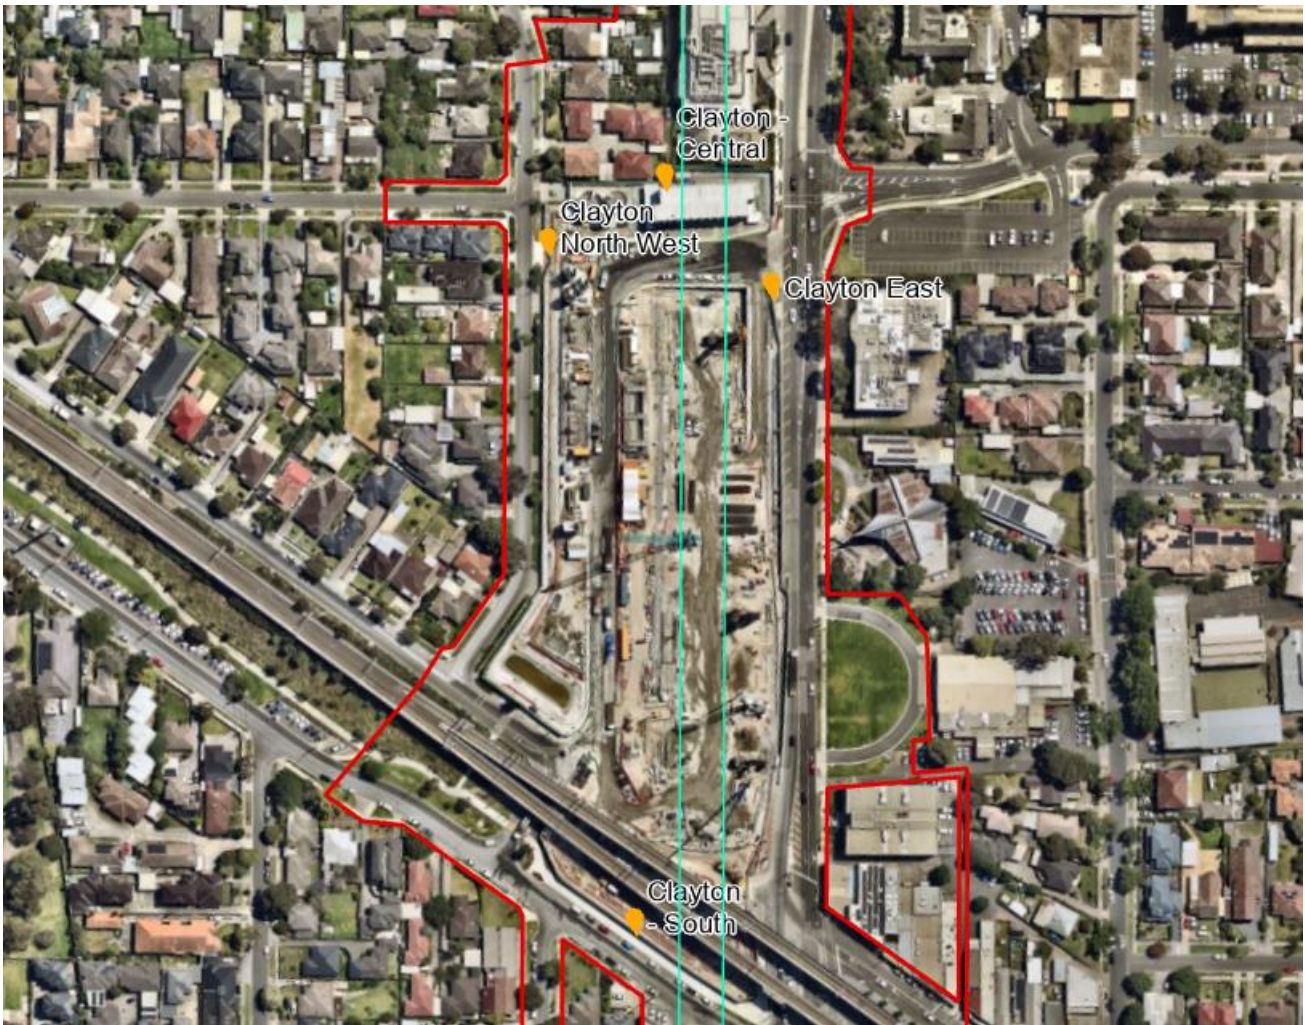
**Figure 7: Clayton air quality monitoring stations**

The Clayton East monitor was relocated to the North West location on 3 February 2026 and replaced the existing monitor there. This was due to technical issues with the North West monitor and inaccurate data readings from the East monitor as it was located along Clayton Road.

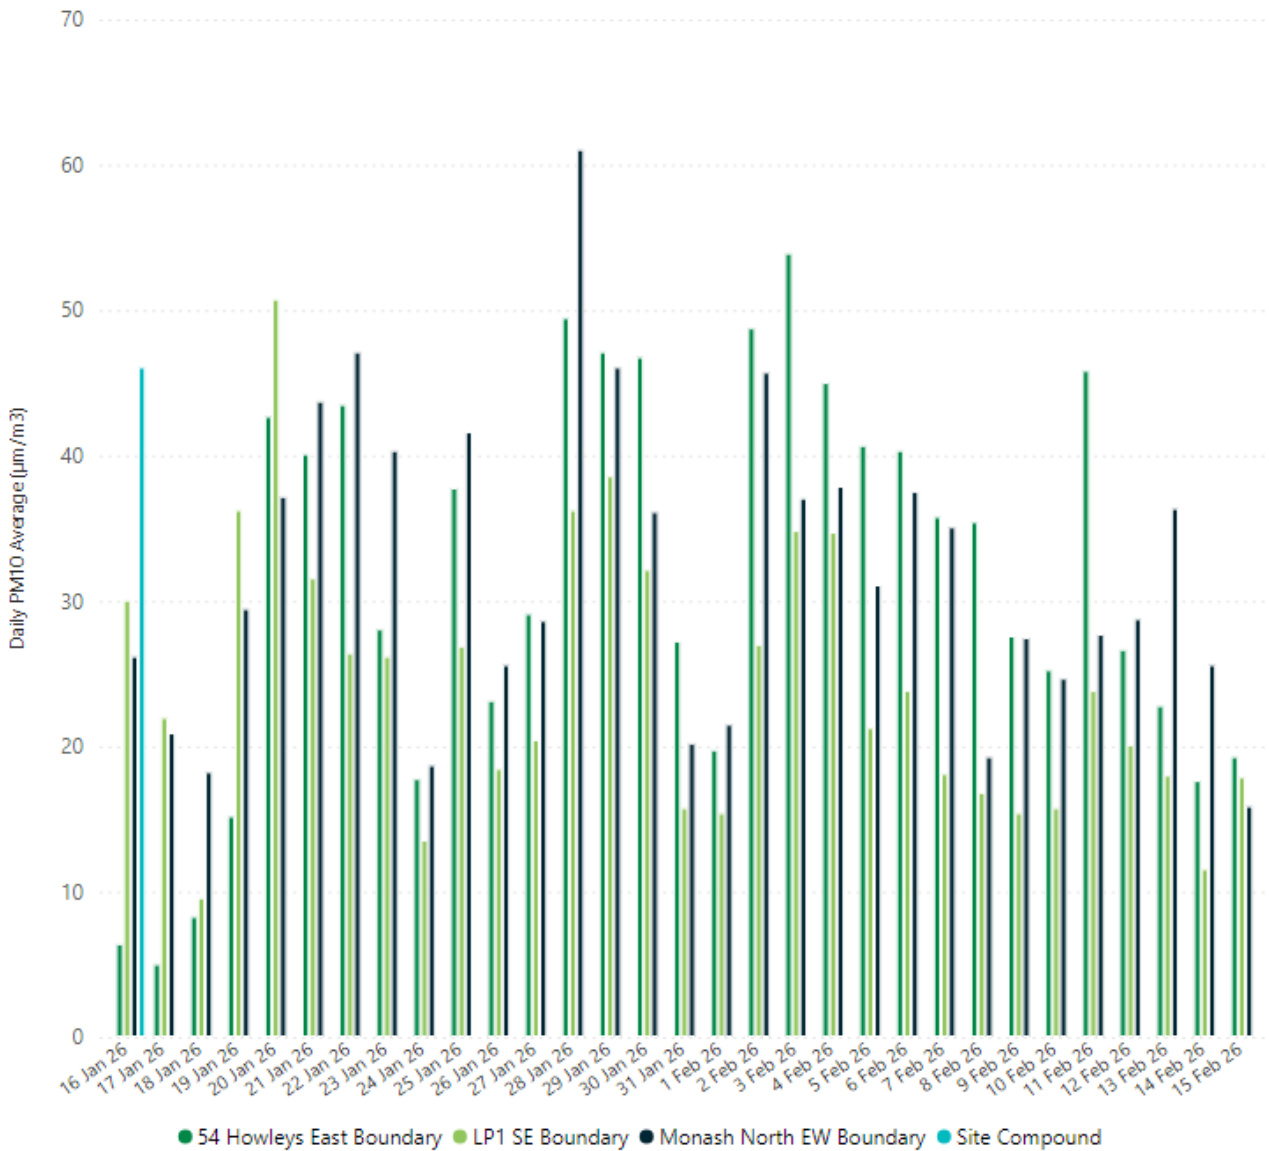
**Figure 10: Daily Averages PM<sub>10</sub> Results at Monash**

Three elevated daily average PM<sub>10</sub> events above 50 µg/m<sup>3</sup> occurred at the 54 Howleys East Boundary monitor, the LP1 SE Boundary monitor and the North EW Boundary monitor during the reporting period. Investigations determined the elevated levels were attributed to extreme weather conditions and works occurring in close proximity of the monitors, which was not representative of the actual dust levels on site. Dust management measures were confirmed to be active and sufficient for the activities on site.

Due to dry dusty conditions and works occurring in close proximity of the monitor, TARP actions were implemented on 3 February 2026 including increased frequency of water cart operation and redirection of trucks to other activities on site was implemented to reduce dust generation.

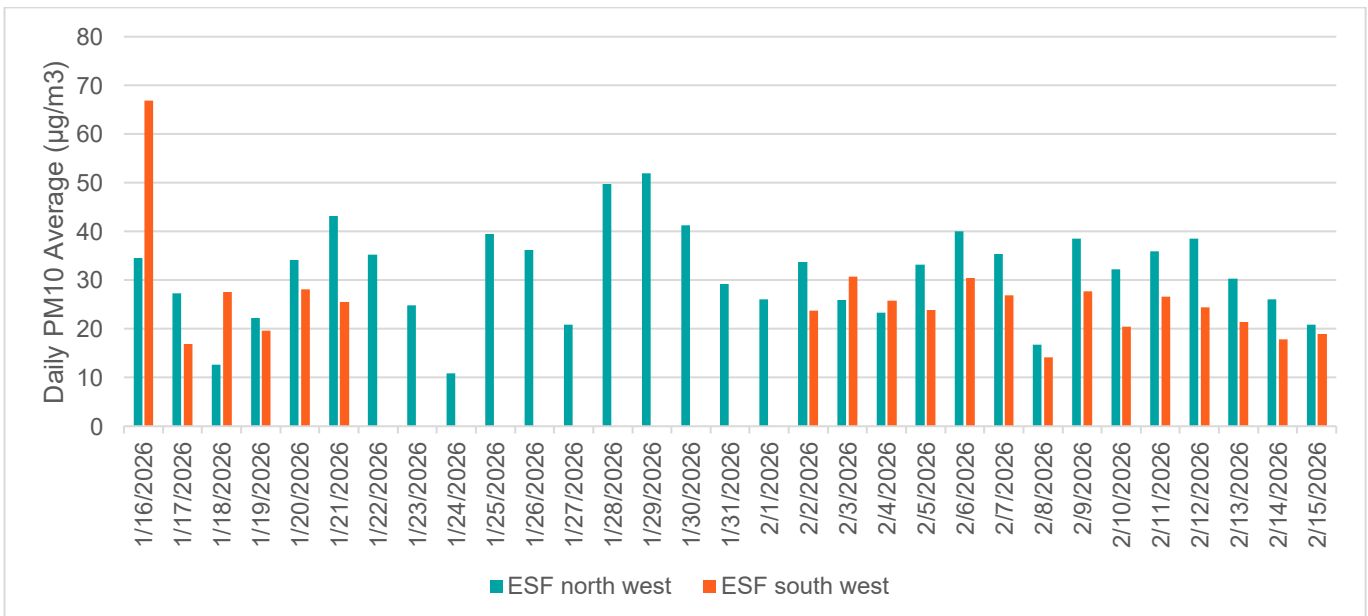
Figure 2: ESF PM<sub>10</sub> daily averages from 16 January to 15 February

A daily average above the objective was recorded during the reporting period. The maximum daily average was 66.9 µg/m<sup>3</sup> at the ESF Southwest monitor on 16 January. A proactive visual inspection was undertaken on the day. Dry site conditions and winds travelling East–South-East were present.

Elevated particulate levels coincided with regional bushfire smoke events affecting Victoria, and an exceedance was also recorded at the EPA Dandenong monitoring station (81.7 µg/m<sup>3</sup>) on the same day. These regional smoke conditions likely contributed to the increased PM<sub>10</sub> concentrations recorded by the site monitoring equipment.

No dust was observed leaving the site, and ongoing dust suppression measures were implemented, including the use of hoses in the piling work areas.

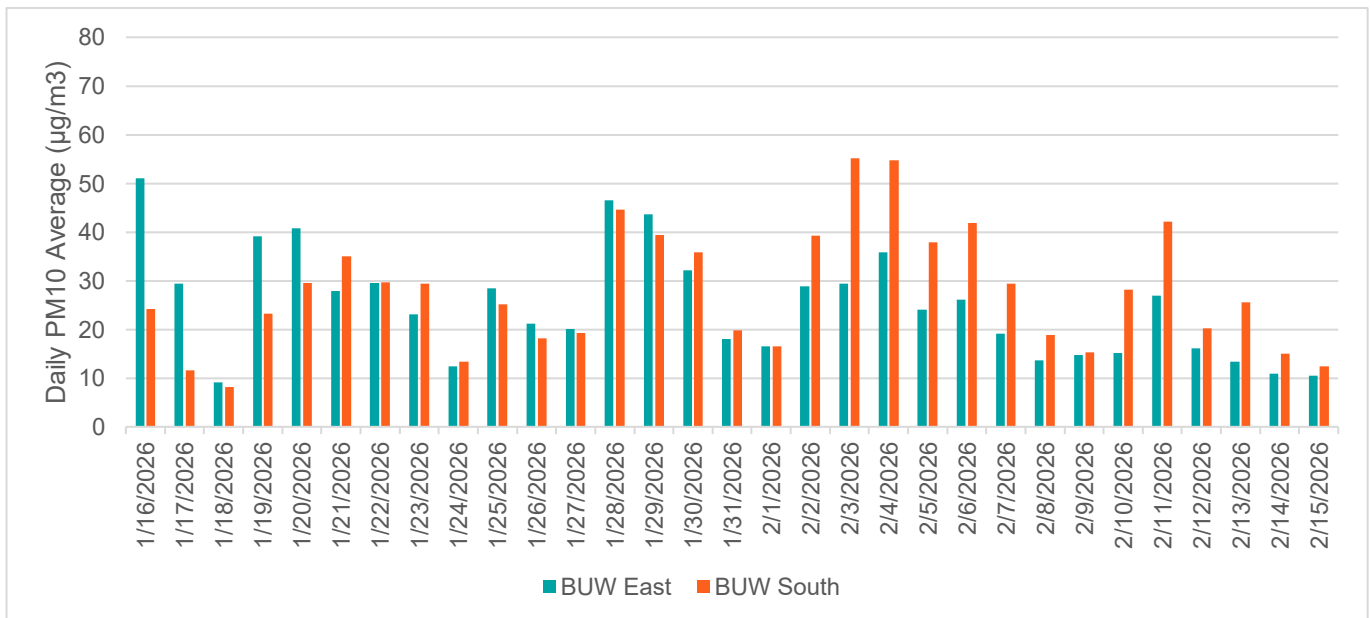
Figure 4. Burwood PM<sub>10</sub> daily averages from 16 January to 15 February

No daily averages above the daily objective were recorded during the reporting period. The maximum daily average PM<sub>10</sub> concentration was 55.2 µg/m<sup>3</sup> at the BUW South monitoring location, dry conditions and movement of plant and equipment adjacent to the monitor likely contributed to the increased PM<sub>10</sub> concentrations recorded by site monitoring equipment. Proactive visual inspection was carried out, and dust controls were in place. Two water carts operate on site regularly and are called to specific areas as required.

TARP Level 3 was triggered on two occasions (16 and 19 January). At the time of the triggers, excavation works for a new drainage line were being undertaken adjacent to the BUW East monitor. Dry conditions were present on site, increasing the potential for dust generation. Dust control measures were implemented, including the deployment of two water carts covering the two active work fronts and the use of hoses in areas with more difficult access.

In response, proactive visual inspections were undertaken, and additional dust suppression measures were implemented, including the use of two water carts during TBM assembly area and piling works until conditions were back to normal.

Two water trucks were deployed to wet down the affected areas until dust levels returned to acceptable levels and continued operating as required. Water hoses were also used across multiple excavation fronts to further control dust. No visible dust emissions were observed beyond the site boundary.
