Appendix F. Baseline Measurements

This document presents details on the baseline measurements undertaken for the Melbourne Metro. The types of measurements that have been undertaken and their corresponding sections in this appendix are described below:

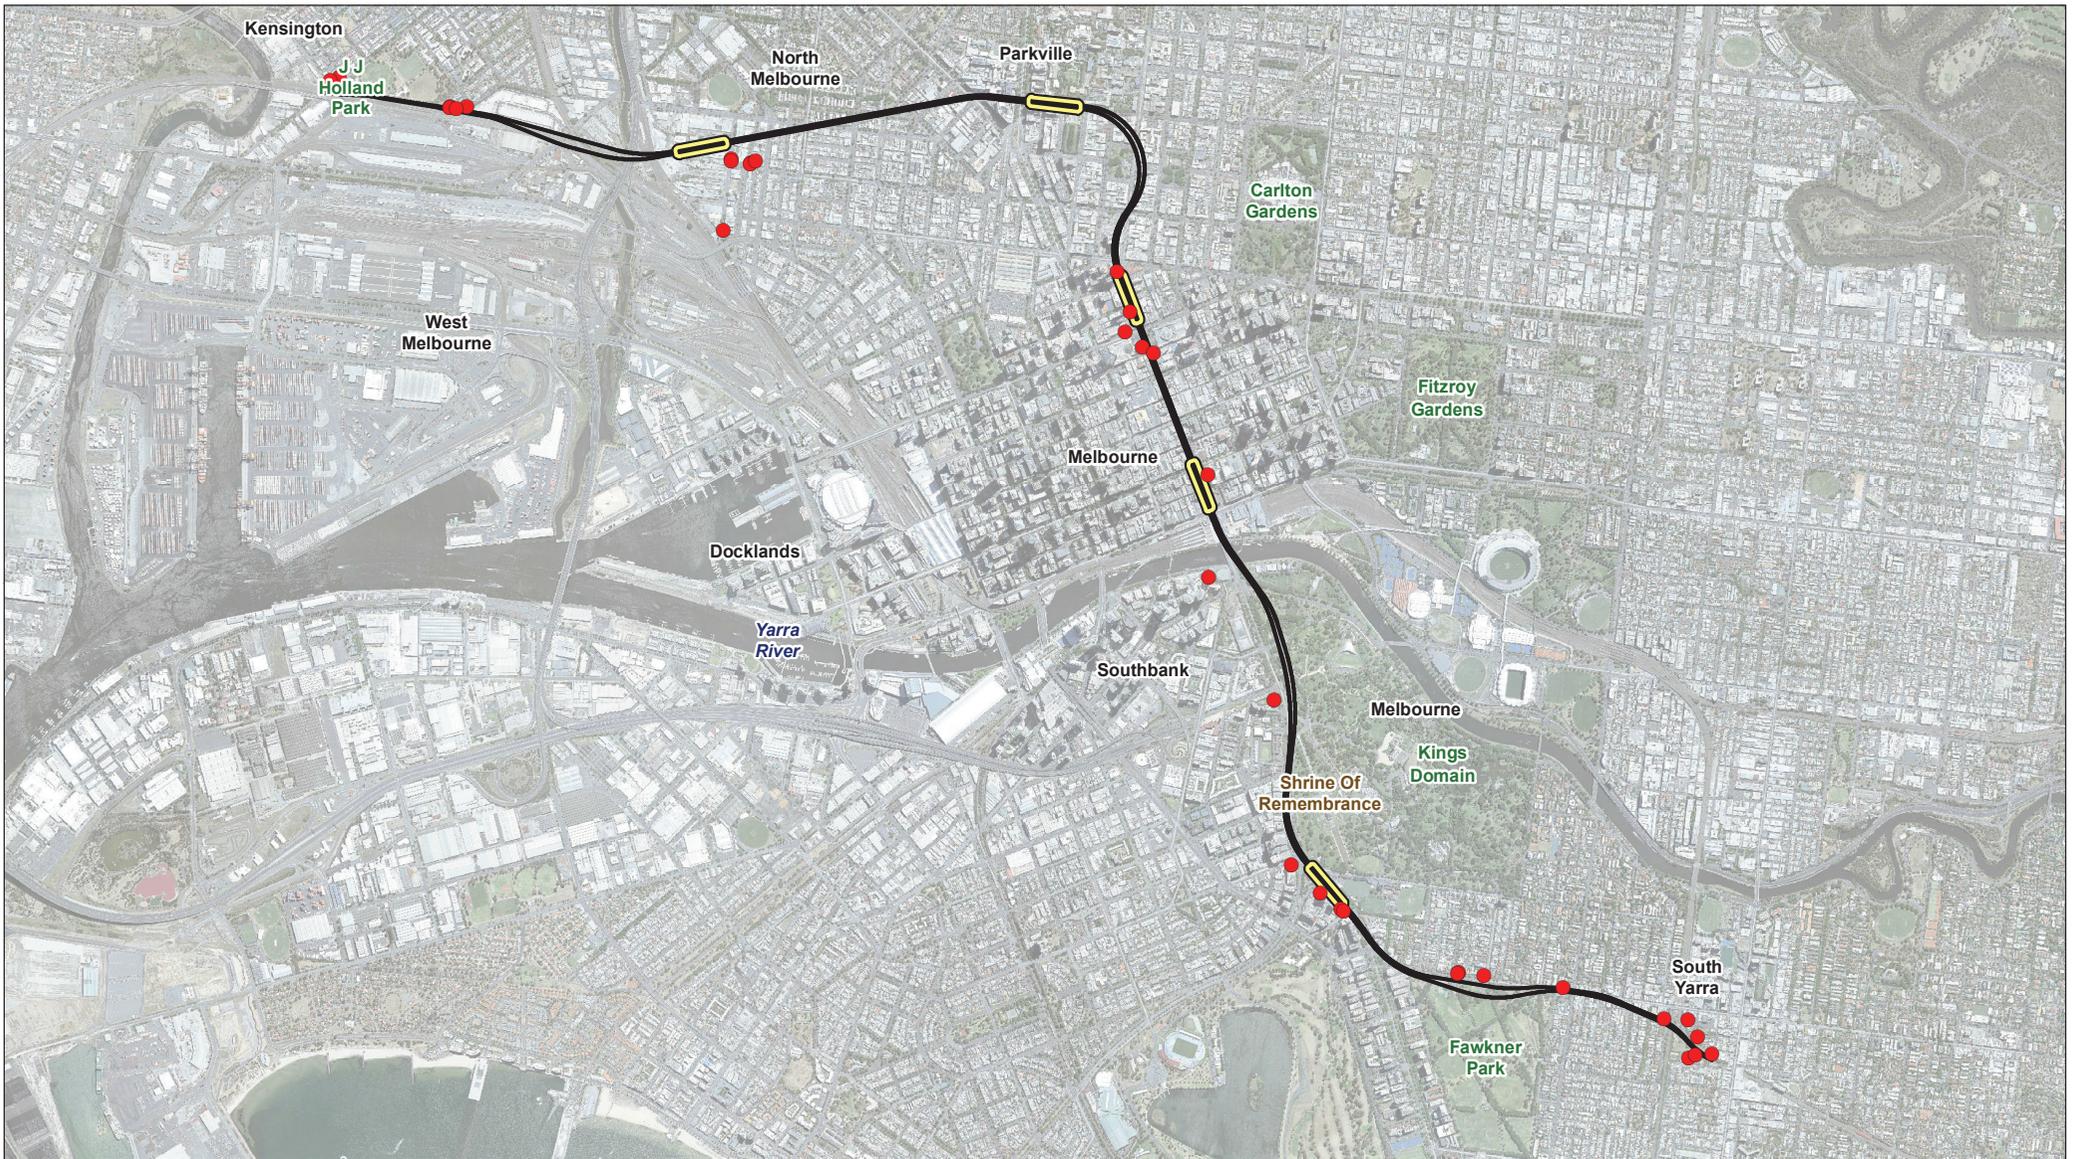
Figure F1: Noise Measurement Locations

Noise Monitoring has been conducted at 22 locations across the Melbourne Metro. The specific locations are detailed in Table F1 and shown in Figure F1.

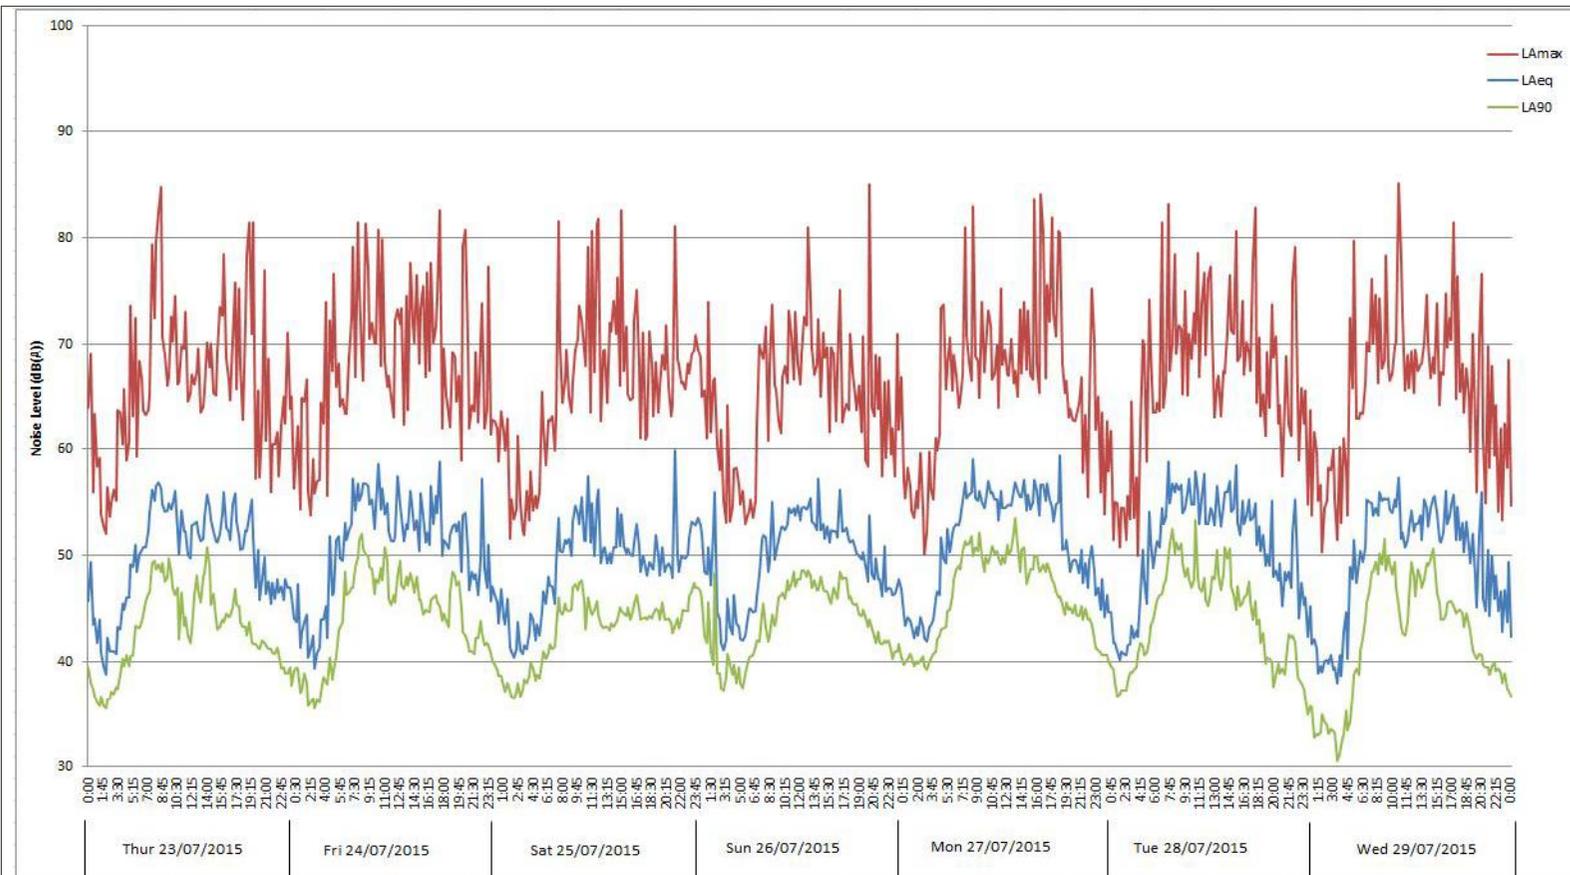
Figure F2: Measurement at Location 1: 148 Kensington Road, Kensington

Image 1: View from logger

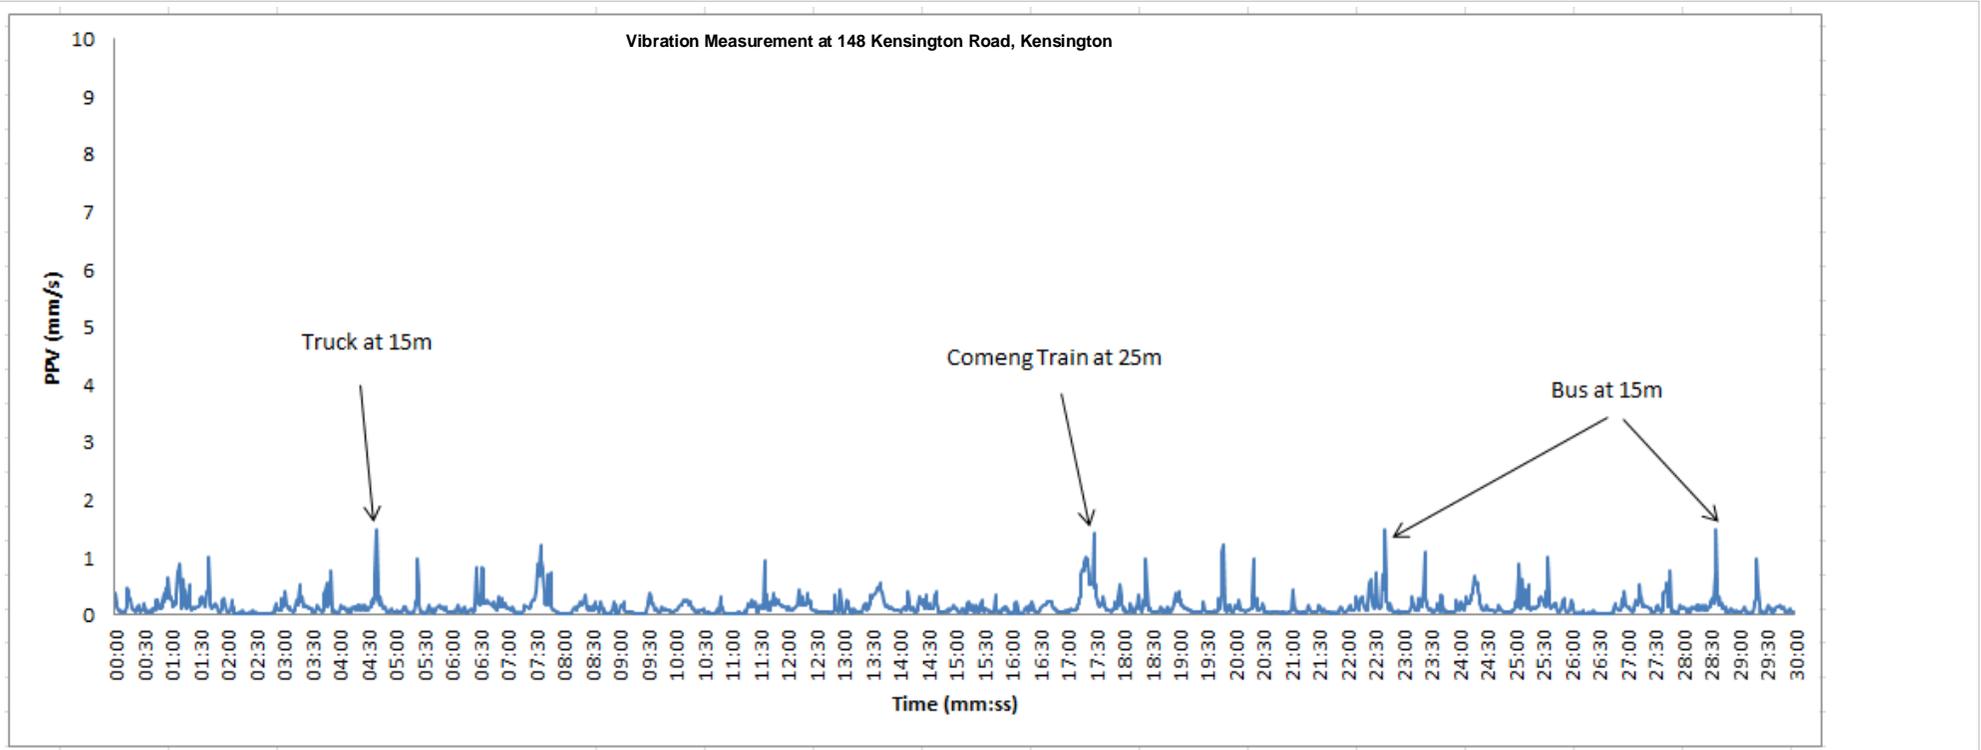
Figure F26: Vibration levels measured at Location 1: 148 Kensington Road, Kensington

Image 1: Measurement equipment

Image 2: Imperfection on Kensington Road

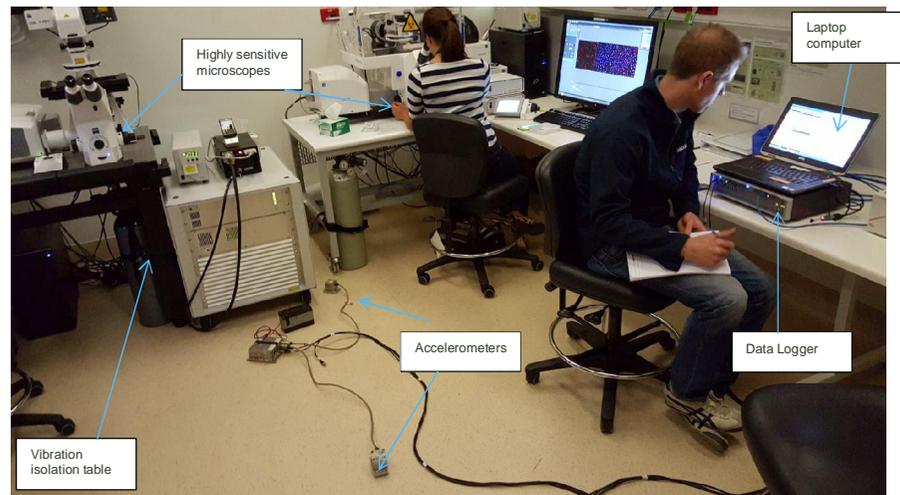
Figure F67: Typical floor vibration measurement setup

Vertical floor vibrations were monitored for approximately 30 minutes under 'normal' operating conditions at a mid-span position or position proximate to the sensitive equipment within each area to capture typical floor vibration levels due to staff footfall, doors closing as well as lifts and services operating. In addition, peaks in the frequency content of ambient floor vibration measurements or from a heel drop were used to estimate the lowest natural frequency of each floor. Staged walk-by tests were conducted using a metronome in order to match harmonics of the pacing frequency to the floor natural frequency or conduct a walk-by test at the maximum practical pacing frequency for high frequency slabs (slabs with natural frequencies greater than 10Hz). Accelerometers were mounted to the floor using bees wax to achieve a good connection to the floor that was free from rocking due to any uneven surfaces. Measurements were sampled at a frequency of 1000Hz. Figure F67 shows a typical test setup with accelerometers mounted on the floor adjacent to microscopes.

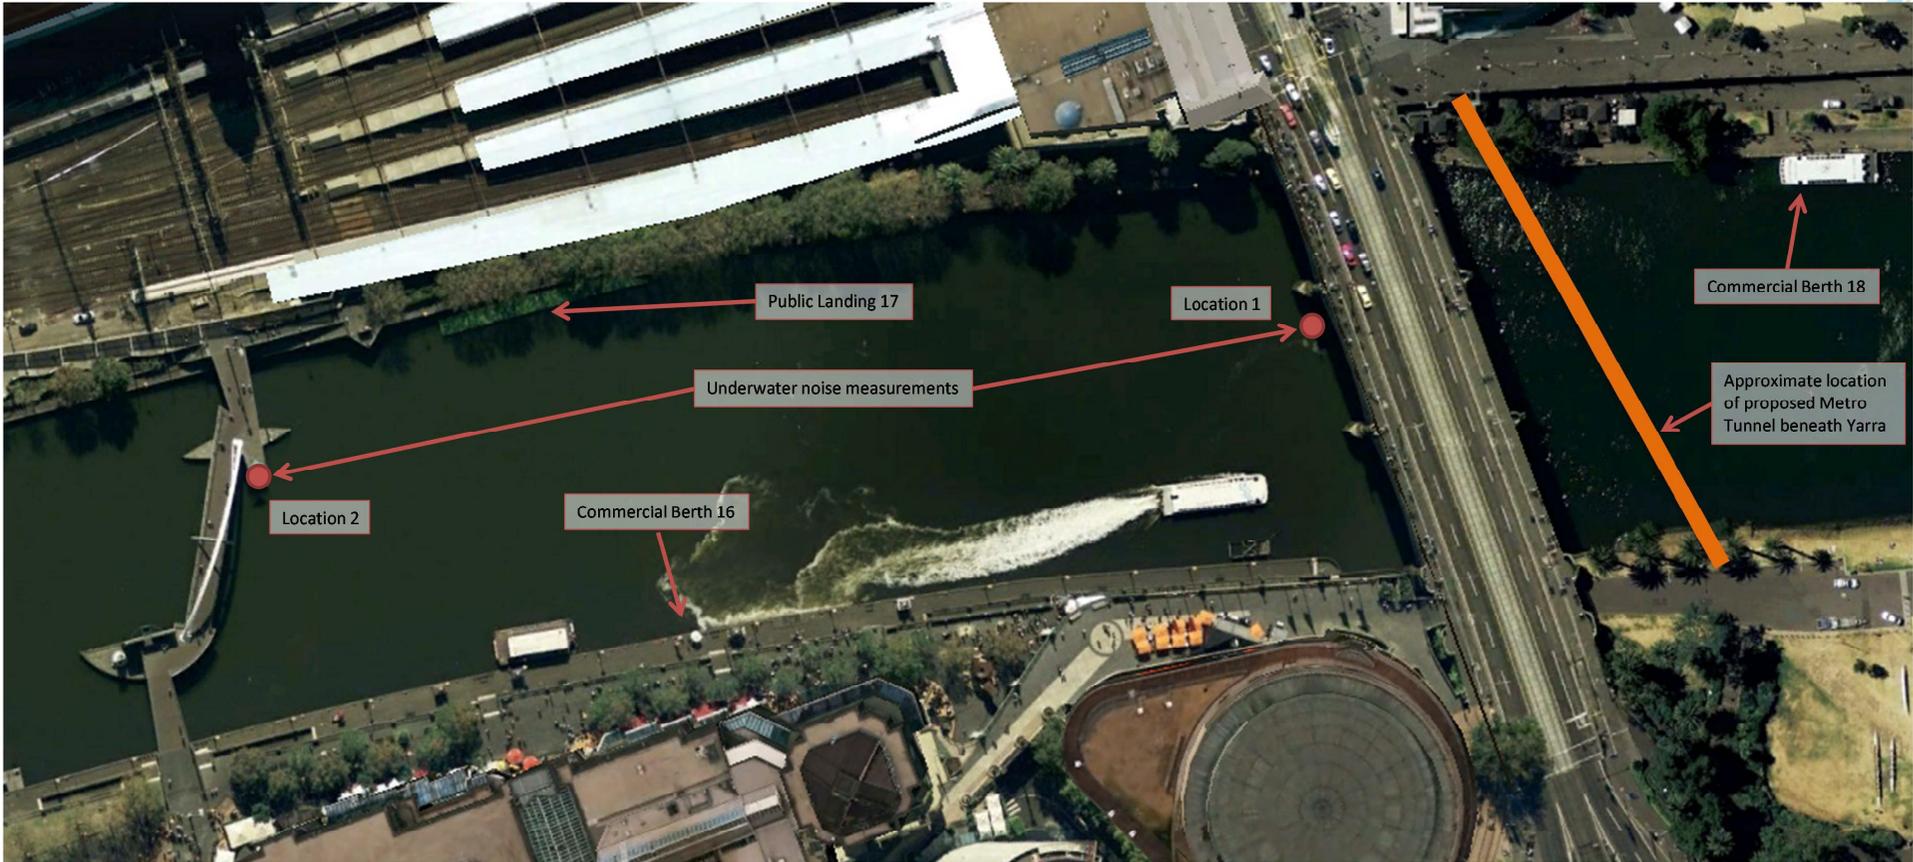
Figure F111: Underwater Noise Measurement Locations

A weighted line, marked at intervals, was used to first determine the approximate depth of the Yarra River at the two measurement locations. The water depth at Location 1 was found to be approximately 4.3 m deep and 3.5 m deep at Location 2.

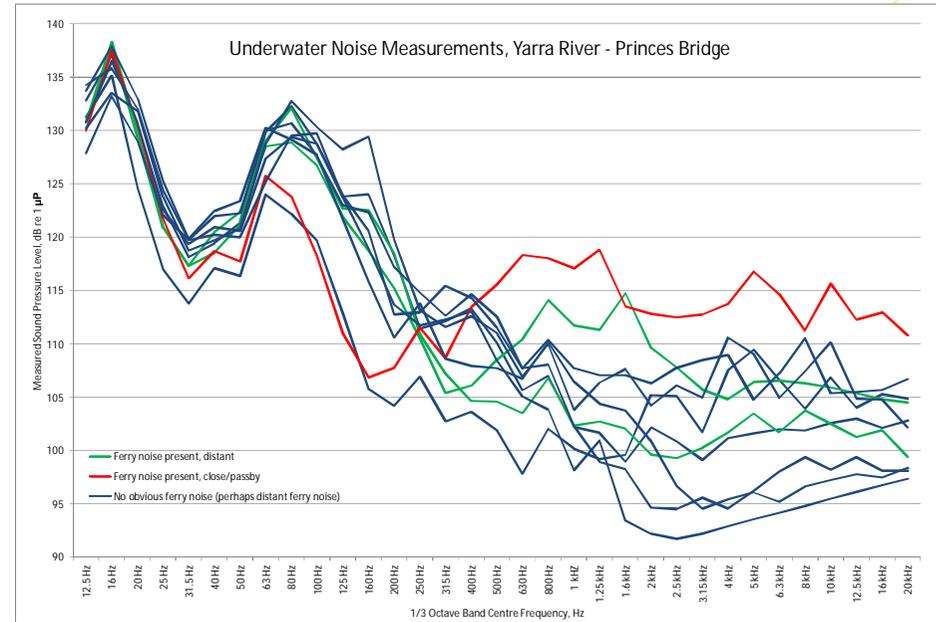
Figure F112: 1/3 Octave Band Noise Measurements at Location 1

The values in Table F32 are unweighted (linear) broadband noise levels. Relatively high levels at low frequencies dominate the overall noise levels regardless of the presence of nearby underwater noise sources.

The cause of the relatively high low frequency noise is not known, but may be associated with potentially significant sources of low frequency noise from international shipping and bulk container ships and carriers, located further downstream in the Yarra River approximately 3-4 km to the west. Given the distance from these potential noise sources and the width and depth of the Yarra River it would be expected that higher frequency underwater noise levels would dissipate faster than low frequency noise.

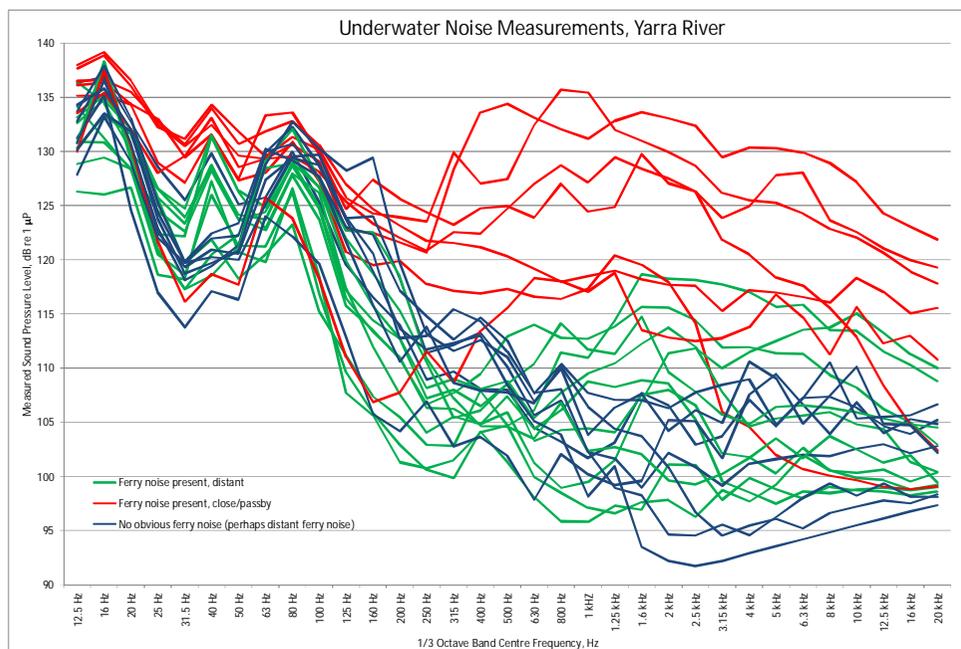
Figure F114: Combined 1/3 Octave Band Noise Measurements at both locations

The combined 1/3 octave noise spectra from both underwater noise measurement locations is shown in Figure F114. This figure shows that there is a high level of noise at low frequency in a number of peaks (16 Hz, 40 Hz and 80 Hz) which was noted whether the ferries were present or not. For this reason the overall noise level descriptors of sound (dB L_{Z90}, dB L_{Z50}, dB L_{Zeq} etc.) was not found to be a good descriptor of the noise environment.

The noise associated with the ferry pass-bys was most easily identified at frequencies above approximately 250 Hz where the measured noise levels are generally above 115 dB, and up to 135 dB. The ambient noise level when there were no ferried or other significant noise sources identified nearby, the levels were generally less than 110 dB (above 250 Hz).

These underwater noise measurements indicate that the overall noise level in the Yarra is dominated by low frequency noise and overall noise levels were found to be between 136-149 dB L_{Zeq} .
