Melbourne Metro Rail Project

MMR-AJM-PWAA-RP-NN-000832

**Aquatic Ecology and River Health Impact
Assessment**

Melbourne Metro Rail Authority

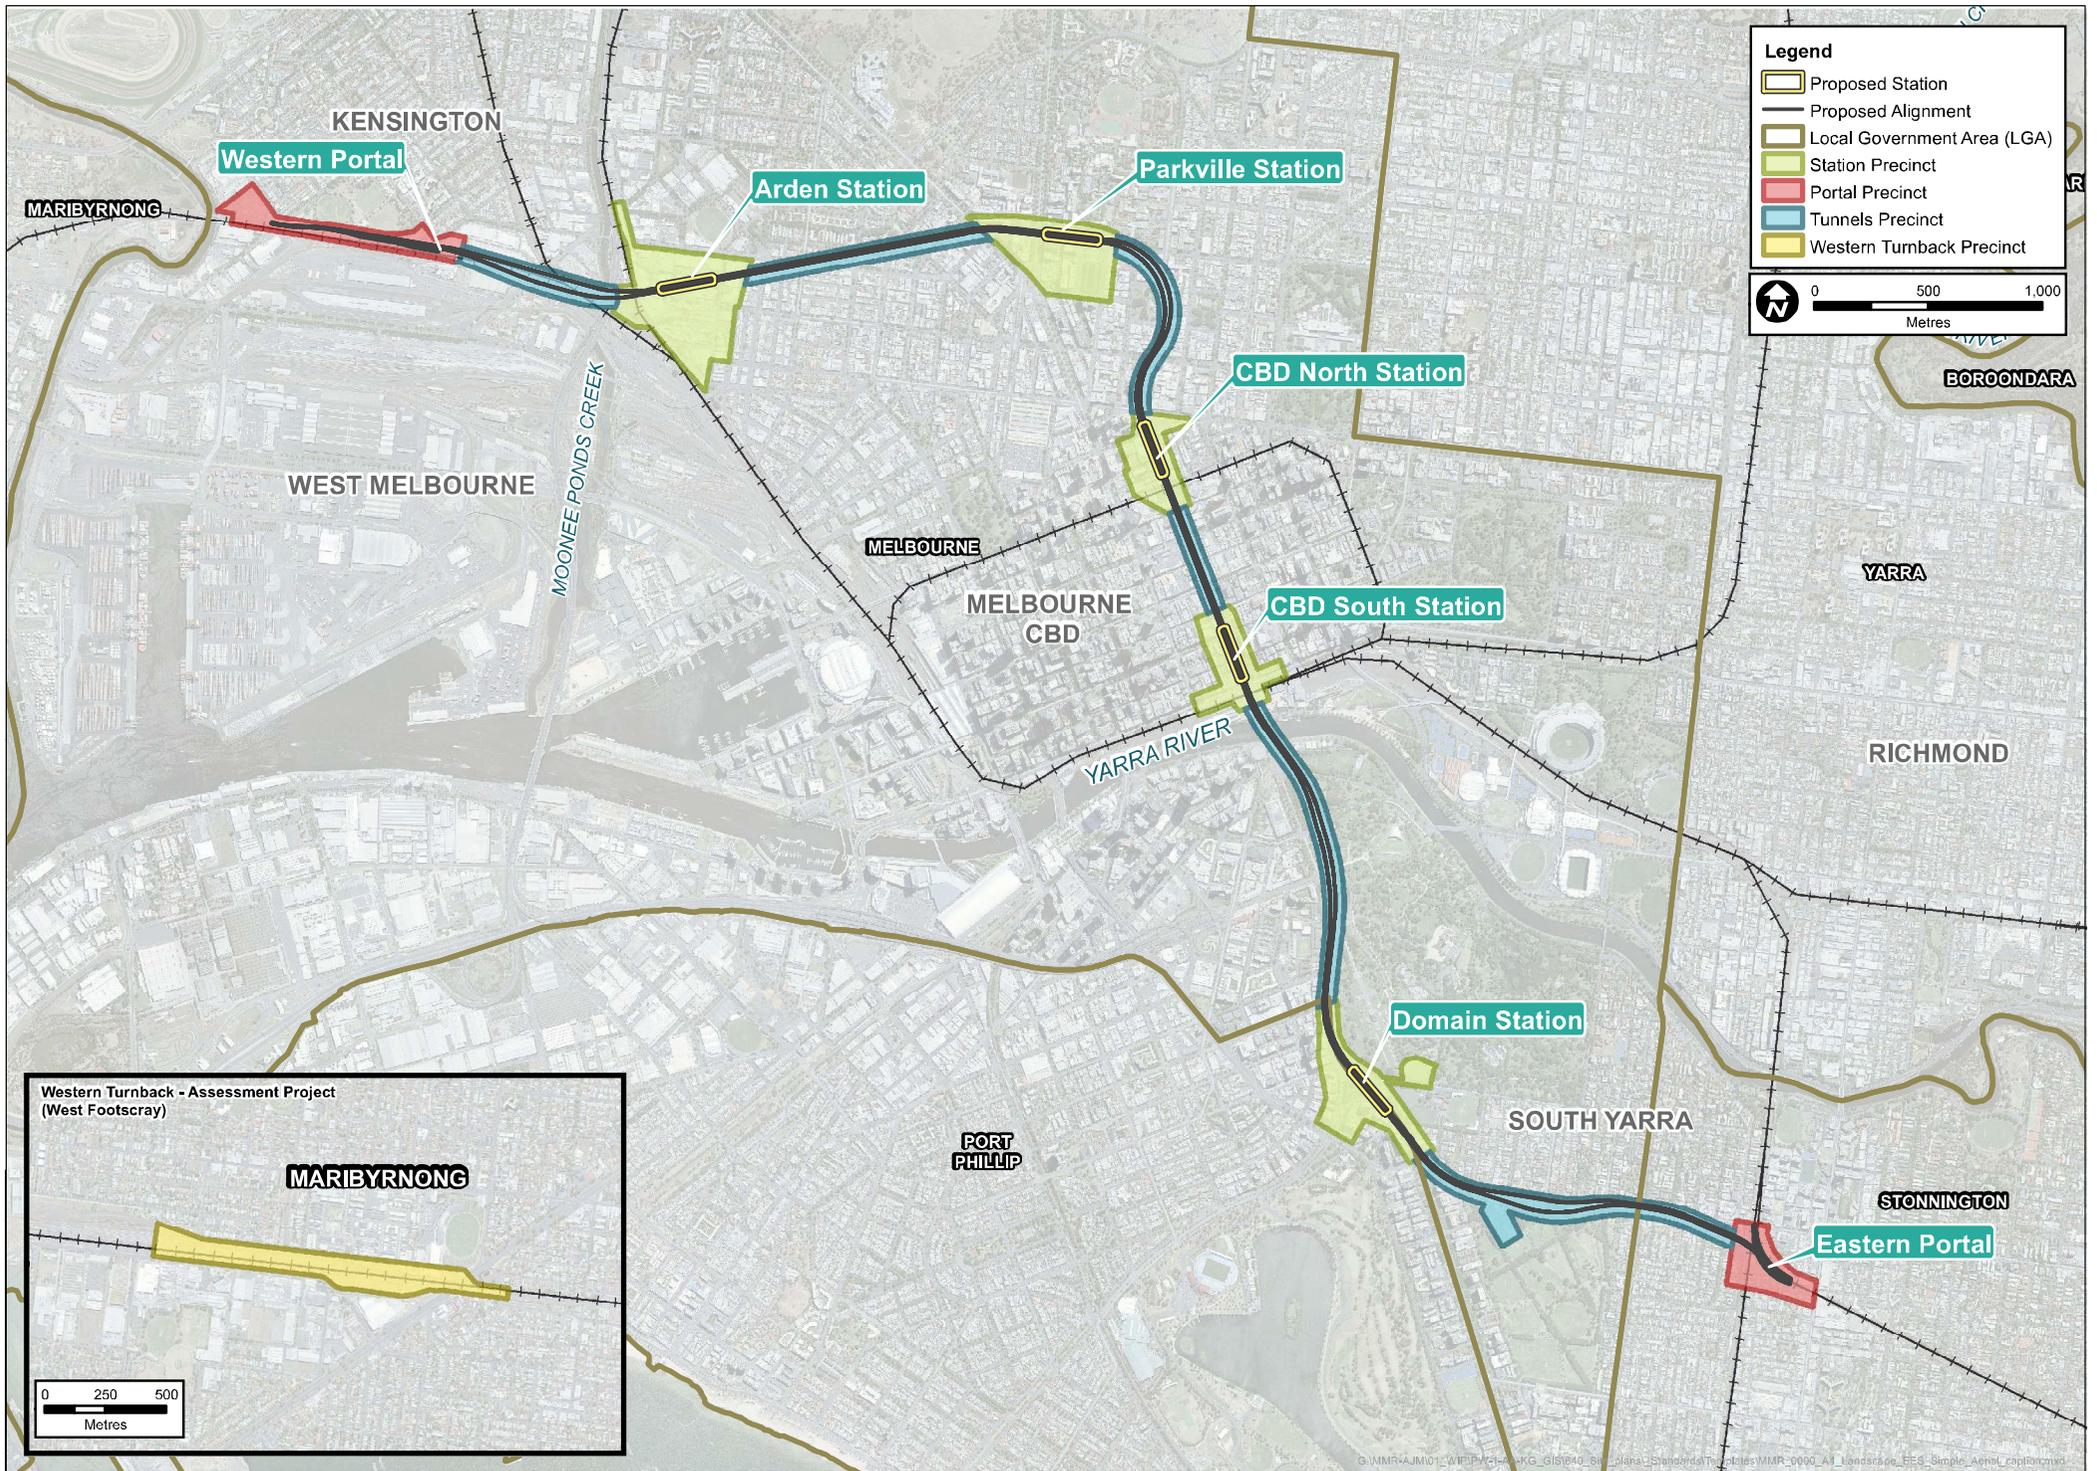
Figure 1-1 Melbourne Metro precincts

The nine precincts are shown in Figure 1-1.

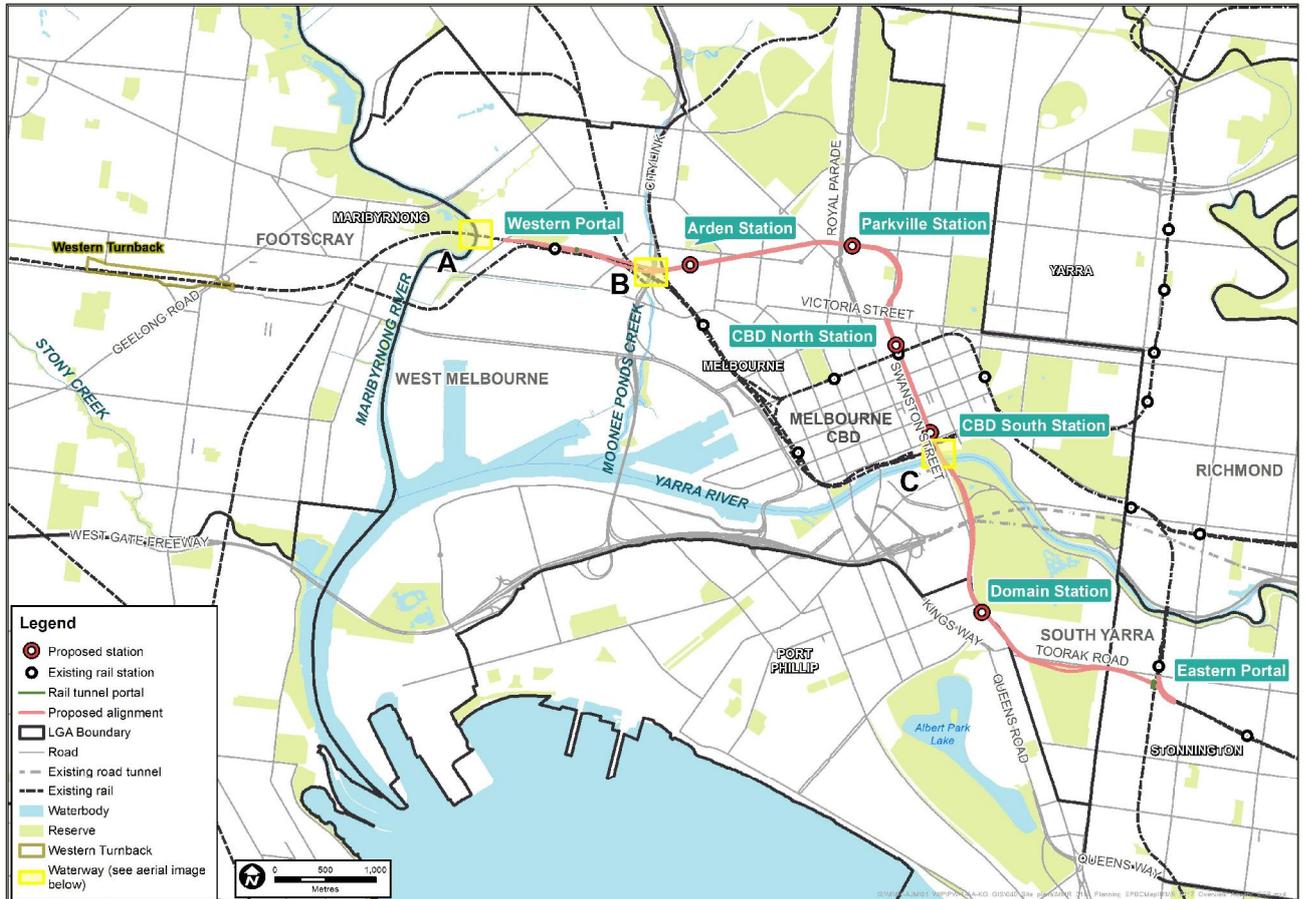
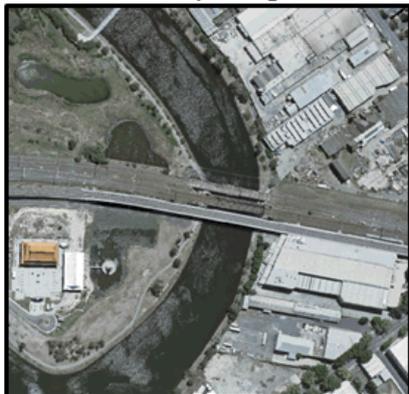
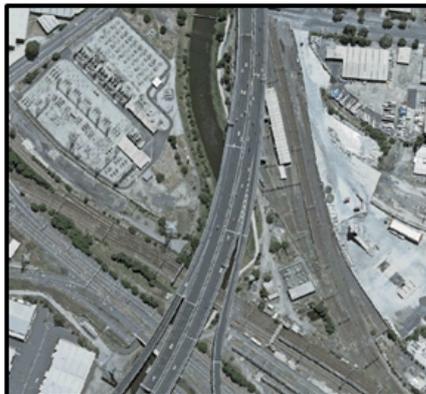
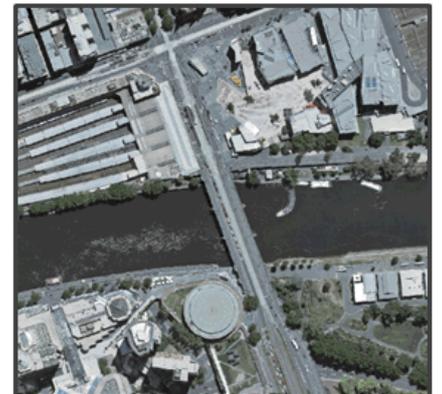
Figure 1-2 Site map showing waterways in relation to the Concept Design

The focus for this assessment is the Yarra River, Maribyrnong River and Moonee Ponds Creek in the vicinity of the project boundary (Figure 1-2). The study area itself extends along the entire alignment because of the possibility that stormwater runoff from portal and station precincts could enter the stormwater drainage system and ultimately discharge to the waterways listed above and also to Stony Creek and Albert Park Lake via the stormwater drainage system.

A – Maribyrnong River

B – Moonee Ponds Creek

C – Yarra River

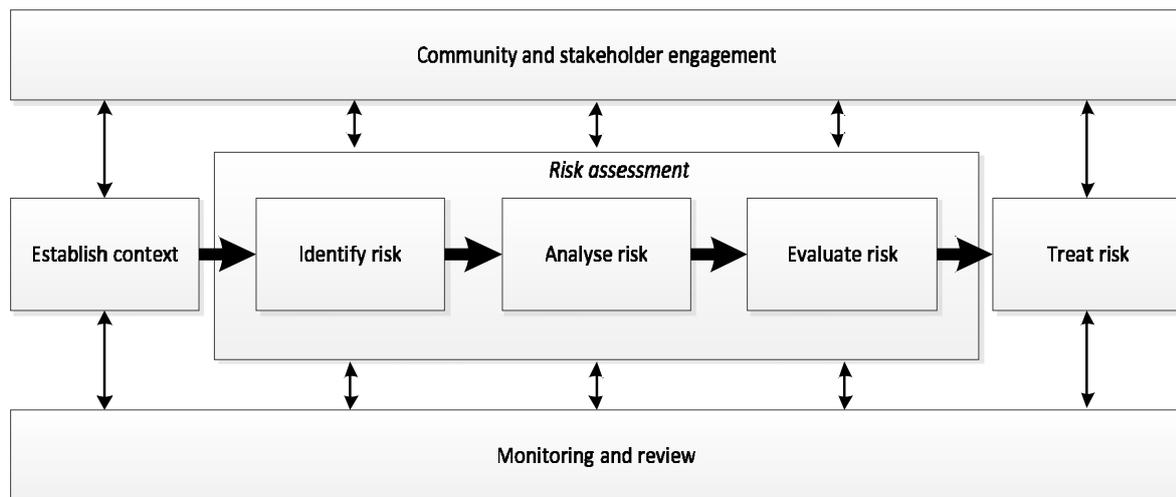
Figure 4-1 Overview of AS/NZS ISO 31000-2009 Risk Process

The overall risk assessment process adopted was based on AS/NZS ISO 31000:2009, as illustrated in Figure 4-1.

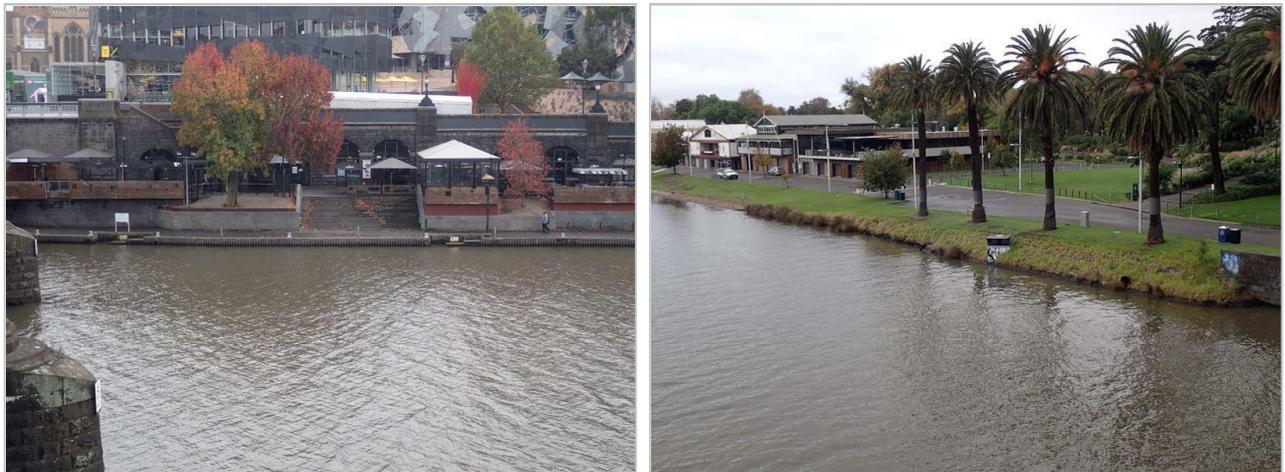
Figure 5-1 Vegetation present on the north (right) and south (left) banks of the Yarra River

The northern bank of the Yarra River in the area upstream of the Princes Bridge is a bluestone block construction and does not support any aquatic macrophytes or littoral vegetation. The southern bank supports cultivated lawn with some littoral/emergent macrophytes, namely spiny rush (*Juncus acuta*) present along the river's edge (refer to Figure 5-1). Spiny rush is an introduced plant that is a declared noxious weed in Victoria. The overall aquatic habitat at this location is limited, with the small amount of fringing vegetation not likely to provide high habitat value for aquatic species.

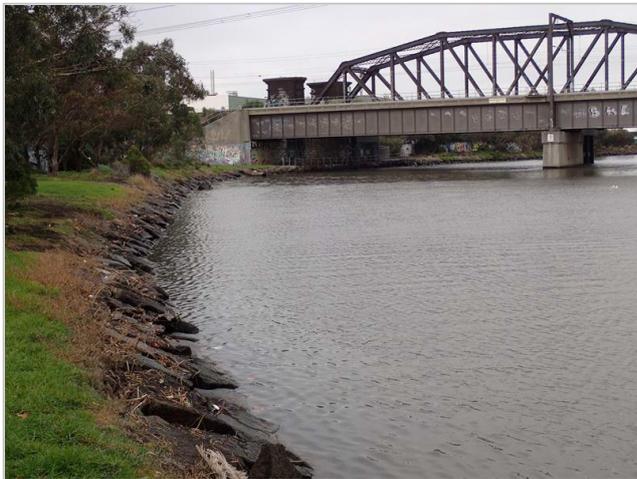
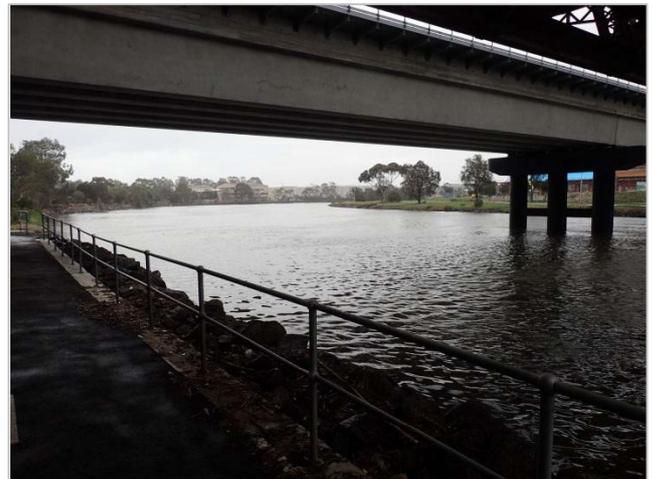
Figure 5-2 Maribyrnong River west of the Melbourne Metro area

emergent macrophytes in this area and the rock embankments appear to have been sprayed with herbicide to control weed growth (evidenced by the brown, dead grass along the top edge of the rocks).

An inspection of the waterway was carried out on 14 May 2015. Visual assessments of the condition of the bed and bank were carried out near the project alignment. The purpose of the assessment was to confirm the presence and quality of aquatic habitat.

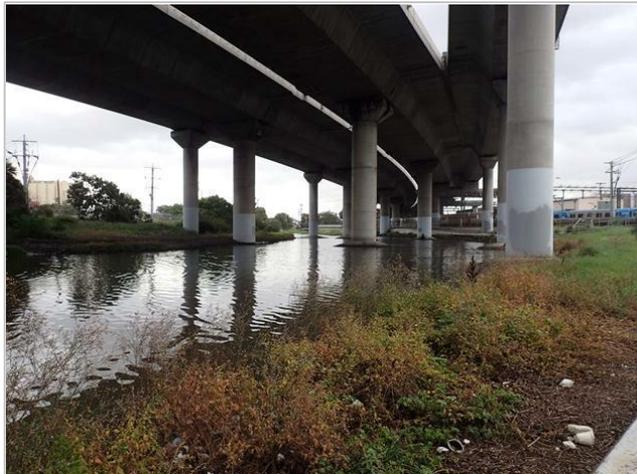
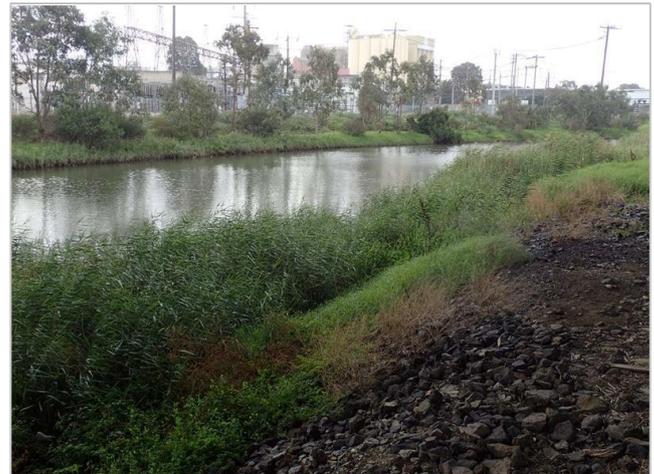
Figure 5-3 Vegetation present at the Moonee Ponds Creek

The riparian zone at Moonee Ponds Creek within the study area is made up primarily of weedy shrubs with no obvious aquatic macrophytes. The majority of the channel is shaded in this area by the CityLink tollway with limited instream habitat (Figure 5-3).

Upstream of the alignment, and away from the shading by the tollway, the channel is fringed by emergent macrophytes, mostly common reed (*Phragmites australis*). These relatively large reed beds may provide habitat for small-bodied fish, aquatic macroinvertebrates, common amphibian species and small birds, and represent an important habitat in the urban landscape.

The left panel shows bank condition at the alignment point; the right panel shows bank condition further upstream and away from the alignment point

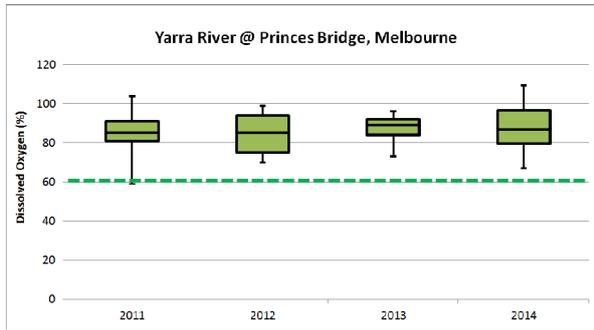
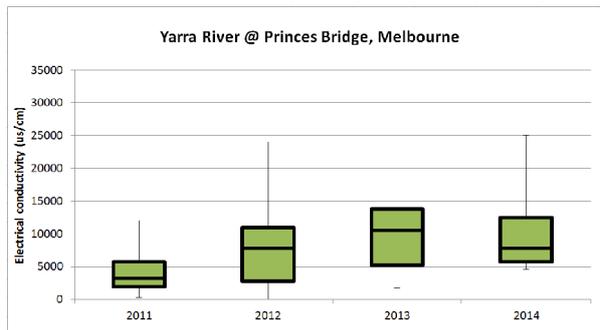
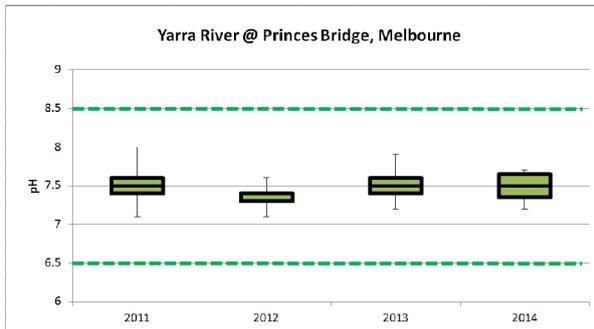
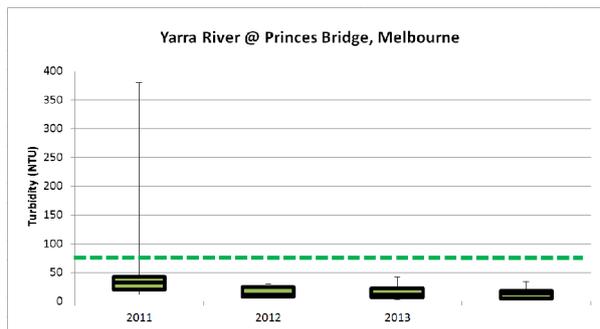
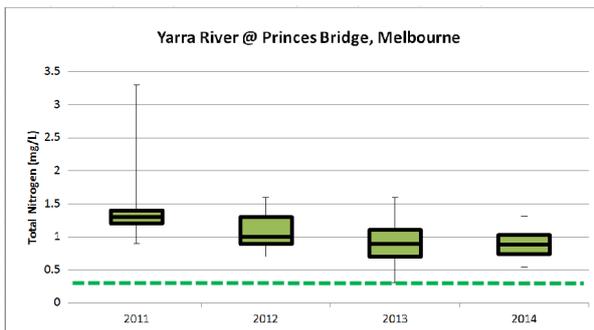
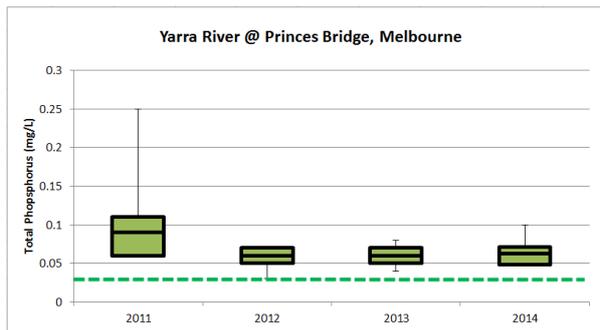
Water quality measured in the Yarra River at Princes Bridge Melbourne in 2011-2014. Boxplot: Box ends equal 25th and 75th percentile, mid line equals the 50th percentile. Whiskers equal maximum and minimum values recorded. Green dashed line equals the relevant guideline concentrations (from SEPP or ANZECC)

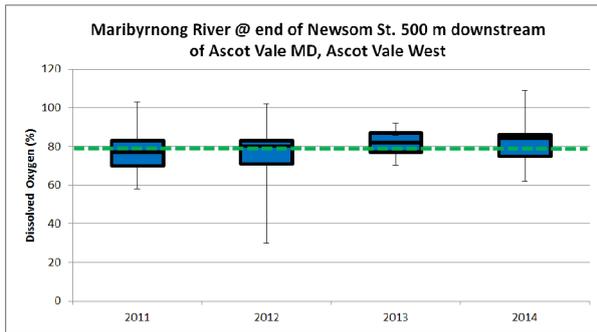
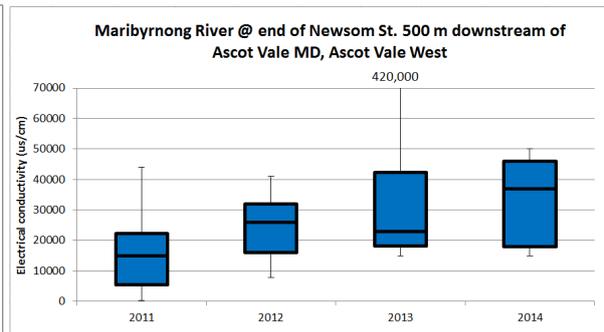
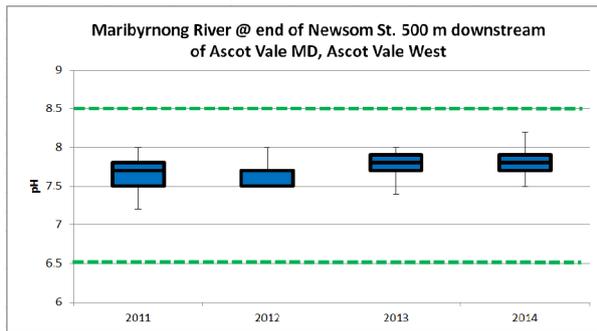
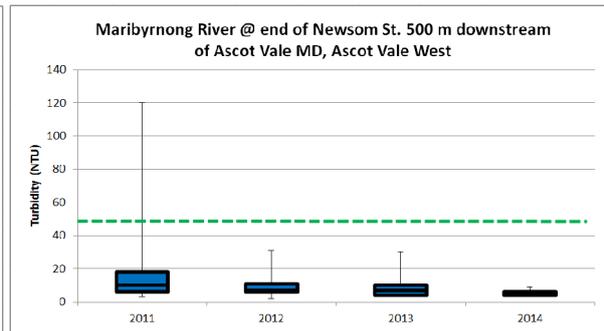
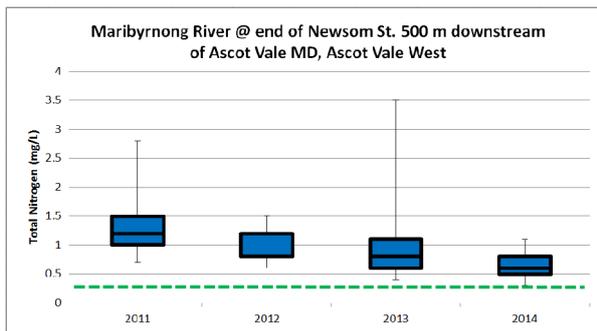
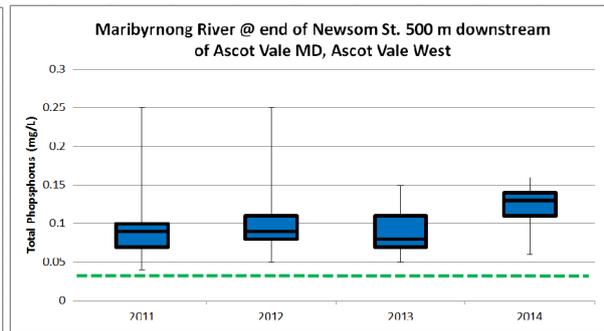
Water quality measured in the Maribyrnong River at the end of Newsom Road, Ascot Vale in 2011, 2012, 2013 and 2014. Boxplot: Box ends equal 25th and 75th percentile, mid line equals the 50th percentile. Whiskers equal maximum and minimum values recorded. Green dashed line equals the relevant guideline concentrations (from SEPP or ANZECC (2000)).

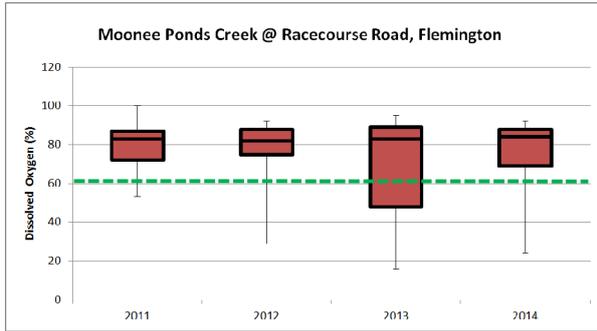
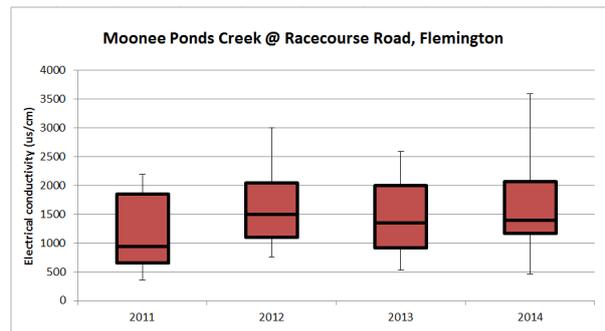
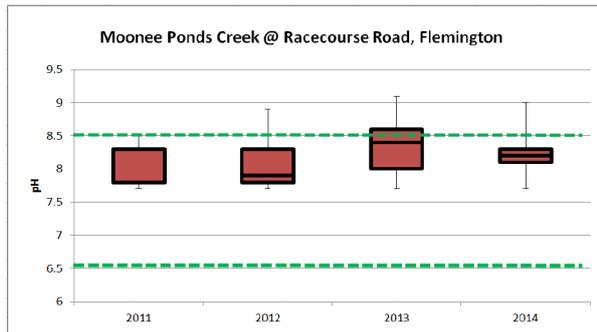
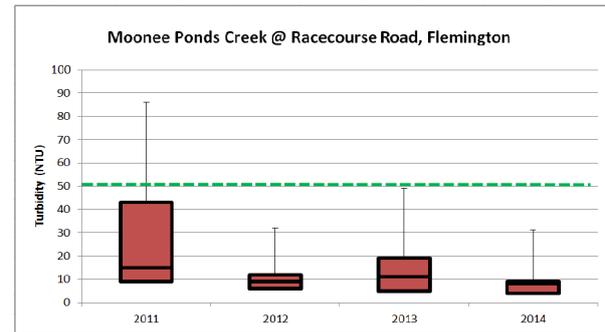
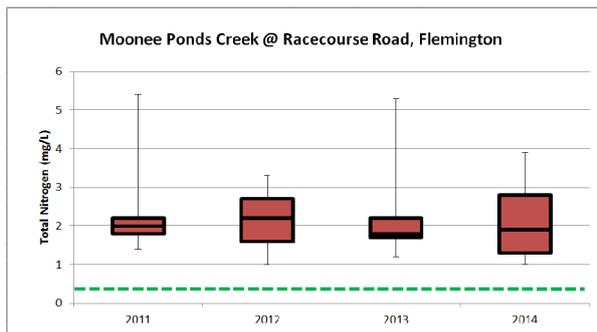
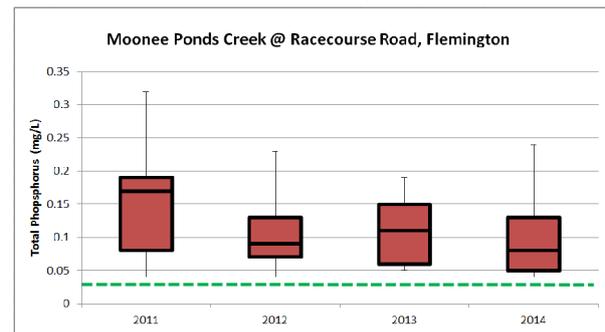
Water quality measured in Moonee Ponds Creek at Racecourse Road, Flemington in 2011, 2012, 2013 and 2014. Boxplot: Box ends equal 25th and 75th percentile, mid line equals the 50th percentile. Whiskers equal maximum and minimum values recorded. Green dashed line equals the relevant guideline concentrations (from SEPP or ANZECC (2000)).

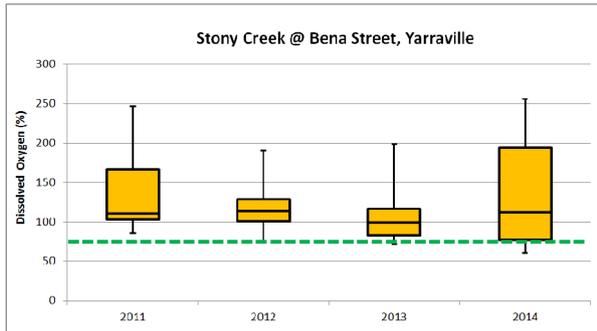
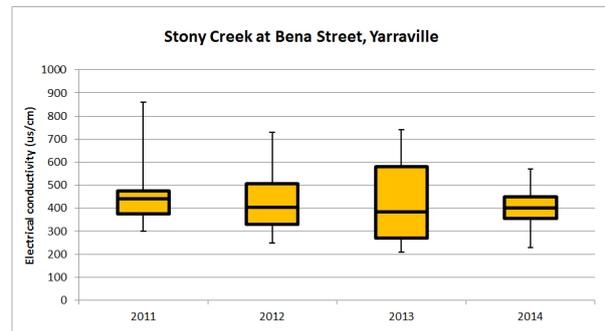
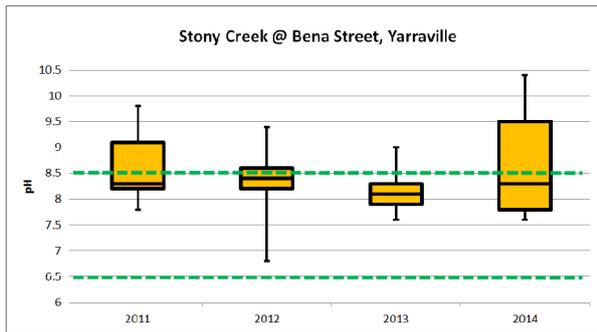
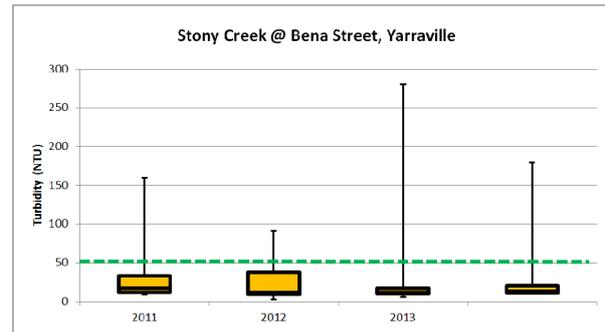
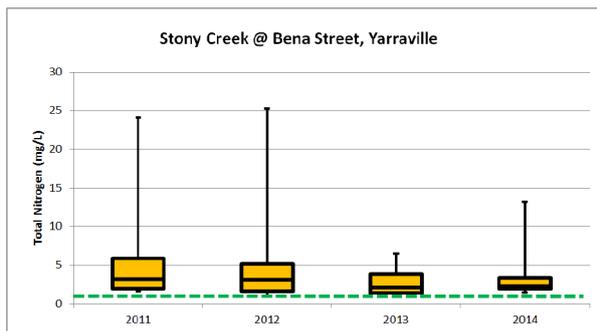
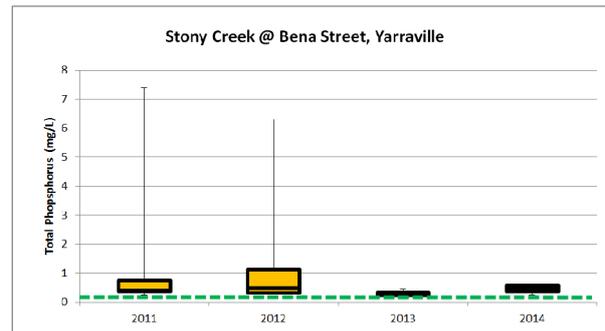
Water quality measured in Stony Creek at Bena Street, Yarraville in 2011, 2012, 2013 and 2014. Boxplot: Box ends equal 25th and 75th percentile, mid line equals the 50th percentile. Whiskers equal maximum and minimum values recorded. Green dashed line equals the relevant guideline concentrations (from SEPP or ANZECC (2000)).
