Final Report

Princes Highway Duplication Winchelsea to Colac EPBC Preliminary Documentation

VicRoads (Geelong Ring Road Project)

October 2015

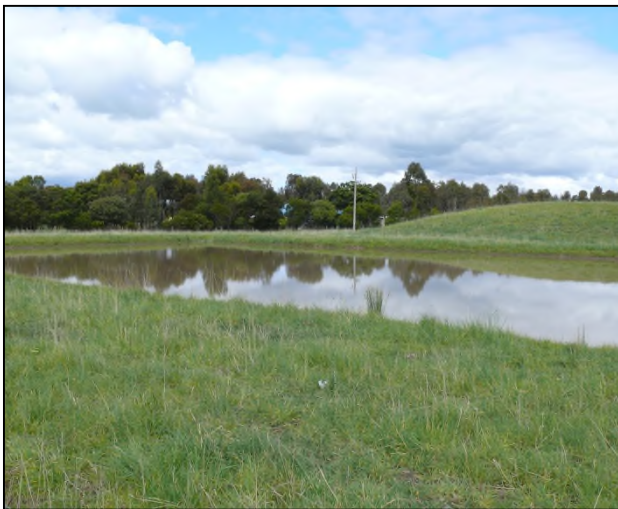
Plate 1: Low quality waterbody within the project alignment with little native terrestrial or aquatic vegetation (Source: Ecology and Heritage Partners Pty Ltd).

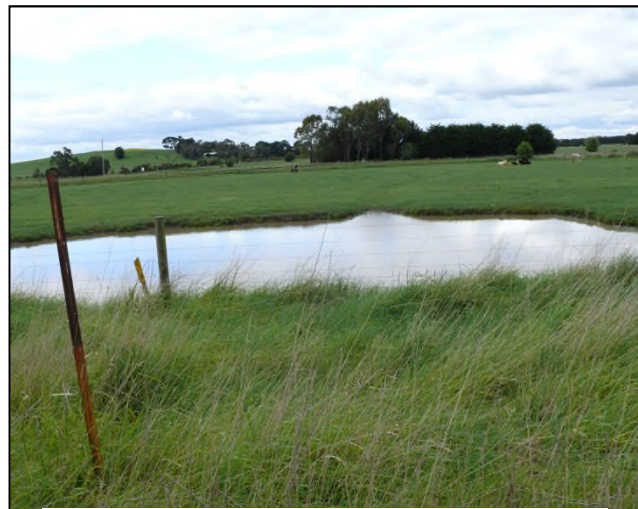
Plate 2: Low quality waterbody within the project alignment subject to grazing (Source: Ecology and Heritage Partners Pty Ltd).

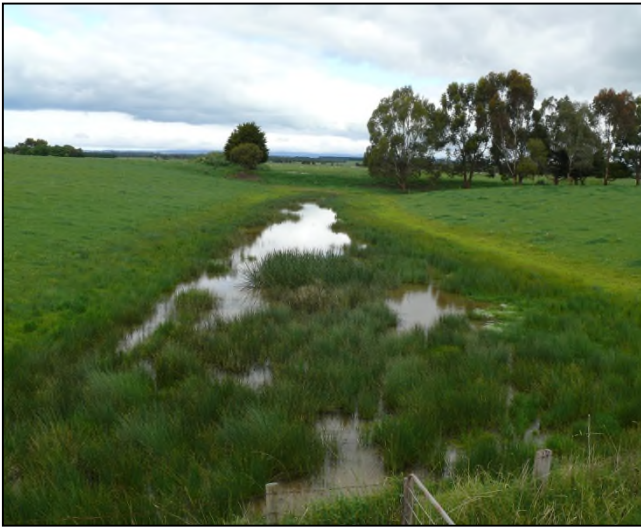
Plate 3: 52DL south of the Princes Highway (Ecology and Heritage Partners Pty Ltd).

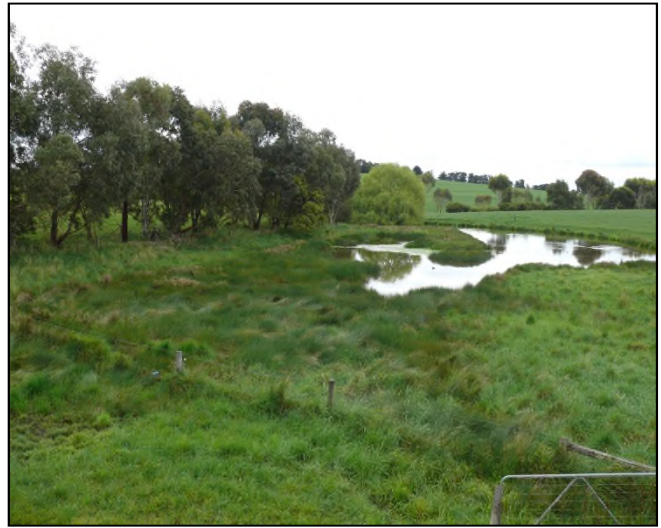
Plate 4: 52a north of the Princes Highway 2011 (Ecology and Heritage Partners Pty Ltd).

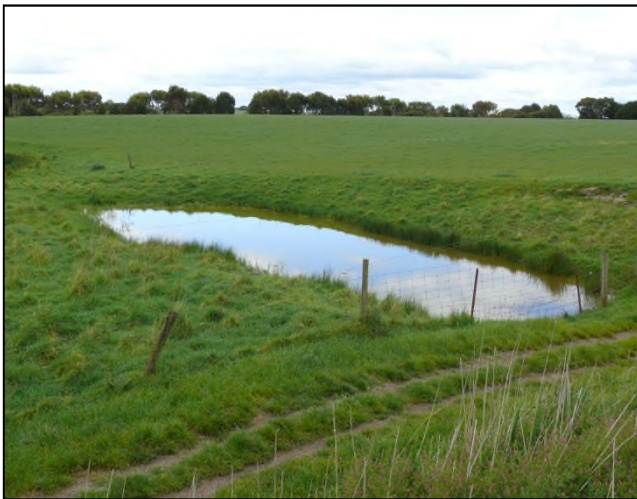
Plate 5: 51a north of the Princes Highway (Ecology and Heritage Partners Pty Ltd).

Sheepwash Creek forms a tributary of Birregurra Creek although the flow has been halted through the creation of a stock crossing running under the Princes Highway which has the stopped natural water flows under normal conditions. A large culvert will be placed on the northern side of the Princes Highway to duplicate the highway (Plate 4). While there are permanent areas of water both north and south of the Princes Highway, there are likely to be minimal impacts to these habitats during construction (Plates 3 and 4). Waterbody 51a will be removed during construction; however, appropriate mitigation measures will be implemented (Plate 5).

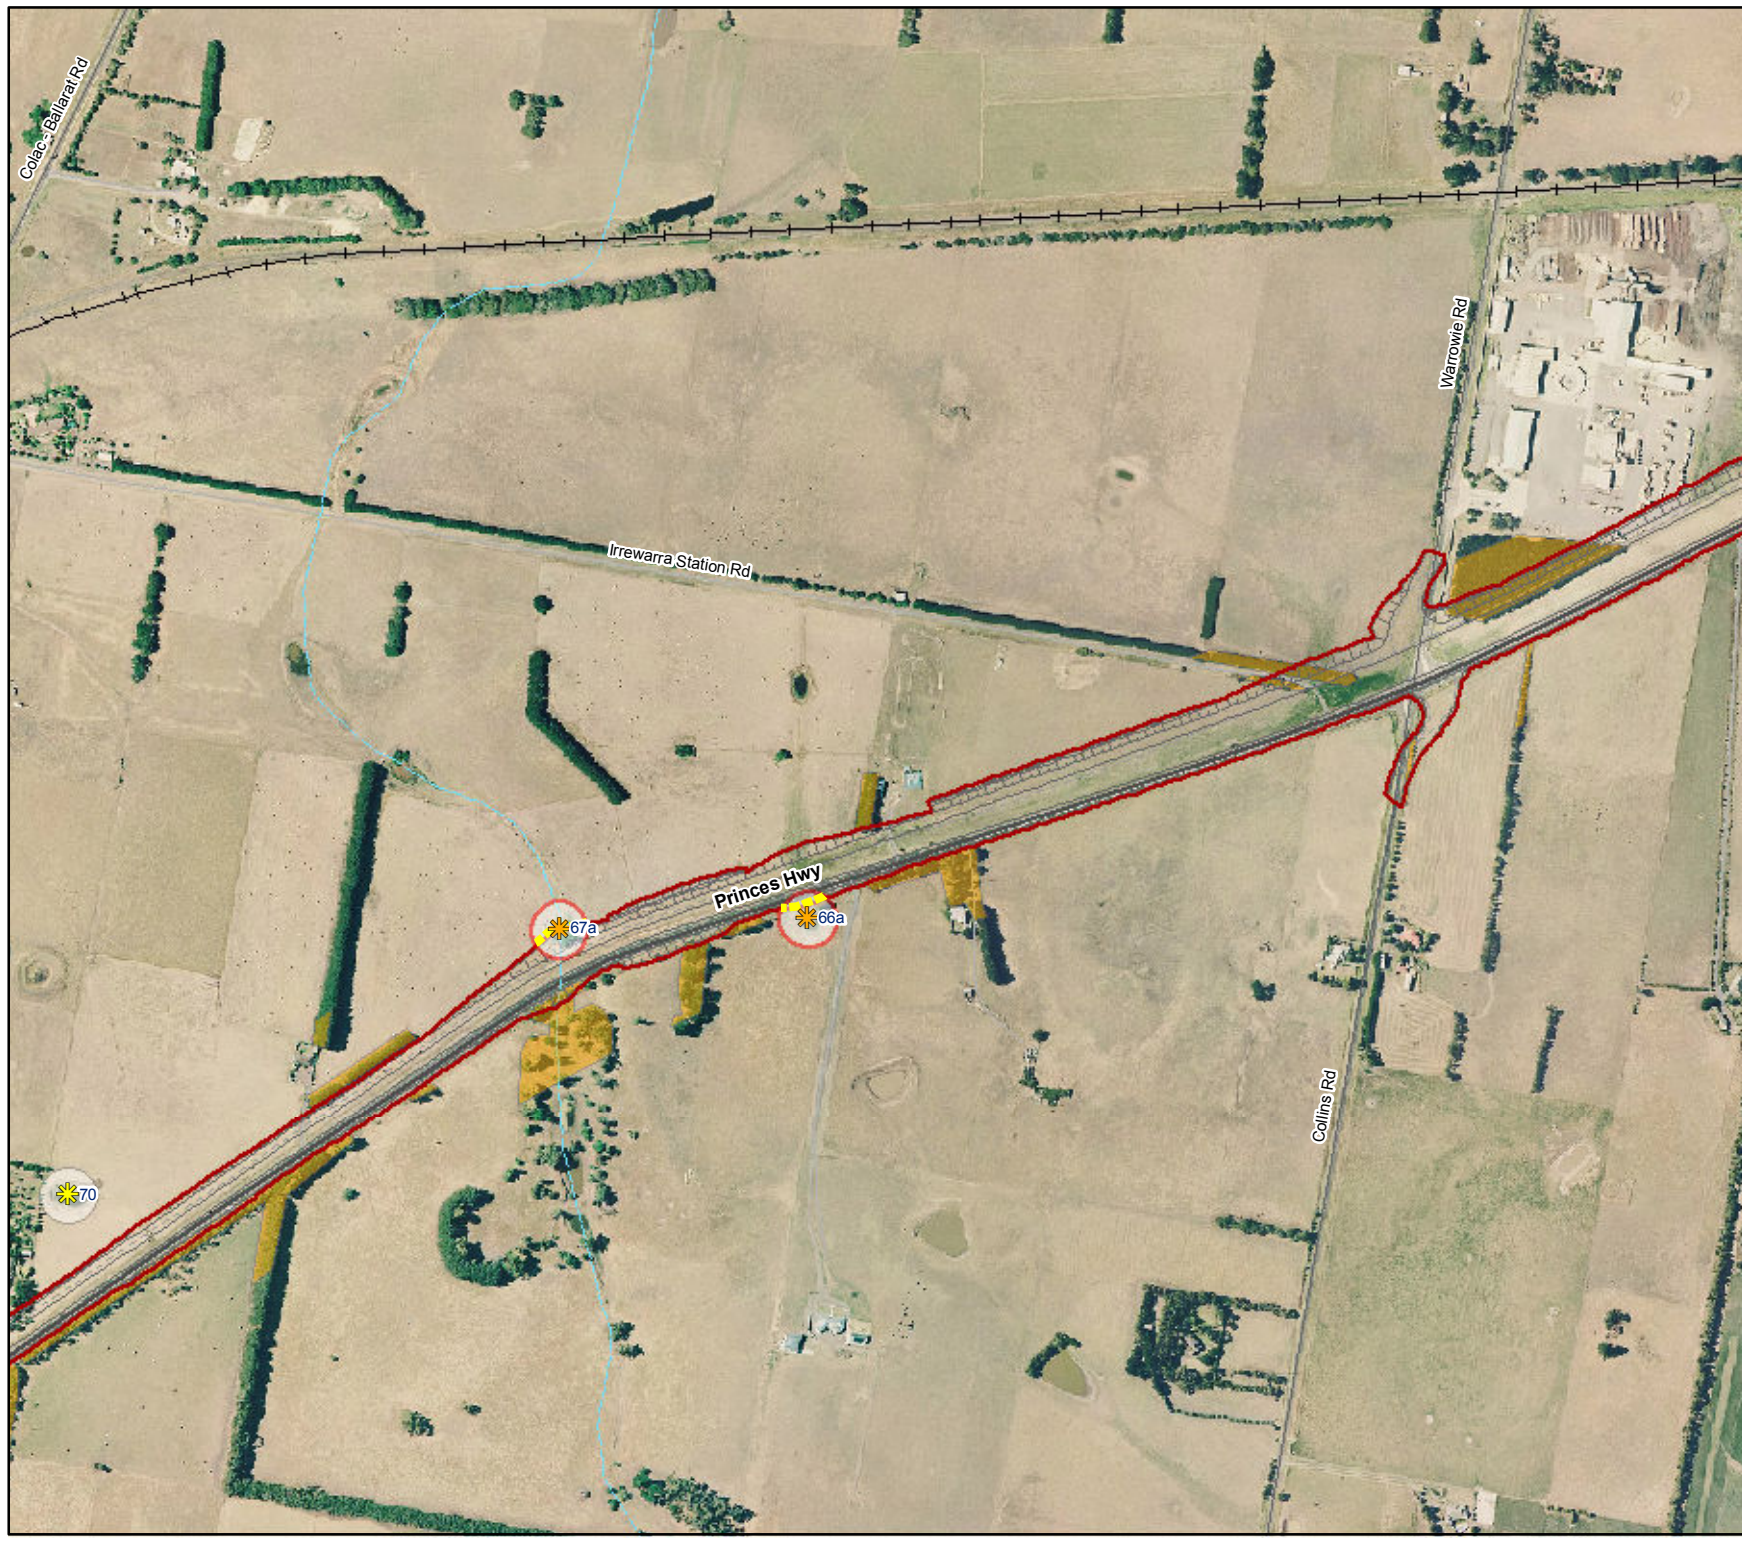
Figure 2w
 Fauna habitat impacted within the study area
 Princes Highway Duplication
 Winchelsea to Colac

- Construction Footprint (with 2m buffer)
- Vegetation**
- Planted trees and shrubs
- Fauna Habitat**
- * Moderate Quality Waterbody
- * Low Quality Waterbody
- Impact**
- Waterbody not impacted (pre-clearance survey required)
- Waterbody not impacted (no pre-clearance surveys required)
- No Go Zone Fencing

NOTE: Vegetation mapping is based on a site assessment undertaken in October 2011. The boundary of mapped vegetation patches identified may vary over time due to seasonal variation in growth, decline, structural changes and/or natural regeneration due to changes in land management practice. Aerial photography is from 2007.

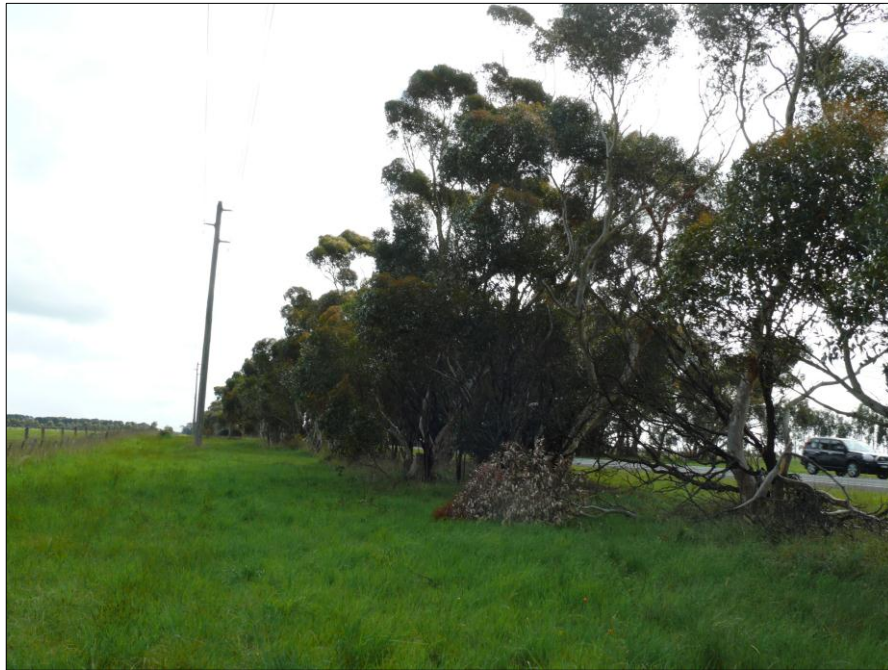
Plate 1. Example of roadside verges in the study area

Roadside verges supporting areas of native and non-native vegetation (e.g. Plate 1), and privately owned agricultural land supporting primarily non-native vegetation (e.g. Plate 2), dominate the study area (Figures 3a-3y).

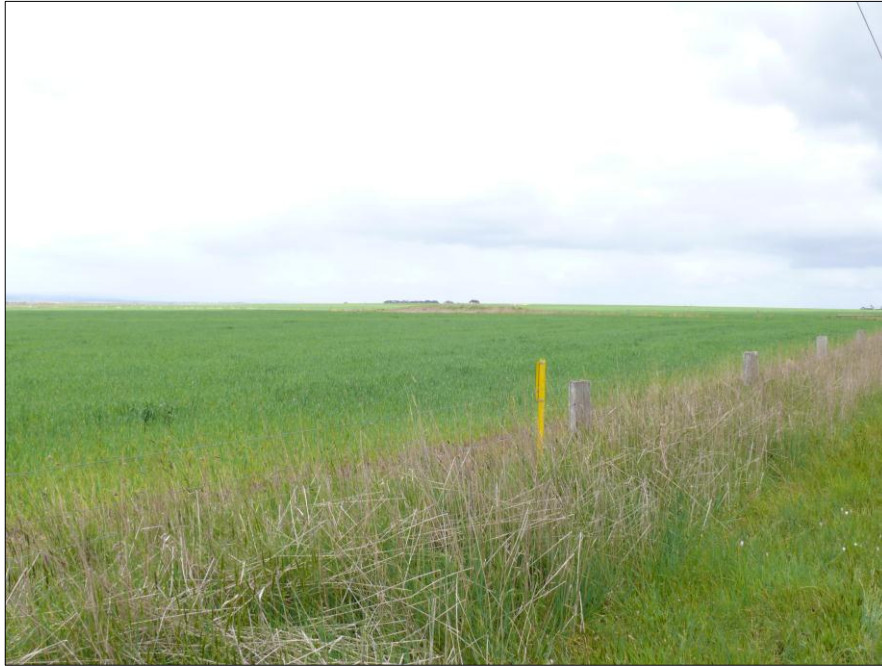
Plate 2. Example of agricultural landscape in the study area. Roadside reserve in foreground.

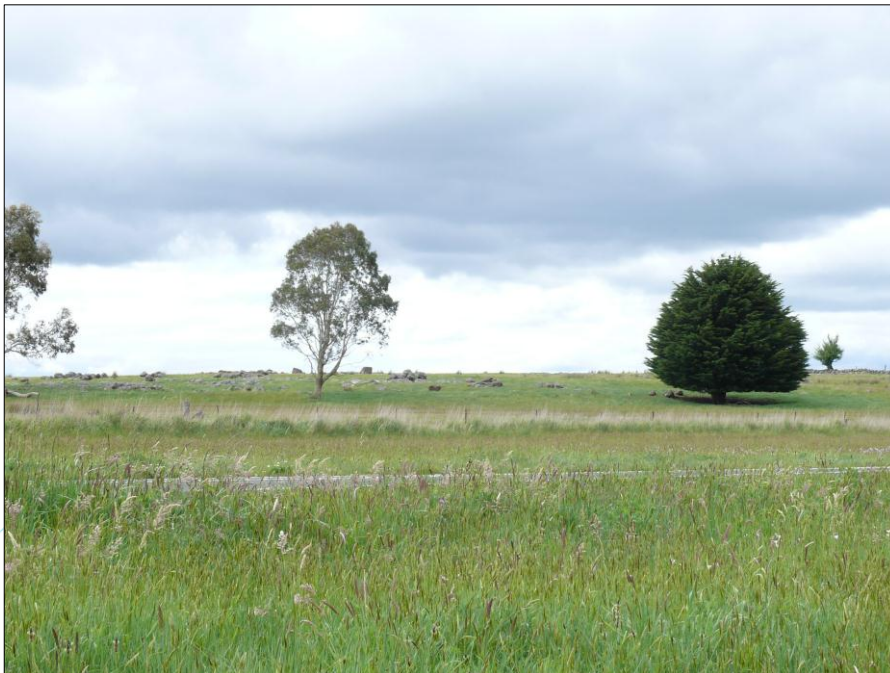
Plate 3. Example of area of embedded rock (in the background) present within the study area.

Areas of embedded rock and rock piles can also be found within the study area; however, most of these areas are lacking suitable refuge habitat (i.e. cracks in soil and native tussock grasses), are grazed by livestock or dominated by introduced vegetation (Plate 3; Figures 3a-3y).
