MORDIALLOC FREEWAY PROJECT

Independent Reviewer and Environmental Auditor

Quarterly Construction Audit

Report 2, June 2020

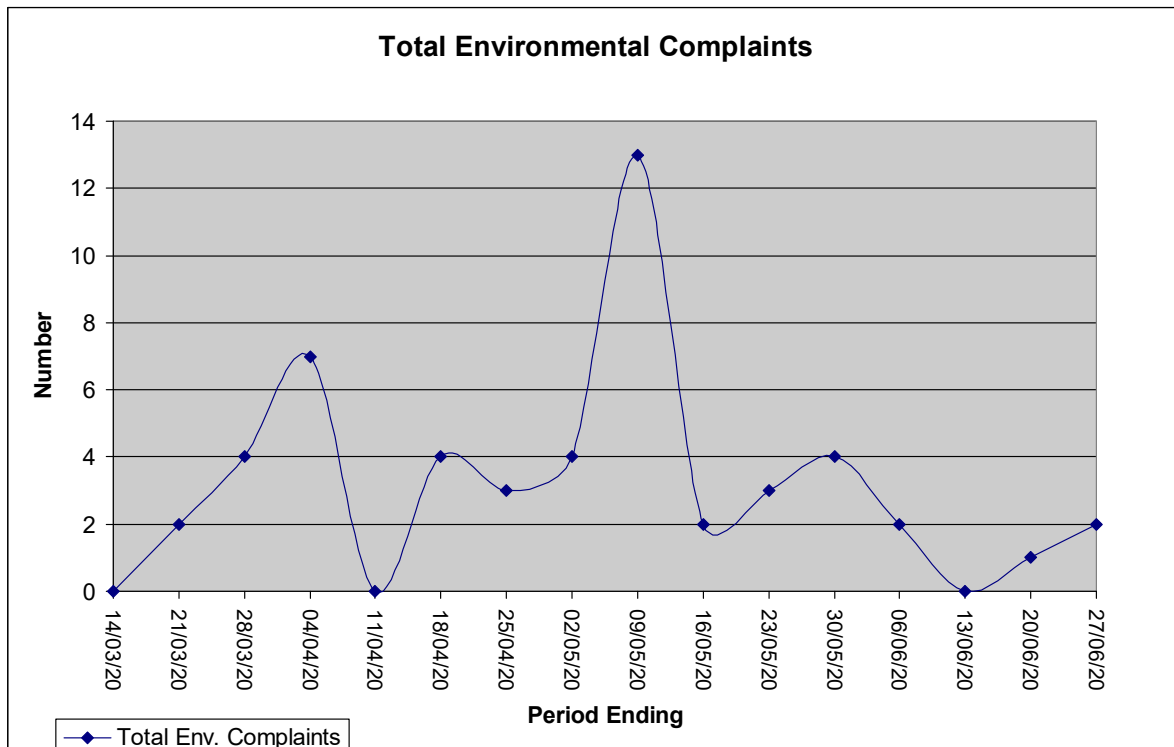
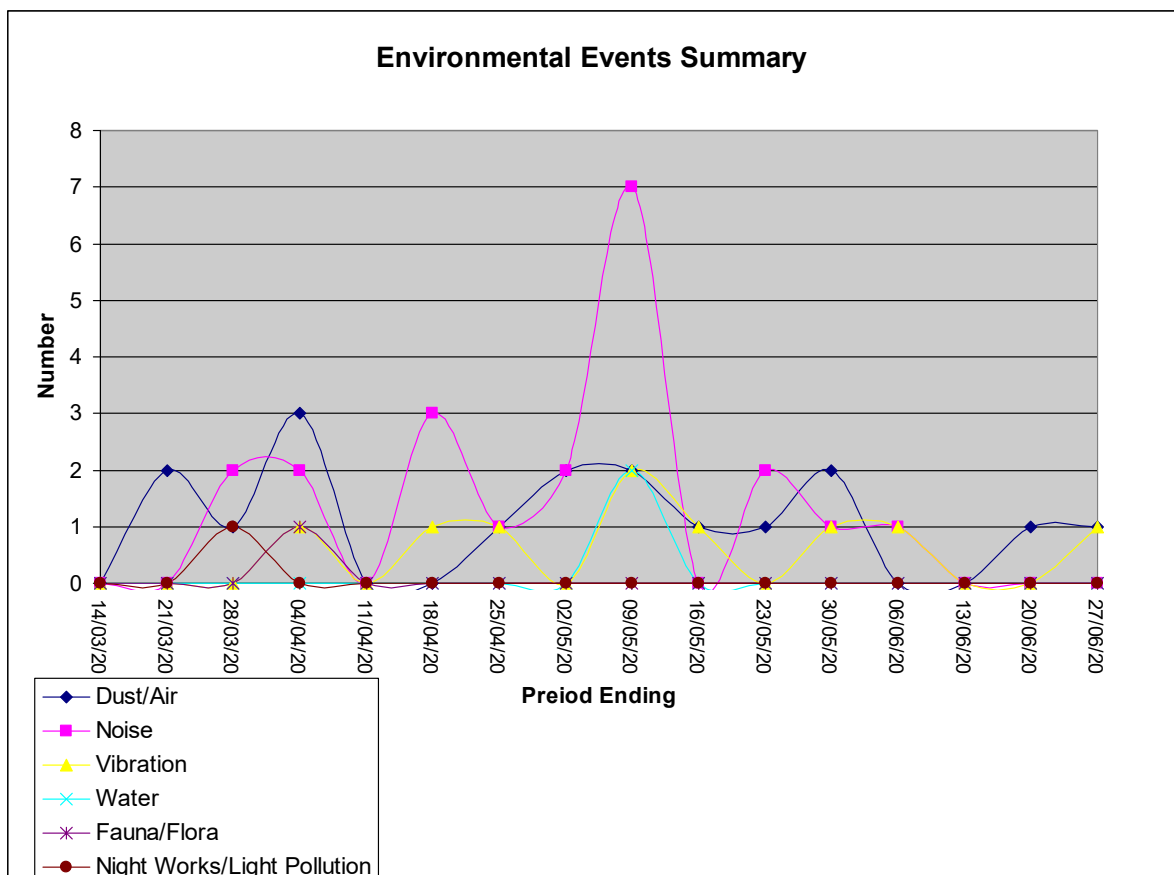
As can be seen in the above table, noise and dust events are the most frequent events. Of note, are the 7 noise complaints that occurred on the 8th May 2020. The complaints were all related to loud construction noise that extended into the Friday evening period (i.e. after 7 pm). Based on the number of noise complaints due to a single event, and in accordance with

it's complaint response procedure, MCDDJV implemented a full investigation of the event. A description of the incident is provided in Section 7 of this report.
