Yan Yean Road Upgrade – Stage 2:
Kurrak Road to Bridge Inn Road

Technical Report C

Arboriculture Assessment

17 July 2020

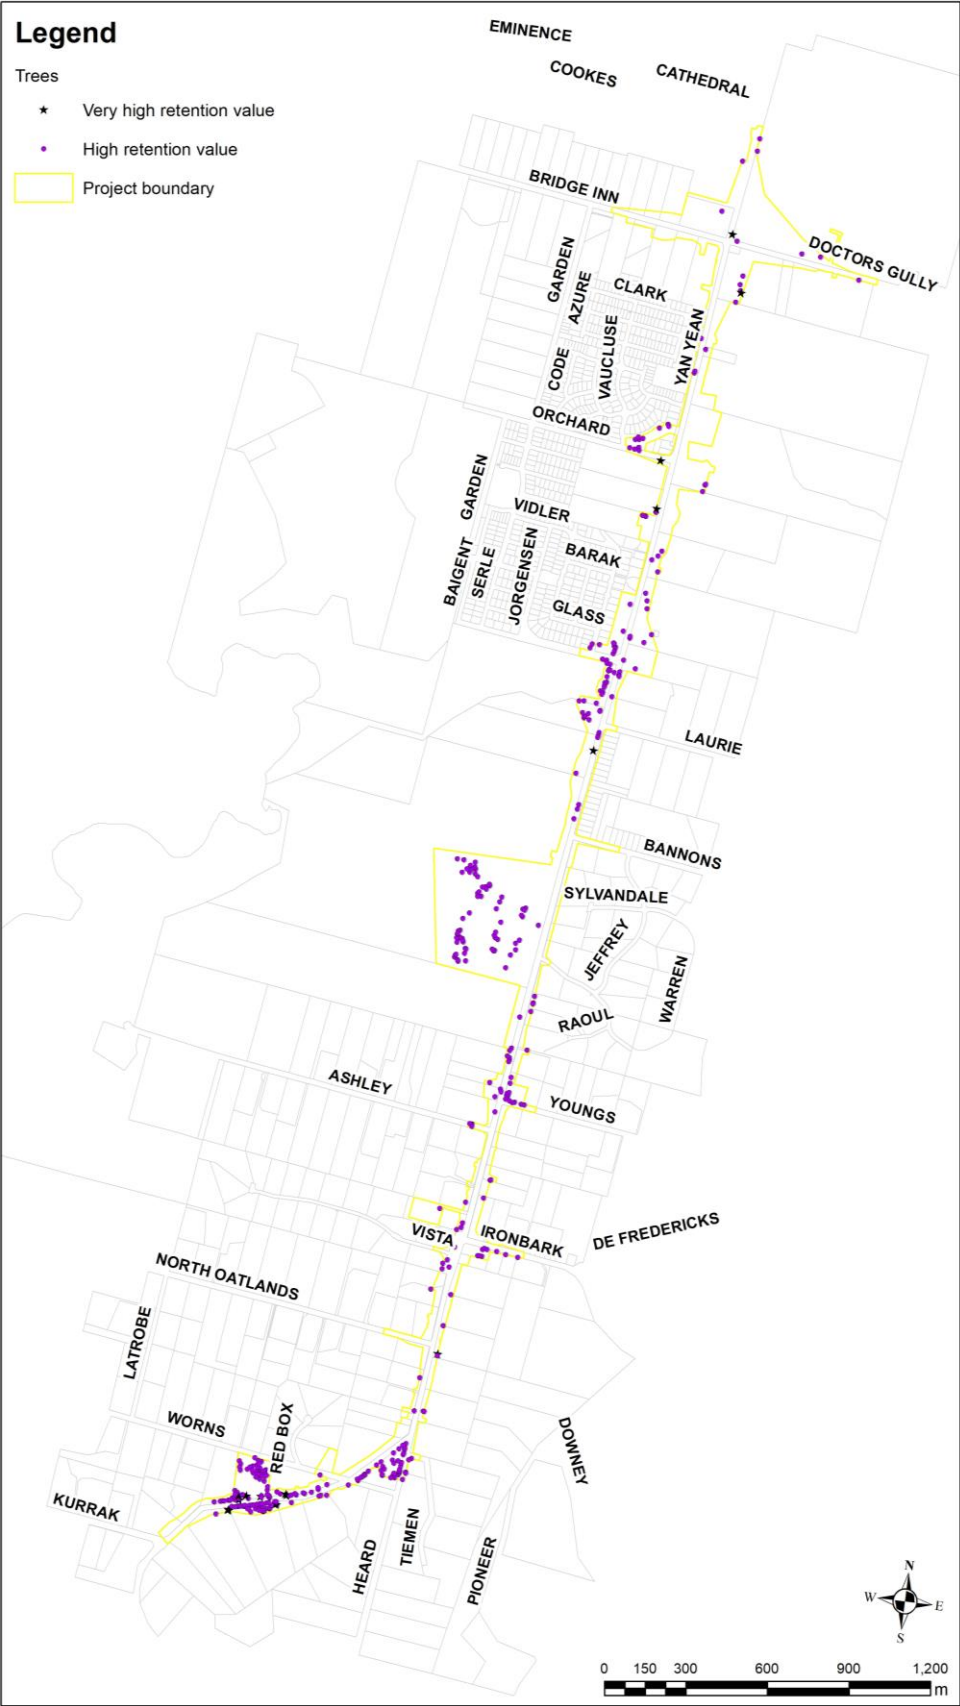
Figure 8: Trees assessed as very high retention value and high retention value at the project site

Figure 8 shows very high retention value trees across the subject site. All the trees assessed in this category are demonstrating fair to good health and structure and have 10-20 years or 20+ years of ULE. They should be retained and protected for their indigenous origin, habitat significance or large size.

A total of 346 trees were assessed as high retention value (Figure 8). Their retention is preferred, and the design should accommodate them wherever possible. Most of the specimens in this category are indigenous eucalypts.

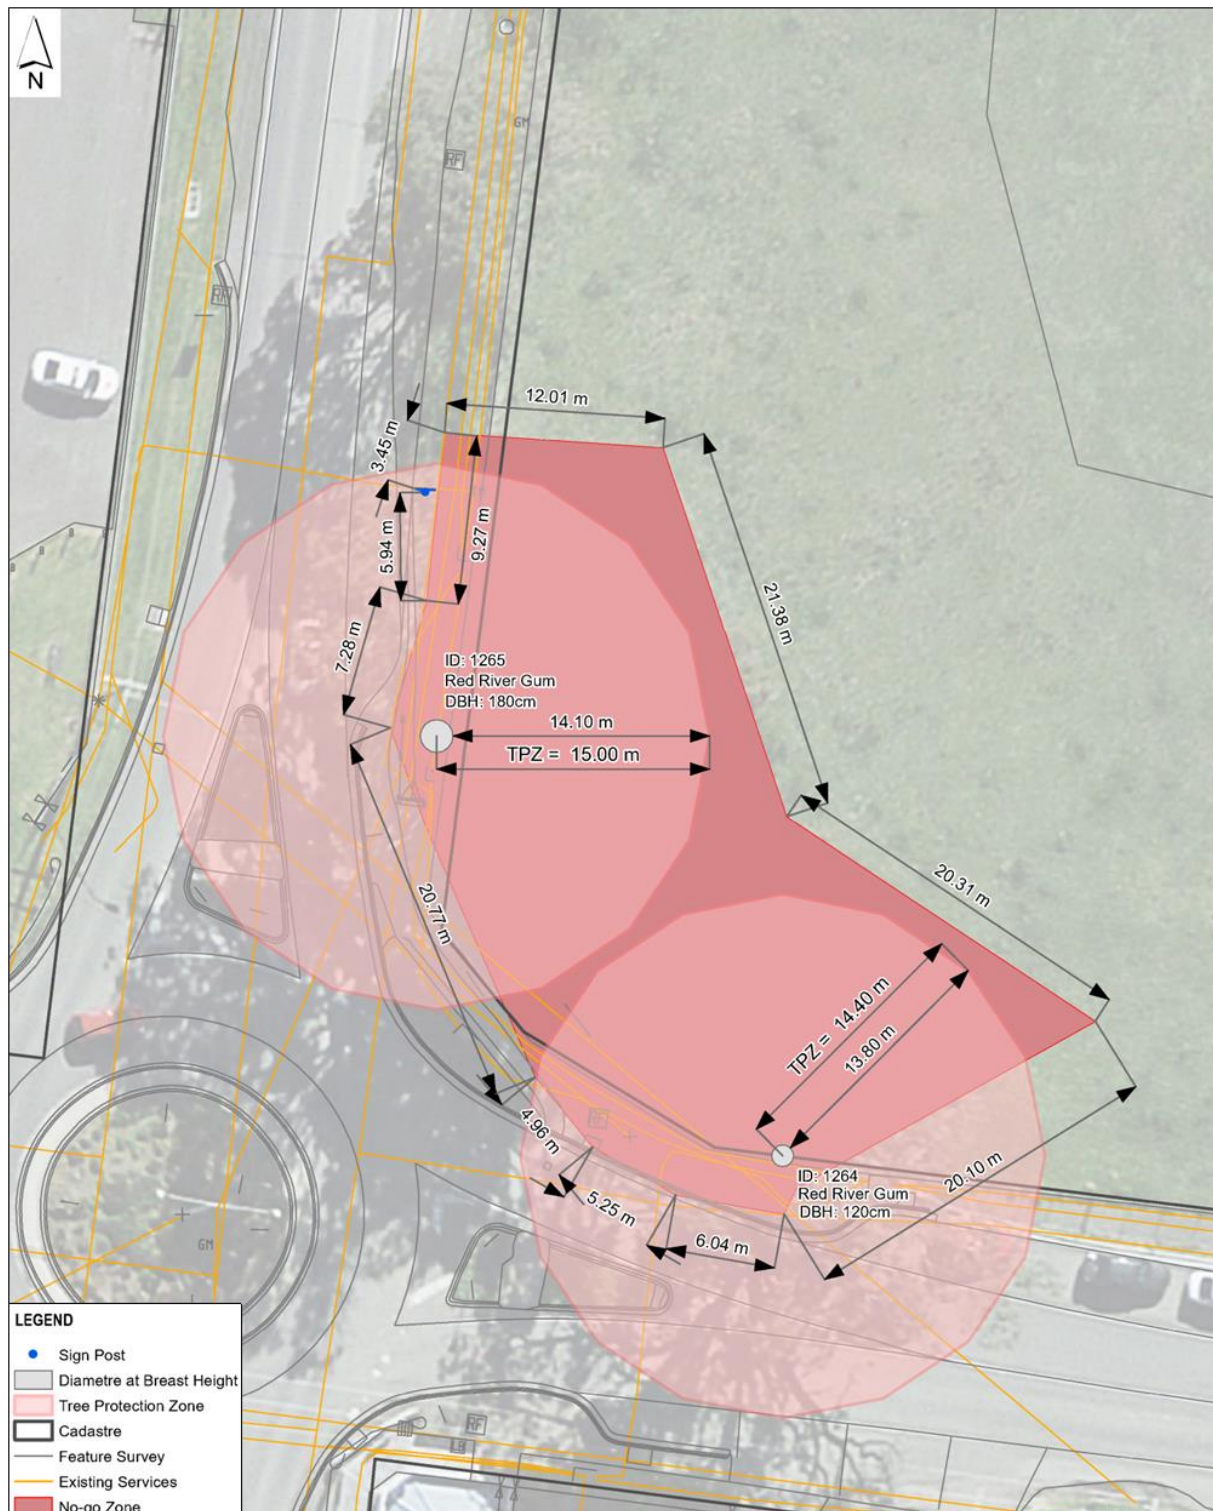
Appendix 6. Indicative Tree Protection Plan for Doreen Red Gums

Figure 14: Indicative tree protection Plan for two River Red Gum trees at Bridge Inn Road intersection.
