Assessment of proposed road design at  
the intersection of Yan Yean Road and  
Bridge Inn Road, Doreen

## **Root Investigation Report**

**Prepared For:** WSP

**28 May 2019**

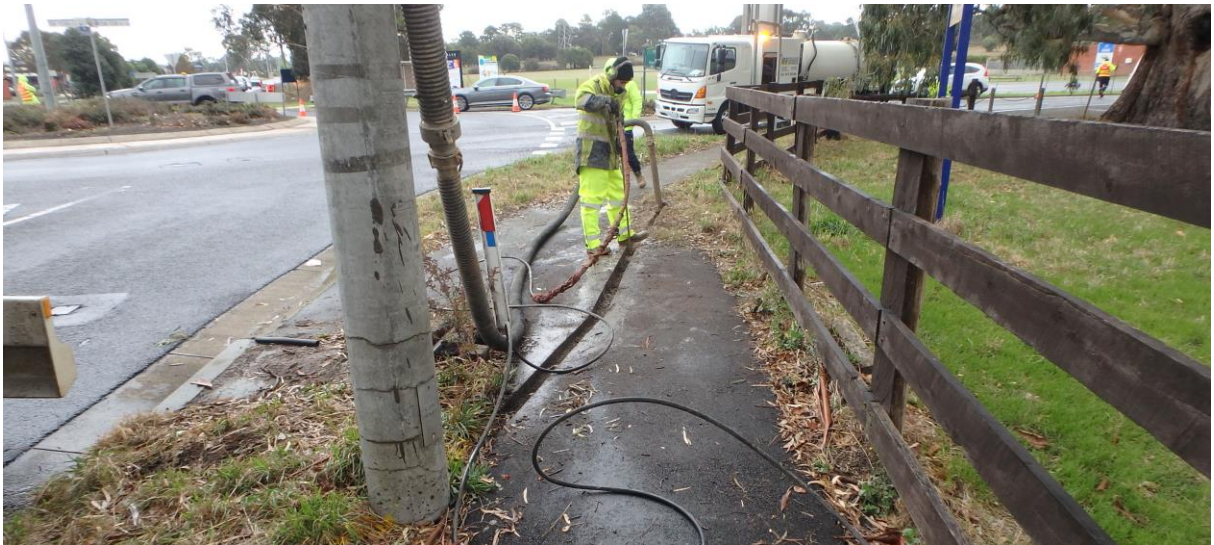
The hydro excavation was completed on Monday 27 May, 2019. Trenches were excavated to 600-800mm depth unless buried features precluded this (Figure 1 & Figure 2). The hydro excavation allows roots and utilities to be retained whilst excavating the soil and gravel.

Figure 1: Hydro excavation in action

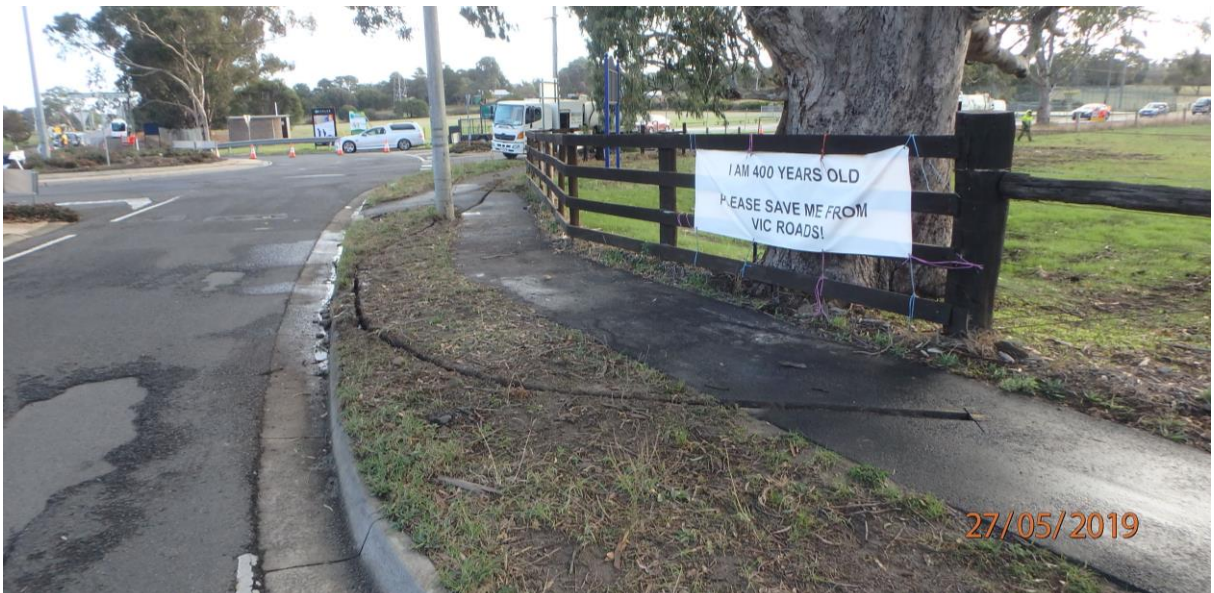
Figure 2: Completed slot trench.

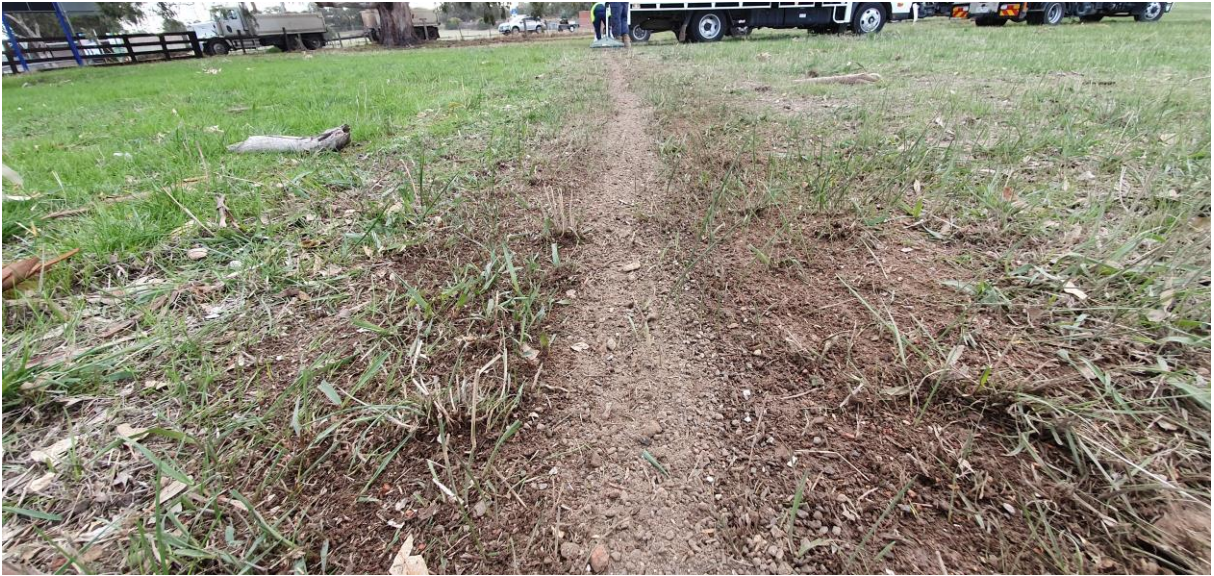
Following completion of the below ground assessments, the site was reinstated with crushed rock and cold mix asphalt or topsoil where required (Figure 3).

Figure 3: Reinstated trench within the paddock.

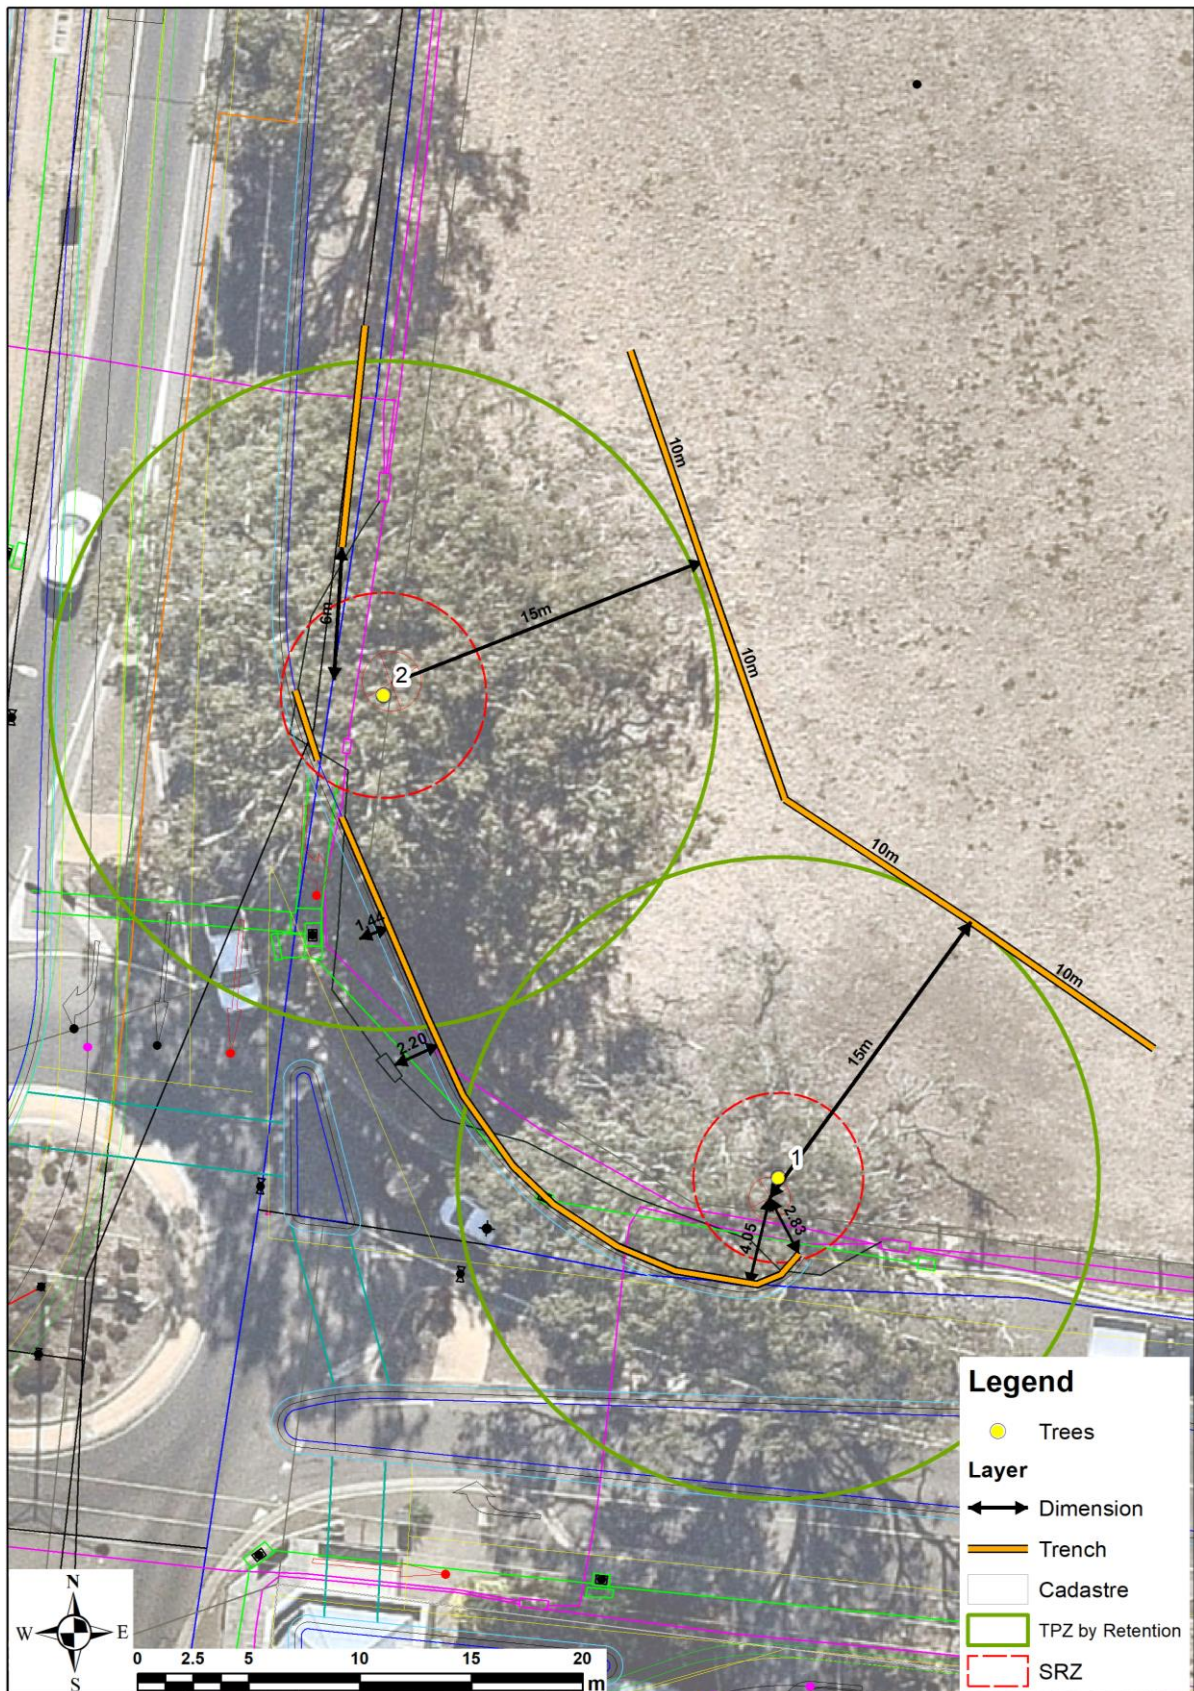
Figure 4: Map of trees and areas that were trenched using NDRI
