# **MORDIALLOC FREEWAY PROJECT**

Independent Reviewer and Environmental Auditor

Quarterly Construction Audit

Report 3, September 2020

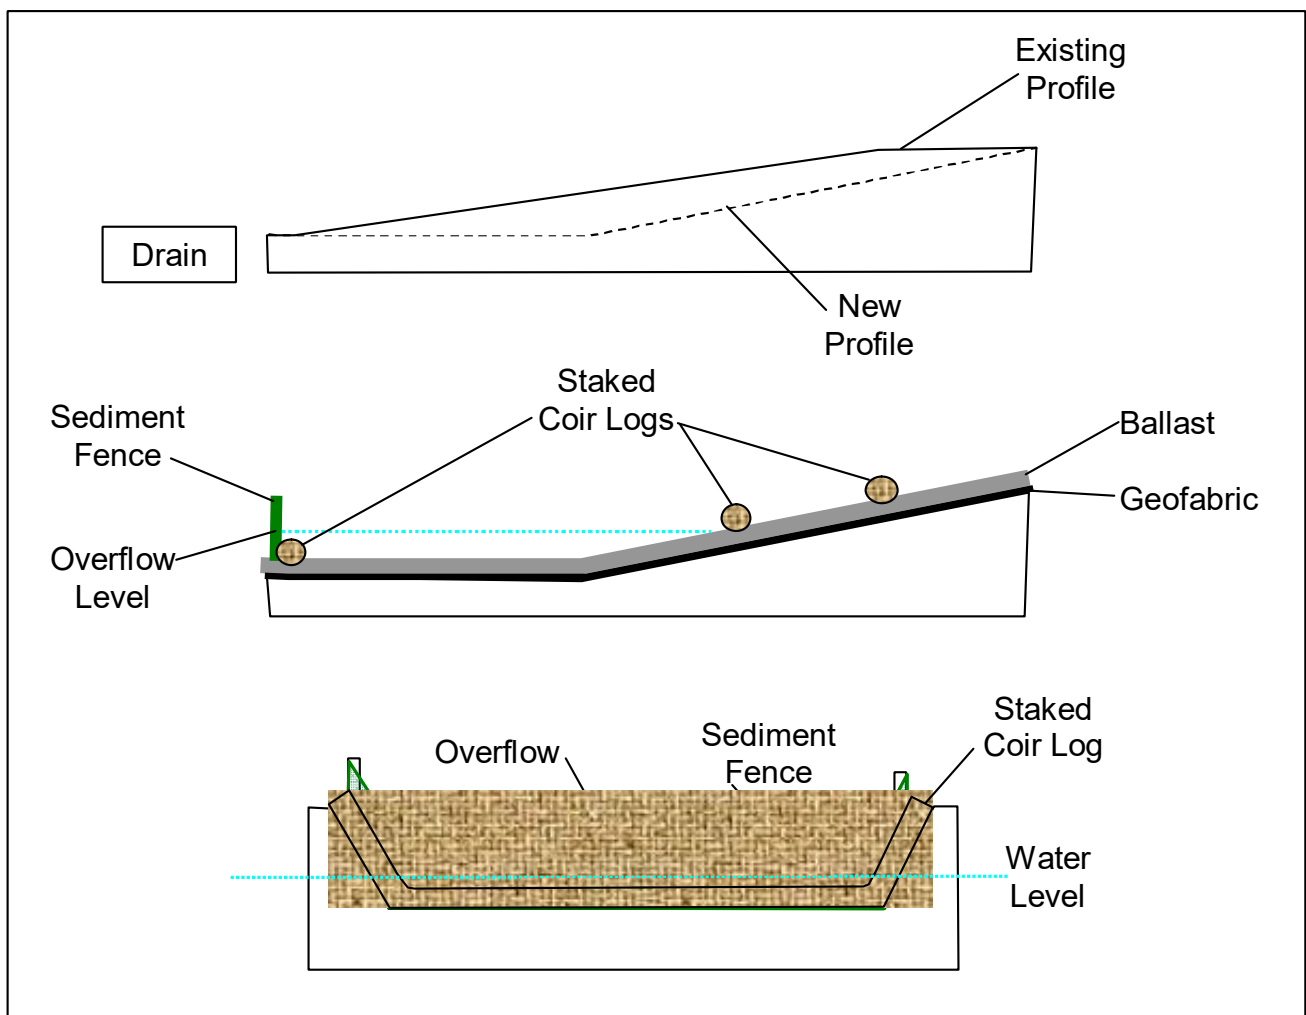
The contract specification requires any sedimentation ponds or basins to be designed to adequately treat the volume of water that could be collected. However, due to the lack of room, it is not possible to install a suitably large settling pond. Therefore, alternate treatment methods to remove any suspended sediment are required. The following methods should be considered.

The treatment area could be scraped out to increase the depth slightly and re-establish the surface with geofabric covered with a layer of ballast. This will slow the flow of water down and prevent erosion of the surface. Two sets of coir logs should be installed across the treatment area. The sediment fence should be re-established, however, it should extend partially up the side of the bank to prevent water running around the fence. A coir log can be placed along the base of the fence to help prevent water scoring out the base of the fence. An overflow should be installed at the mid point of the sediment fence (refer to diagrams below). Alternatives that achieve the water quality objectives can also be implemented.

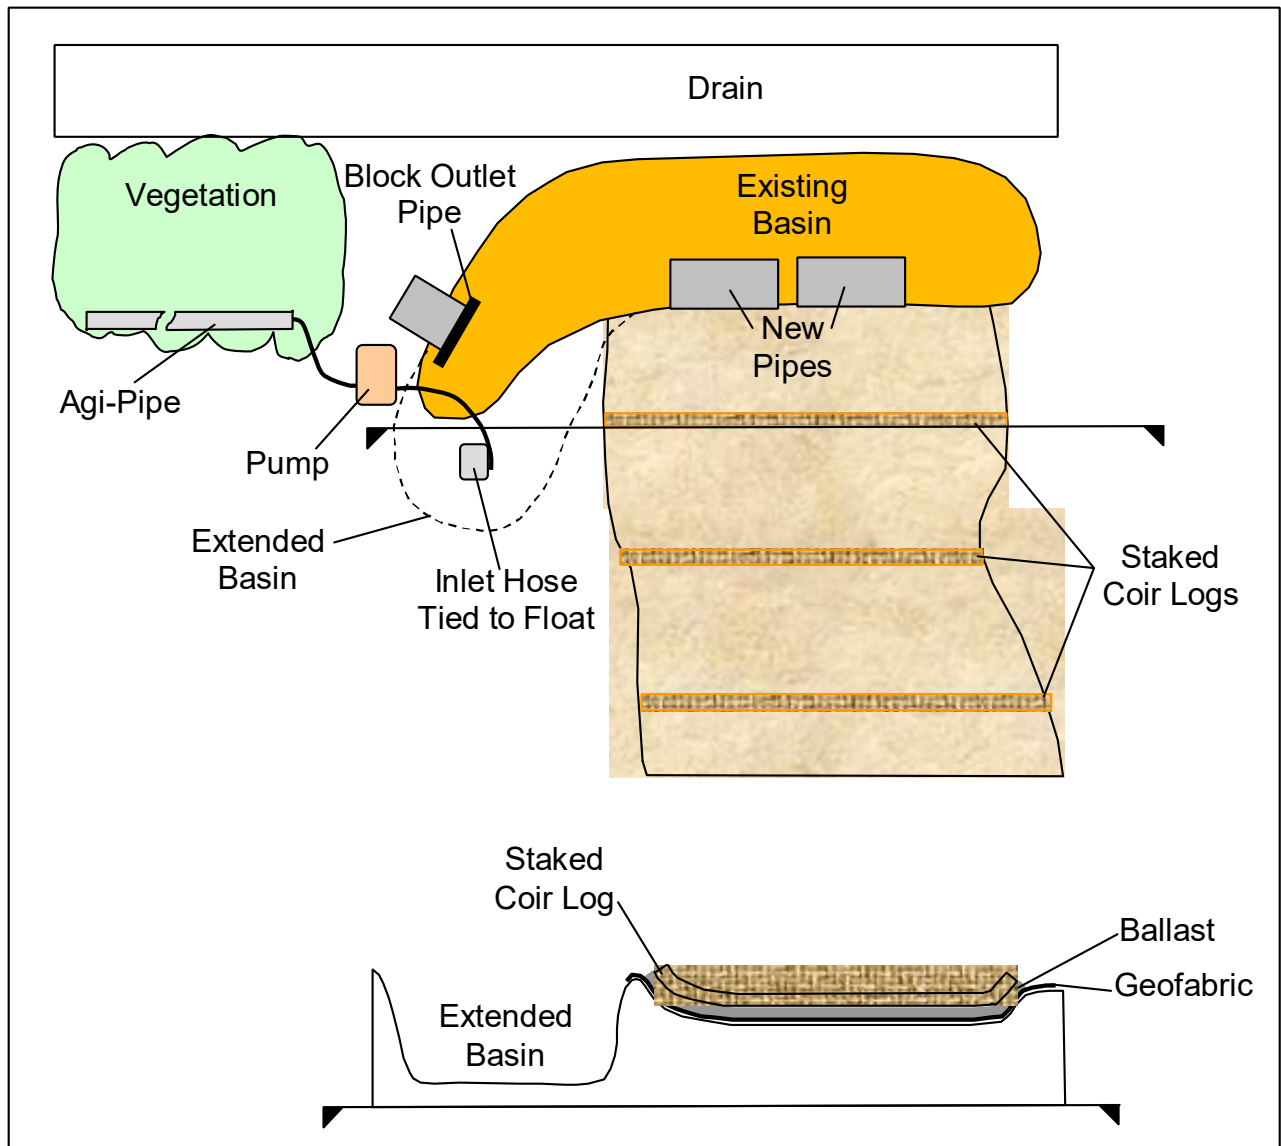
Above: Discharge point into drain approximately 100m south of Centre Dandenong Road.

The sediment fence at the top of the treatment area has been partially buried by soil. As stated for the previous treatment area, the sediment fence acts as a dam and water builds up and flows around the fence causing scouring of the underlying soil. Again, it is not possible to install a large settling pond and alternate treatment methods should be installed and the following should be considered.

The catchment for this area is larger than the area discussed above, therefore the holding capacity should be increased. The surface should again be stabilised with geofabric and ballast. The water currently discharges via a 500mm pipe that appears to have existed before construction commenced. The larger catchment for this location will produce a larger volume of water during rain events compared to the treatment area discussed above. Therefore, it would be preferable to treat this water further before it is discharged. The 500mm pipe inlet should therefore be blocked and a suitably sized pump installed to discharge the water through a length of slotted “agi-pipe” placed along the vegetated boundary of the site. This will allow water to trickle through the dense grass and undergrowth. The majority of the water will likely soak into the soil and the remainder will be filtered through the vegetation before it enters the drain (refer to diagrams below). Again, alternatives that achieve the water quality objectives can also be implemented.
