Assessment of trees along the proposed Mordialloc Bypass

Preliminary Tree Assessment Report

31 May 2018

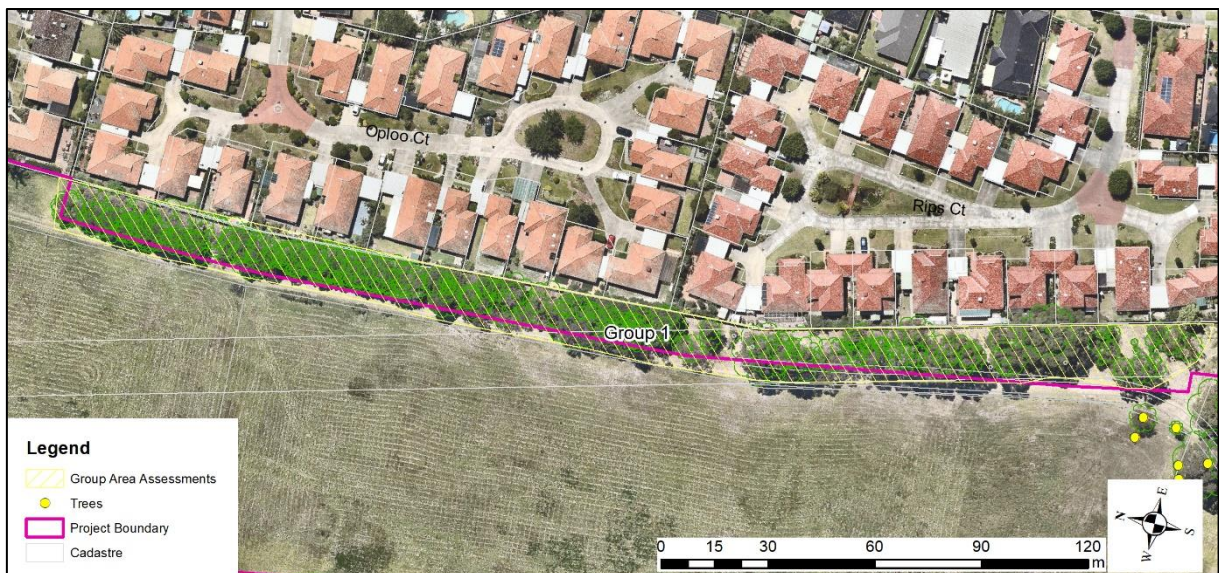
Figure 8: Area of group 1.

Group 1 is a long row of approximately 320m comprising largely planted specimens south of Centre Dandenong Road (Figure 8). The dominant planted species is Giant Honey Myrtle *Melaleuca armillaris* along with a number of River Red Gum *Eucalyptus camaldulensis* (Figure 9). Near the southern end of the group area is one, large River Red Gum likely to be a remnant specimen (Figure 10).

In general, the trees present a significant screen between the houses and currently vacant paddock. The trees are generally in good health, with fair structure and as a patch are likely to be functional for another 10-20 years. Within that time, it is likely that many of the Giant Honey Myrtle will fail. The River Red Gums are likely to survive significantly longer.

There is an existing track that runs along the western side of the group. This could be retained if desired and used for continued small vehicle access.

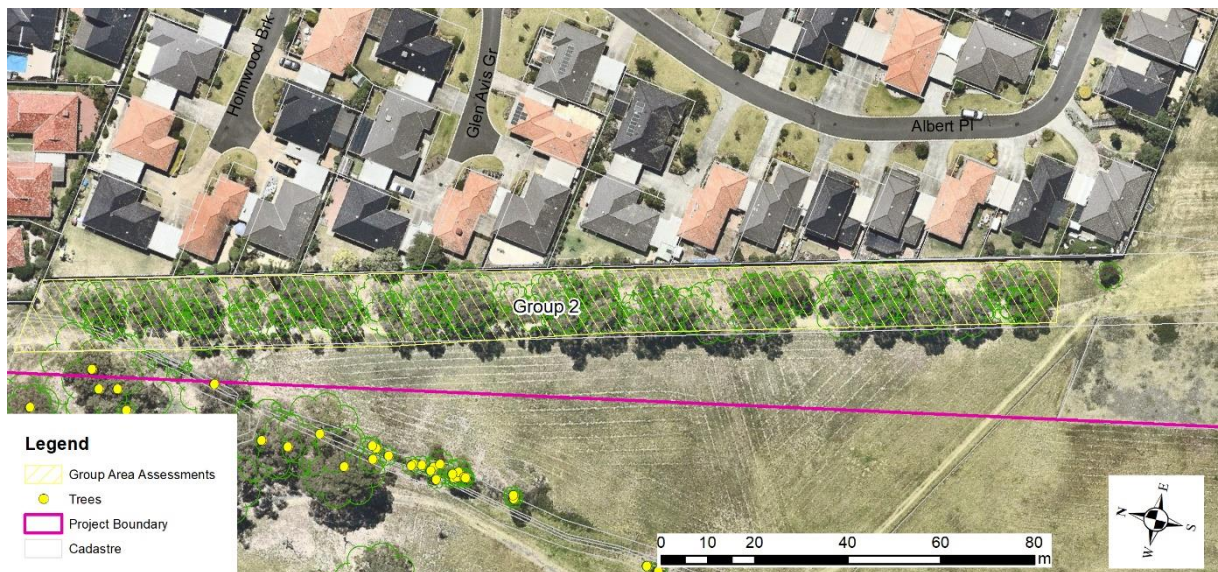
Figure 11: Area of group 2.

Group 2 is a long row of approximately 220m comprising largely planted specimens south of Centre Dandenong Road (Figure 11). It comprises 3 main species being River Red Gum *Eucalyptus camaldulensis*, Swamp Gum *Eucalyptus ovata* and Yellow Gum *Eucalyptus leucoxylon* (Figure 12). At the northern end of the group is a row of mixed eucalypts and a larger patch of mature, likely remnant River Red Gums that were assessed individually (Figure 13).

In general, the trees present a screen between the houses and currently vacant paddock. The trees are generally in good health, with fair structure and as a patch are likely to be functional for at least another 20 years. General pruning and tree management will be required as the trees continue to increase in size.

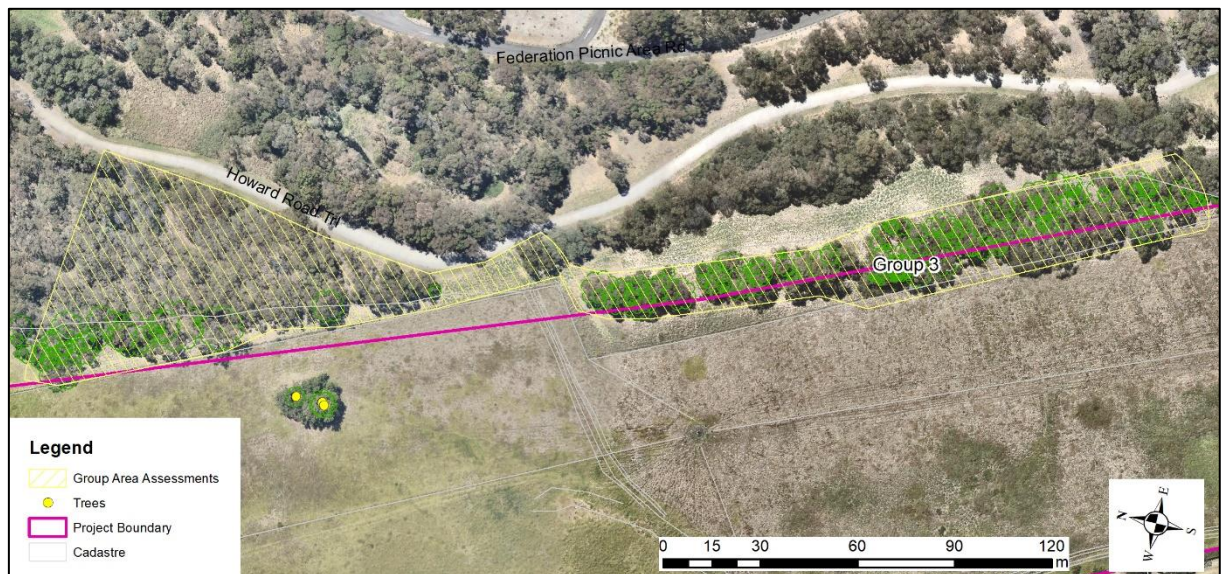
Figure 14: Area of group 3.

Group 3 is a large patch of trees located within Braeside Park (Figure 14). It comprises predominantly River Red Gum *Eucalyptus camaldulensis* at the northern end (Figure 15) transitioning to Gippsland Manna Gum *Eucalyptus viminalis* subsp. *pryoriana* at the southern end (Figure 16).

The trees are part of the park and are dense sections of bushland. The trees have good health and fair structure given that they have largely been left unmanaged. Canopy pruning may be a requirement as some of the trees have grown out and into the reserve area. The mapped buffer represents an area required for adequate protection of the trees.

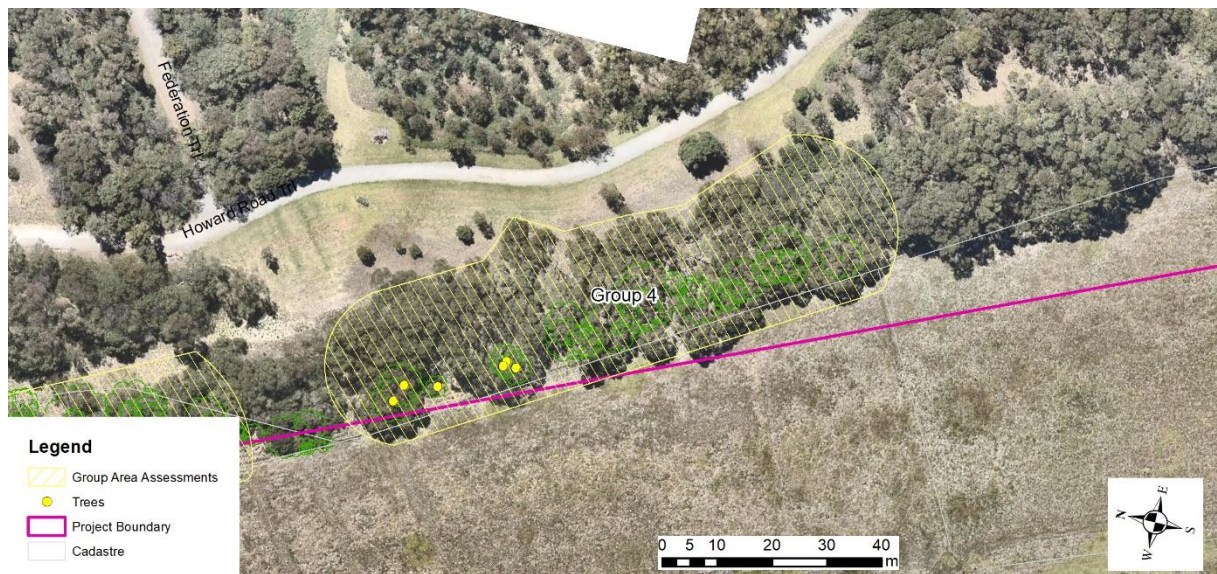
Figure 17: Area of group 4.

Group 4 is a moderate-sized patch of trees located within Braeside Park (Figure 17). It comprises predominantly Gippsland Manna Gum *Eucalyptus viminalis* subsp. *pyroriana* with relatively few understorey species (Figure 18).

The trees are part of the park and are dense sections of bushland. The trees have good health and fair structure given that they have largely been left unmanaged. Canopy pruning may be a requirement as some of the trees have grown out and into the reserve area. The mapped buffer represents an area required for adequate protection of the trees.

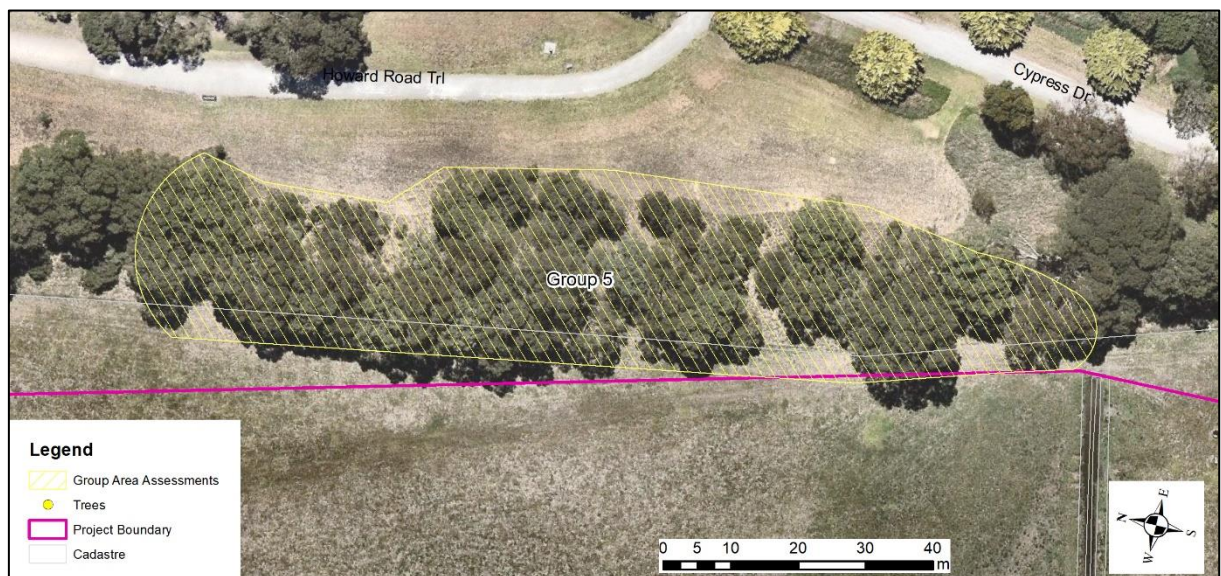
Figure 19: Area of group 5.

Group 5 is a large patch of trees located within Braeside Park near Cypress Drive (Figure 19). It comprises predominantly River Red Gum *Eucalyptus camaldulensis* (Figure 20 and Figure 21).

The trees are part of the park and provide a screen for trail users within the park to the vacant land to the west. The trees have good health and fair structure given that they have largely been left unmanaged. Canopy pruning may be a requirement as some of the trees have grown out and into the reserve area. The mapped buffer represents an area required for adequate protection of the trees. Detailed investigation of individual trees may result in a reduction of the required buffer intruding into the subject land.

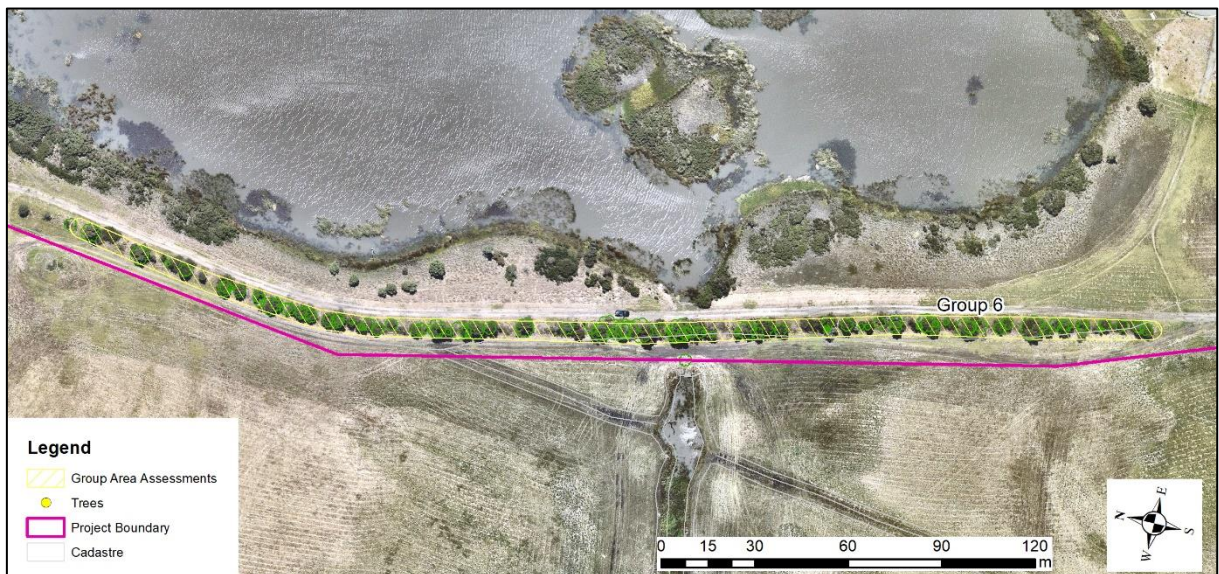
Figure 22: Area of group 6.

Group 6 is a long, narrow strip of planted trees along the eastern border of the Waterways estate (Figure 22). A diverse range of species, the patch comprises River Red Gum, *Eucalyptus camaldulensis*, Swamp Gum *Eucalyptus ovata*, Black Wattle *Acacia mearnsii*, Kangaroo Wattle *Acacia paradoxa*, Lightwood *Acacia implexa*, Blackwood *Acacia melanoxylon*, Drooping Sheoak *Allocasuarina verticillata* and Sweet *Bursaria Bursaria spinosa* (Figure 23 and Figure 24).

The trees have variable conditions and size dimensions ranging from 2-3m to 8-10m tall. A track exists on both sides of the strip of vegetation. A no-go zone of 6m width is ample to protect this row of vegetation.

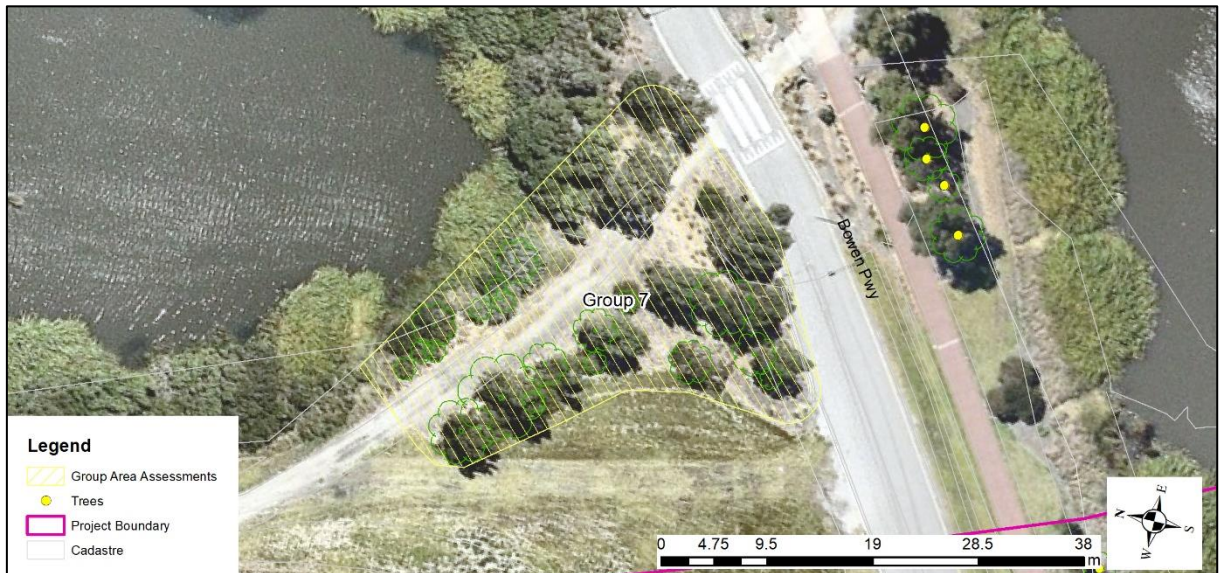
Figure 25: Area of group 7.

Group 7 is a small patch of approximately 15-20 trees located adjacent to Bowen Parkway (Figure 25). It largely comprises River Red Gum, *Eucalyptus camaldulensis* with a few other smaller specimens (Figure 26).

The trees have variable conditions and size dimensions ranging from 8-10m tall and trunks 20-30cm in diameter at breast height. A track exists through the middle of the patch (Figure 26).

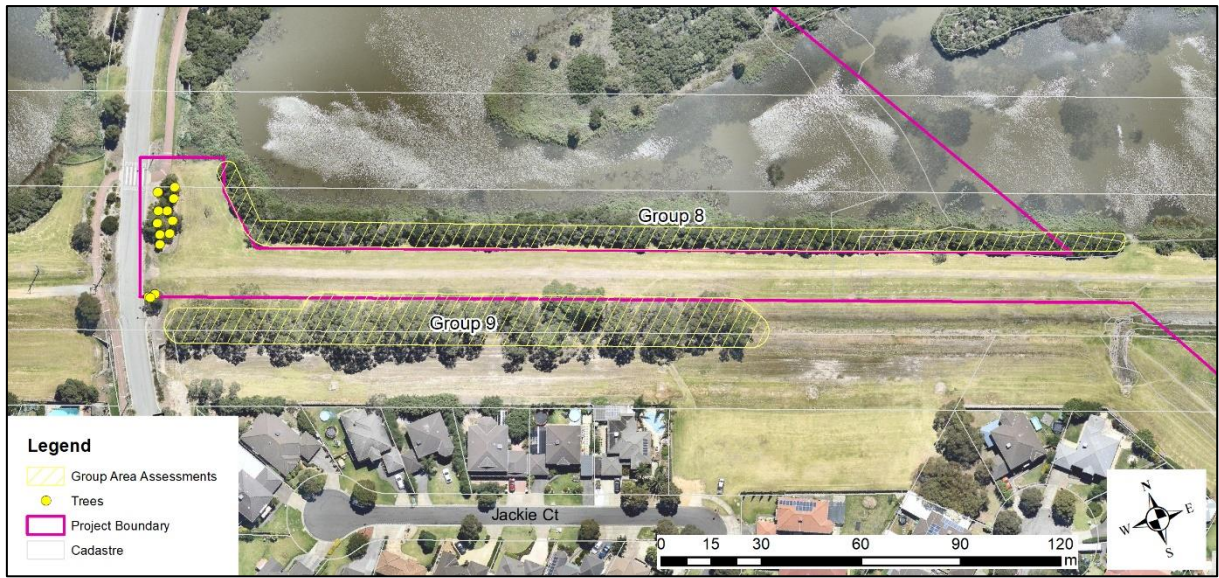
Figure 27: Area of groups 8 & 9.

Group 8 is a long thicket of Swamp Paperbark growing along the water's edge running off Bowen Parkway (Figure 27). It comprises a dense patch of stems ranging from less than 5cm to ~20cm diameter. In general, a relatively small strip is required to protect these trees as they are mostly small trees with small protection zones (Figure 28).

Group 9 is a row of River Red Gum growing along a narrow, deep channel. To the north of the trees is a levy and the south a deeper, wider channel drain. The offset as shown for the trees should ensure that they are sufficiently protected (Figure 29 and Figure 30)
