North East Link Program – Central Package

# IEA Six-Monthly Environmental Compliance Report – May to October 2023

A Report to the Minister for Planning

NEL-CNT-AAA-2990-EEE-REP-0003

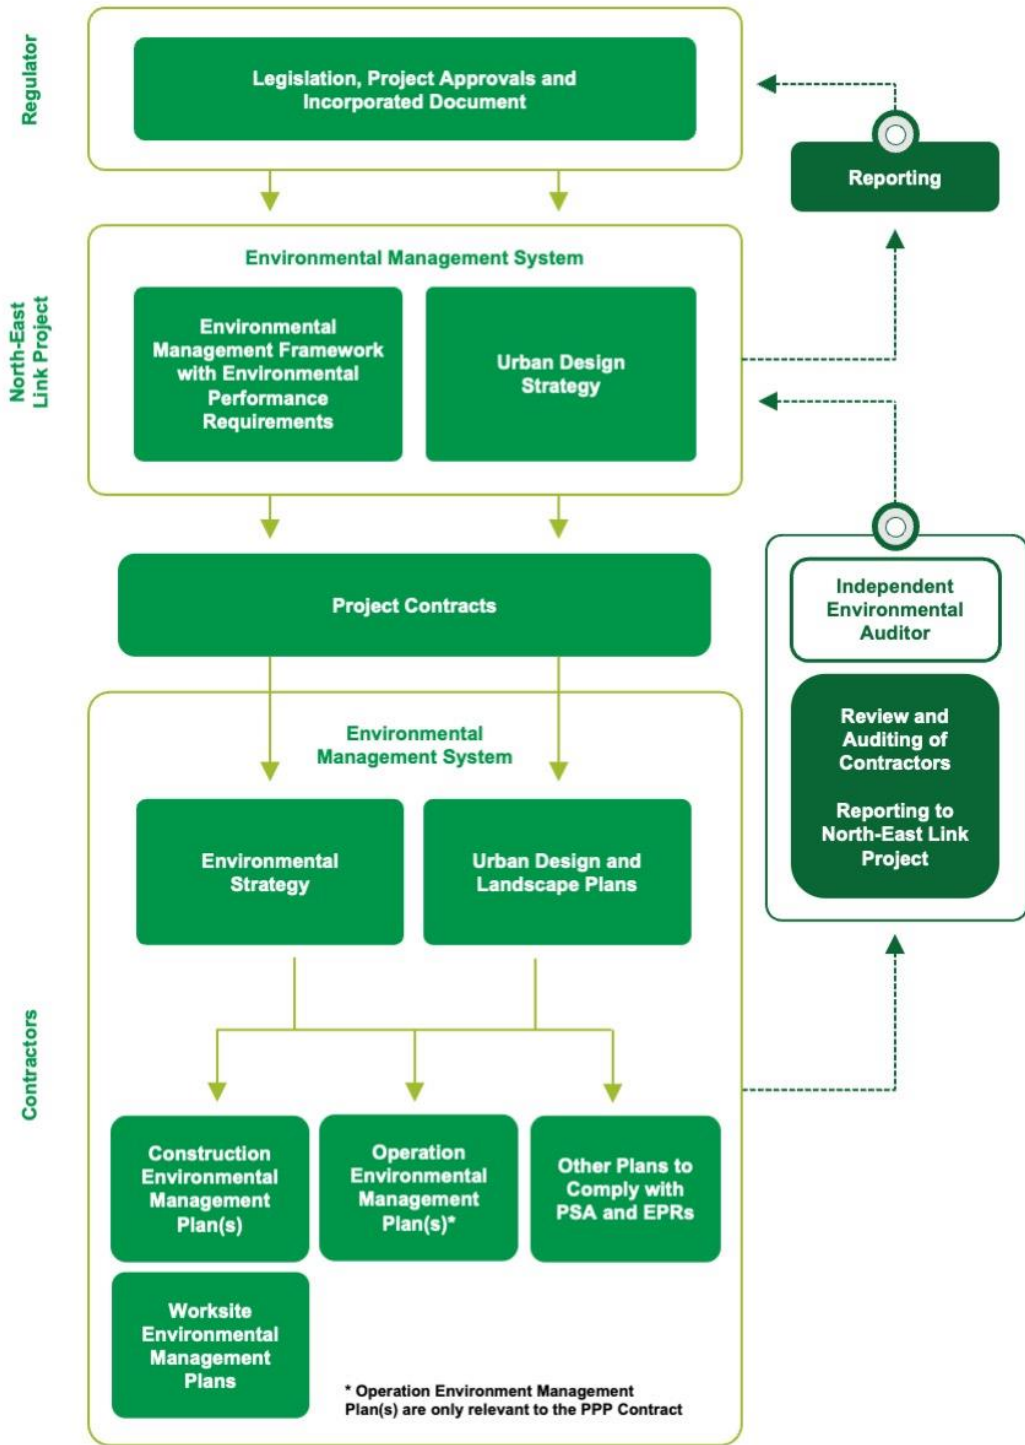
**Figure 2: Environmental Documentation**

The EMF documentation is summarised below in Figure 2.

(adapted from the EMF)

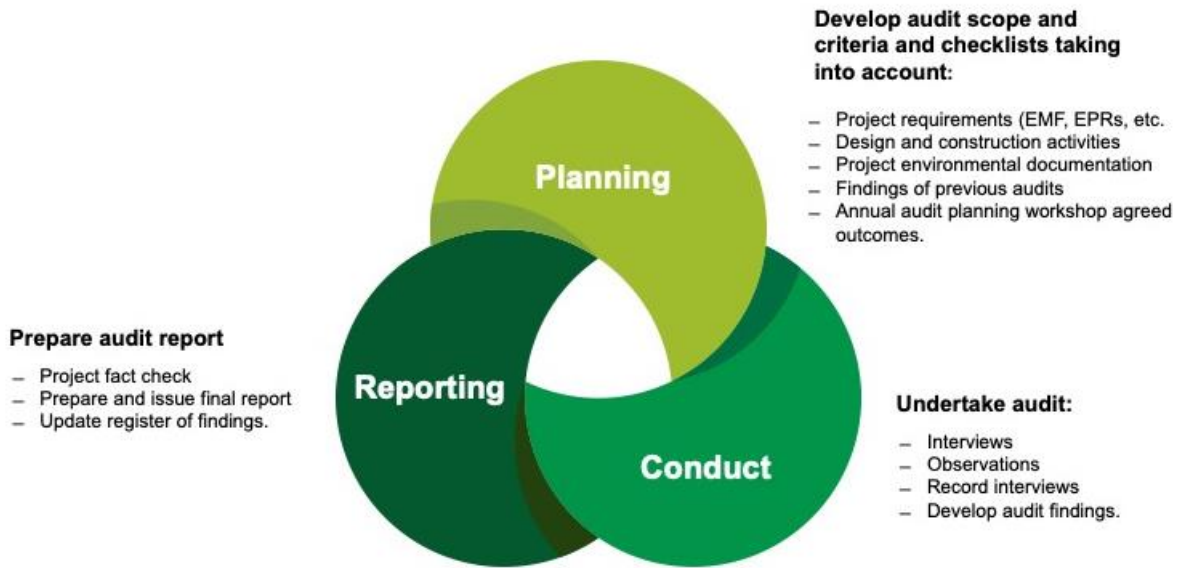
**Figure 3: Audit process**

The audit planning process for each environmental audit includes defining the objectives, scope, criteria, and additional information. The overall process for each audit is given in **Figure 3** below.

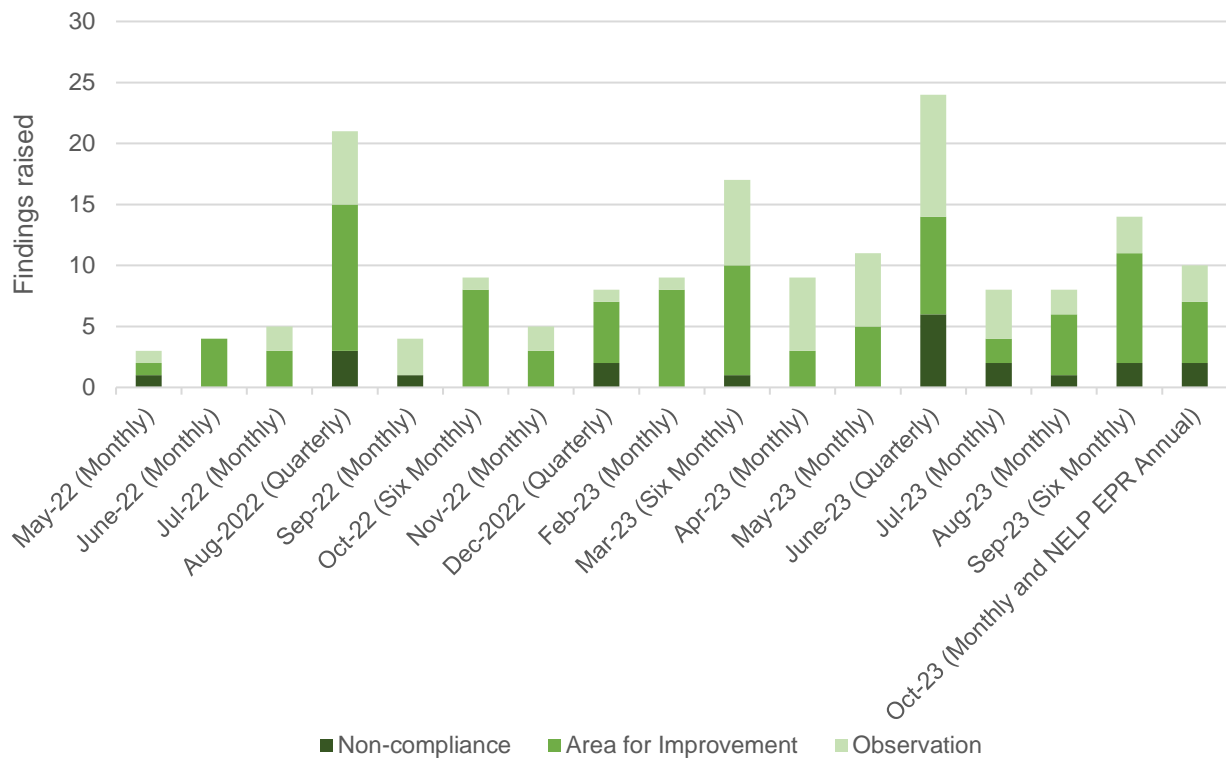
**Figure 4: Audit findings by type and audit date (Project commencement to October 2023)**

A total of seventy-five (75) audit findings were raised comprising thirteen (13) Non-compliances, thirty-four (34) Areas for Improvement, and twenty-eight (28) Observations.

Most of the audit findings were raised in the June 2023 quarterly audit, which assessed compliance against the requirements of most of Spark’s environmental documentation, and the requirements of selected EPRs (see Figure 4).

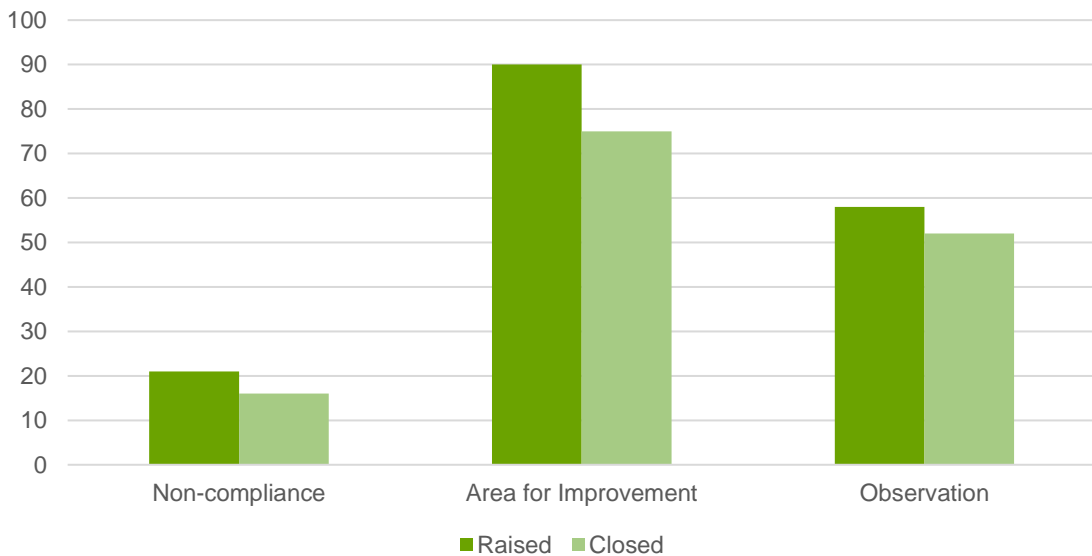
Figure 5: Cumulative audit findings raised and closed - Project commencement to October 2023

Spark D&C established corrective actions to address the audit findings. Ninety (90) findings were closed during the reporting period. Twenty-seven (27) findings remained open at the end of the reporting period. (See Figure 5).

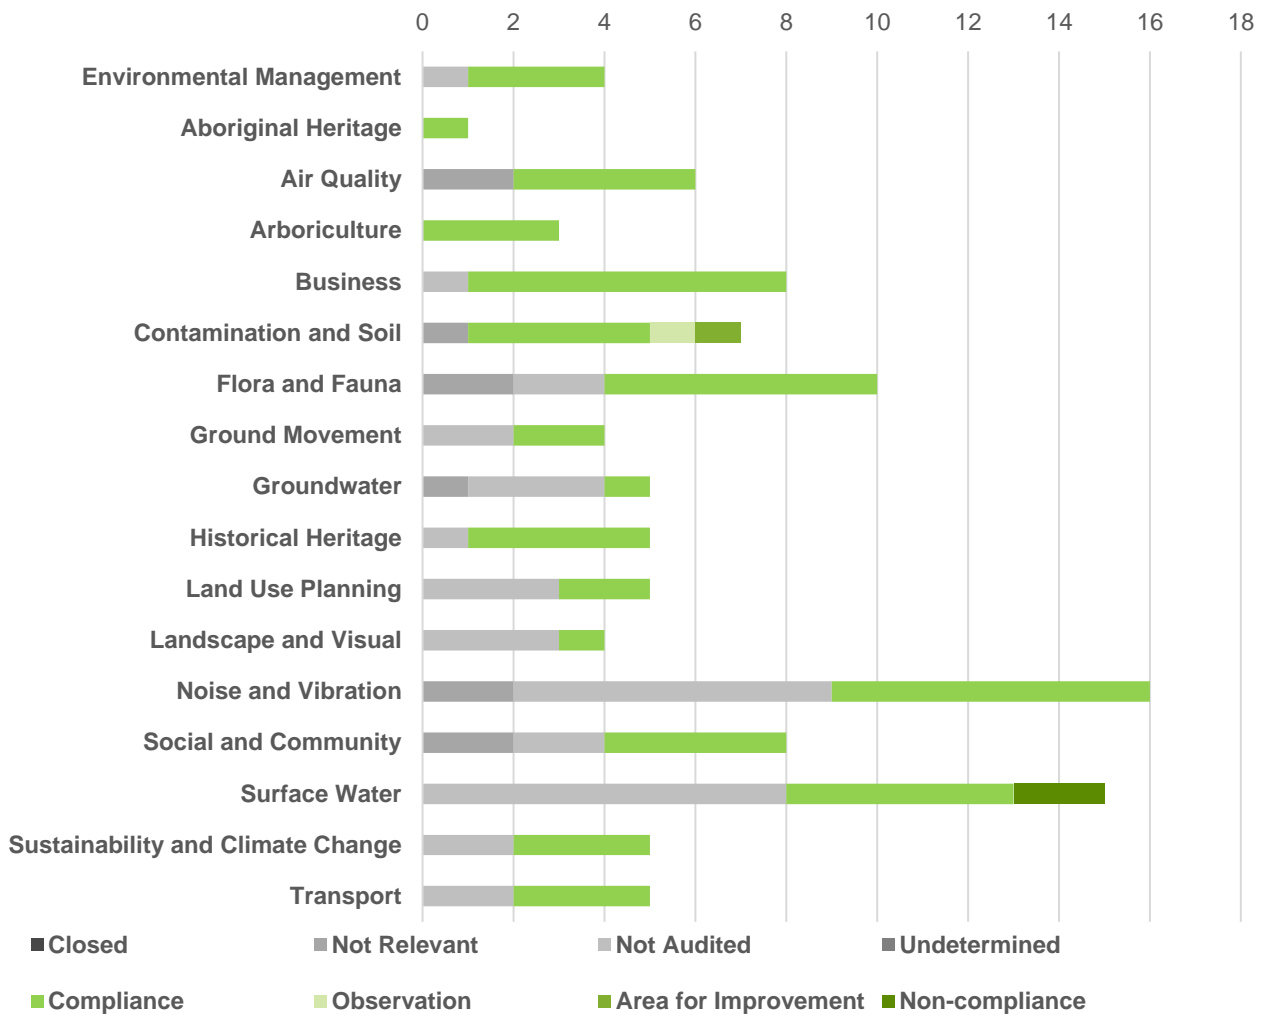
Figure 6: EPR audit findings by EPR category May - October 2023

Figure 6 shows the distribution of EPRs in each of the categories noting which were audited, and the status of compliance for the reporting period. Only EPRs relevant to the design and construction underway during the reporting period were included in the audit schedule for the period. Further, not all EPRs have equally detailed requirements, and there are different numbers of EPRs in each EPR category. The number of EPRs audited does not directly reflect the relative weight of environmental management requirements.

As each EPR category includes several EPRs, some of these were not included in the audits in the reporting period. All environmental issues are audited through the audits of Management Plans.
