Environment
Effects Statement

Chapter 21

Ground movement

This chapter provides an assessment of the ground movement impacts associated with the construction and operation of North East Link. This chapter is based on the impact assessment presented in Technical report M – Ground movement.

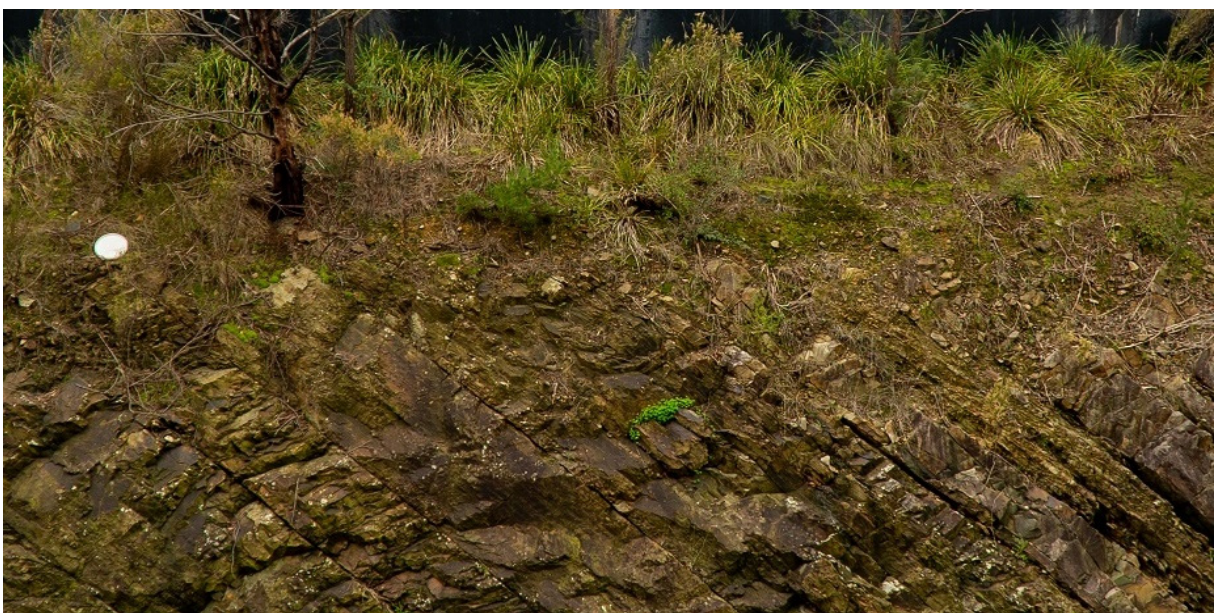
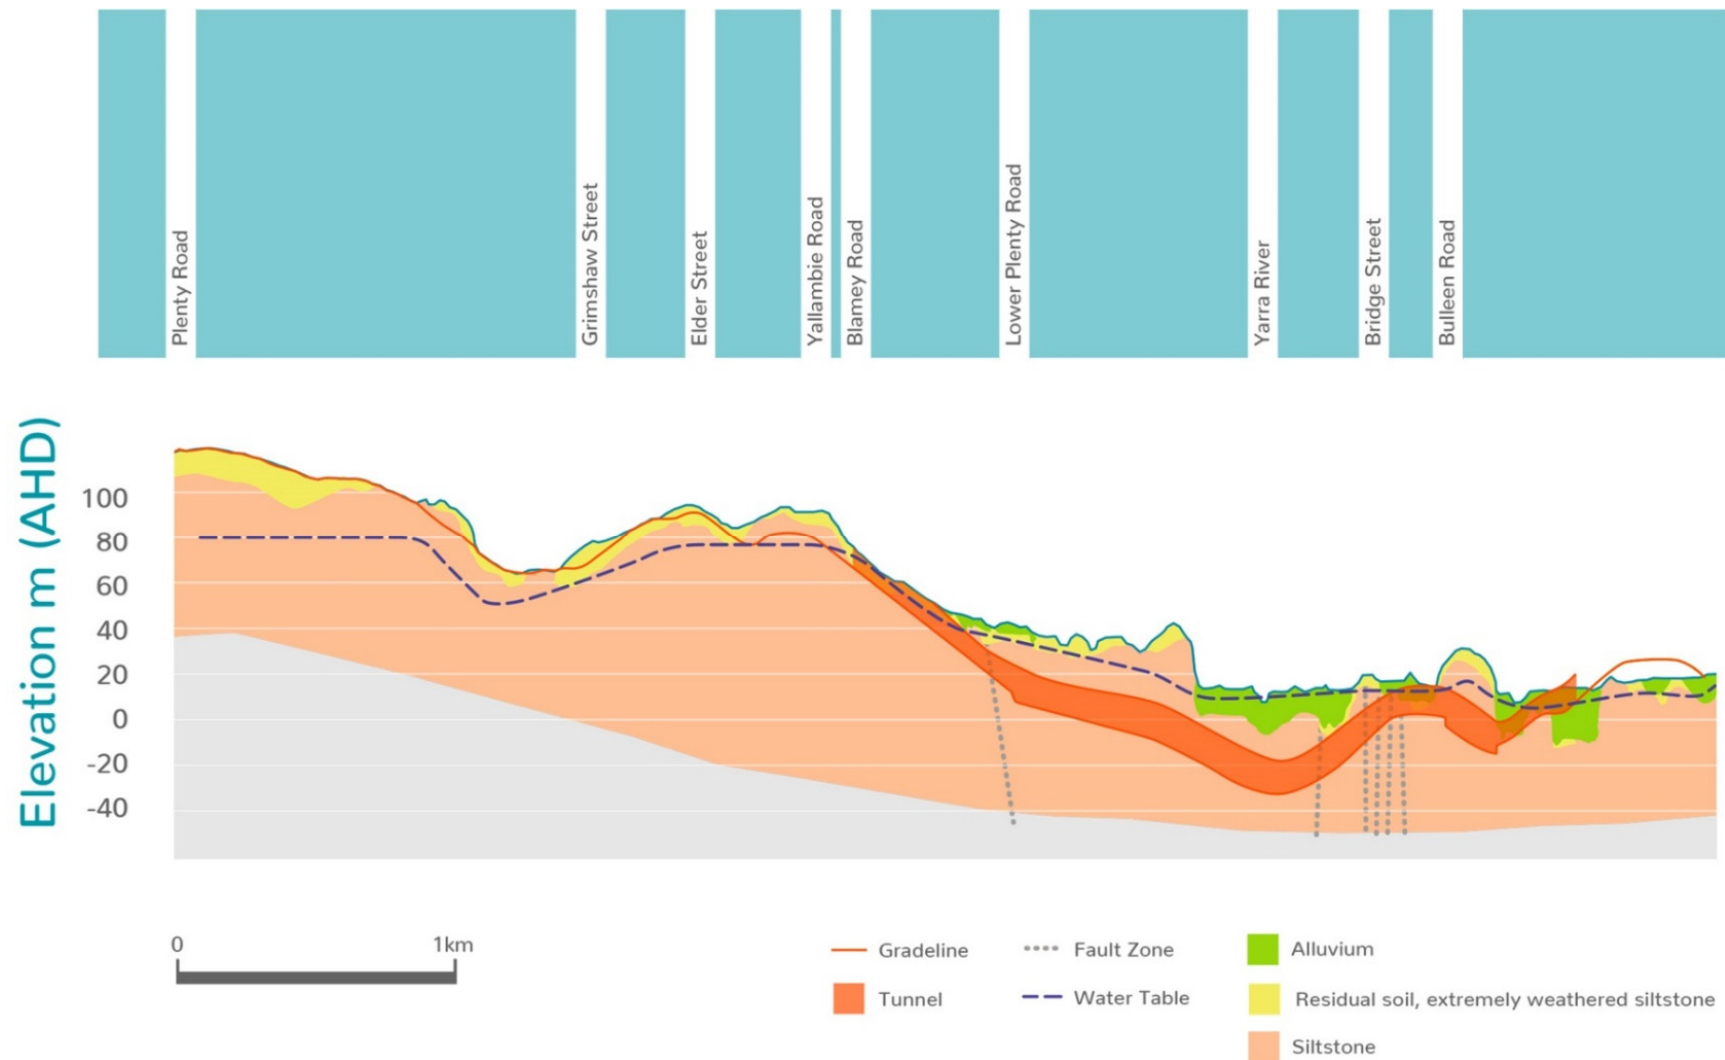
Figure 21-1 Simplified geological long section

The geology underlying the study area encompasses a sequence of marine, alluvial, sedimentary and volcanic deposits laid down over a time interval of more than 400 million years. A geological long section of the study area is presented in Figure 21-1.

The study area, from the M80 Ring Road to the Eastern Freeway and from Hoddle Street to Springvale Road, spans the transition between the Silurian Anderson Creek and Melbourne Formations. These rocks comprise thinly bedded/laminated siltstone and fine sandstone. They have been folded on a north to north-east trending axis, faulted and intruded by igneous dykes over geological time.
