10. Soils and Geology

The Soils and Geology Assessment examined the potential for the Project to encounter adverse geological conditions, affect soil stability, cause soil erosion or expose contaminated or acid sulfate soils (ASS).

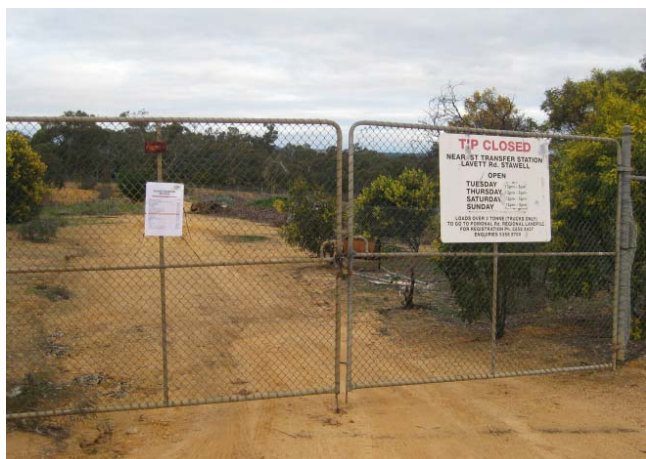
Entrance to former landfill

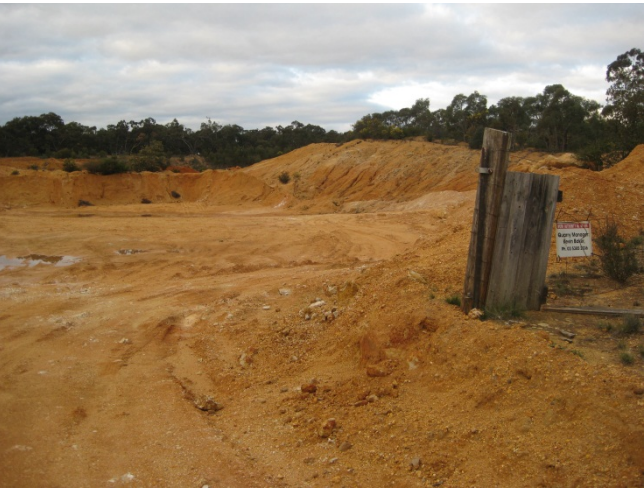
Former quarry site
