10. Soils and Geology

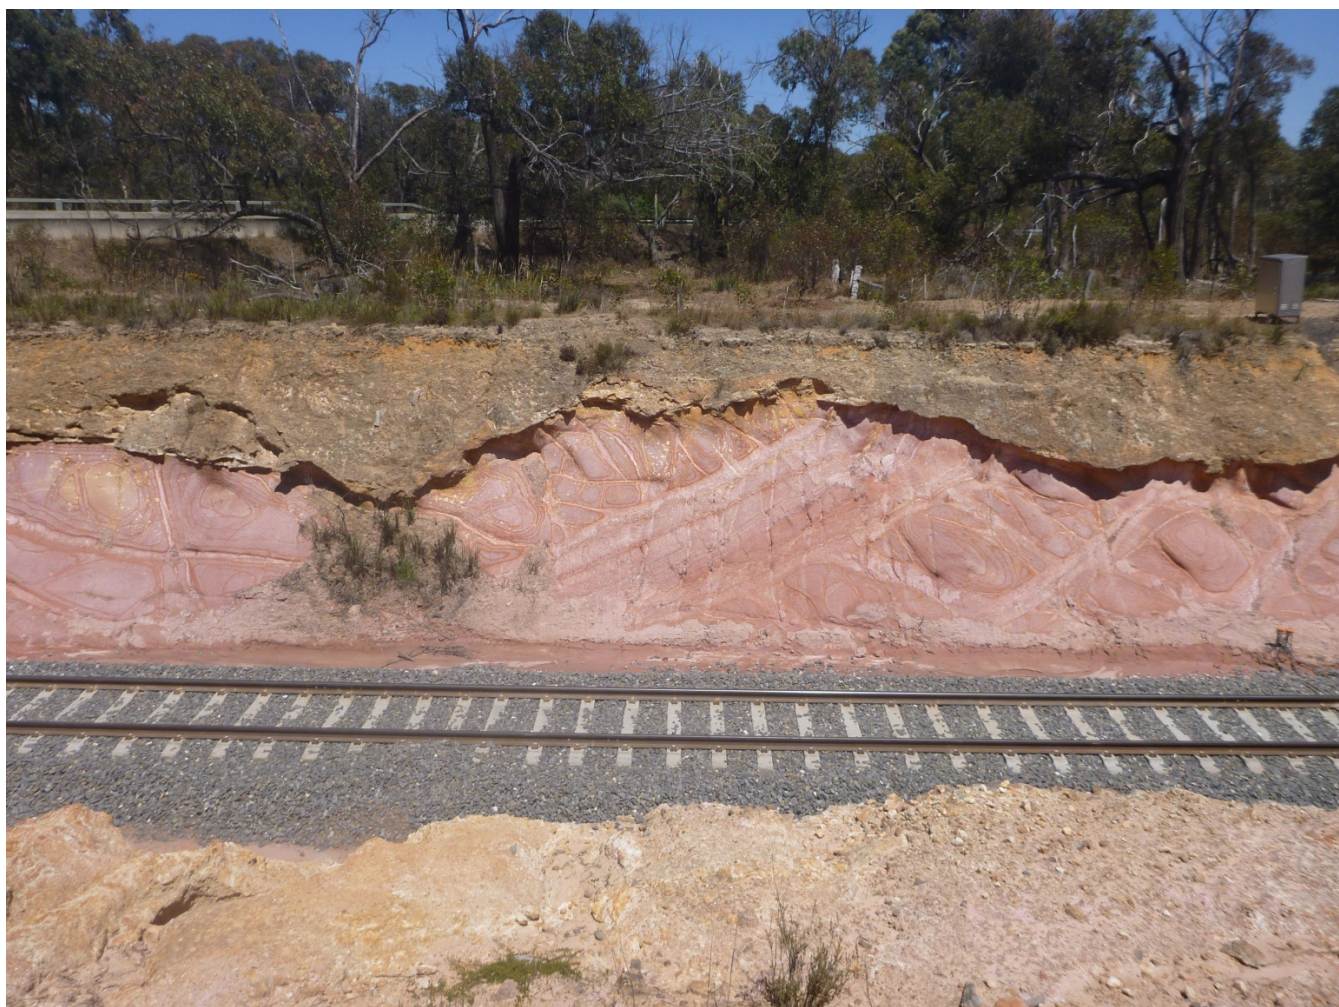
Figure 10-1 Geology of the study area

The regional geology is relatively simple with only a limited number of formations occurring within the study area. A description of the geological formations or layers found in the region is mapped in Figure 10-1.

Deposited within these old valleys and drainage lines are the Calivil Formation or "Deep Leads". Although this layer does not outcrop at the surface, it was the target of historical gold mining activities within the study area, and therefore has relevance for potential ground subsidence and potential contamination.

The youngest geological formation within the construction corridor consists of unconsolidated gravels, sands and silt alluvium. These are associated with existing and previous depositional stream channels and floodplains.
