Traffic Management Plan

Bulla Spoil Processing Facility 570-650 Sunbury Road, Bulla

Prepared for Hi-Quality Group

G27938R-02E

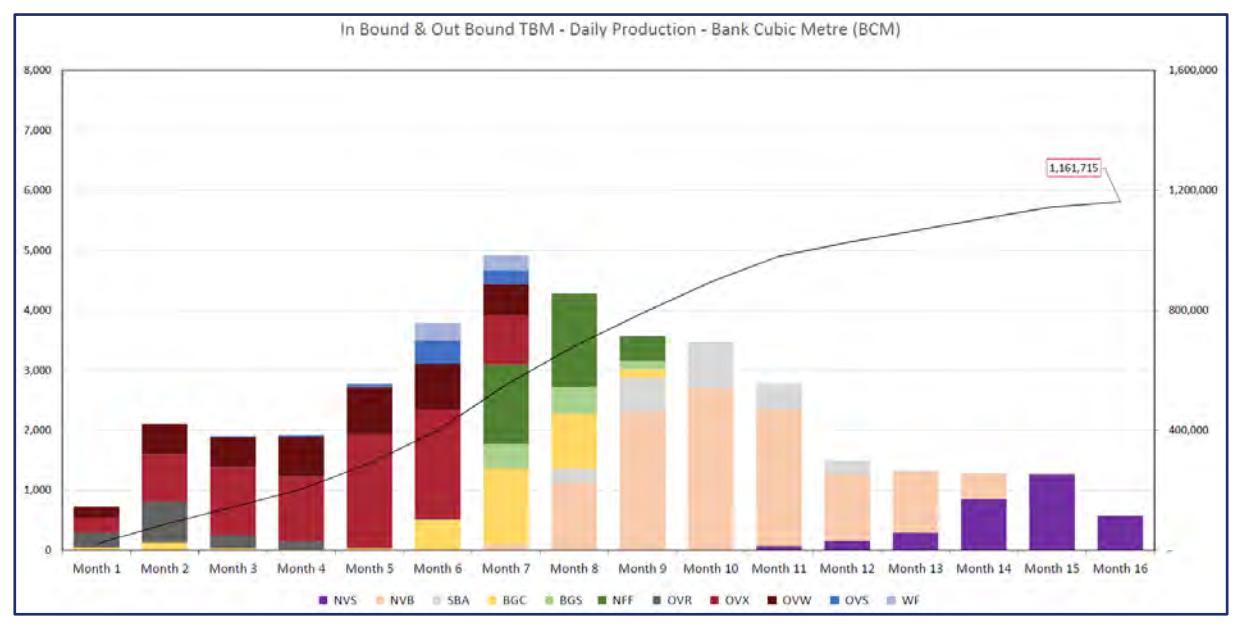
Figure 1: Daily Spoil Production Throughout Project

As a result of the tunnelling, an anticipated peak of up to 15,000 tonnes of spoil will be removed per day, with typical daily spoil removal to be between 4,000 and 9,000 tonnes per day. A histogram outlining the anticipated spoil removal throughout the project is provided in Figure 1 below.

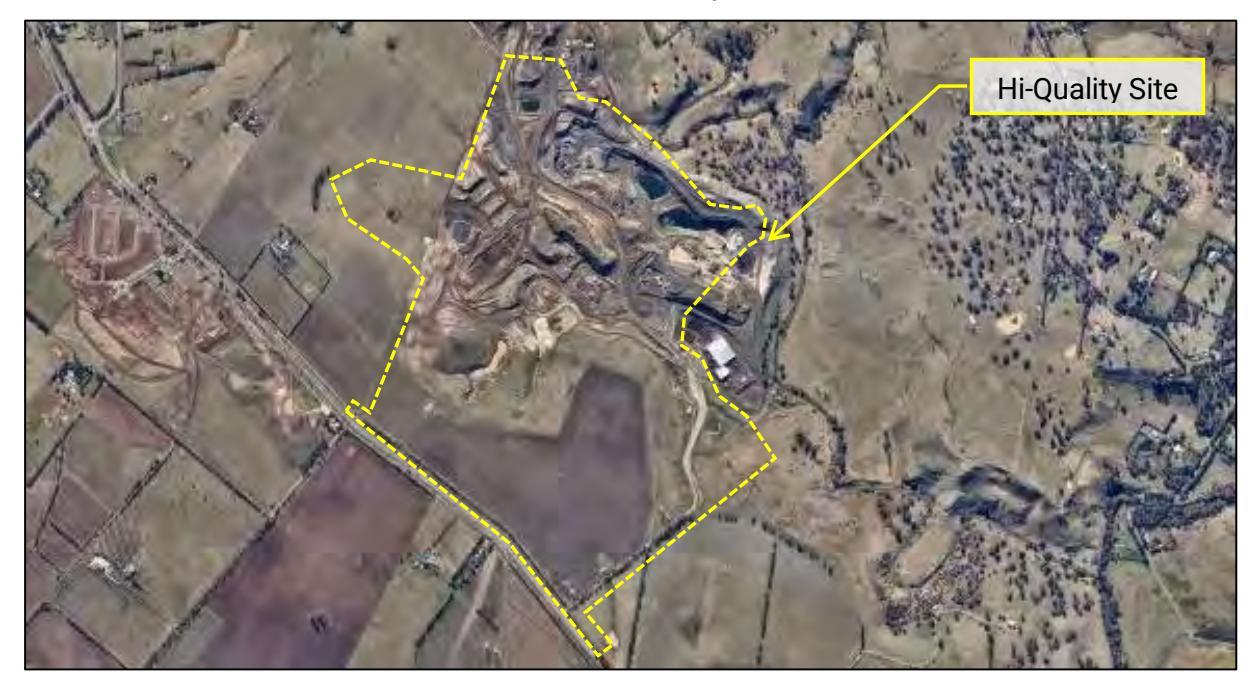
Figure 4: Aerial View of Hi-Quality Site (Source: www.nearmap.com - 6 May 2021)

The site has a frontage to Sunbury Road of approximately 1.2km. Part of the site is currently occupied by a quarry and associated activities and the remainder of the site is currently undeveloped farmland. An aerial view of the Hi-Quality Site is presented in Figure 4.

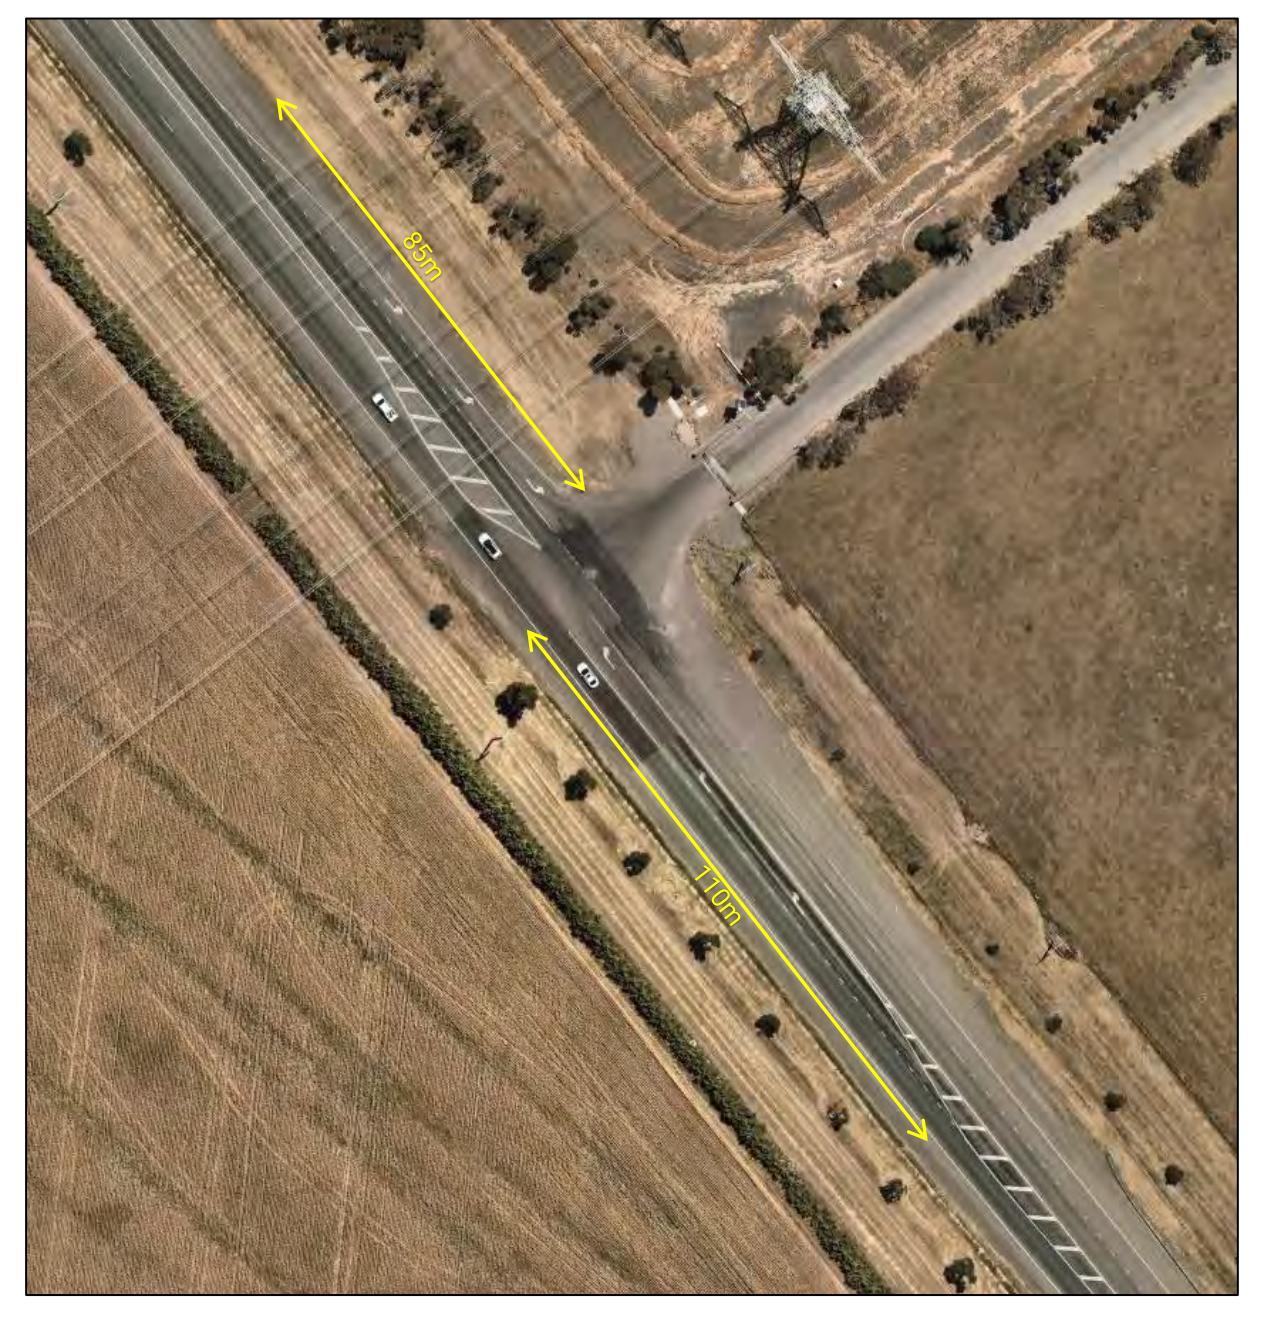
Figure 5: Hi-Quality Site - Existing Access Arrangements

An aerial view of the existing access arrangements is provided in Figure 5 below.

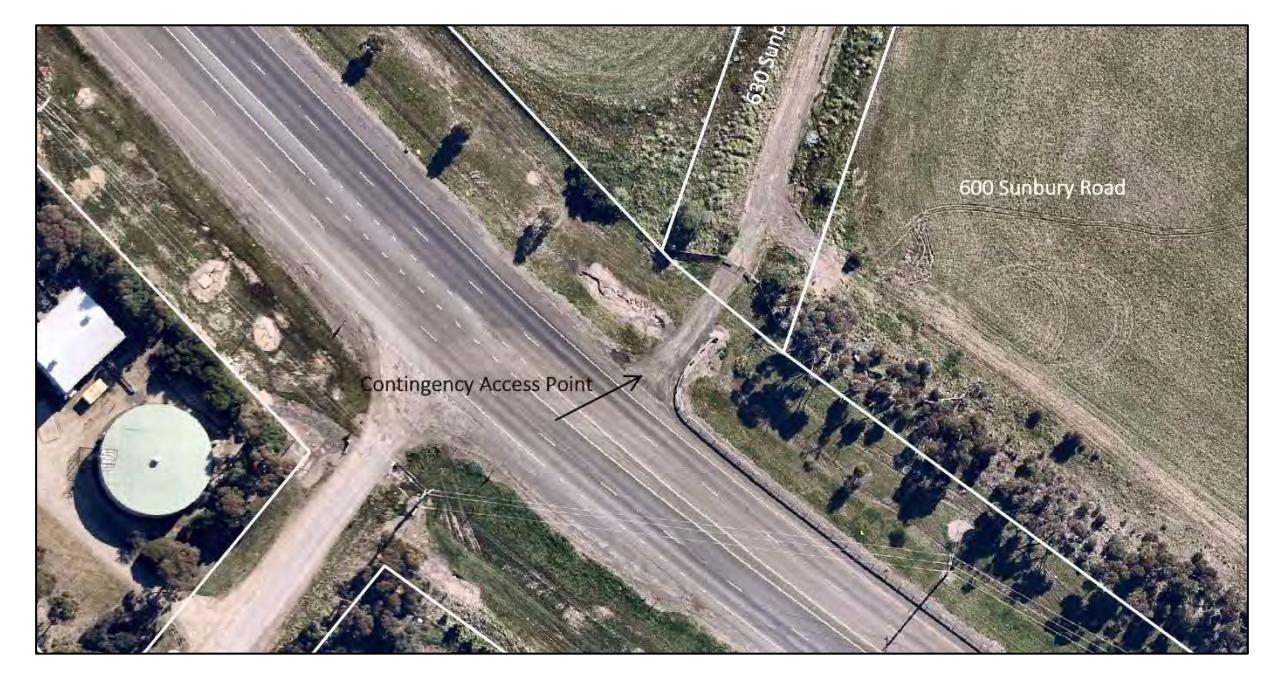
Figure 6: Hi-Quality Site - Existing Contingency Access

A contingency access is also provided at the south-western corner of the site as shown in Figure 6 below.

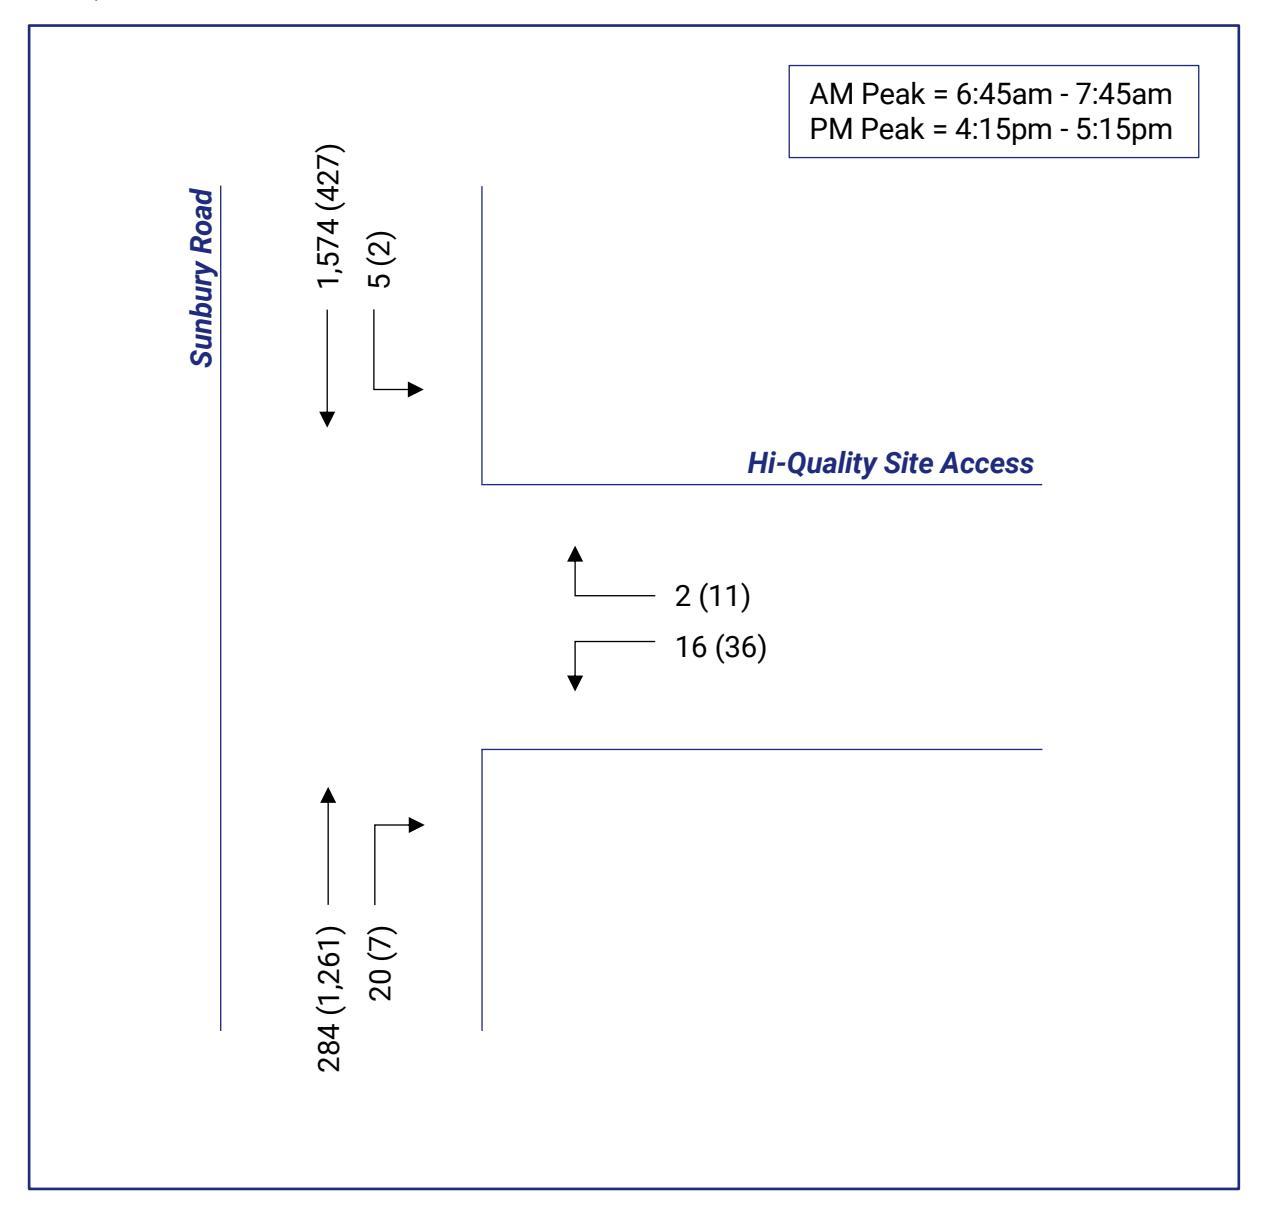
Figure 7: Hi-Quality Site Access - AM(PM) Peak Hour Traffic Volumes

The results of the peak hour volumes recorded for the peak weekday (Monday 10th December 2018) are summarised in Figure 7 below.

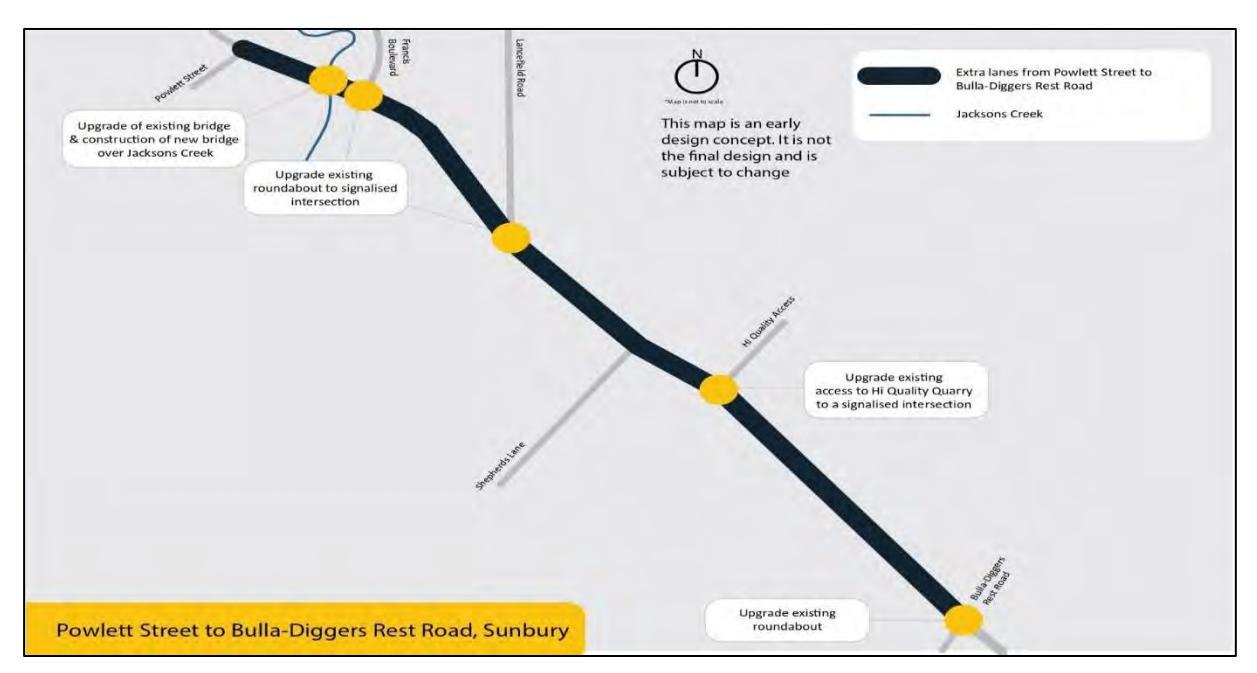
Figure 12: Sunbury Road Upgrade

The timing of the upgrade works on this section of Sunbury Road is not yet determined. It is significant however that the project includes signalisation of the Hi-Quality Access, as shown in a diagram from Hume Planning Scheme Amendment C235 explanatory report provided in Figure 12 below.

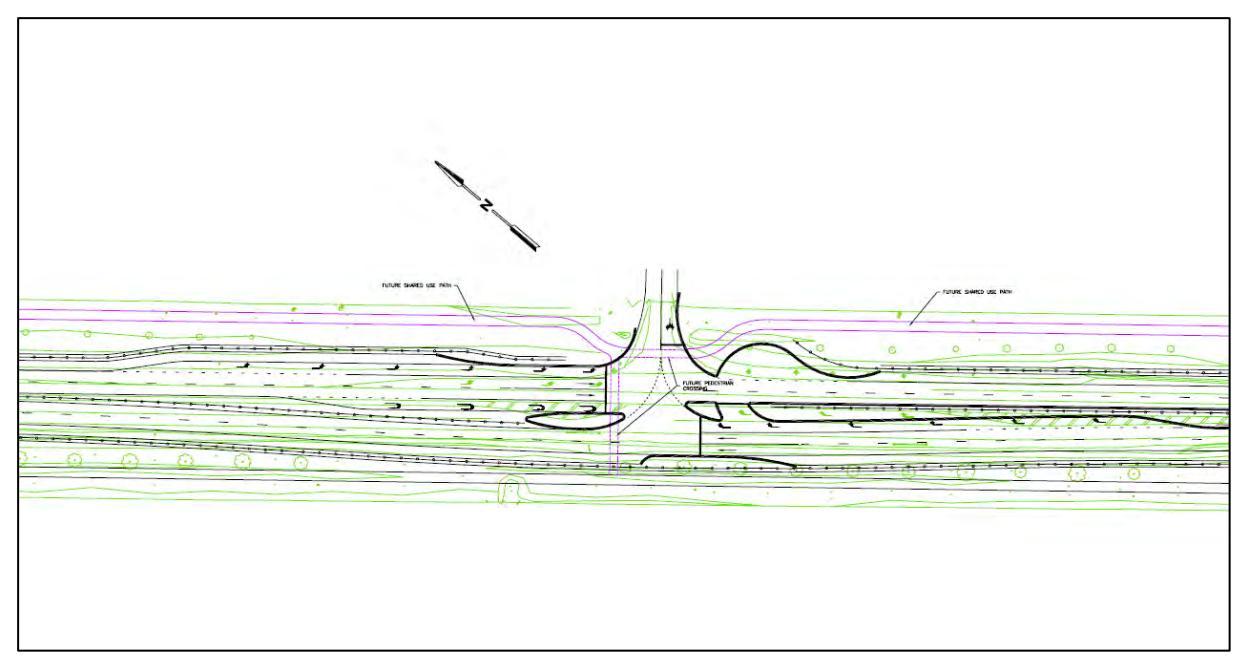
Figure 13: Future Hi-Quality Site Signalised Access - Concept Plan

A possible layout plan provided by MRPV for the Hi-Quality Site access intersection is shown in Figure 13 below.

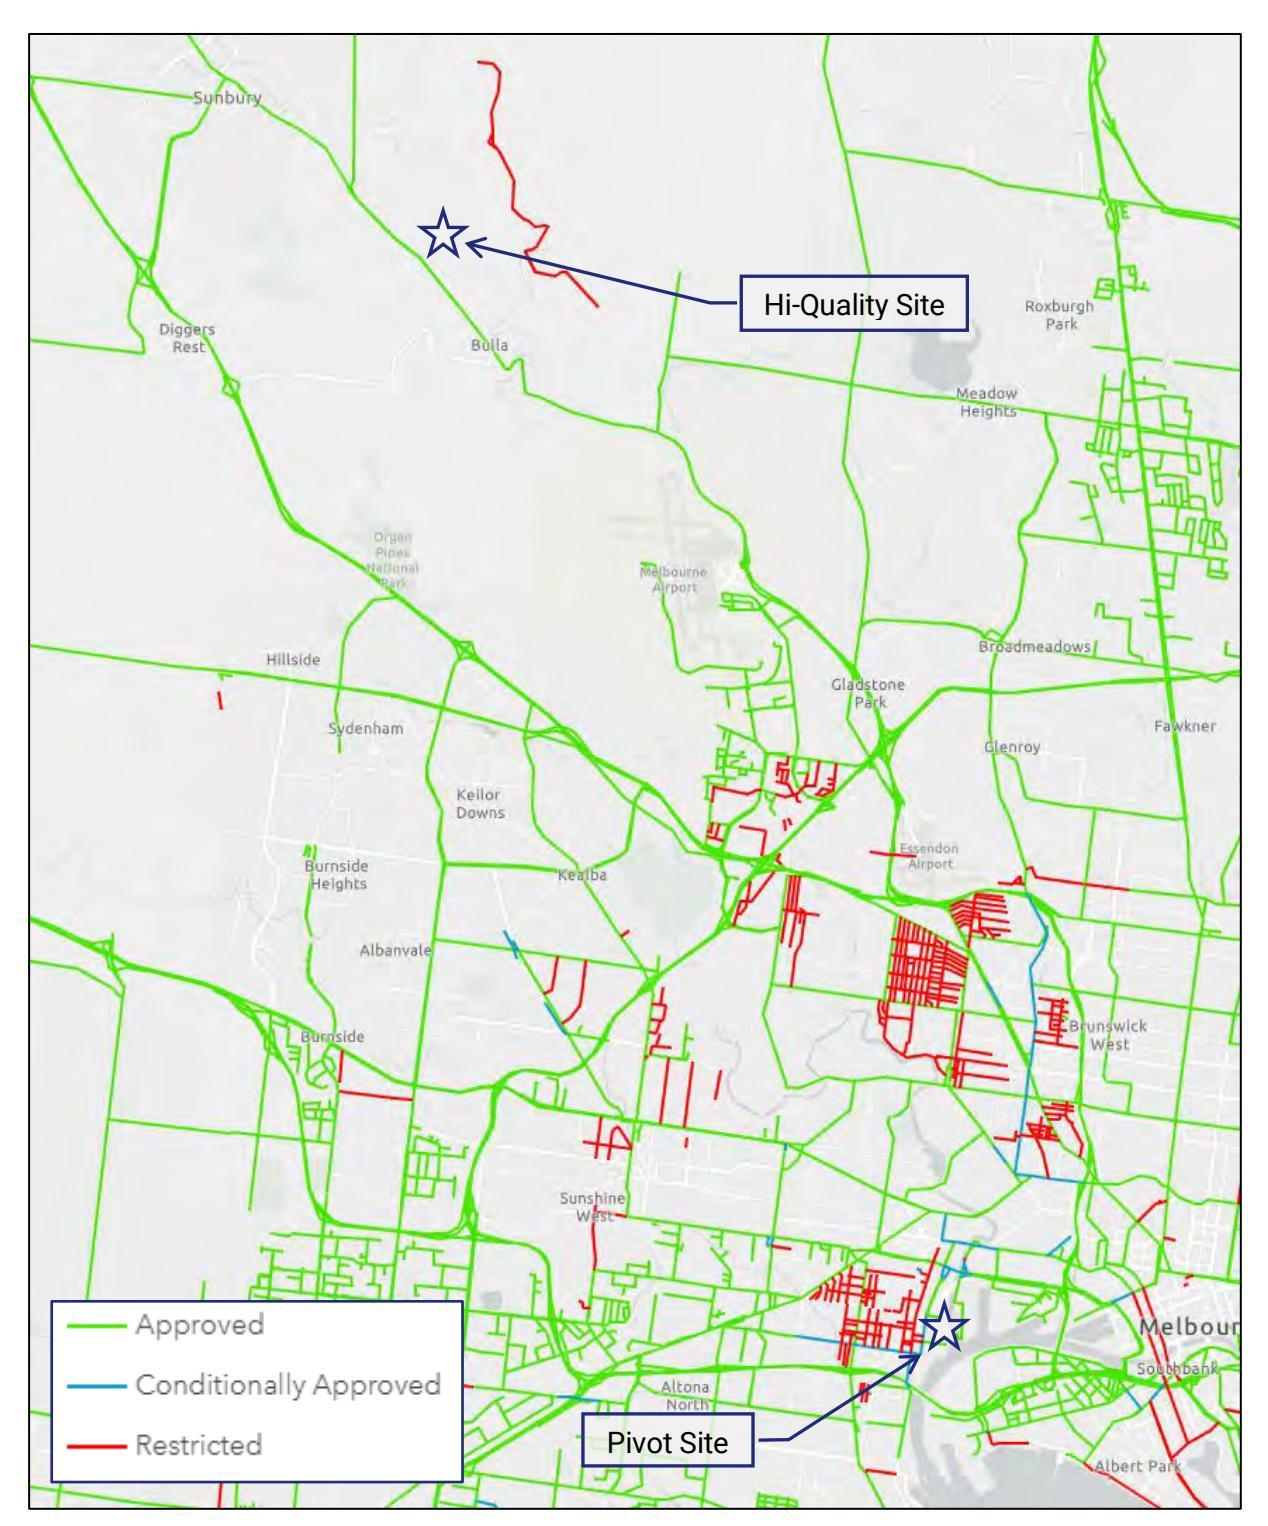
Figure 14: B-Double Approved Road Network

In the vicinity of the Pivot Site, a number of streets are B-double approved routes with others conditionally approved. A number of streets immediately to the west of the Pivot Site are restricted.

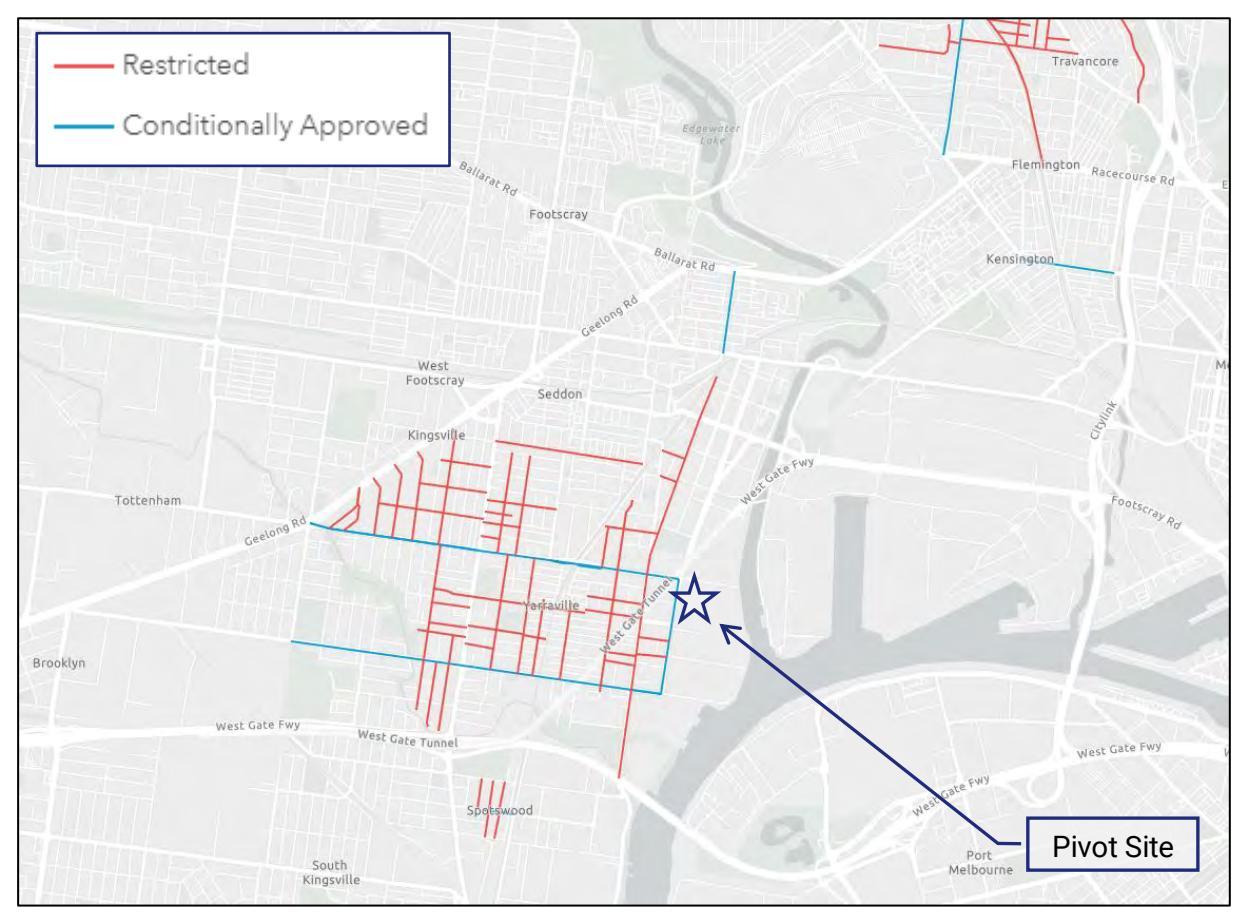
Figure 15: Truck Curfews and Restrictions

A map showing truck curfews and restrictions in the area surrounding the Pivot Site is shown in Figure 15 below. No restrictions are in place in the area surrounding the Hi-Quality site.

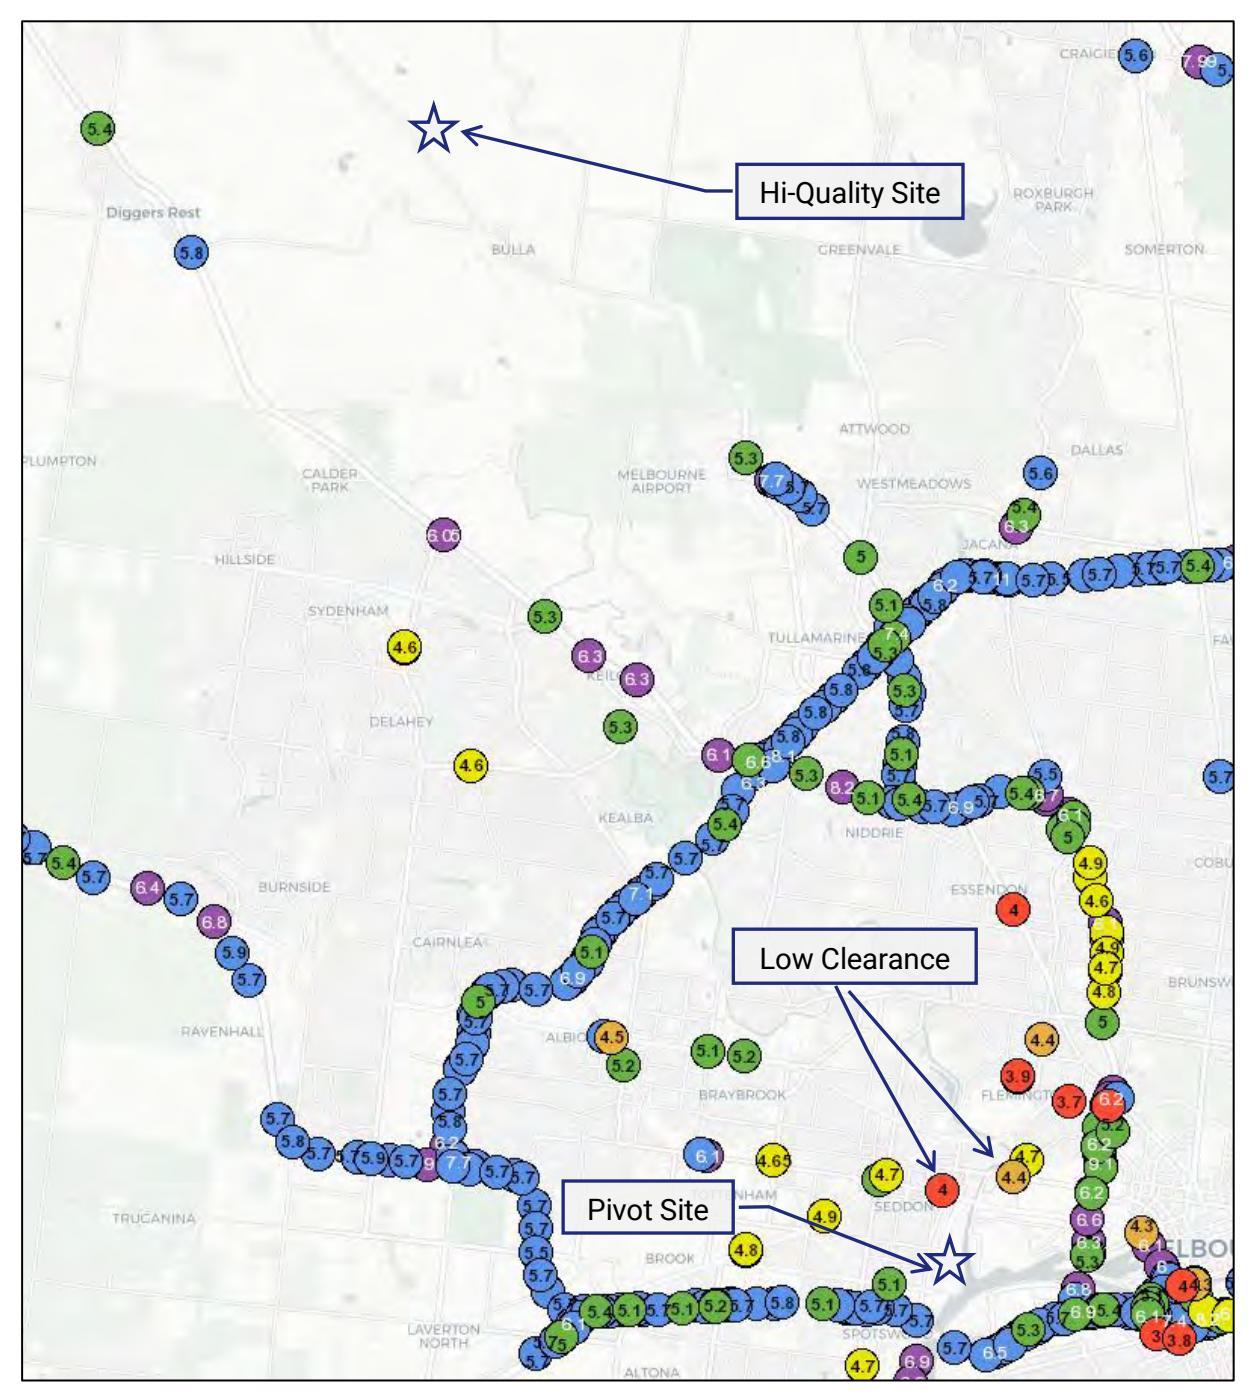
Figure 16: Height Clearances Map

Height clearances on roads between the Pivot Site and the Hi-Quality Site are presented on the map at Figure 16 below. Notably, there is a 4m low clearance bridge on Napier Street beneath the Footscray to Newport Railway and a 4.4m low clearance bridge on Dynon Road beneath the freight rail lines. The design clearance for articulated vehicles outlined in the Australian Standards is 4.3m.

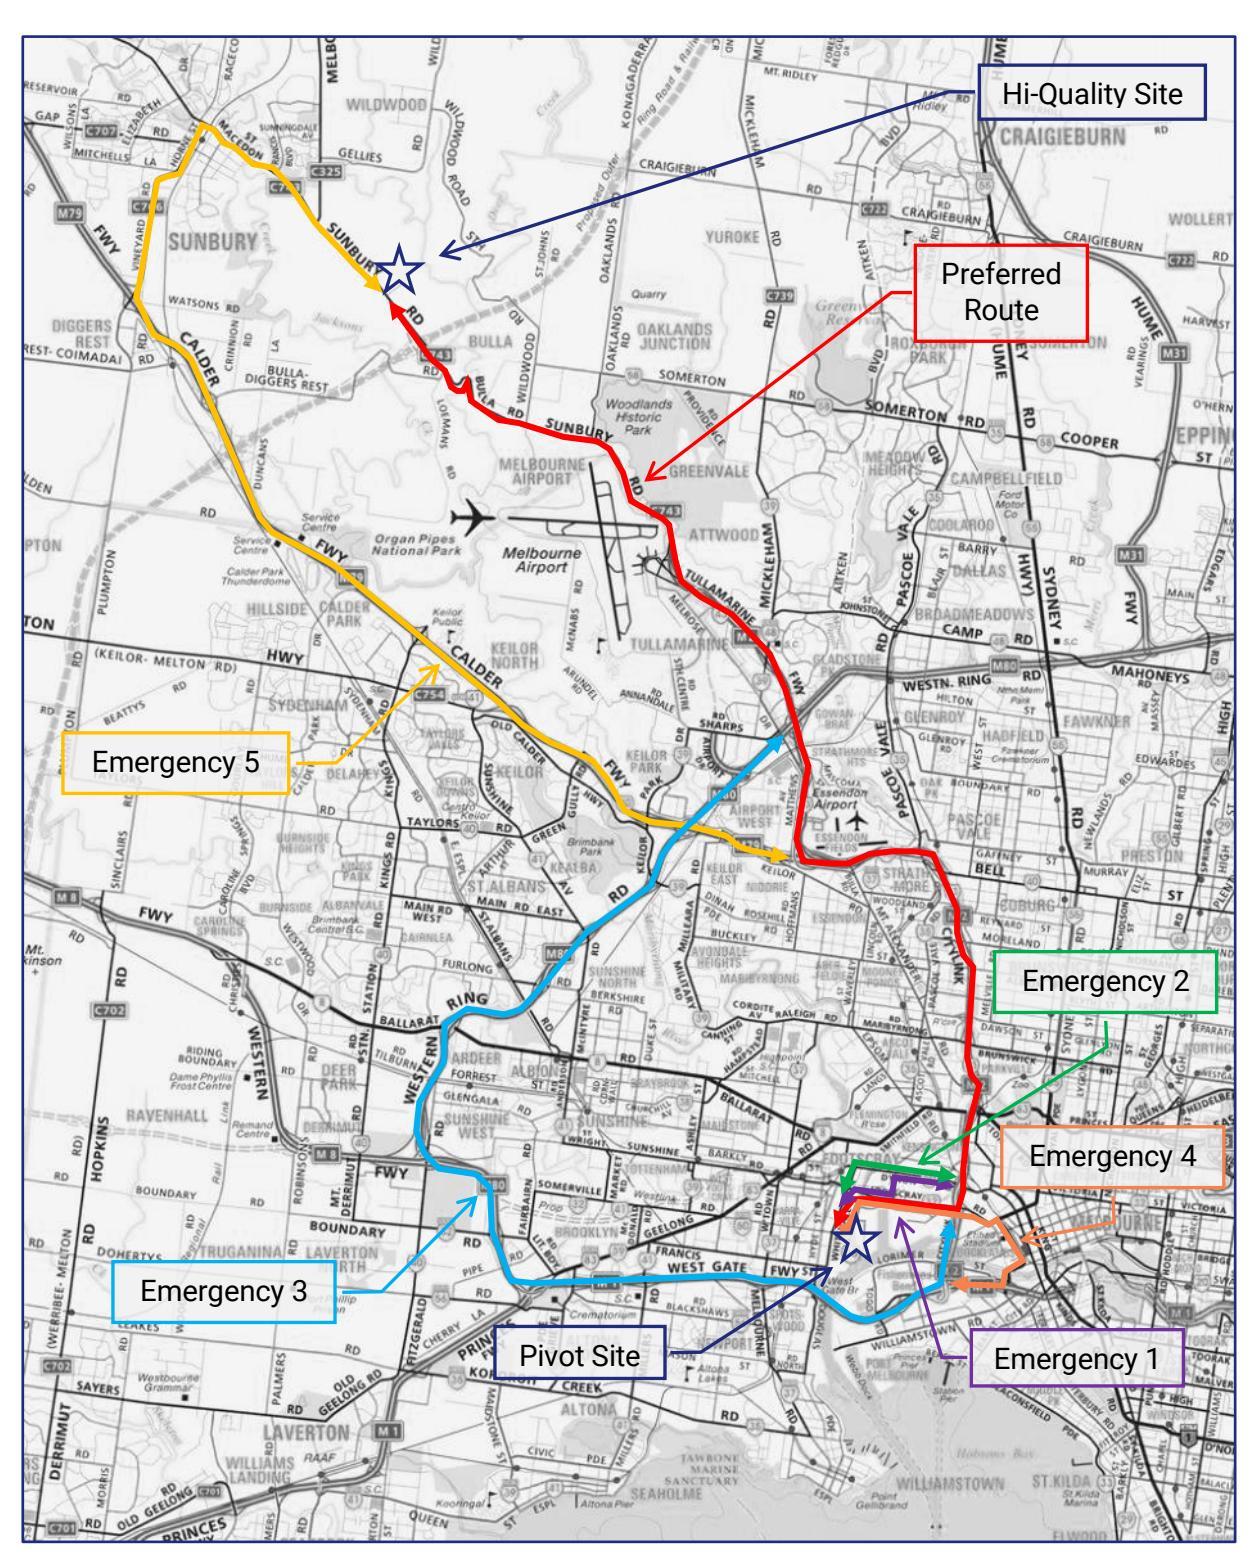
Figure 18: Emergency Haulage Routes

Alt. Route No.	Route Description	Conditions for Use
Emergency Route 1	Whitehall Street, Moreland Street, Footscray Road, Dock Link Road, Dynon Road to CityLink then as per Preferred Route.	For total road closure of Footscray Road east of Dock Link Road.
Emergency Route 2	Whitehall Street, Dynon Road to CityLink then as per Preferred Route.	For total road closure of Footscray Road west of Dock Link Road.
Emergency Route 3	Whitehall Street, Moreland Street, Footscray Road, CityLink, West Gate Freeway, M80 Ring Road to Tullamarine Freeway then as per Preferred Route.	For total road closure of CityLink north of Dynon Road.
Emergency Route 4	Whitehall Street, Moreland Street, Footscray Road, Dudley Street, Wurundjeri Way to Westgate Freeway then as per Emergency Route 3.	For total road closure of CityLink north of Dynon Road and south of Footscray Road
Emergency Route 5	As per Preferred Route to end of CityLink, then Calder Freeway, Vineyard Road, Horne Street, Macedon Street to Sunbury Road.	For road closure to all traffic on Tullarmaine Freeway-Sunbury Road.

The emergency haulage routes are shown in Figure 18 below.

Should a structural inspection required by Condition 5.1.5.5 identify significant change in the structural condition of the Deep Creek bridge, the emergency haulage route identified as Emergency 5 in Figure 18 of this Traffic Management Plan will be implemented until such time as repair works can be completed.

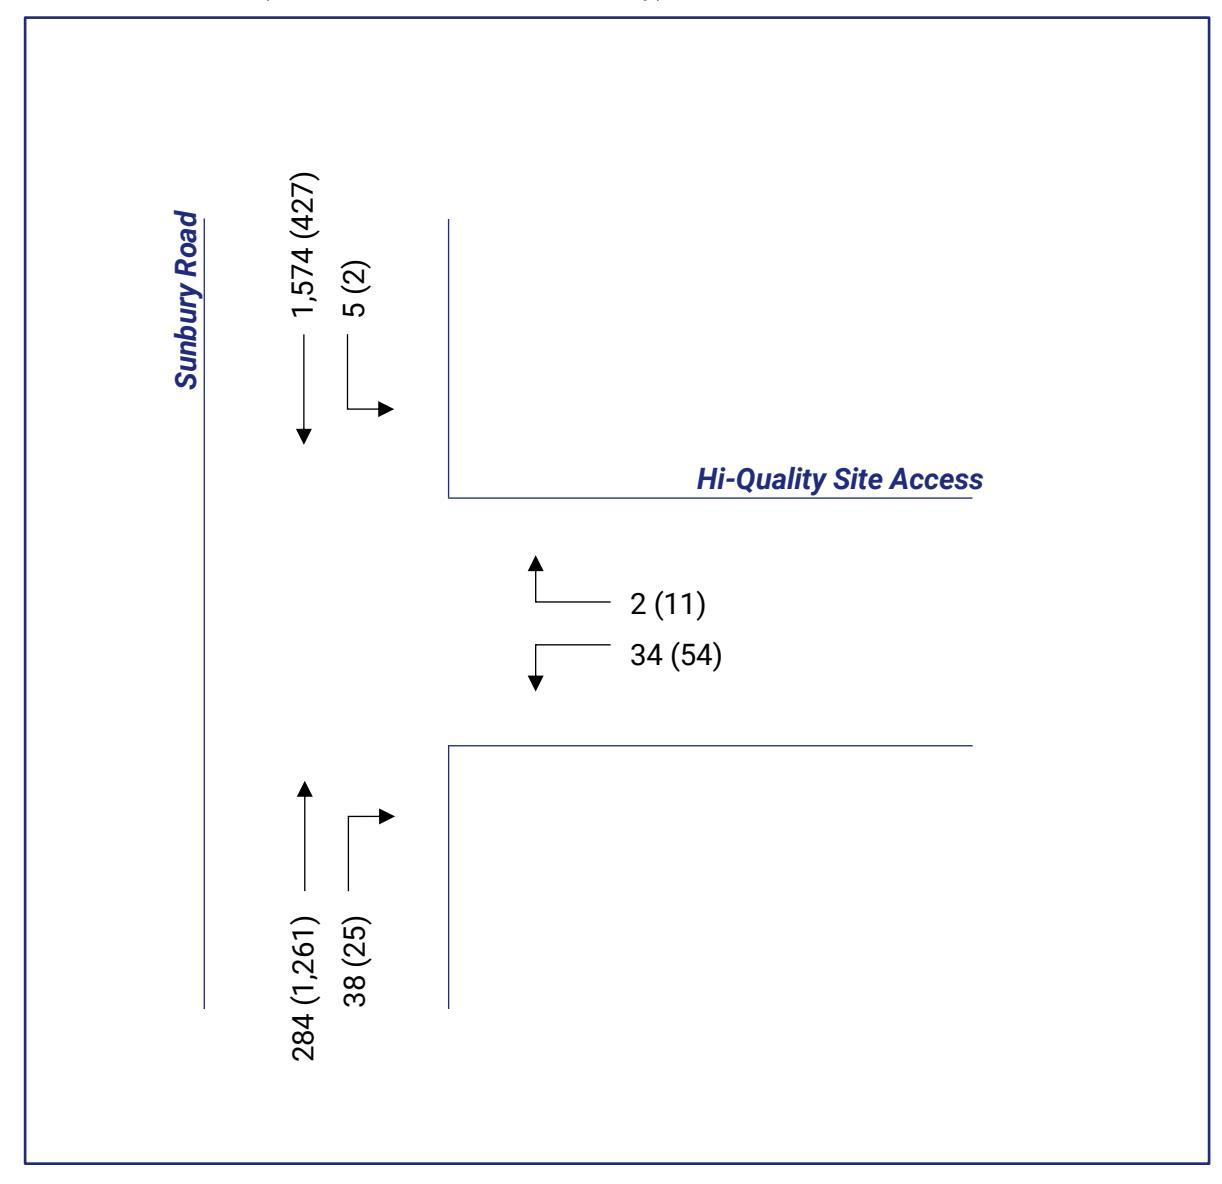
Figure 19: Hi-Quality Site Access - Post-development AM(PM) Peak Hour Traffic Volumes – Peak Conditions

The anticipated post-development traffic volumes at the Hi-Quality Site's access during peak operation periods (15,000 tonnes of spoil per day) are shown in Figure 19 below.

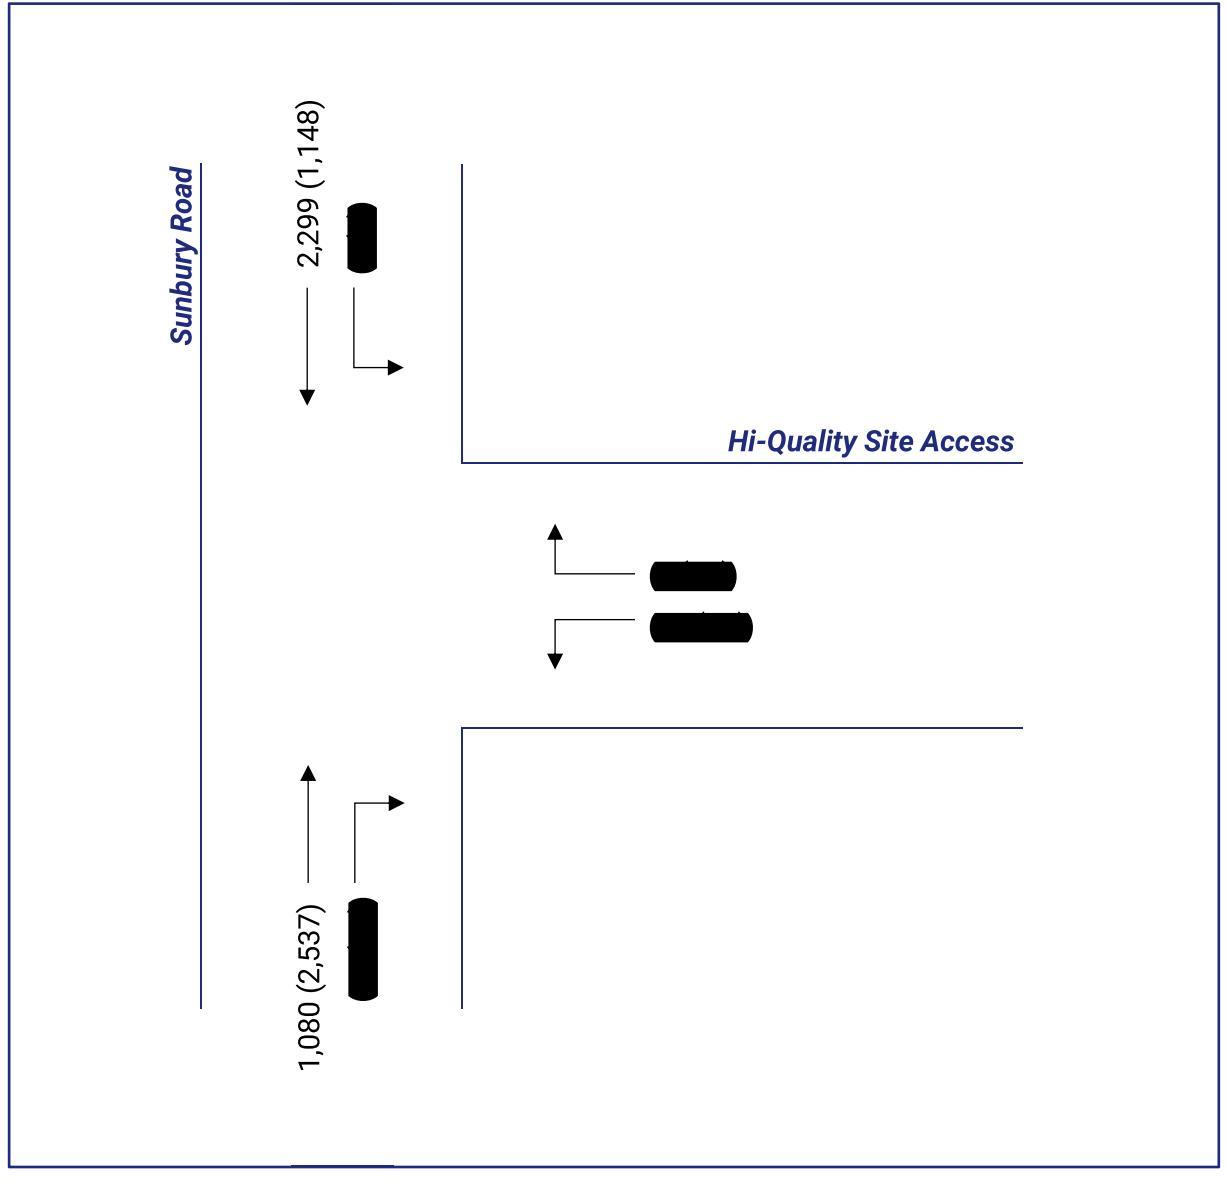
Figure 20: Hi-Quality Site Access - Future AM(PM) Peak Hour Traffic Volumes

The anticipated future traffic volumes at the Hi-Quality Site's access point (taking into account the projected year 2031 volumes outlined in Table 1) are shown in Figure 20 below.

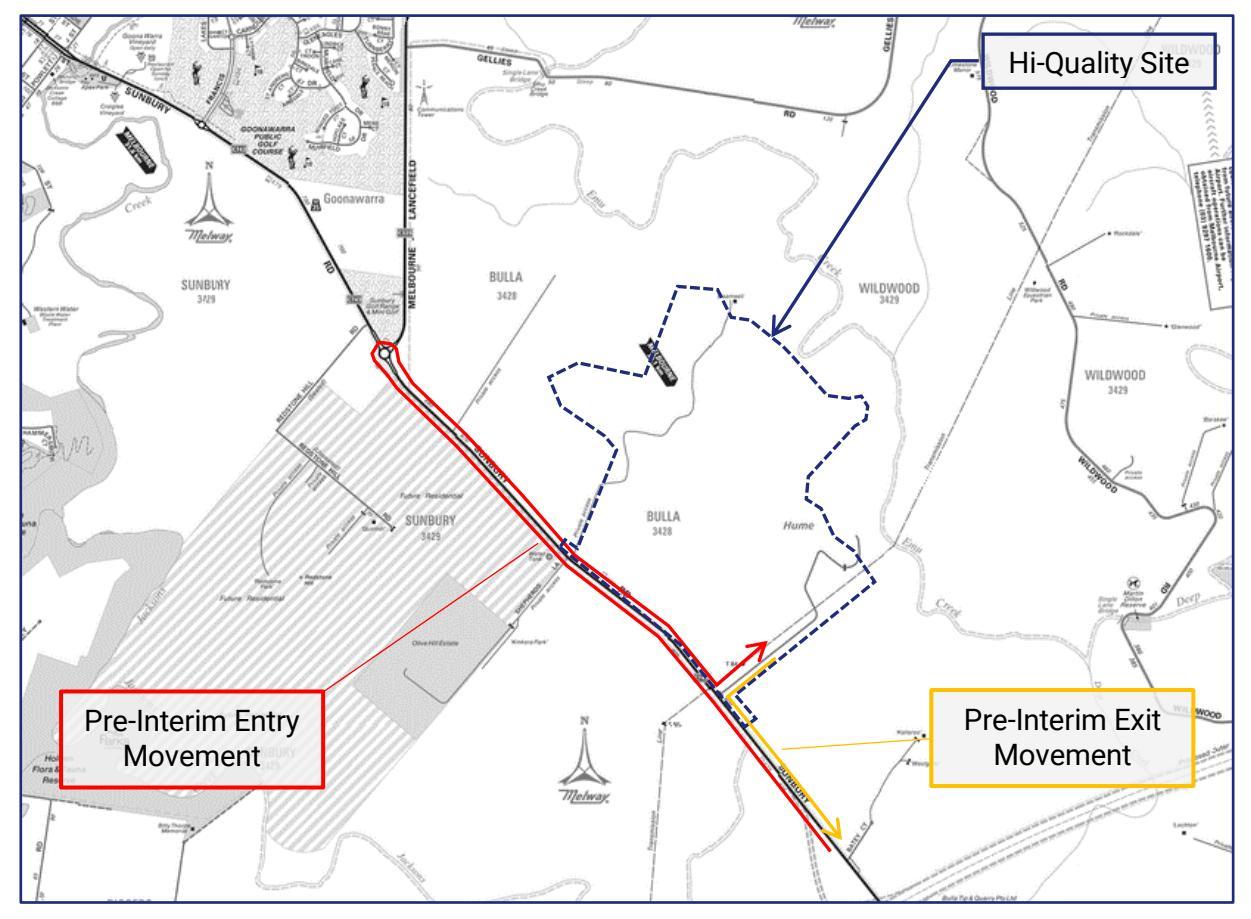
Figure 21: Pre-Interim Alternative Site Access Route - Contingency Route

The contingency route is shown in Figure 21 below.

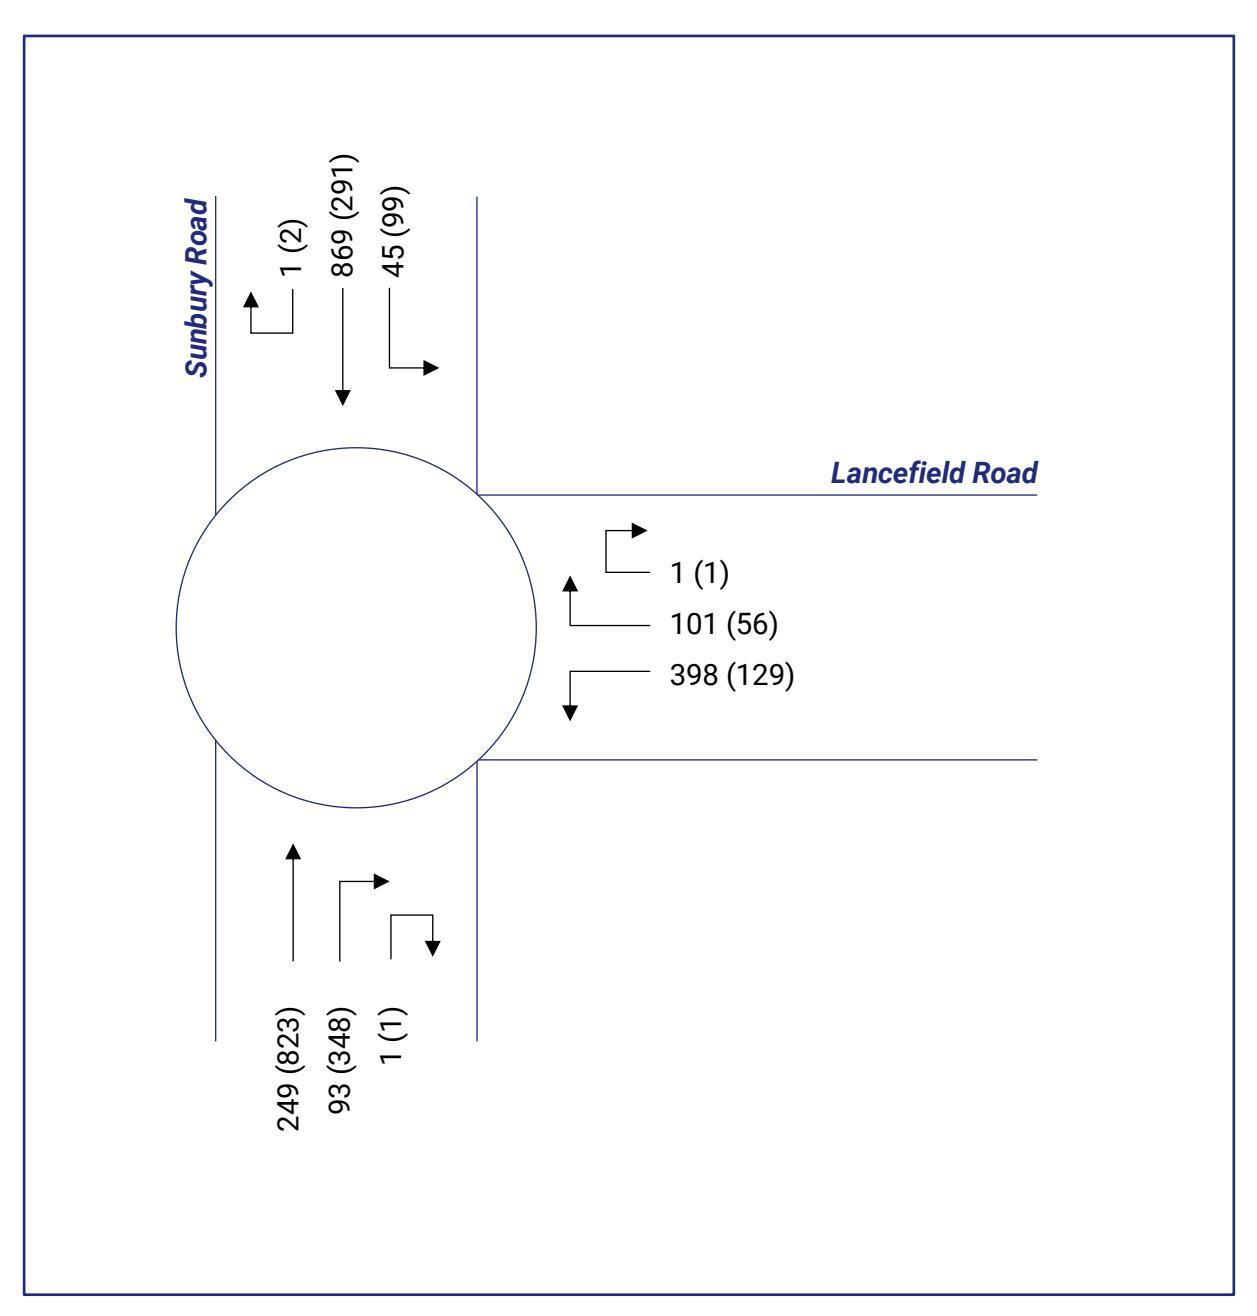
Figure 22: Sunbury Road/Lancefield Road - Existing AM(PM) Peak Hour Traffic Volumes

A SIDRA analysis of the intersection under existing conditions, and "worst case" (peak spoil removal) pre-interim conditions, where an additional 18 heavy vehicles undertake a U-turn from the south-east approach has been undertaken.

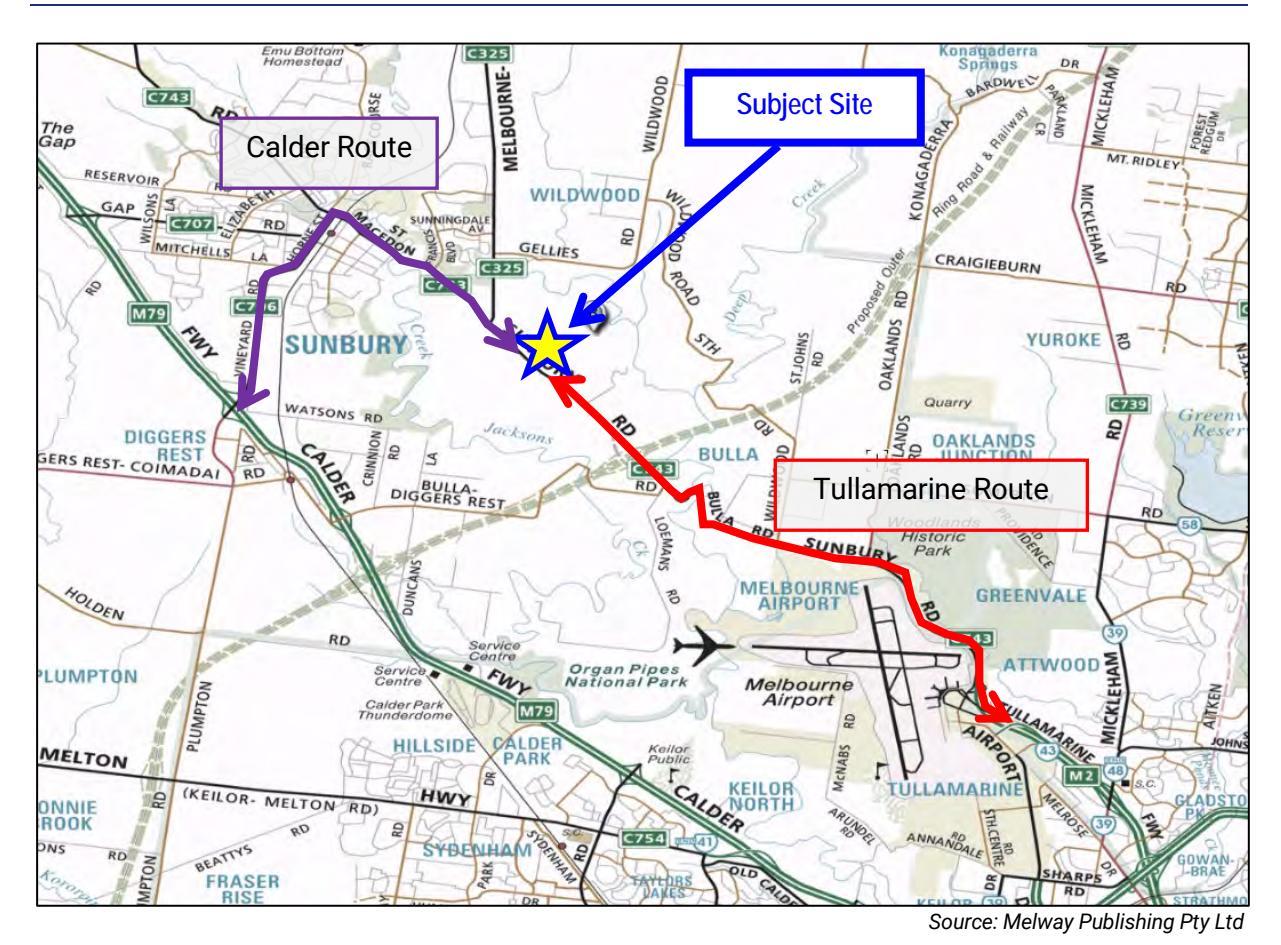
Figure 2: Vehicle Routes

The vehicle routes to/from the site, referred to herein as the Tullamarine and Calder Routes, are shown within Figure 2.
