Traffic Management Plan

Bulla Spoil Processing Facility 570-650 Sunbury Road, Bulla

Prepared for Hi-Quality Group

G27938R-02E

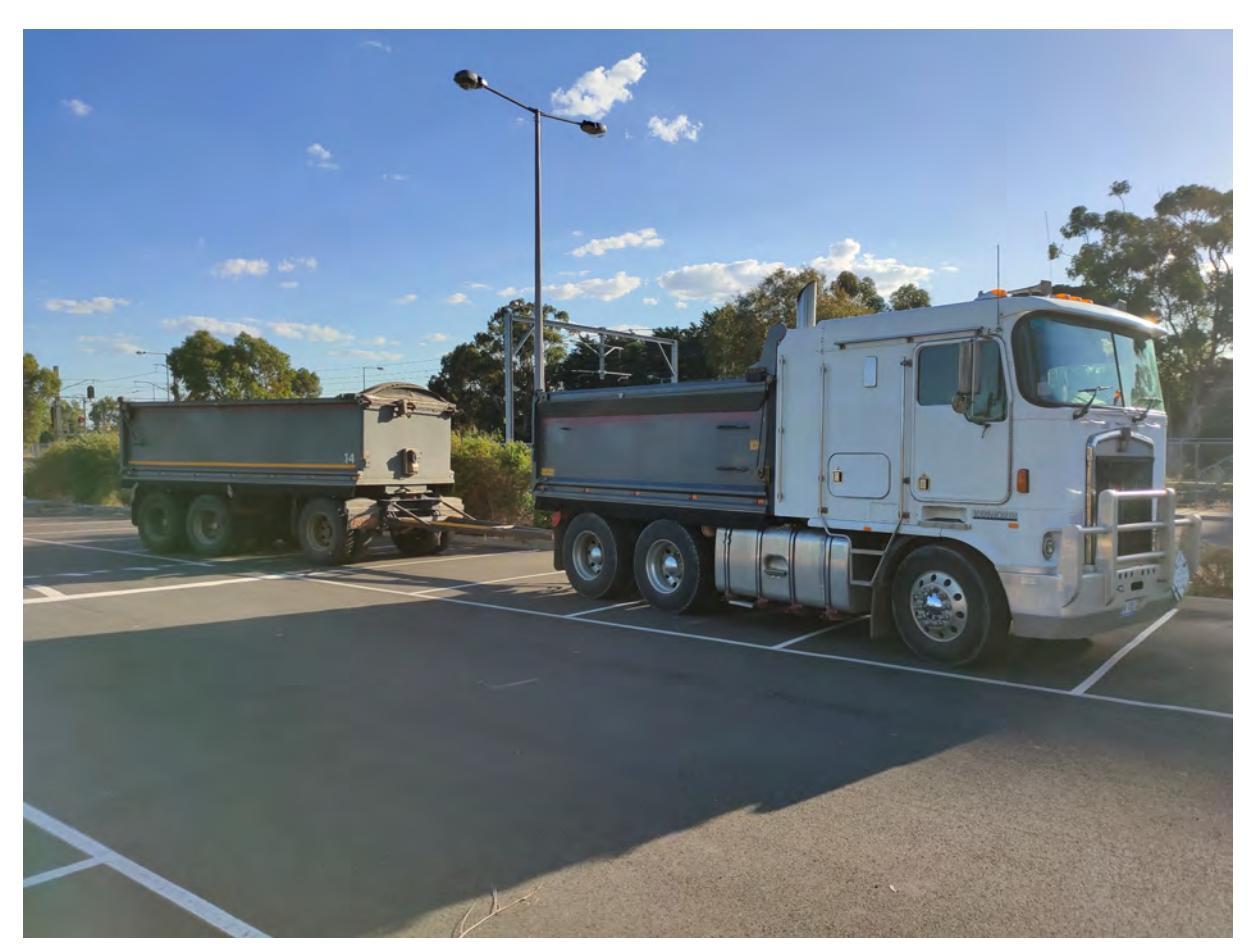
Figure 3: Truck & Dog Trailer used for inspection

As described previously, a member of the project team travelled the two routes (both directions) in a truck and dog trailer during the daytime and evening periods. This allowed greater consideration of road safety associated with truck movements by allowing the team member to both observe conditions from a typical vehicle which travels to/from the Site as well as leveraging the insights of a truck driver who is familiar with the routes.

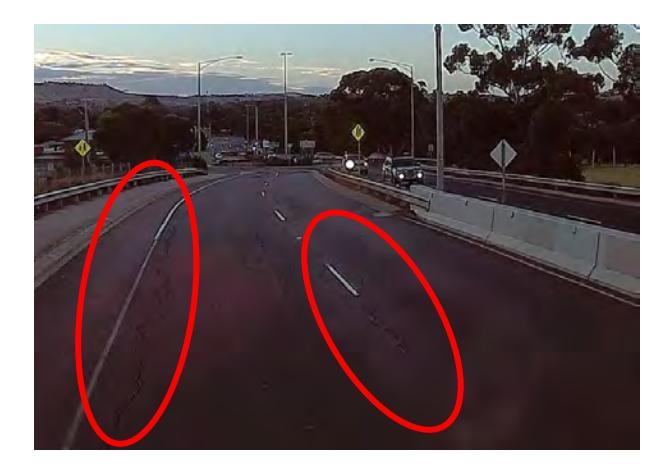
Photograph 1:

Road cracking visible

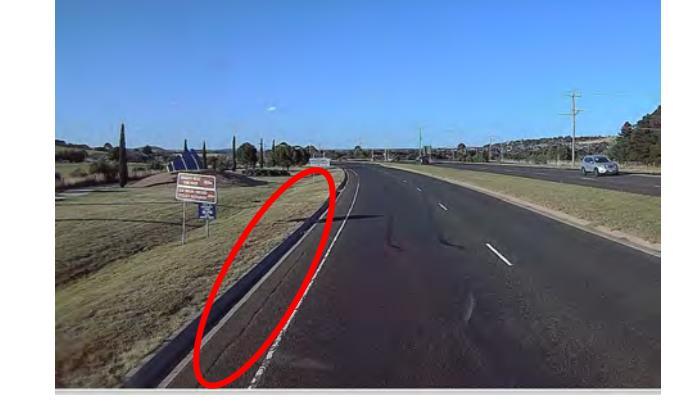
Photograph 2:

Road seal join in middle of bicycle lane

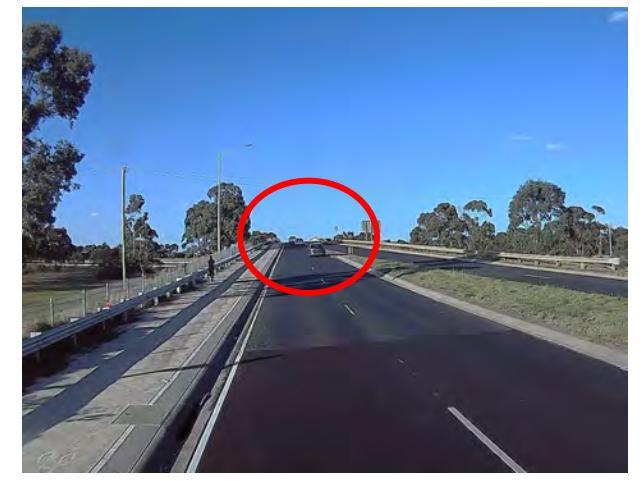
Photograph 3:

Zip merge without signage or line marking

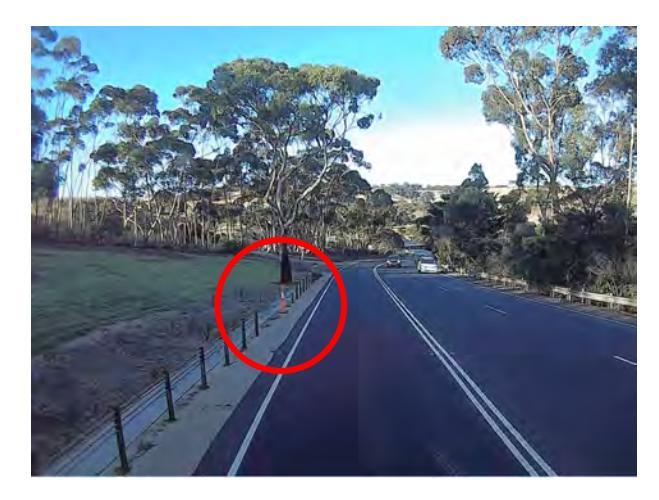
Photograph 9:

Missing barrier sections

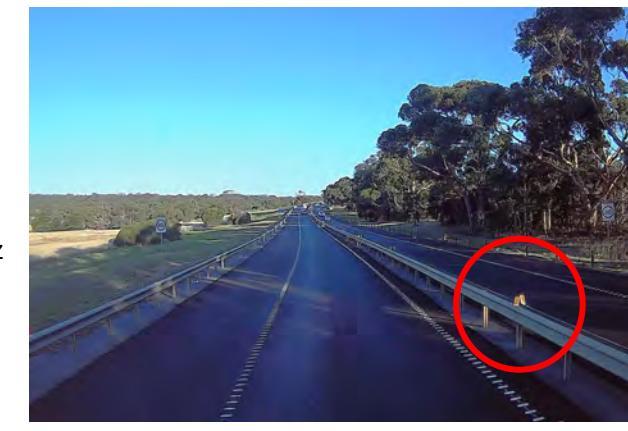
Photograph 10:

Coloured markers (night-time)

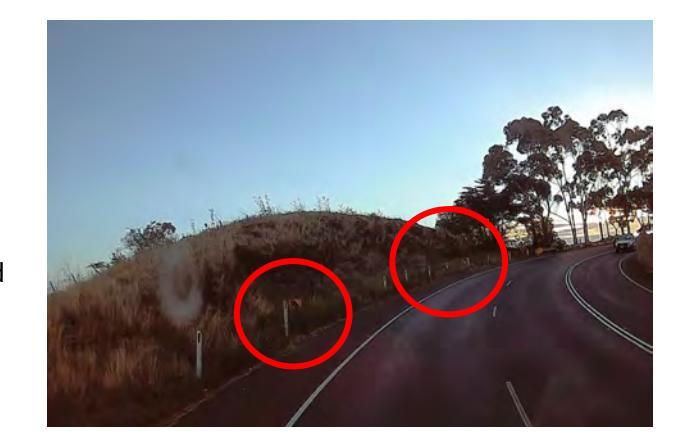
Photograph 18:

Vegetation blocking road signs

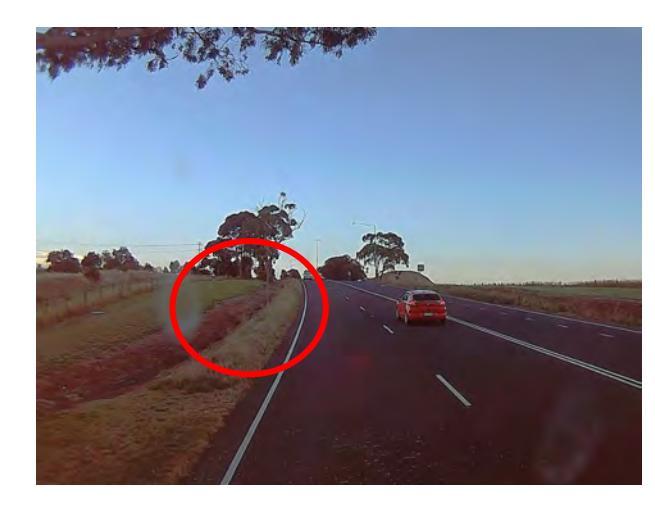
Photograph 21:

Signage pole missing sign

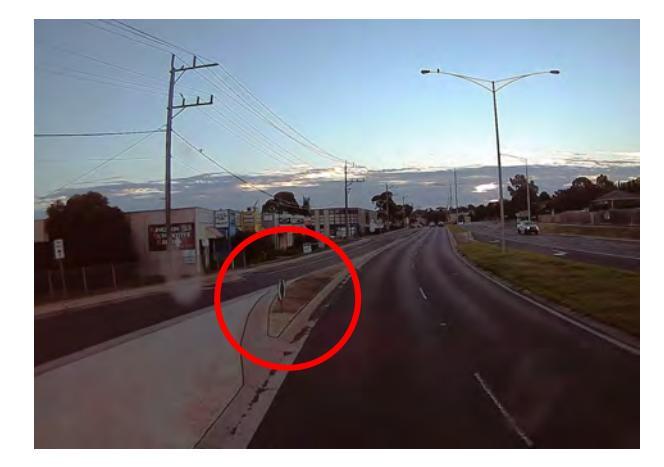
Photograph 25:

Rotated road sign

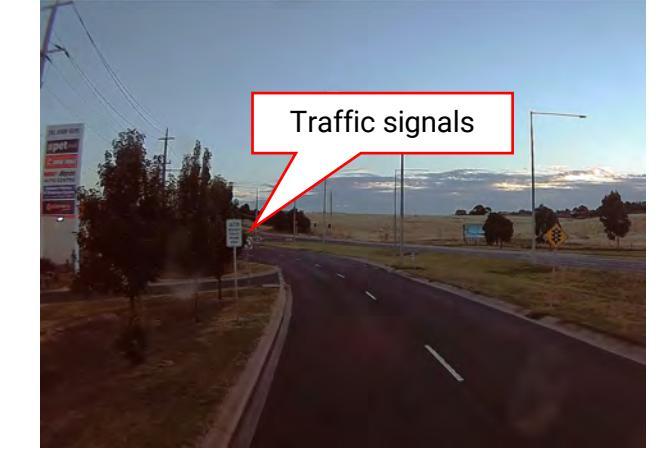
Photograph 26:

Sight distance on approach to traffic signals

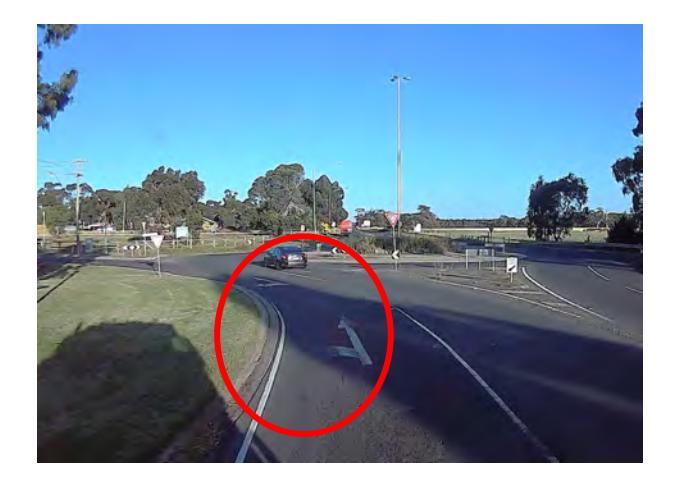
Photograph 29:

Faded directional arrows
