Suburban Rail Loop East Early Works Air Quality Monthly Report

19 March 2024 – 18 April 2024

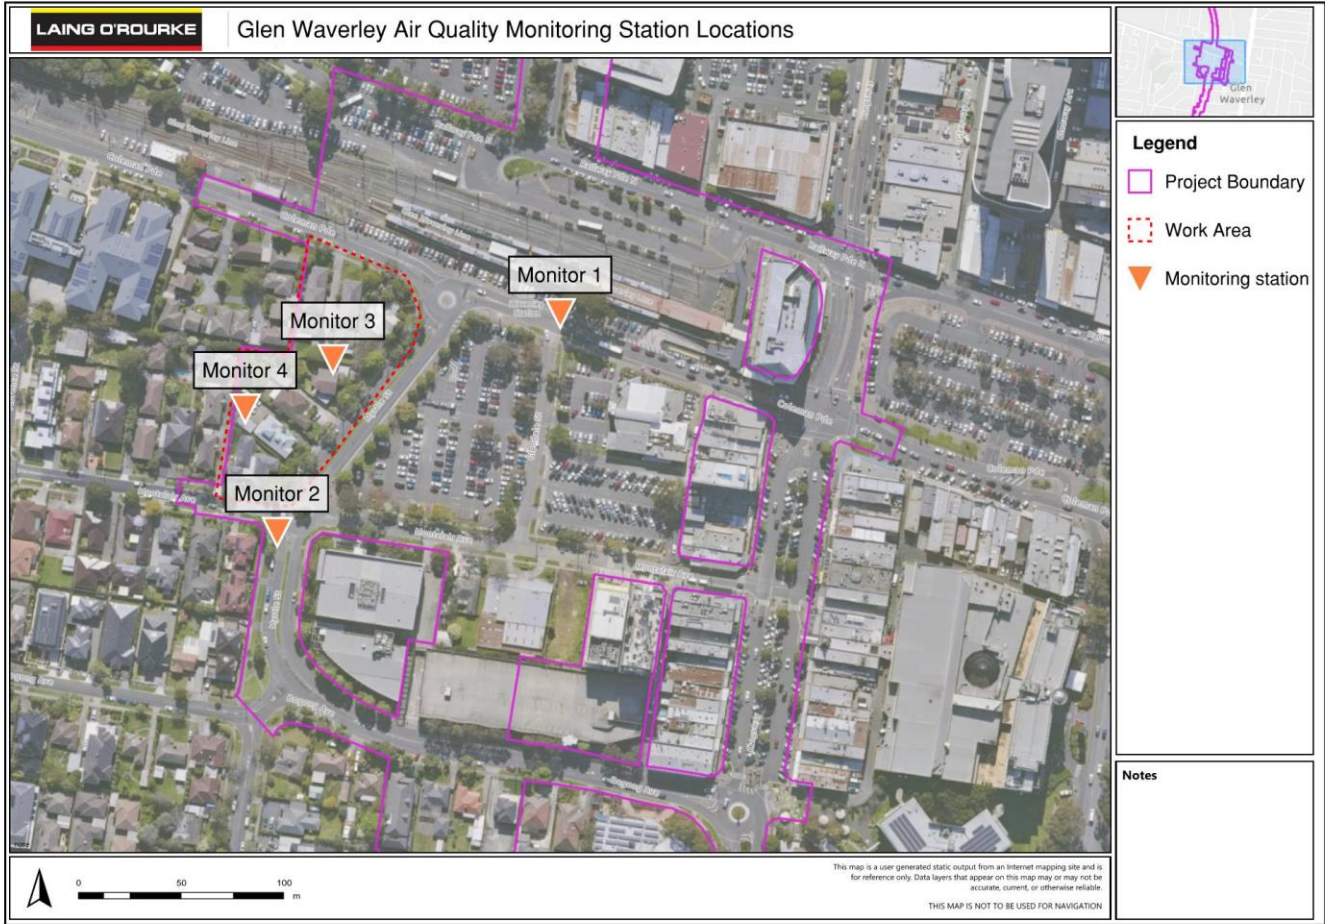
Figure 5: Glen Waverley air quality monitoring stations.

New air quality monitors were commissioned on 11 March 2024 and 11 April 2024 at Monitoring points 3 and 4, respectively, to monitor air quality during demolition works on Myrtle Street.

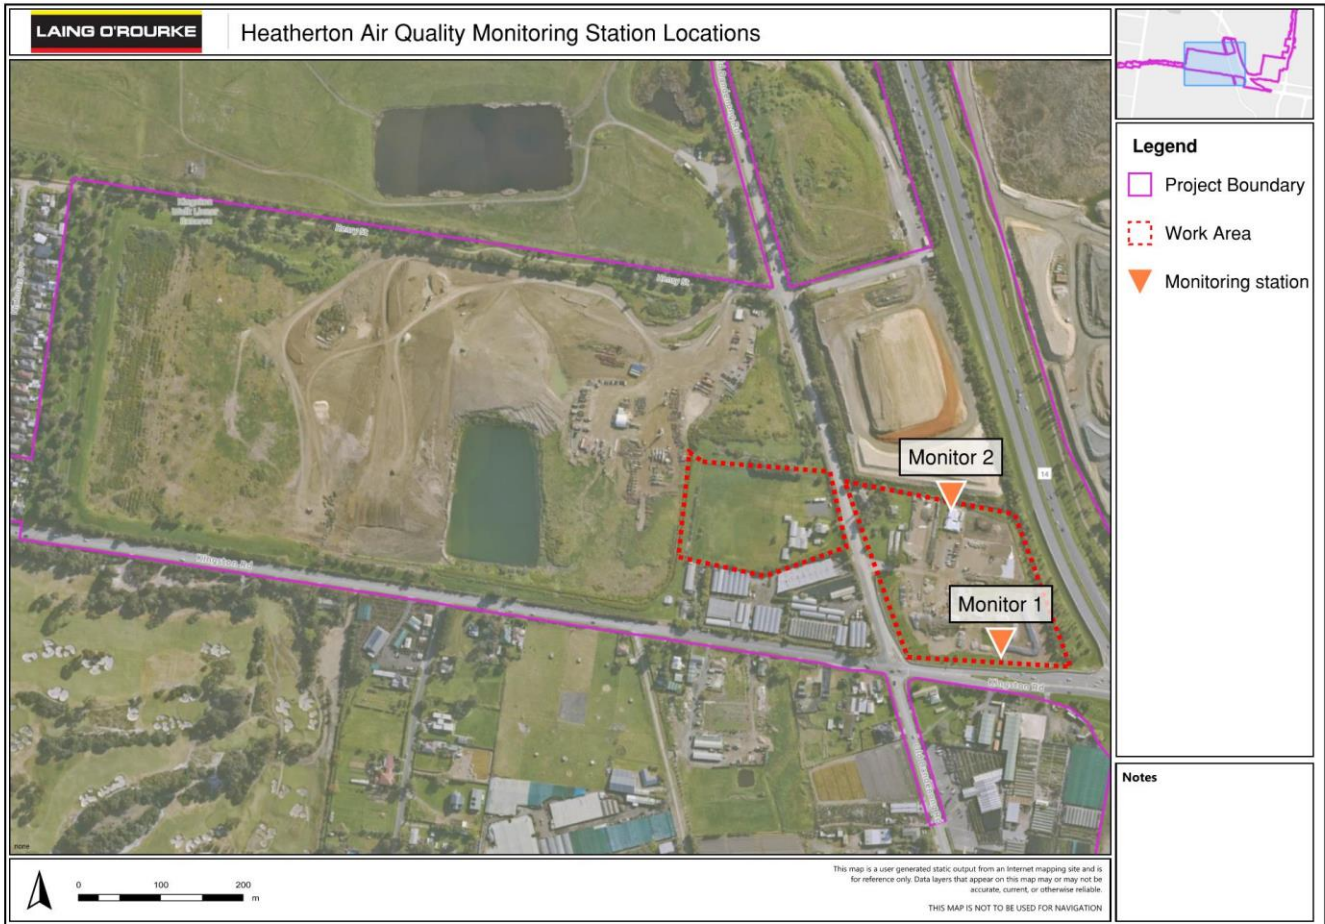
Figure 11: Heatherton air quality monitoring stations.

Note, as demolition has concluded at the 217 Kingston Rd location, Monitor 3 has been decommissioned and removed from site with no data captured during this monitoring period.
