**SUBURBAN  
RAIL LOOP**

# **Air Quality Monthly Report**

## **Early Works**

## **Tunnels South**

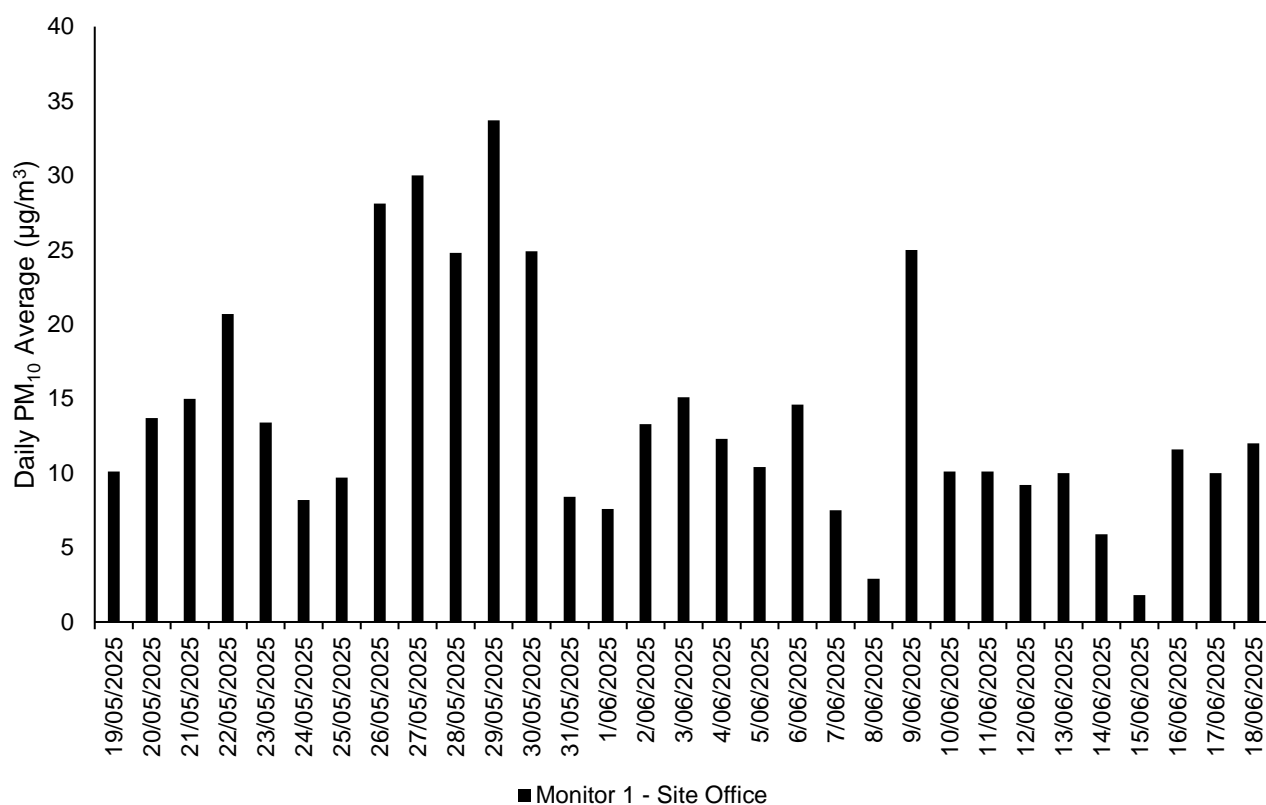
Figure 2: Box Hill PM<sub>10</sub> daily averages.

The TARP was not implemented during the reporting period. Dust generated from site establishment works were proactively suppressed using water carts and hoses. The proactive use of hoses on exposed surfaces ensured dust levels were managed. Additional dust management measures conducted on site included ensuring trucks covered their loads prior to leaving site during spoil haulage.

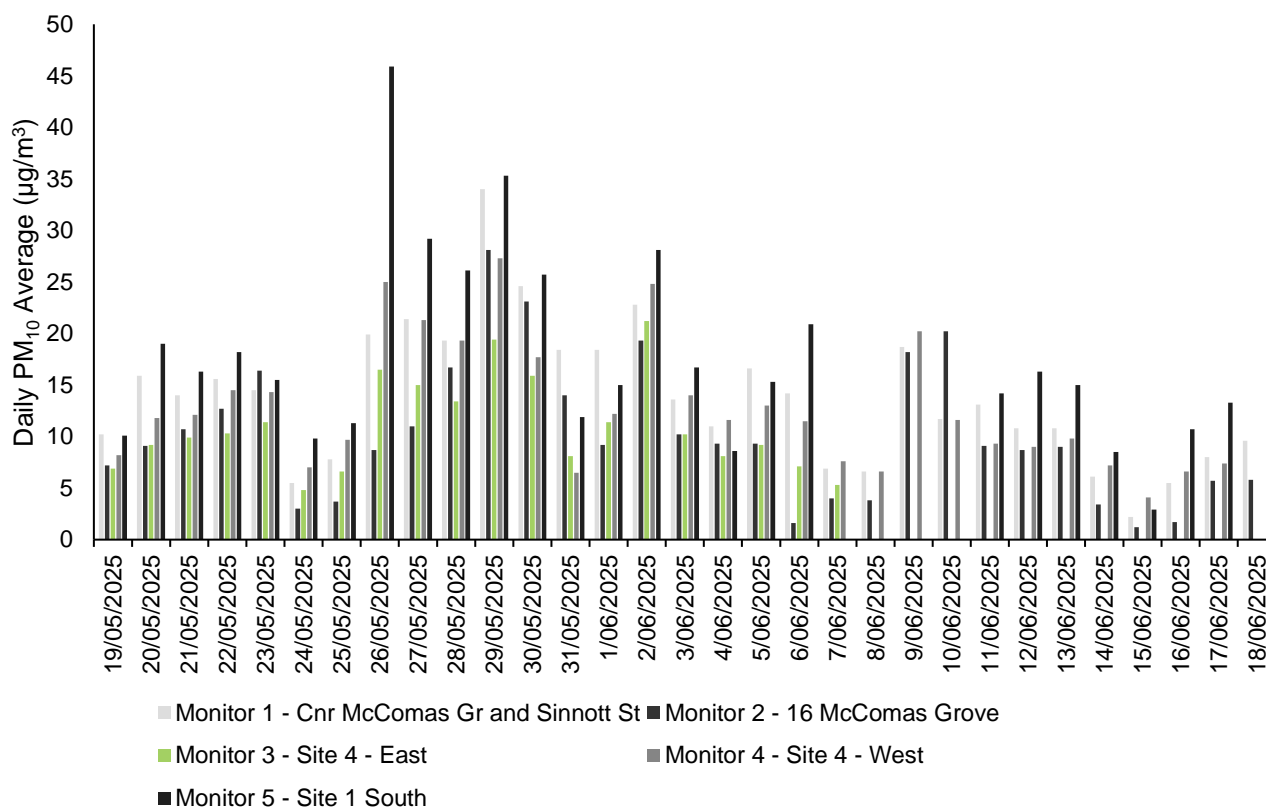
Figure 4: Burwood PM<sub>10</sub> daily averages.

The TARP was not implemented during the reporting period. Water carts and hoses were used proactively to manage dust. Other dust management measures implemented on site included trucks covering loads prior to leaving site during spoil haulage. Stockpiles of soil were maintained below the top of the hoarding to minimise the risk of dust leaving the site. Additionally, stockpiles and exposed surfaces were routinely dampened during worktimes to prevent dust.

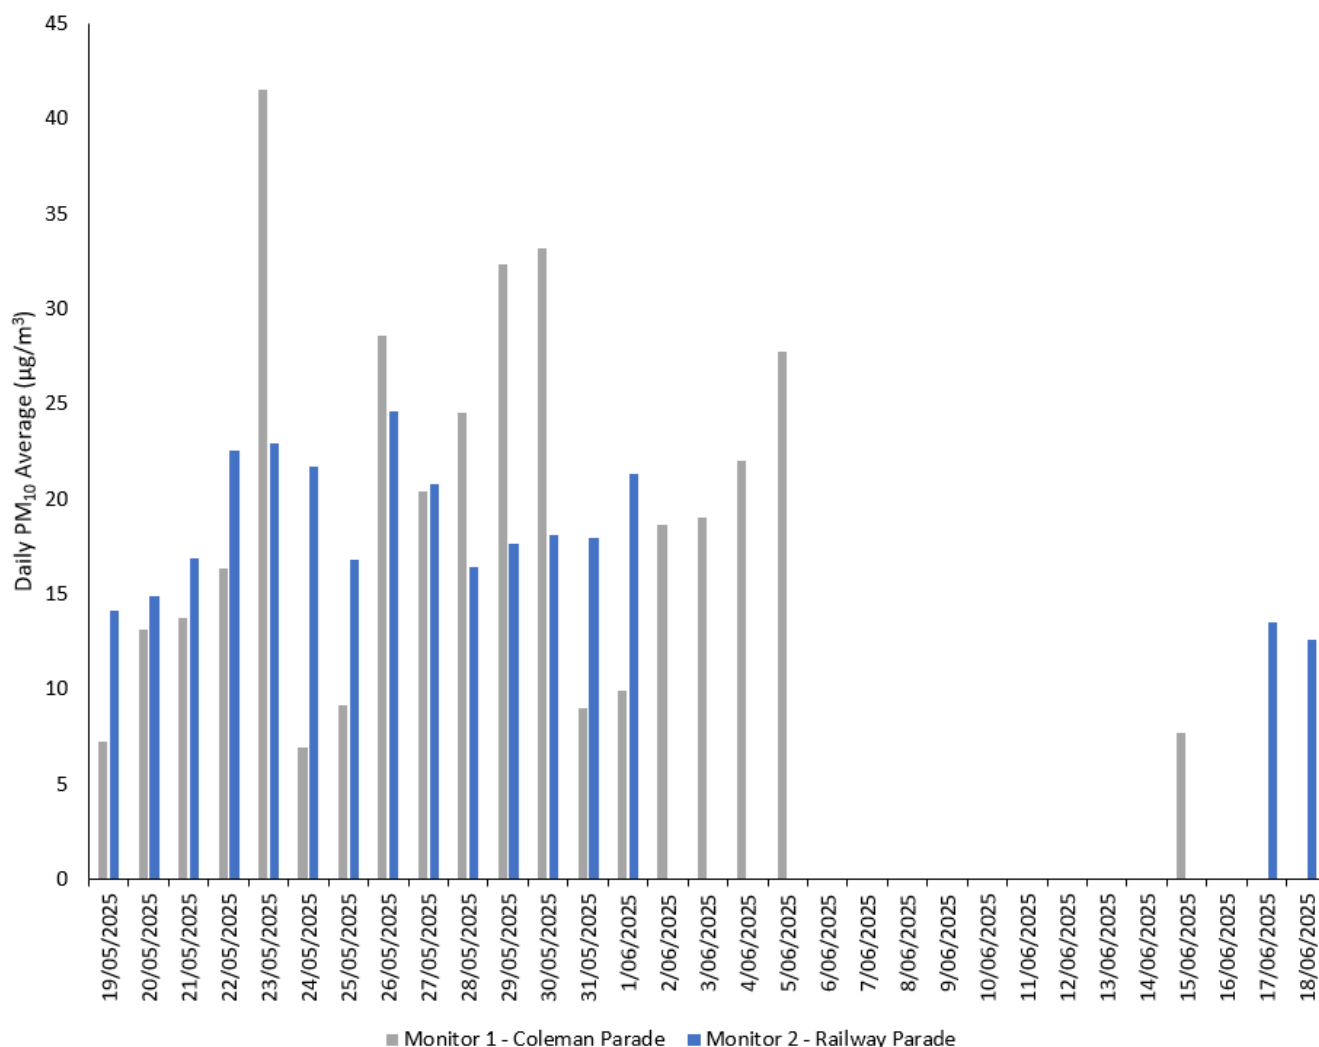
Figure 6: Glen Waverley PM<sub>10</sub> daily averages.

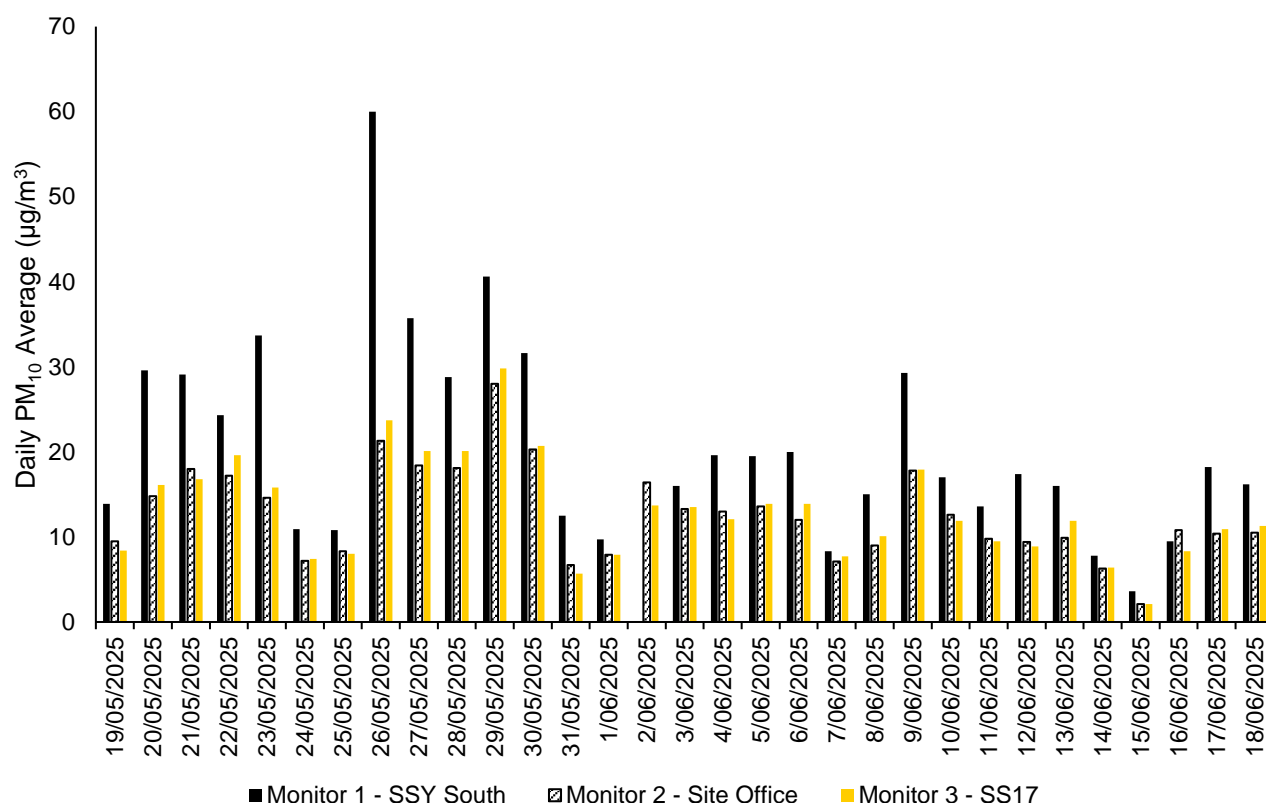
Figure 8: Heatherton PM<sub>10</sub> daily averages.

Throughout the month, southerly winds likely caused high readings for the SSY South Monitor. These readings do not accurately reflect on-site conditions. The Heatherton site is in an industrial area with several neighbouring properties undertaking earthworks with large areas of exposed soil. On days where there are strong winds, airborne dust generated off-site has been observed to be blown onto the Heatherton site, contributing to elevated onsite monitoring results.

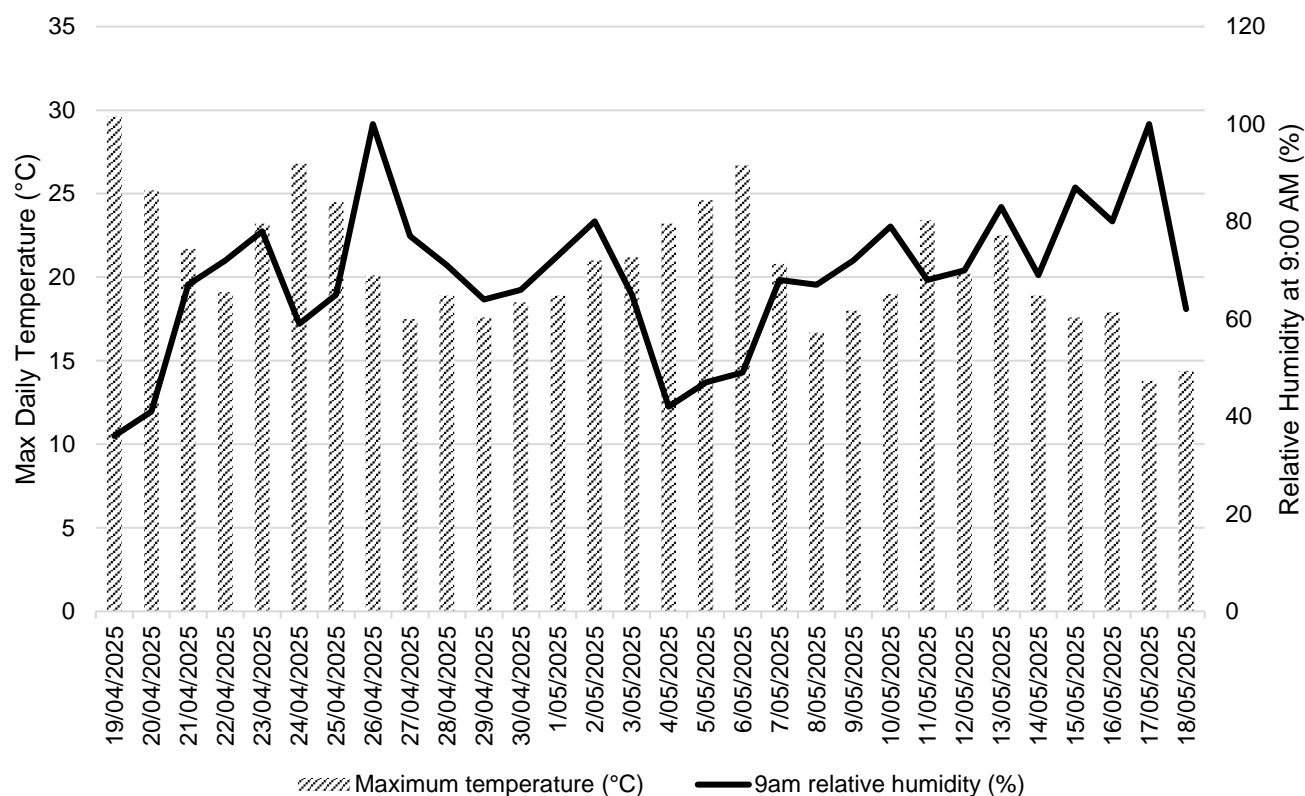
Figure 9: Daily relative humidity and temperature observations for Melbourne (Olympic Park), Victoria 19 May 2025 – 18 June 2025. Data Source BOM.

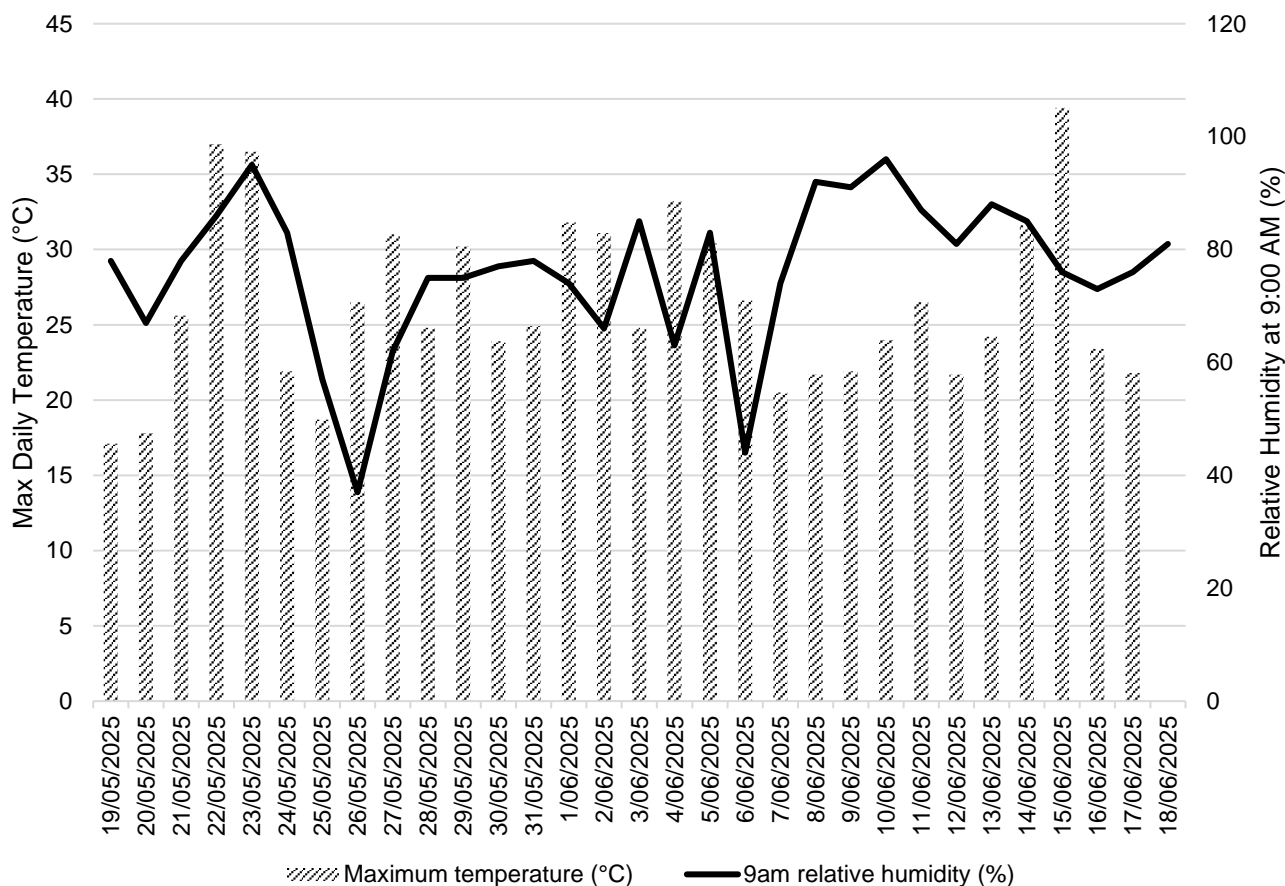
Figure 10: Daily relative humidity and temperature observations for Melbourne (Moorabbin), Victoria 19 May 2025 – 18 June 2025. Data Source BOM.

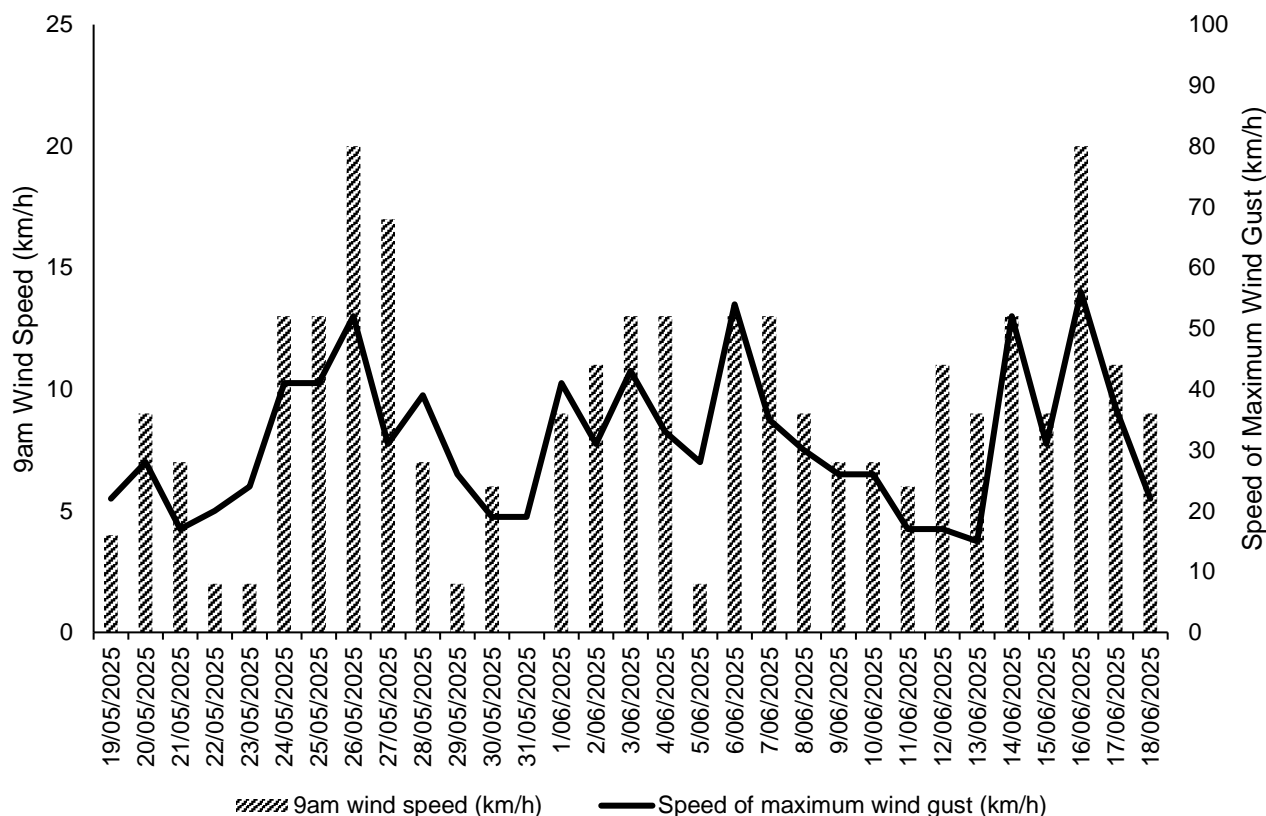
Figure 11: Daily wind speed observations for Melbourne (Olympic Park), Victoria 19 May 2025 – 18 June 2025. Data Source BOM.

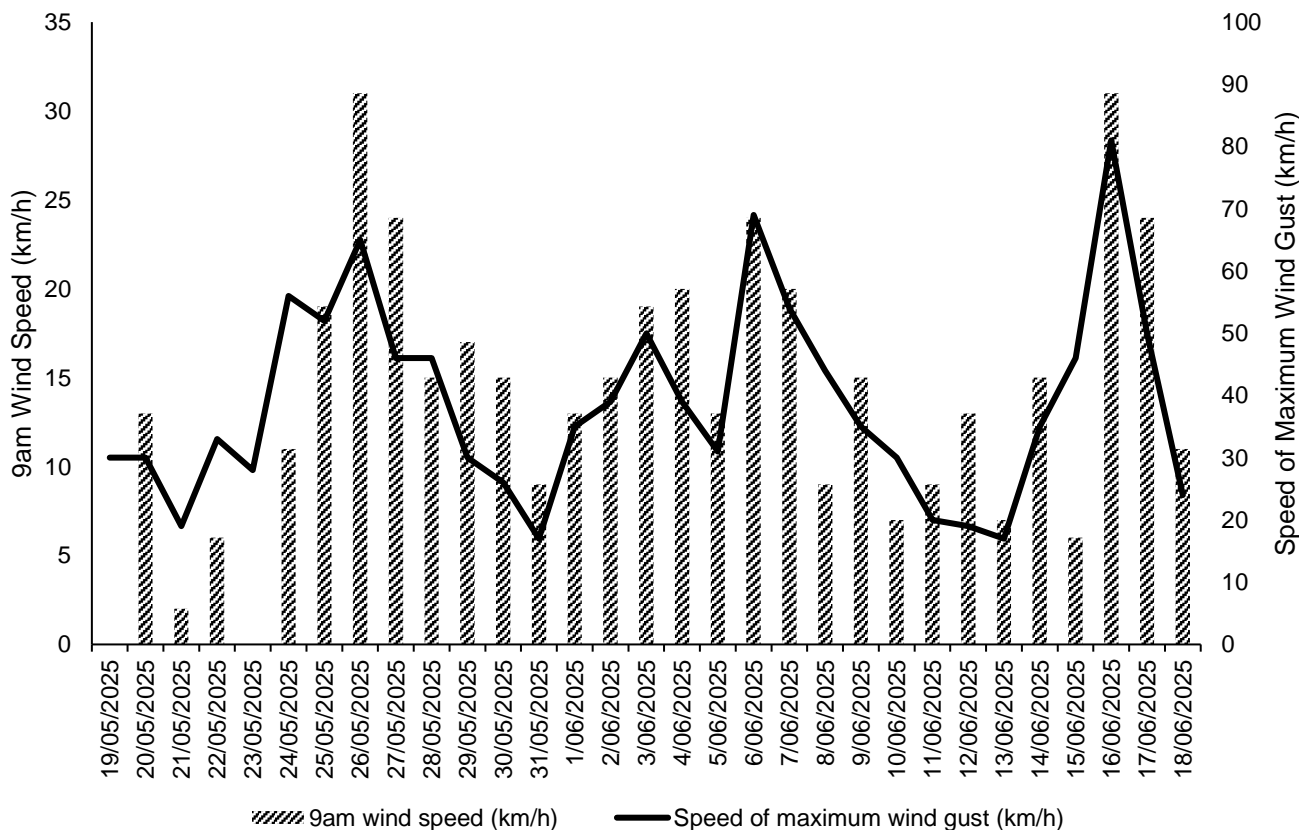
Figure 12: Daily wind speed observations for Melbourne (Moorabbin), Victoria 19 May 2025 – 18 June 2025. Data Source BOM.

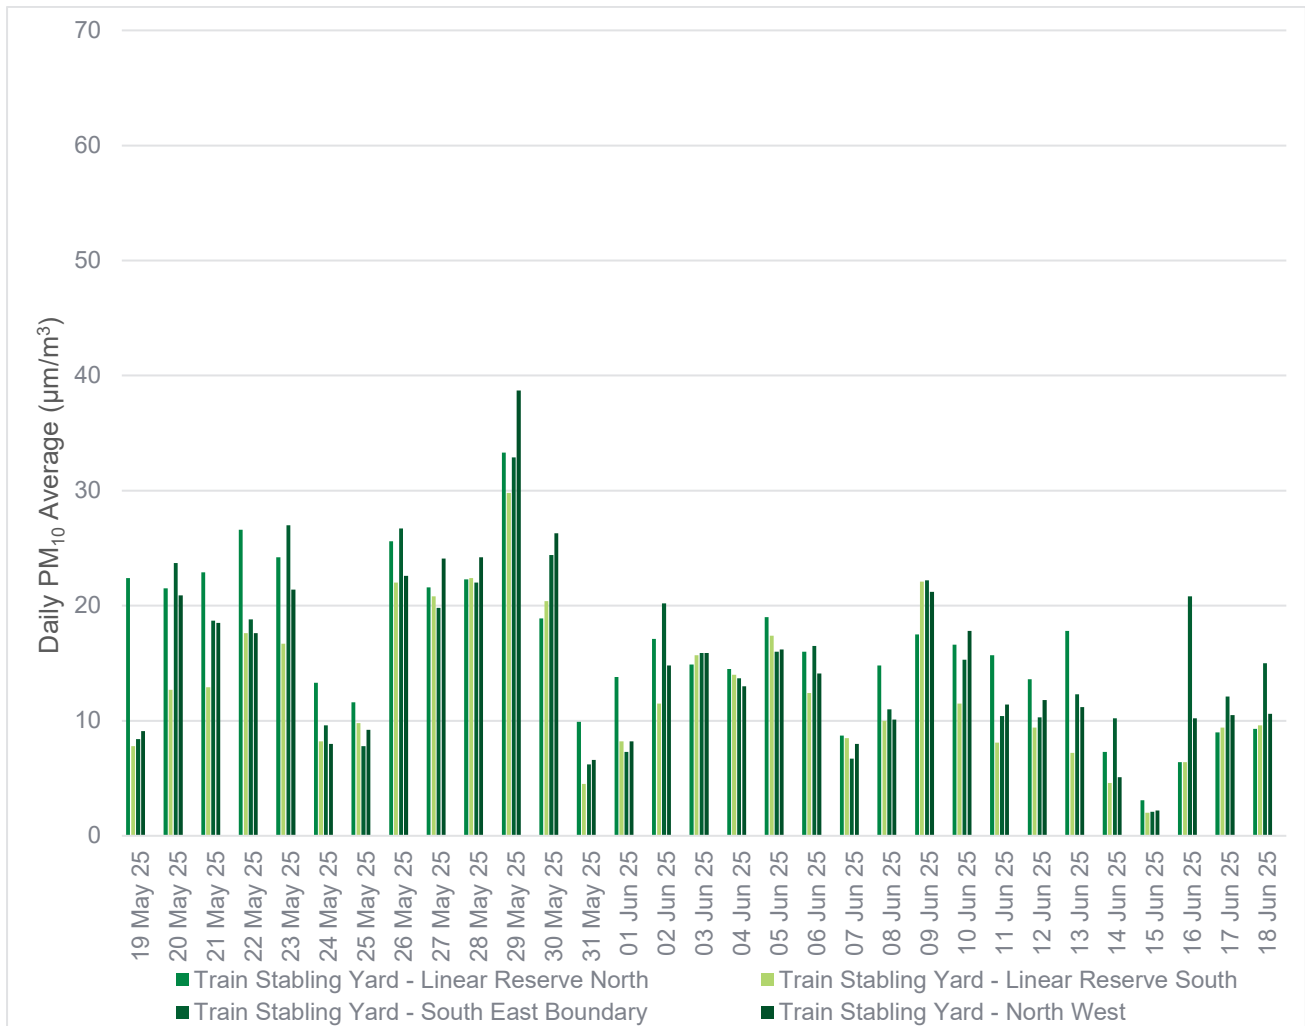
Figure 2: Daily Averages PM<sub>10</sub> Results at Train Stabling Facility West

Water carts were used proactively on site when works were occurring. The existing mitigation measures were sufficient to manage dust onsite, there were no elevated PM<sub>10</sub> events and the TARP was not implemented during the reporting period.

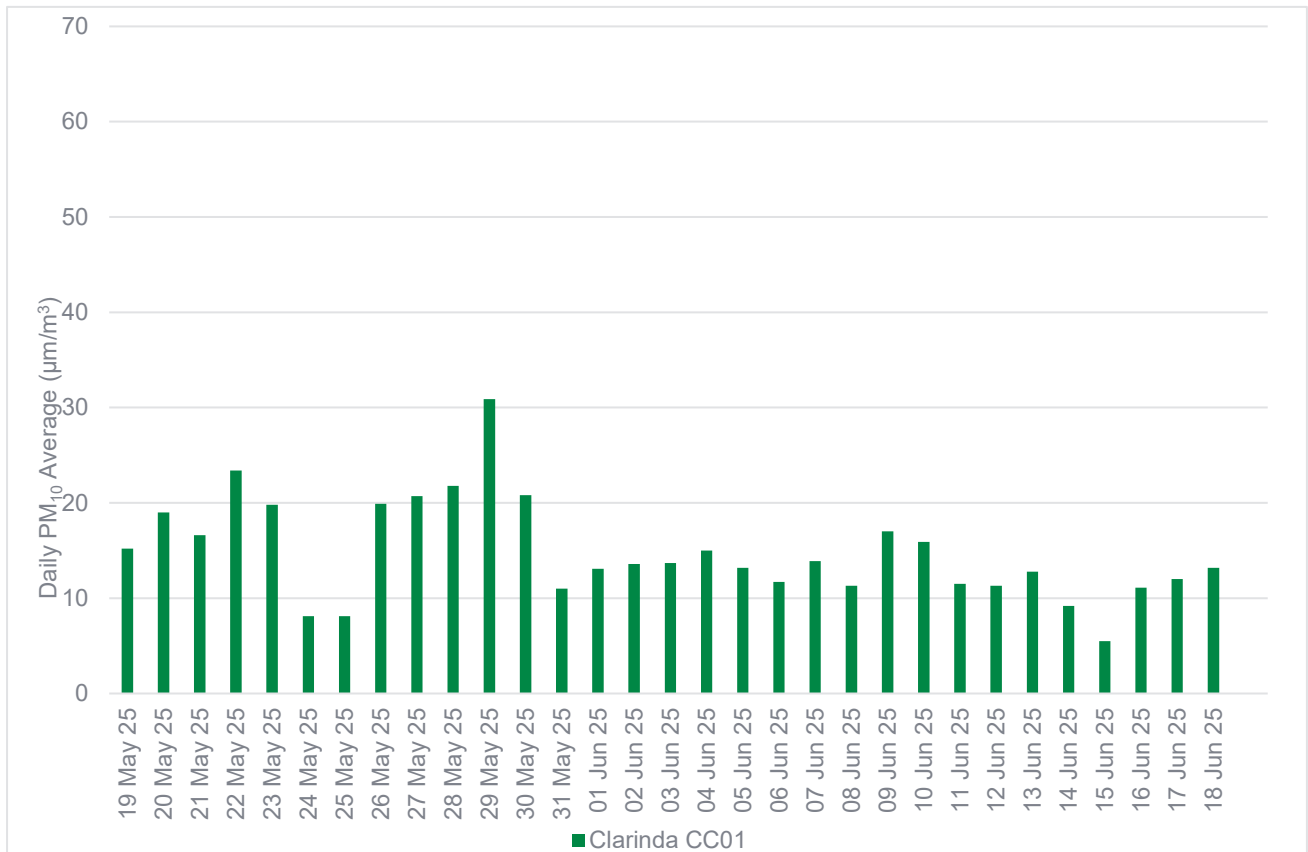
**Figure 4: Daily Averages PM<sub>10</sub> Results at Clarinda CC01**

The existing mitigation measures were sufficient to manage dust onsite. There were no elevated PM<sub>10</sub> events, and the TARP was not implemented during the reporting period.

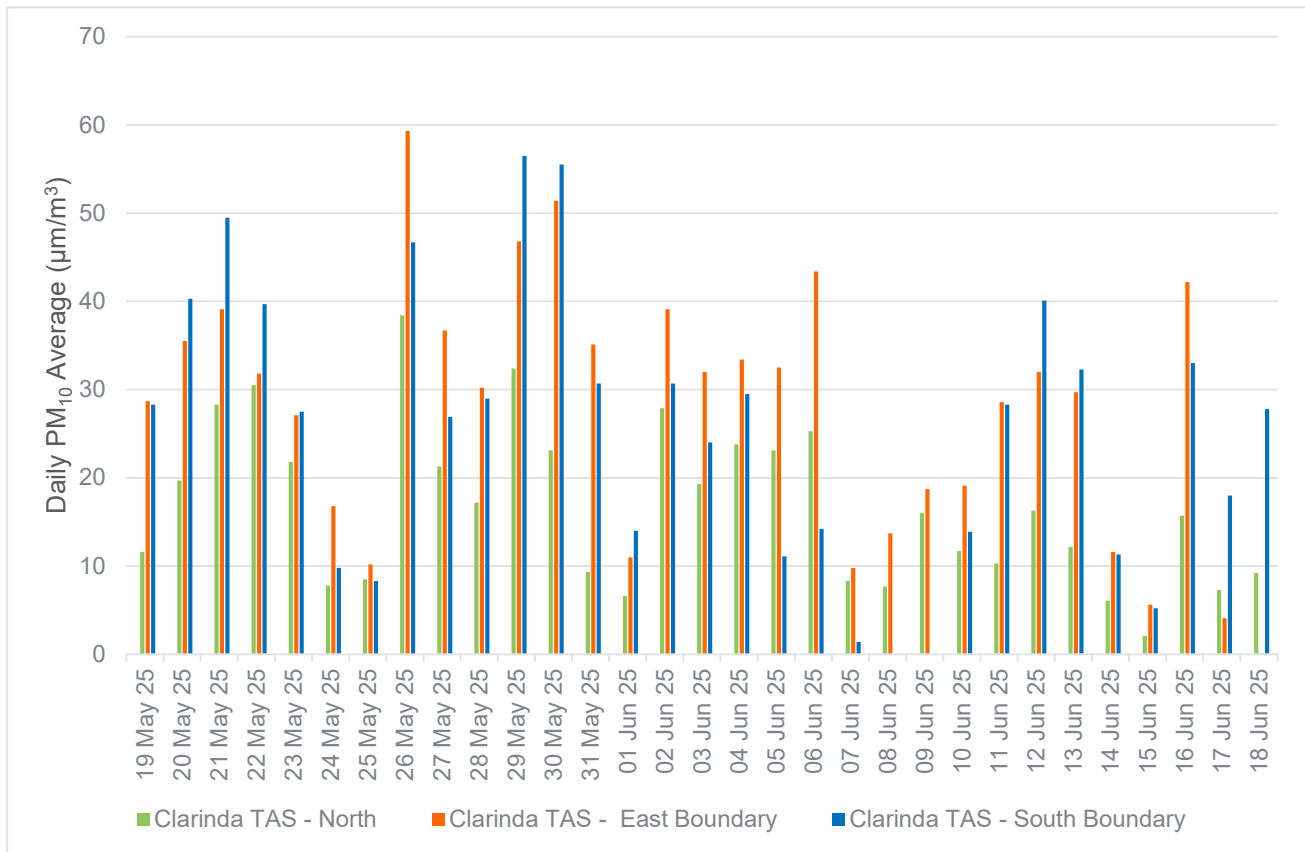
**Figure 6: Daily Averages PM10 Results at Clarinda Tunnel Access Structure Site**

Visual air inspections were also undertaken to proactively monitor and confirm there were no off-site dust impacts due to construction activities on site.

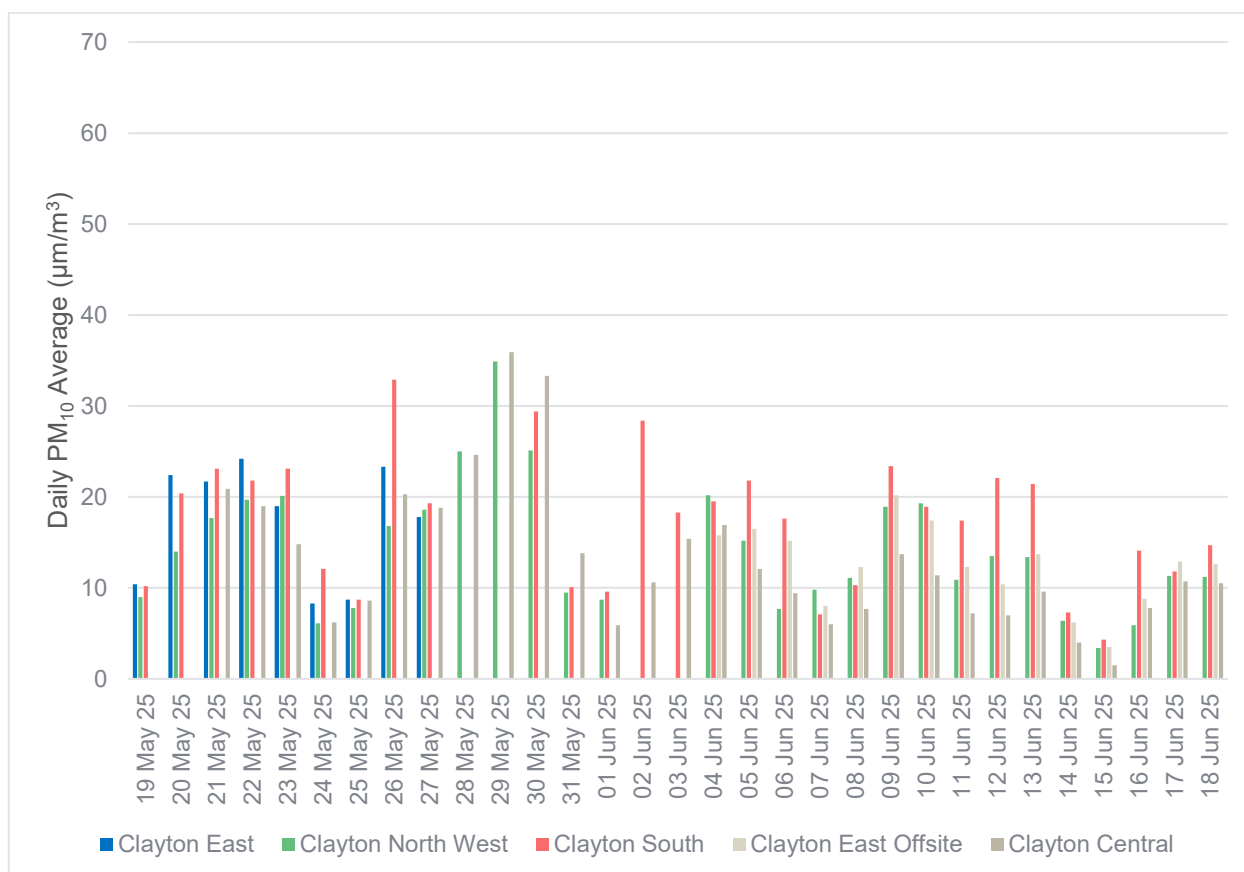
**Figure 8: Daily Averages PM<sub>10</sub> Results at Clayton**

There were two instances where monitoring devices were offline due to low battery. Clayton South was offline for two days (28<sup>th</sup> and 29<sup>th</sup> May) and Clayton North West was offline for two days (2<sup>nd</sup> and 3<sup>rd</sup> June). The batteries of these devices were replaced and have been active since.

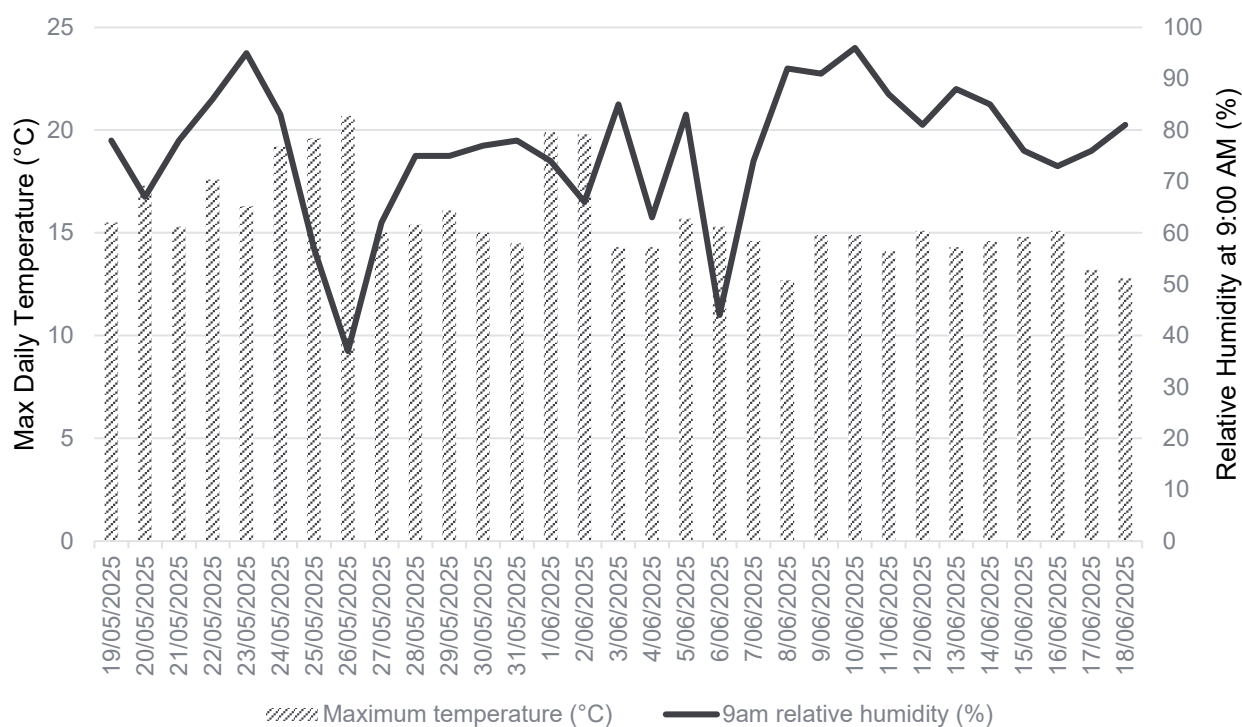
**Figure 9: Daily relative humidity and temperature observations for Moorabbin, Victoria**

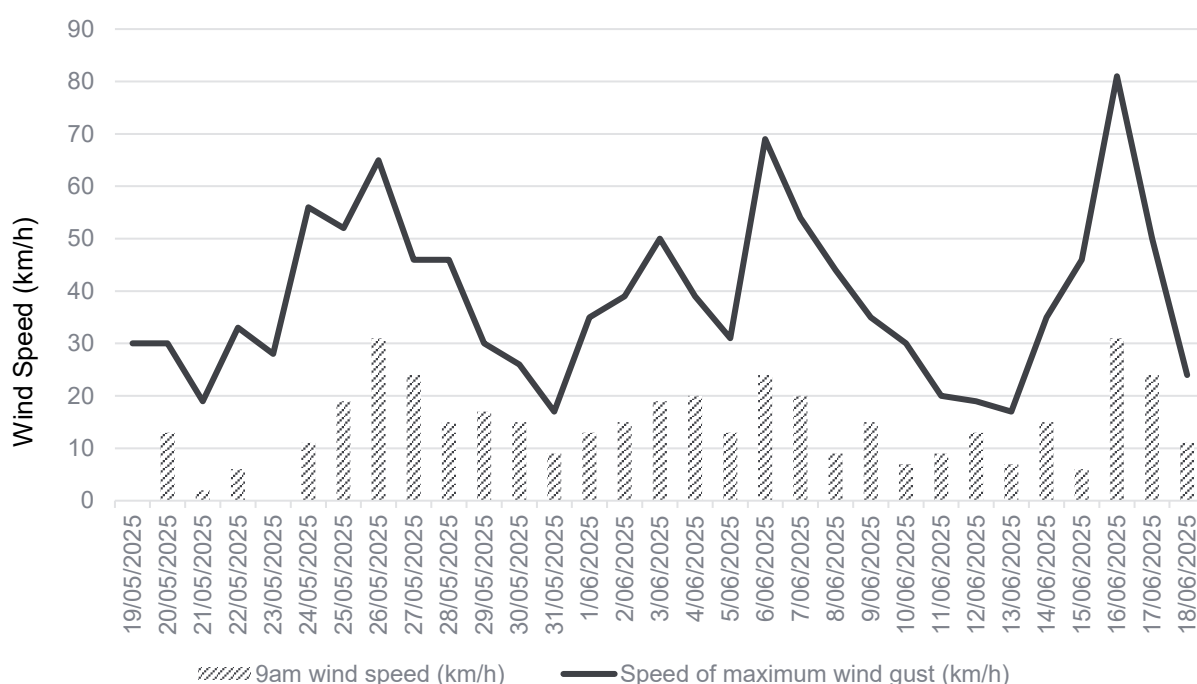
**Figure 10: Daily wind speed observations for Moorabbin, Victoria**
