Document Details			
Issue Date	9/09/2024		
Revision Number	F		
Status	Issued for Review

This report presents the results of the monthly review of the air quality monitoring data for each Suburban Rail Loop (SRL) East Early Works construction site for the period between 19 July 2024 and 18 August 2024 in accordance with SRL East EMF and EPRs AQ1 and AQ2. Laing O'Rourke is delivering the Early Works as Managing Contractor (MC). Early Works for SRL East commenced at Burwood in May 2023, Box Hill in June 2023, Monash and Heatherton in October 2023, Clayton in December 2023, and Glen Waverley and Cheltenham in March 2024.

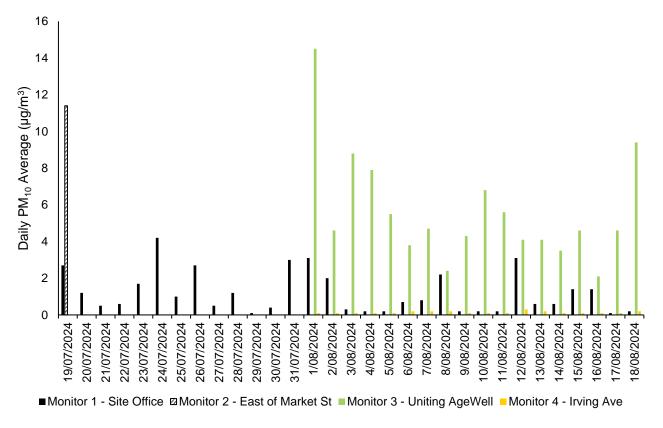
Figure 2: Box Hill PM₁₀ daily averages

The maximum daily average PM₁₀ concentrations were 4.2 μ g/m³ (n = 31)², 11.4 μ g/m³ (n = 1), 14.5 μ g/m³ (n = 18), and 0.3 µg/m³ (n = 18) at the monitoring stations located at the Site Office (Monitor 1), East of Market Street (Monitor 2), Uniting AgeWell (Monitor 3) and Irving Avenue (Monitor 4) respectively. The daily average PM₁₀ concentration readings reflect that the air quality is generally good as represented in Figure 2. Elevated maximum daily average PM₁₀ concentrations were reported on 1 August 2024 during foggy weather conditions. Monitors 3 and 4 were commissioned on 1 August 2024 before works commenced in the area.

The TARP was not implemented during the reporting period as the adopted trigger levels were not met. Dust generated from excavation and spoil haulage activities was suppressed using water carts and hoses. Additional control measures included street sweepers regularly visiting the site and ensuring trucks covered their loads prior to leaving the site.

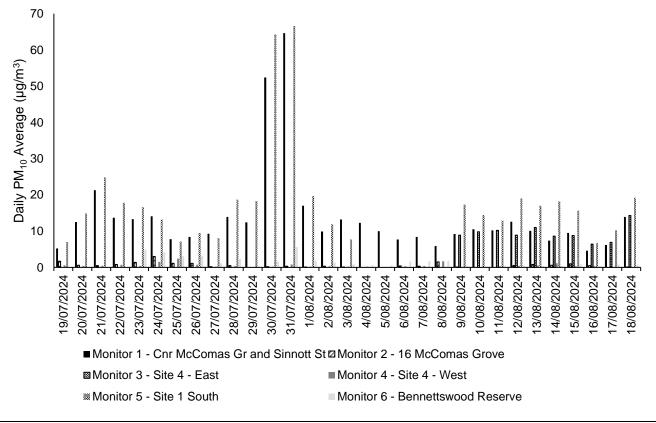
Figure 4: Burwood PM₁₀ daily averages

The maximum daily average PM_{10} concentrations reported at the Burwood monitoring stations were 64.6 $\mu g/m^3$ (n = 31) at the corner of McComas Grove and Sinnott Street (Monitor 1), 3.0 $\mu g/m^3$ (n = 31) at 16 McComas Grove (Monitor 2), 14.3 $\mu g/m^3$ (n = 10) at Site 4 – East (Monitor 3), 2.4 $\mu g/m^3$ (n = 31) at Site 4 – West (Monitor 4), and 66.6 $\mu g/m^3$ (n = 26) at Site 1 South (Monitor 5), 5.6 $\mu g/m^3$ (n=27) at Bennettswood Reserve (Monitor 6) respectively. Monitor 6 was recommissioned before works continued in the area.

A heavy fog persisted across Burwood from 30 to 31 July 2024. The air quality results from these days are not representative of dust impacts from construction.

The TARP was implemented on one day during this reporting period at Site 1. Dust suppression activities included the use of water carts and hoses. Dust generation from spoil haulage was reduced by requiring trucks to cover loads prior to leaving the site. Where dust was generated by site establishment works, appropriate dust suppression controls were employed.

During the reporting period, the water cart was used both proactively and reactively to reduce dust. Stockpiles of soil or rock were maintained at heights to minimise the risk of dust. Additionally, any soil stockpiled for prolonged periods were treated with non-hazardous tackifier to minimise the risk of dust.

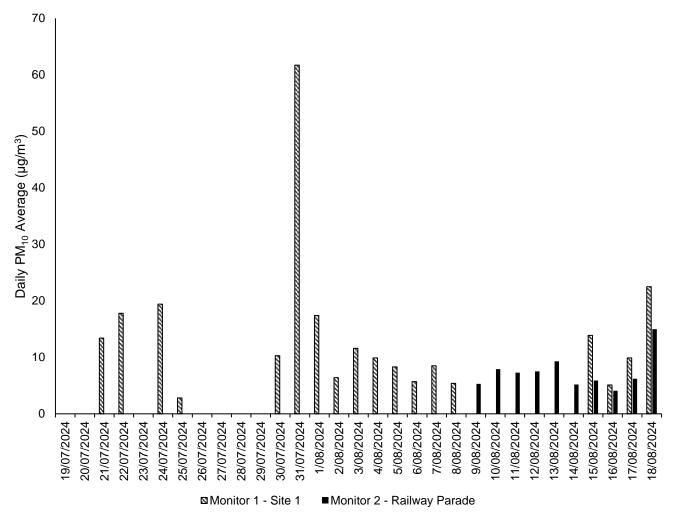
Figure 6: Glen Waverley PM₁₀ daily averages

The maximum daily average PM_{10} concentrations were 61.7 μ g/m³ (n = 18), and 15.0 μ g/m³ (n = 10) at the monitoring locations at Site 1 (Monitor 1) and Railway Parade (Monitor 2), respectively.

The TARP was implemented on one day during the reporting period. A spike in maximum daily average PM_{10} concentration can be seen at Monitor 1, during foggy weather conditions on 31 July 2024, resulting in elevated readings. Dust generated from spoil haulage was reduced by street sweepers visiting the site regularly and requiring trucks to cover loads prior to leaving the site. Dust was suppressed using hoses. Exposed materials such as crushed rock and soil stockpiles were covered on windy days. Stockpiles located within Site 1 not used for more than 10 days have been sprayed with a dust suppressant over the exposed surfaces.

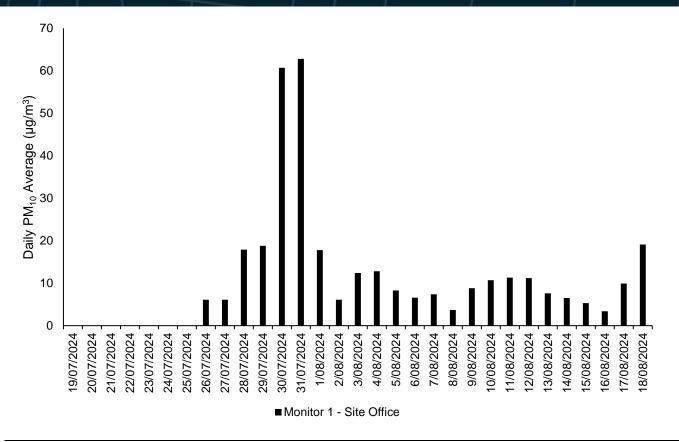
Figure 8: Monash PM₁₀ daily averages

The maximum daily average PM_{10} concentration was 25.3 μ g/m³ (n = 24) at the monitoring location at the Site Office (Monitor 1). PM_{10} readings in the reporting period are reflective of external causes and local weather conditions at the Monash site. The air quality monitoring device was reinstated on 26 July 2024 prior to the commencement of utility works. The TARP was not implemented during the reporting period. A spike in maximum daily average PM_{10} concentration can be seen at Monitor 1 from 30 to 31 July 2024 due to foggy weather conditions, which resulted in elevated readings.

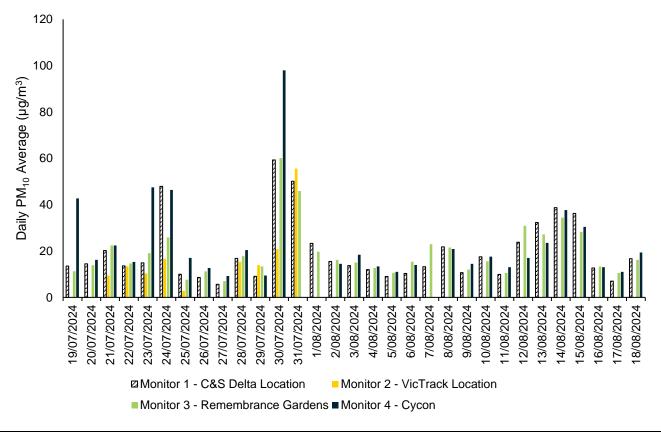
Figure 10: Clayton PM₁₀ daily averages

The maximum daily average PM_{10} concentration were 59.3.0 μ g/m³ (n = 31),55.66.0 μ g/m³ (n = 9), 60.1 μ g/m³ (n = 31), and 98.0 μ g/m³ (n = 28) at the C&S Delta Location (Monitor 1), at the VicTrack (Monitor 2), Remembrance Gardens (Monitor 3) and Cycon (Monitor 4) monitoring locations, respectively. The daily average PM_{10} concentration readings reflect that the air quality is generally good, as represented in Figure 10. The sharp spikes seen from 30 to 31 July 2024 are due to early morning fog, which resulted in elevated levels.

The TARP was implemented on four days during this reporting period with a hose used across all sites to suppress dust. The monitor within the C&S Delta location is near the main access gate, resulting in slightly higher levels than last month's data. Truck movement has increased this month with new work commencing, resulting in more work loads and deliveries. This device will be moved to better represent the site's levels. Cycon recorded the highest maximum average due to excavation. In response, a water cart was used to reduce dust. Proactive measures for dust mitigation, when weather permitted, included hosing down the work areas prior to works commencing for the day. The VicTrack works were completed, and the device was decommissioned on 31 July 2024.

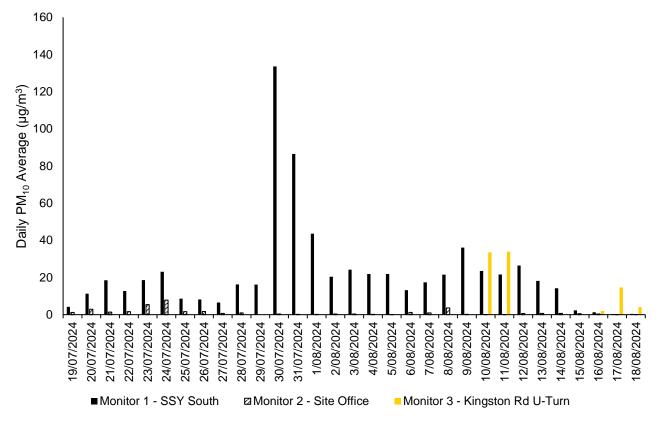
Figure 12: Heatherton PM₁₀ daily averages

The maximum daily average PM₁₀ concentrations were 133.6 μ g/m³ (n = 31), 7.8 μ g/m³ (n = 31), and 33.9 μ g/m³ (n = 5) at SSY South (Monitor 1), Site Office (Monitor 2), and Kingston Rd U-turn (Monitor 3) respectively. The TARP was implemented on two days during the reporting period.

Further, the Heatherton site is in an industrialised area with several neighbouring properties undertaking earthworks with large areas of exposed soil. On days where there are strong winds, visible airborne dust generated off-site has been observed to be blown onto the Heatherton site, contributing to elevated onsite monitoring results. Additionally, a relative humidity of 99% was observed when the TARP was implemented from 30 to 31 July 2024, which may have affected measurements (see Section 2.4).

Where dust was generated, appropriate dust suppression controls were employed. During the reporting period, the water cart was used proactively and reactively to reduce dust.

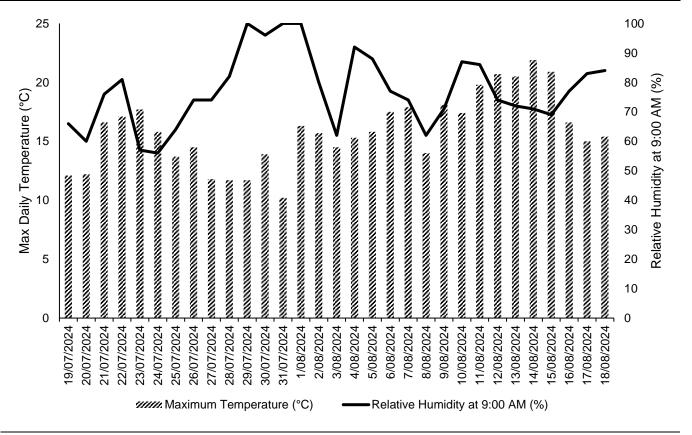
Figure 13: Daily relative humidity and temperature observations for Melbourne (Olympic Park), Victoria 19 July 2024 –18 August 2024. Data Source BOM.
