### **Document Information**

Document Details			
Issue Date	7/06/2024		
Revision Number	D		
Status	Issued for Review

This report presents the results of the monthly review of the air quality monitoring data for each Suburban Rail Loop (SRL) East Early Works construction site for the period between 19 April 2024 and 18 May 2024 in accordance with SRL East EMF and EPRs AQ1 and AQ2. Laing O'Rourke is delivering the Early Works as Managing Contractor (MC). Early Works for SRL East commenced at Burwood in May 2023, Box Hill in June 2023, Monash and Heatherton in October 2023, Clayton in December 2023, and Glen Waverley and Cheltenham in March 2024.

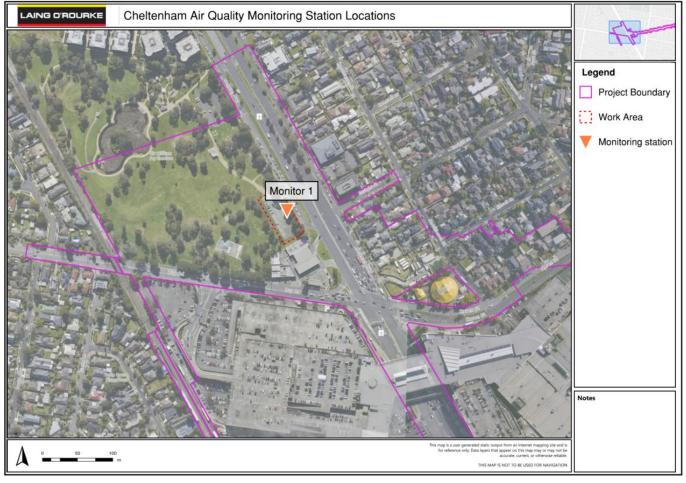
Figure 13: Cheltenham air quality monitoring stations.<sup>5</sup>

<sup>&</sup>lt;sup>5</sup> Monitor 2 is installed at the same location as Monitor 1, see Section 4.1
