**SUBURBAN
RAIL LOOP**

Air Quality Monthly Report

Early Works

Tunnels South

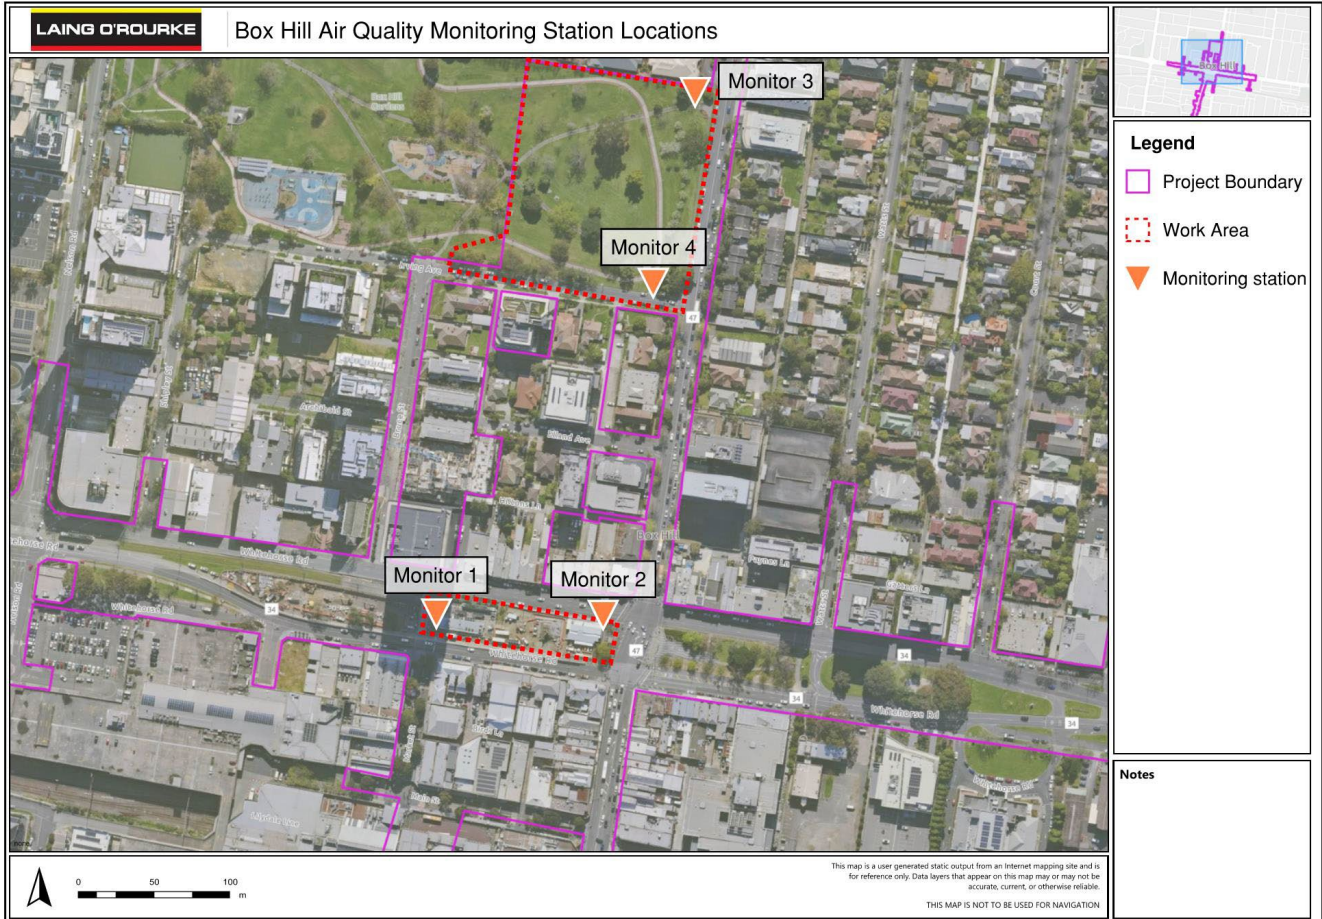
Figure 1: Box Hill air quality monitoring stations.

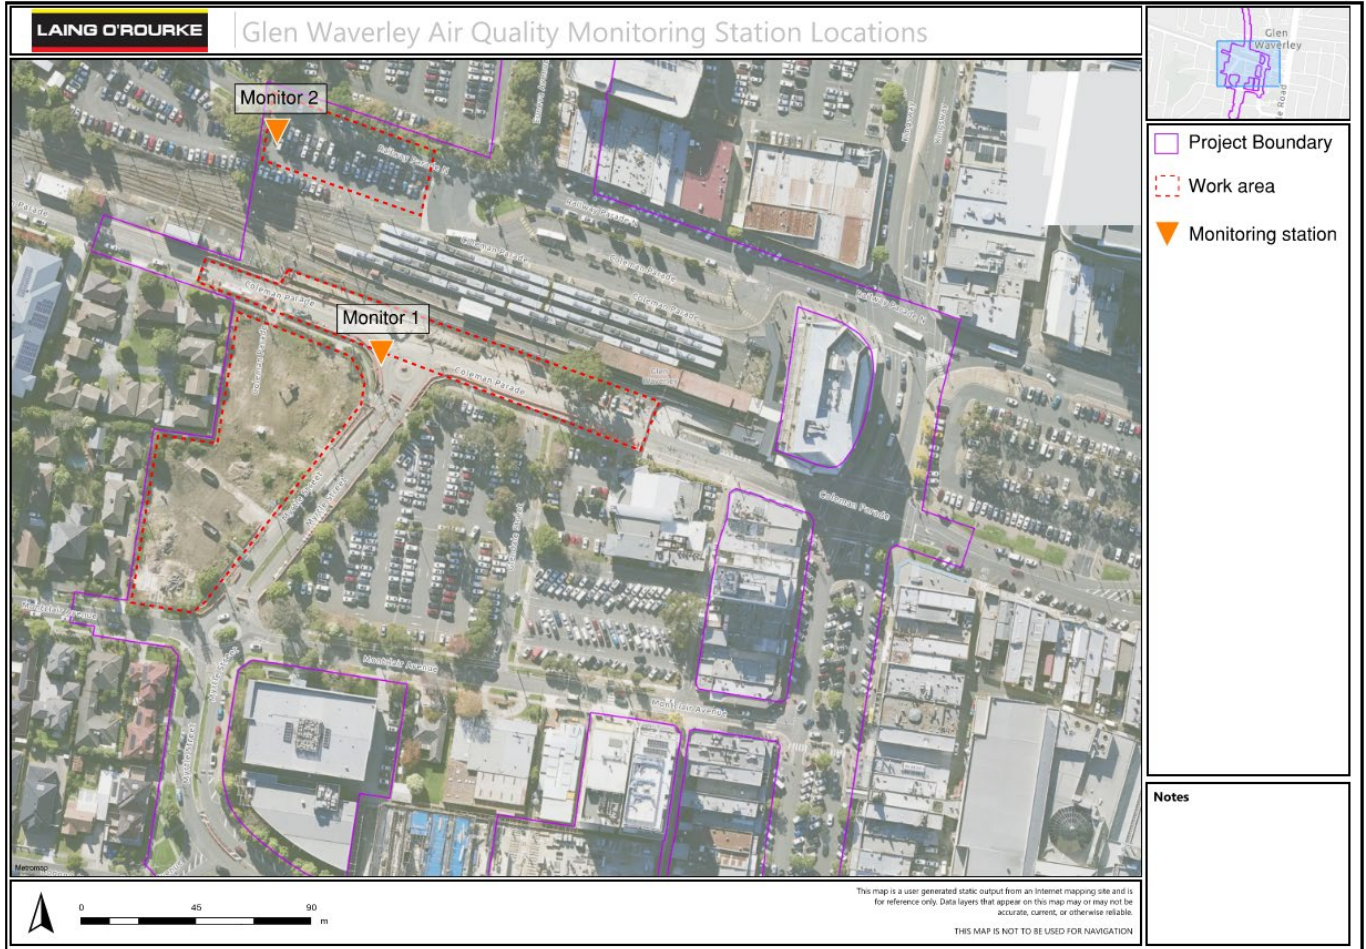
Figure 5: Glen Waverley air quality monitoring stations.

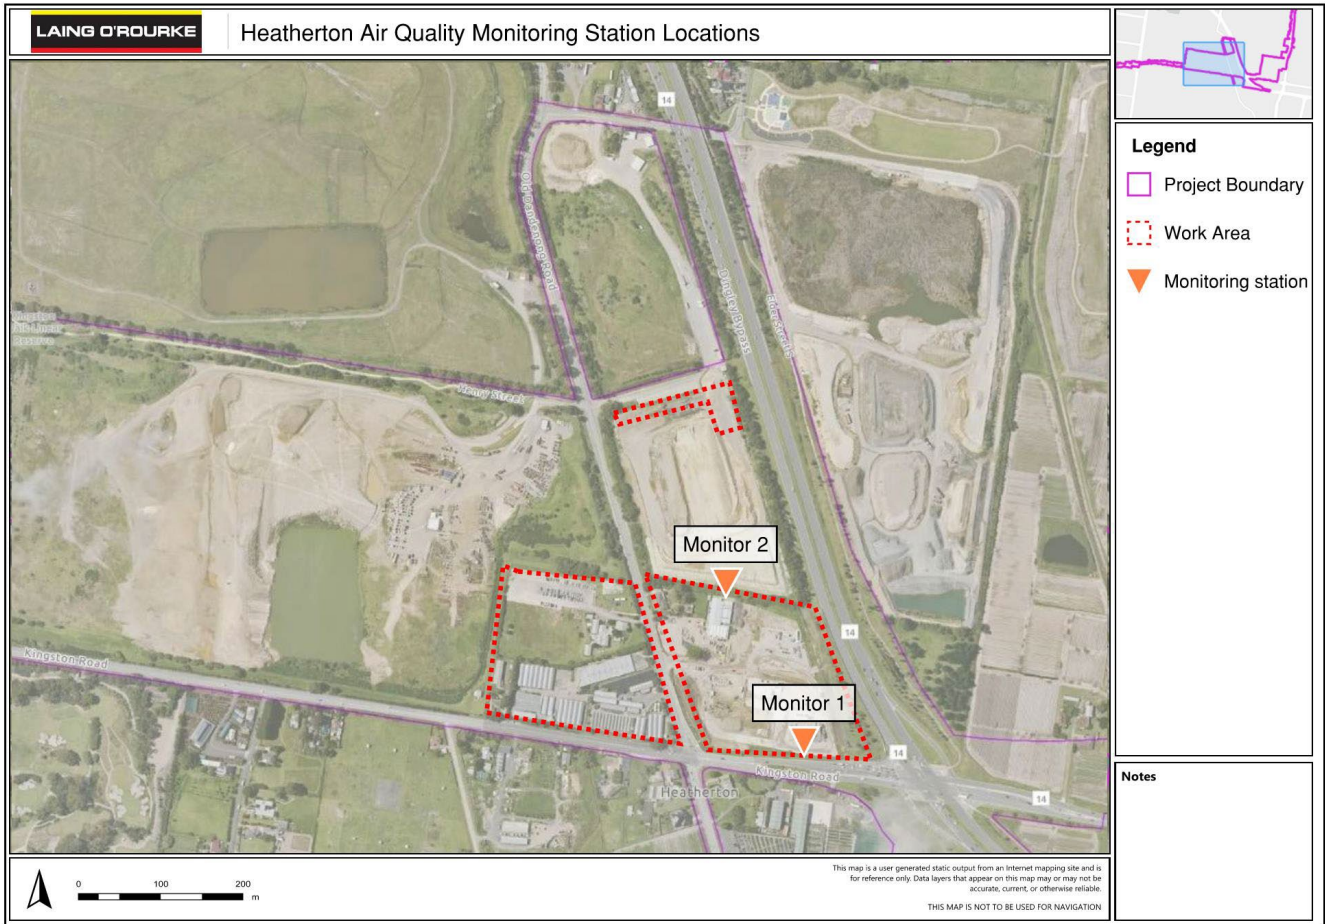
Figure 11: Heatherton air quality monitoring stations.

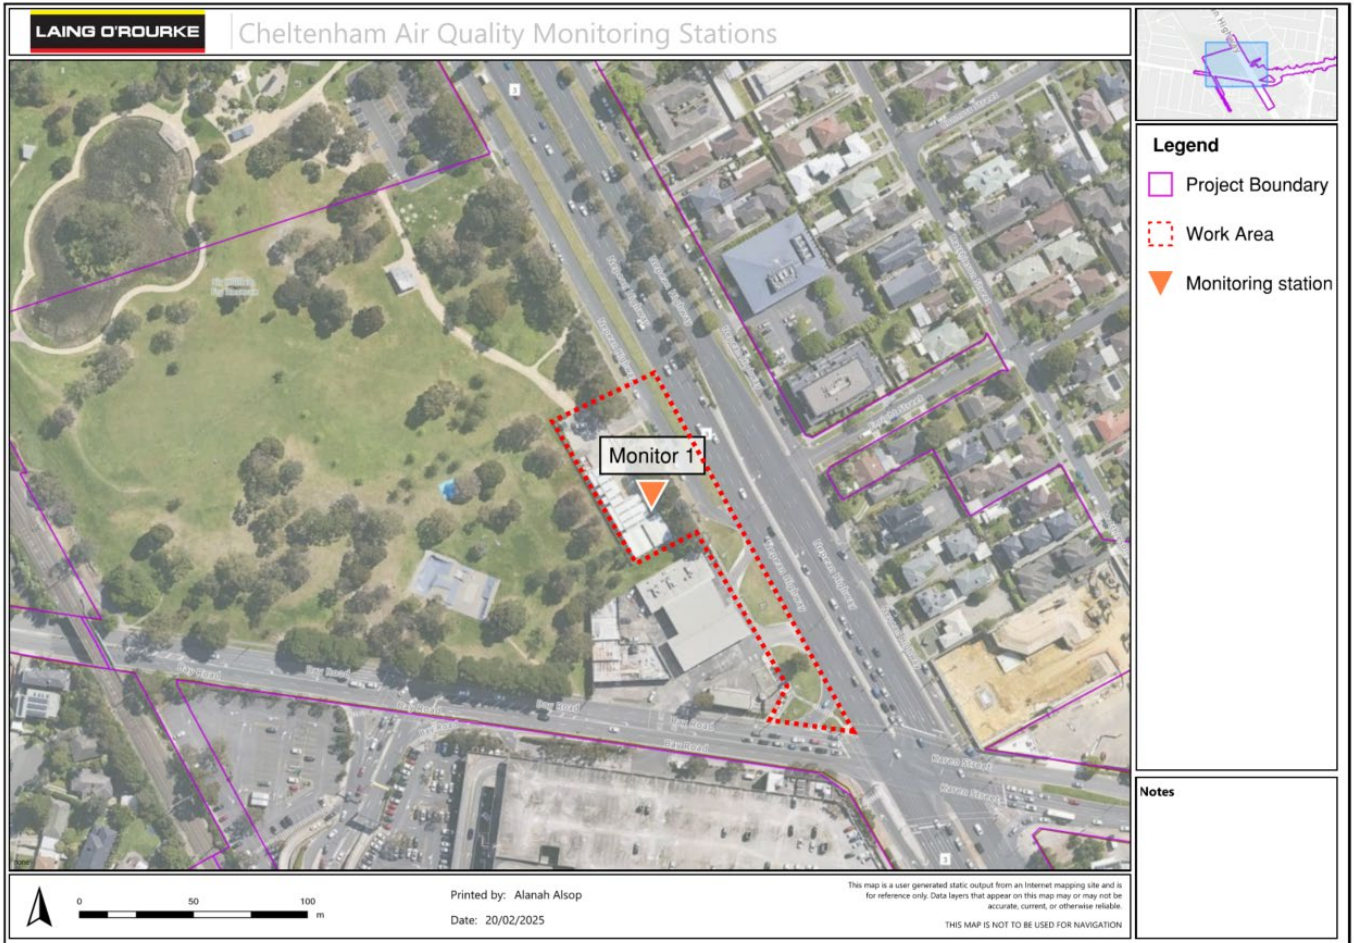
Figure 113: Cheltenham air quality monitoring stations.

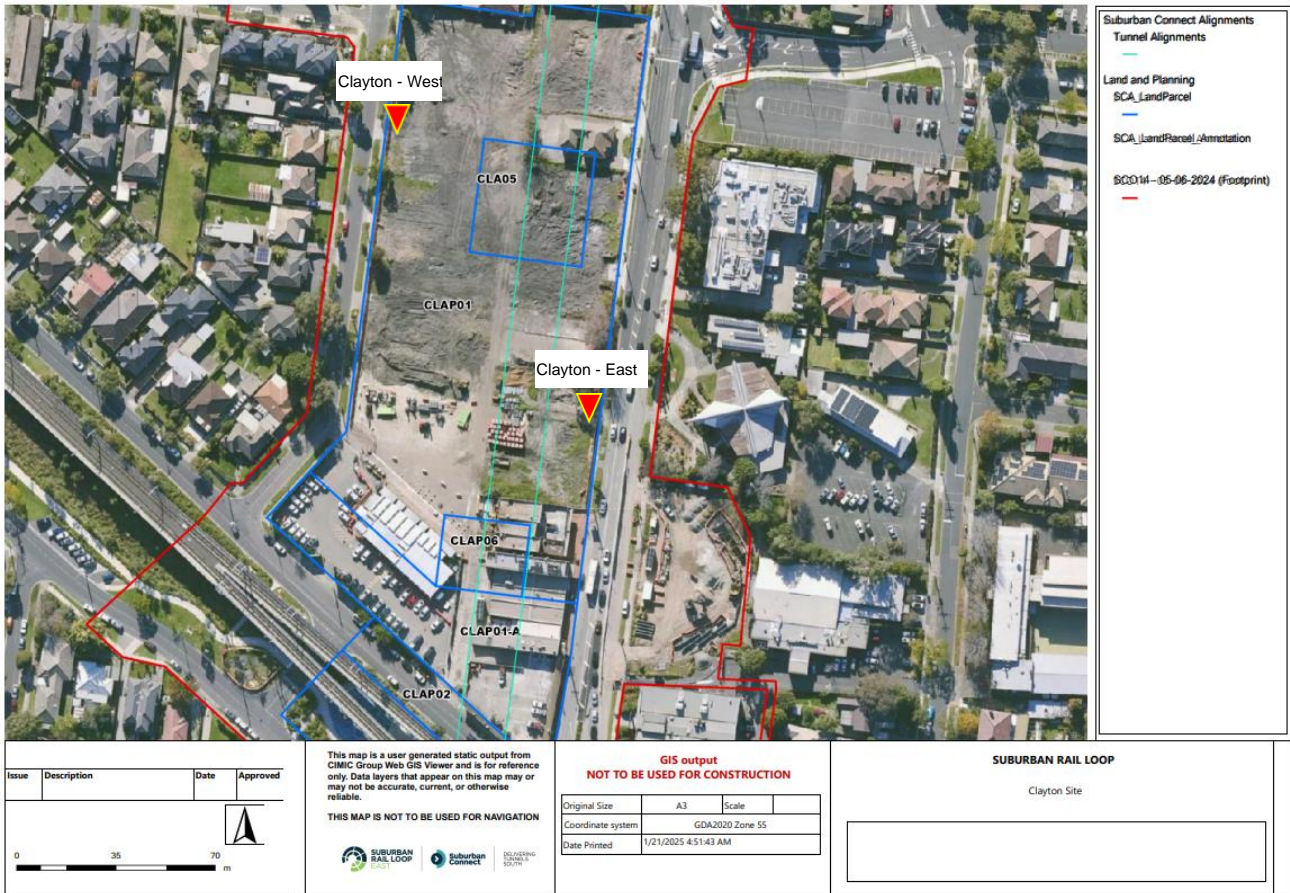
Figure 5: Clayton site air quality monitoring station

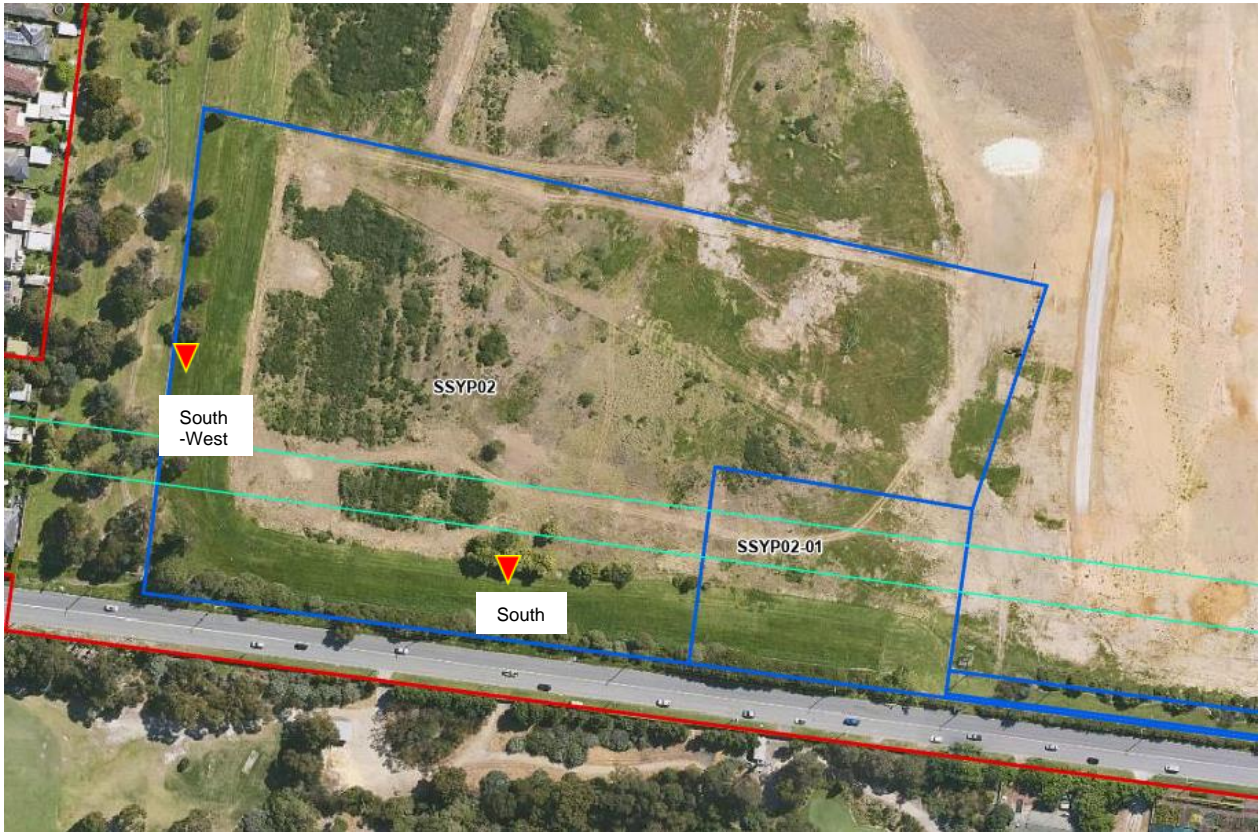
Figure 7: Train Stabling Facility West site air quality monitoring station

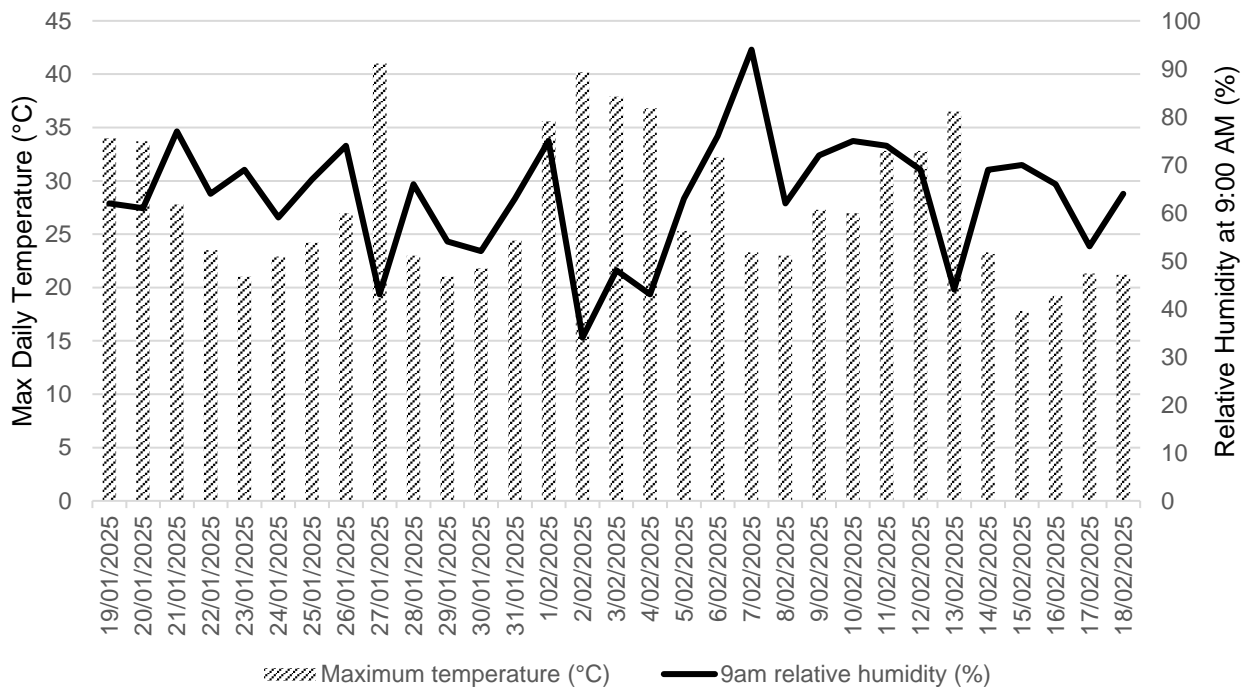
Figure 9: Daily relative humidity and temperature observations for Moorabbin, Victoria
