11.3 Appendix C – Viewshed Analysis Plans

11.4 Appendix D – Photomontages

11.5 Appendix E – Mitigation Concept Plans

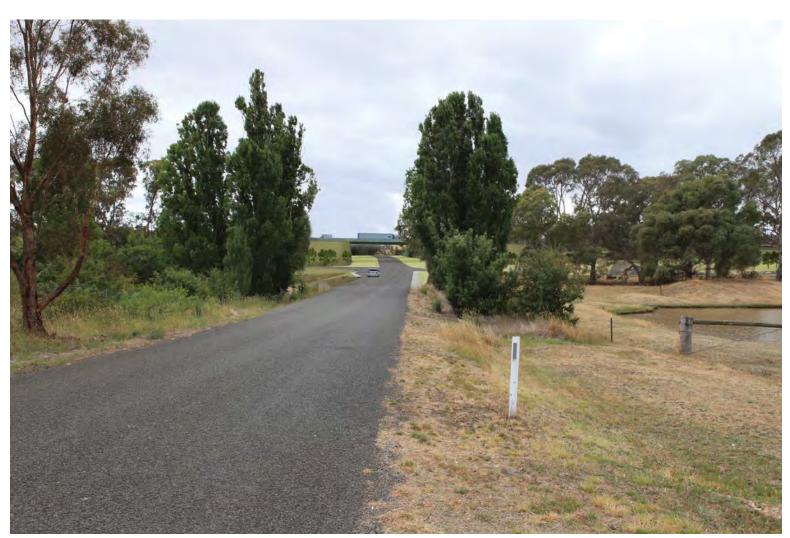
Section 3, Location A, Garden Gully Road, Ch. 6000

Map showing 3D overview of the proposed alignment. White arrows represent photomontatge camera location and angle of view. Existing and proposed vegetation is not modelled in the 3D model

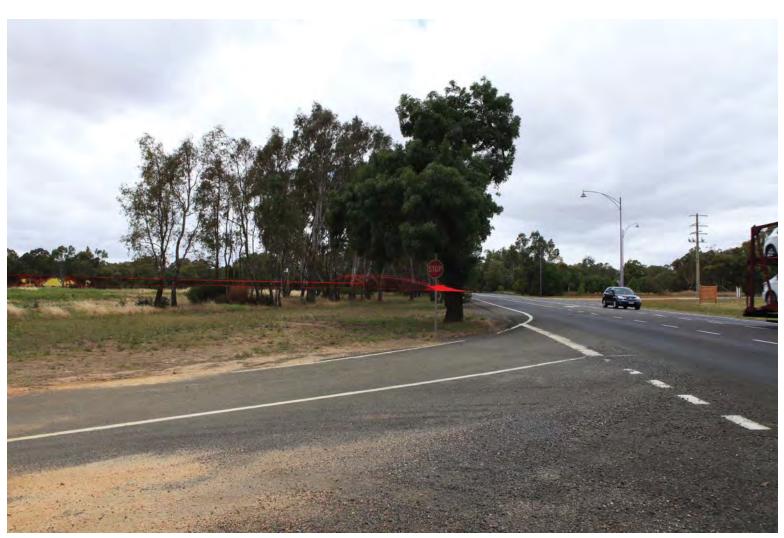
Section 2, Location B, Western Highway, Ch. 12400

Map showing 3D overview of the proposed alignment. White arrows represent photomontatge camera location and angle of view. Existing and proposed vegetation is not modelled in the 3D model

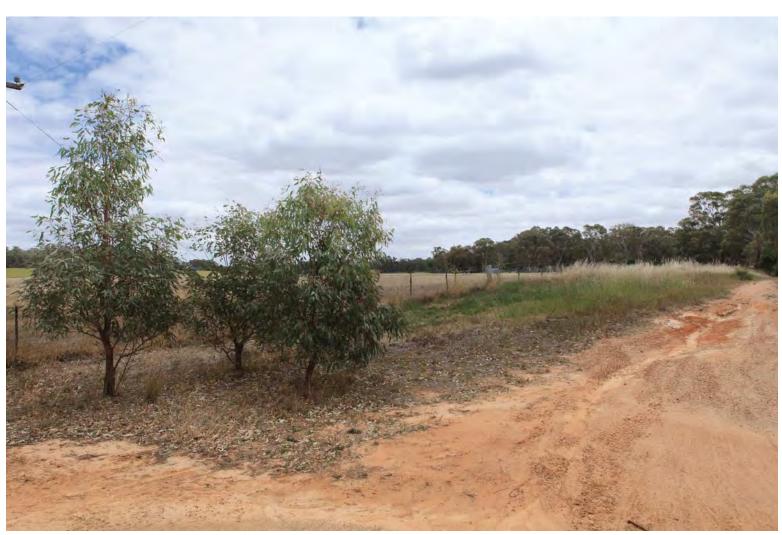
Section 2, Location C, Western Highway, Ch. 14000

Map showing 3D overview of the proposed alignment. White arrows represent photomontatge camera location and angle of view. Existing and proposed vegetation is not modelled in the 3D model

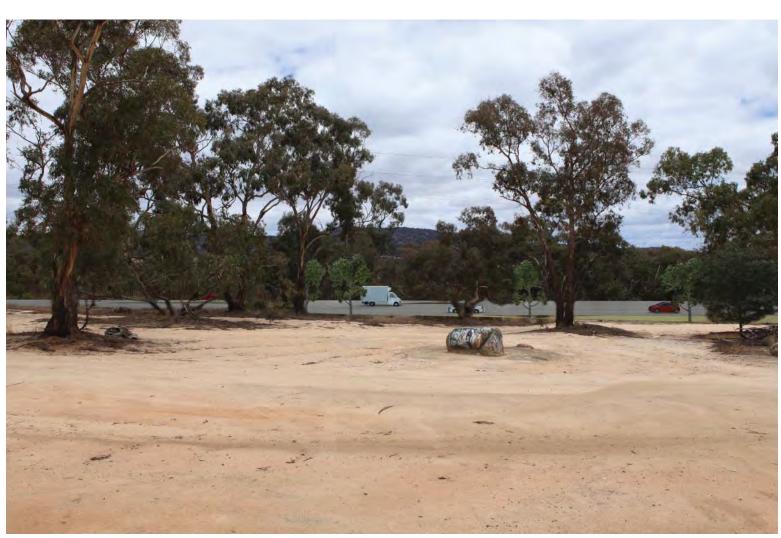
Section 3, Location D, SIsters Rocks, Ch. 22650

Map showing 3D overview of the proposed alignment. White arrows represent photomontatge camera location and angle of view. Existing and proposed vegetation is not modelled in the 3D model
