REPORT Ambient Air Quality Monitoring (AAQM) Report August 2019

West Gate Tunnel Project

1789878-013-R-Rev0

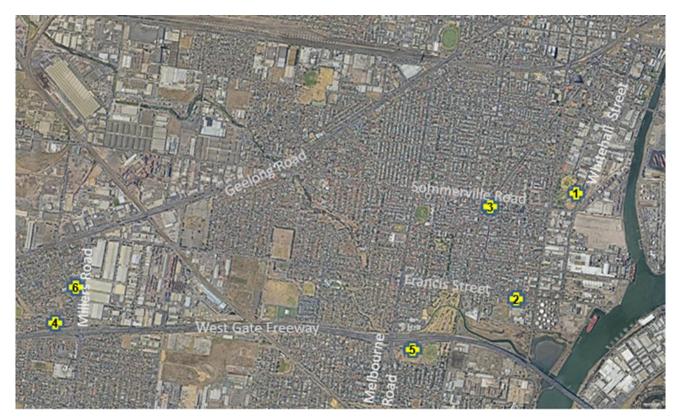
Figure 1: West Gate Tunnel AAQMS site locations

AAQMS Station 1 to Station 5 were installed and commissioned during the period 22/08/2018 to 31/08/2018. AAQMS Station 6 (Millers Road) was commissioned on 12/10/2018. Meteorological sensors (wind speed and direction) were installed later due to delays in calibration from the instrument supplier. AAQMS commissioning dates are provided in Table 2. Figure 1 presents the locations of the AAQMS.

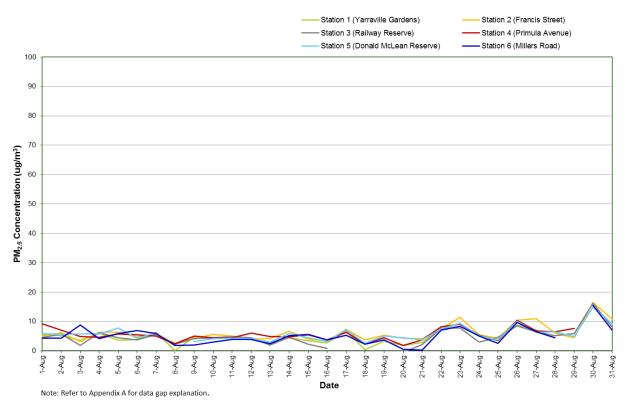
Figure 8: Combined PM_{2.5} concentration (24 hour average) – August 2019

Combined plots of the AAQMS PM_{2.5} and PM₁₀ are presented in Figure 8 and Figure 9 respectively.

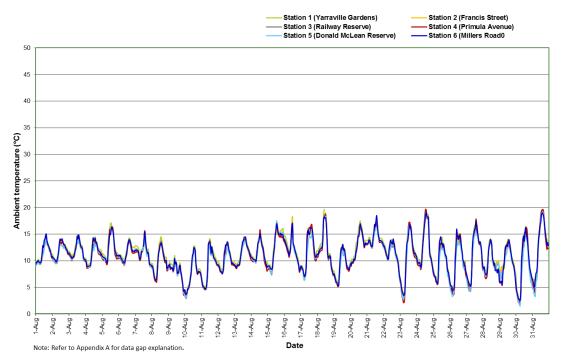
Figure 12: Ambient temperature (1 hour average) All AAQMS - August 2019

Ambient Temperature data for all AAQMS sites are presented in Figure 12 for the reporting period.

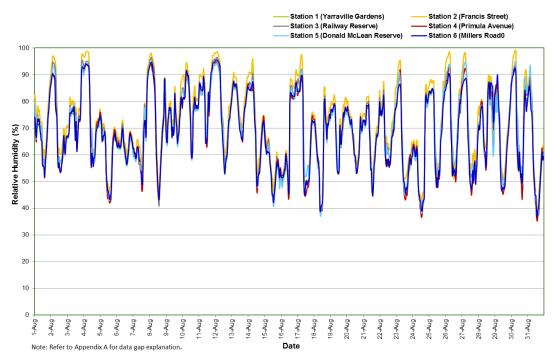
Figure 13: Relative humidity (1 hour average) All AAQMs - August 2019

Relative Humidity data for all AAQMS sites are presented in Figure 13 for the reporting period.

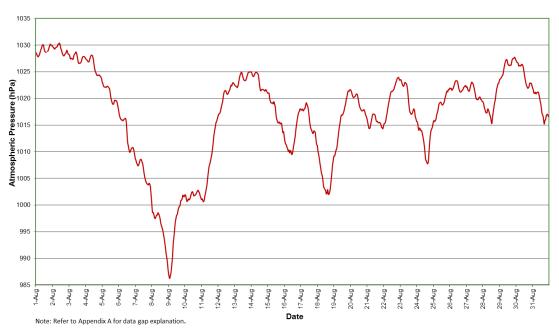
Figure 14: Atmospheric pressure (1 hour average) Station 4 Primula Avenue - August 2019

Atmospheric pressure data for Station 4 (Primula Avenue AAQMS) is presented in Figure 14 for the reporting period.

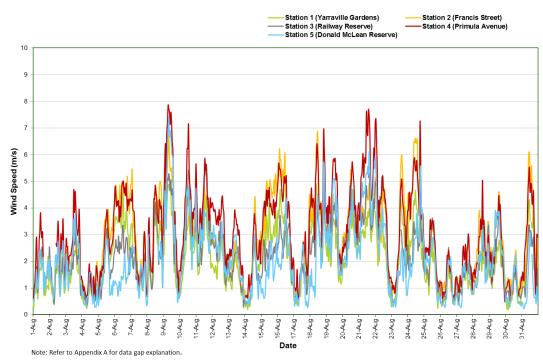
Figure 15: Wind speed (1 hour average) All AAQMs - August 2019

Wind Speed data for all AAQMS sites are presented in Figure 15 for the reporting period.

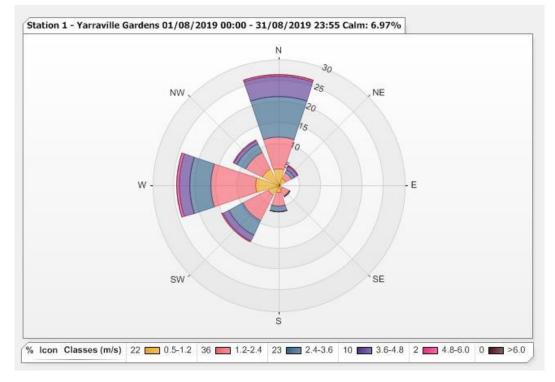
Figure 16: Wind speed (1 hour average) Station 1 - Yarraville Gardens

A wind rose (1 hour average) for Yarraville Gardens AAQMS is presented in Figure 16.

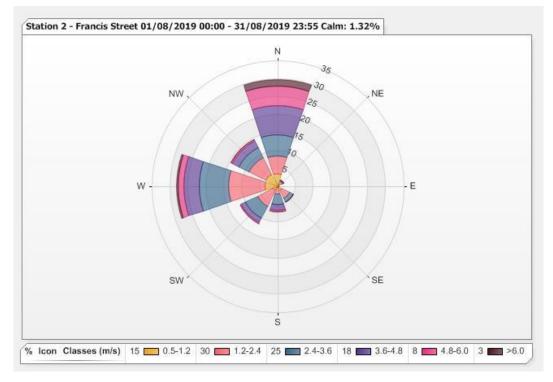
Figure 17: Wind speed (1 hour average) Station 2 - Francis Street

A wind rose (1 hour average) for Station 2 (Francis Street AAQMS) is presented in Figure 17.

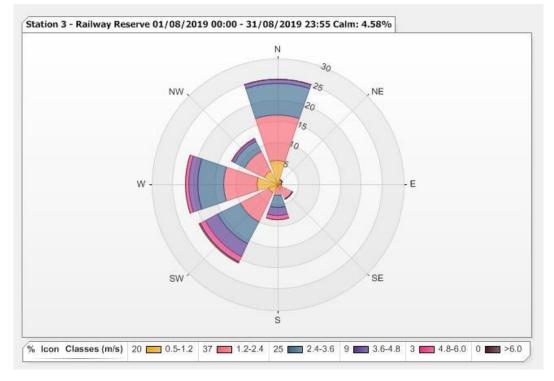
Figure 18: Wind speed (1 hour average) Station 3 Railway Reserve

A wind rose (1 hour average) for Station 3 (Railway Reserve AAQMS) is presented in Figure 18.

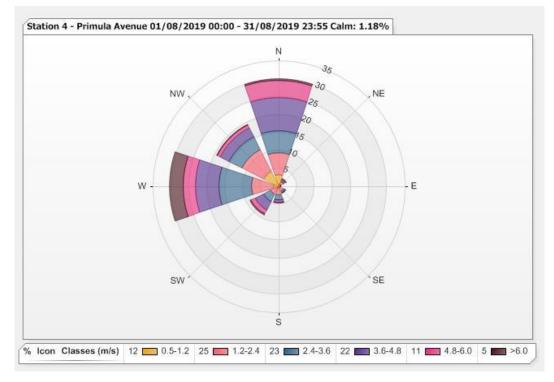
Figure 19: Wind speed (1 hour average) Station 4 Primula Avenue

A wind rose (1 hour average) for Station 4 (Primula Avenue AAQMS) is presented in Figure 19.

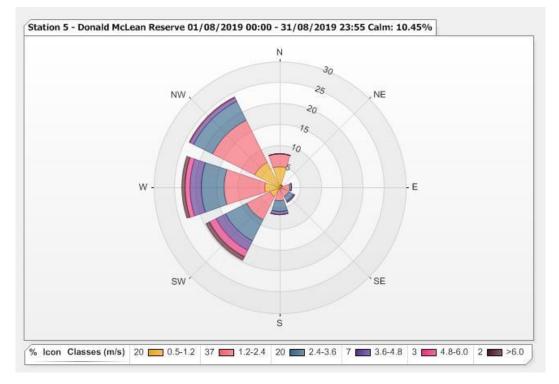
Figure 20: Wind speed (1 hour average) Station 5 Donald McLean Reserve

A wind rose (1 hour average) for Station 5 (Donald McLean Reserve AAQMS) is presented in Figure 20.
