# Ambient Air Quality Monitoring (AAQM) Report June 2019

West Gate Tunnel Project

1789878-011-R-Rev0

July 2019

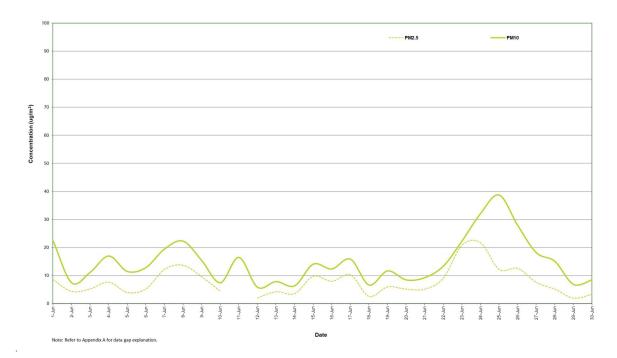
Figure 2: Station 1 PM<sub>2.5</sub> and PM<sub>10</sub> concentration (24 hour average) – June 2019

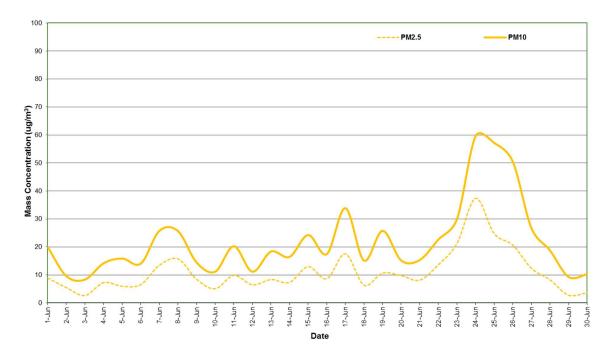
Figure 3: Station 2 PM<sub>2.5</sub> and PM<sub>10</sub> concentration (24 Hour Average) – June 2019

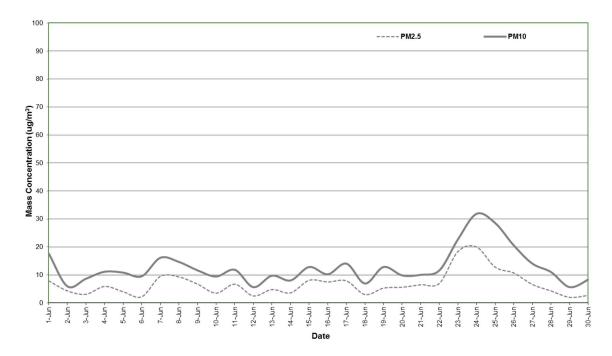
Figure 4: Station 3 PM<sub>2.5</sub> and PM<sub>10</sub> concentration (24 hour average) – June 2019

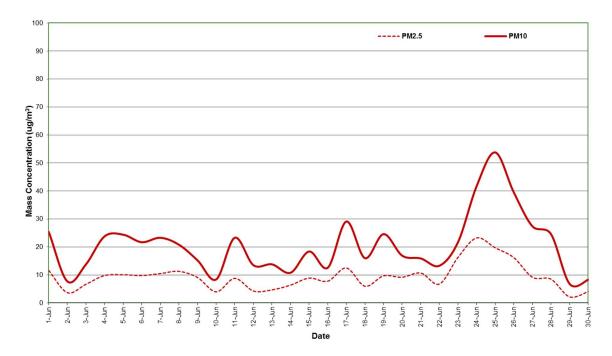
Figure 5: Station 4 PM<sub>2.5</sub> and PM<sub>10</sub> concentration (24 hour average) – June 2019

A construction area (Millers Road exit ramp and noise wall relocation) is now adjacent Station 4, as a result the measured  $PM_{10}$  concentrations may be impacted by construction activities and may not be representative of traffic emissions.

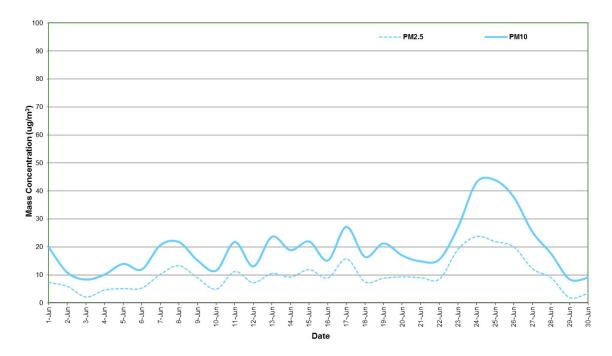
Figure 6: Station 5 PM<sub>2.5</sub> and PM<sub>10</sub> concentration (24 hour average) – June 2019

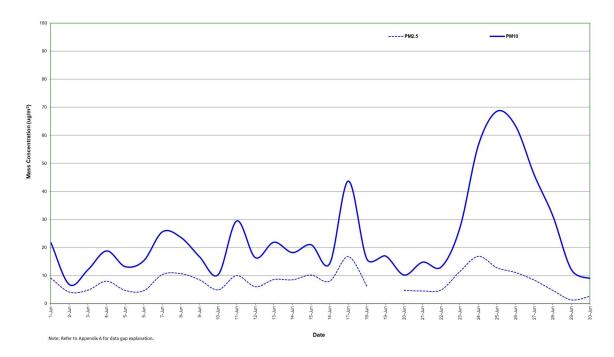
Figure 7: Station 6 PM<sub>2.5</sub> and PM<sub>10</sub> concentration (24 hour average) – June 2019

EPA Victoria's historical air quality data<sup>1</sup> reported elevated levels of  $PM_{10}$  at Brooklyn AAQMS on the 25/06/2019 and 26/06/2019, indicating the exceedances at Station 6 (Millers Road) were likely due to regional events.

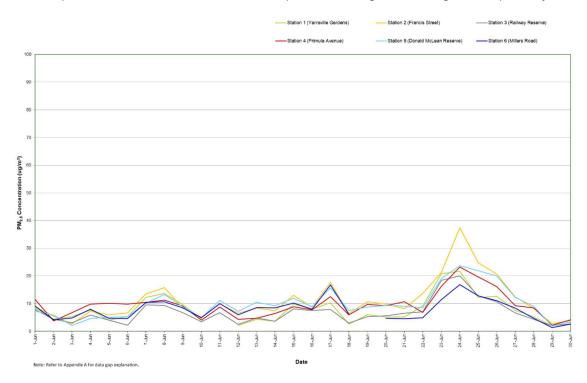
Combined plots of the AAQMS PM<sub>2.5</sub> and PM<sub>10</sub> are presented in Figure 8 and Figure 9 respectively.

Figure 8: Combined PM<sub>2.5</sub> concentration (24 hour average) – June 2019

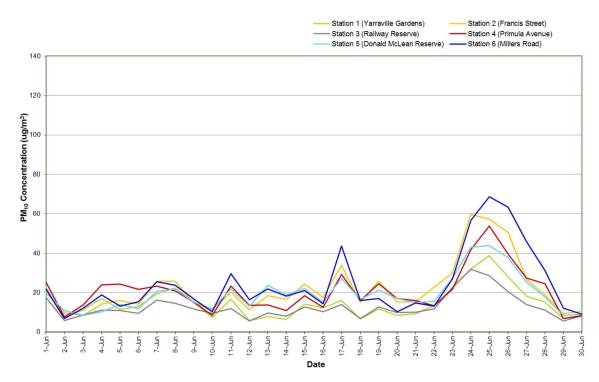
Figure 9: Combined PM<sub>10</sub> concentration (24 hour average) – June 2019

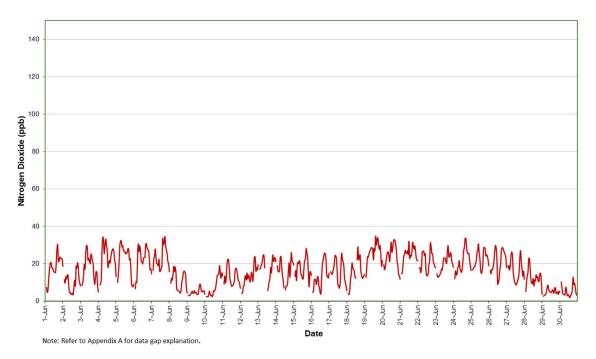
Figure 10: Station 4 NO<sub>2</sub> concentration (1 hour average) – June 2019

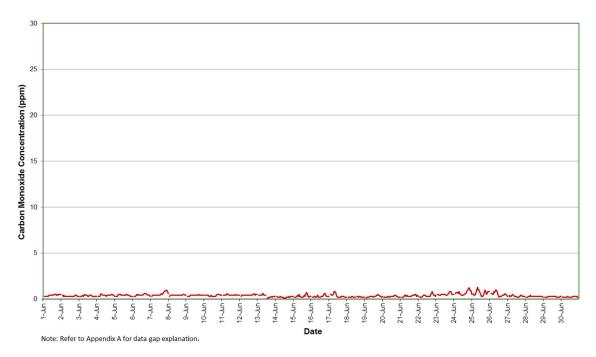
Figure 11: Station 4 CO concentration (1 hour average) – June 2019

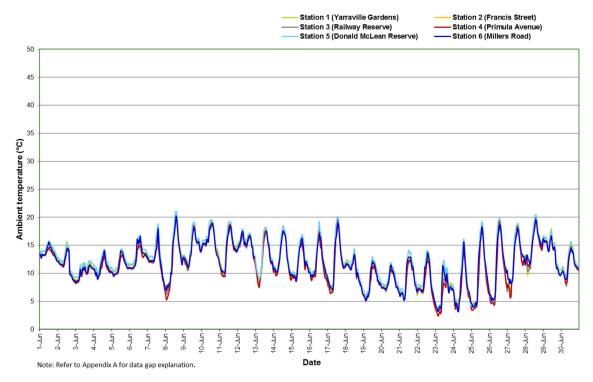
Ambient Temperature data for all AAQMS sites are presented in Figure 12 for the reporting period.

Figure 12: Ambient temperature (1 hour average) All AAQMS - June 2019

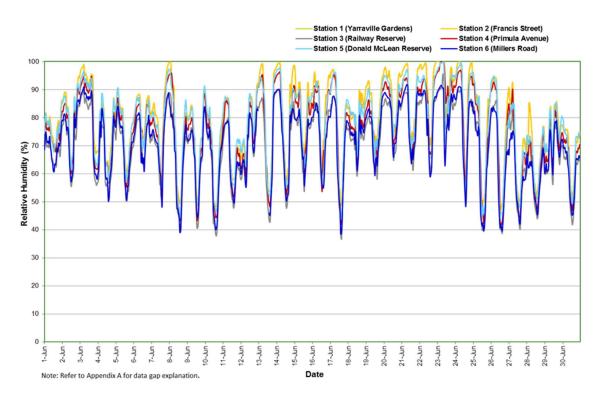
Relative Humidity data for all AAQMS sites are presented in Figure 13 for the reporting period.

Figure 13: Relative humidity (1 hour average) All AAQMS - June 2019

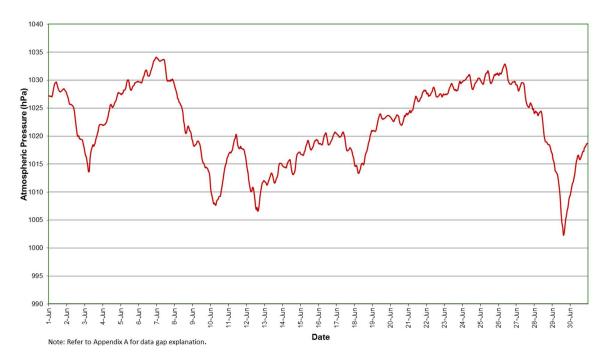
Atmospheric pressure data for Station 4 (Primula Avenue AAQMS) is presented in Figure 14 for the reporting period.

Figure 14: Atmospheric pressure (1 hour average) Station 4 Primula Avenue - June 2019

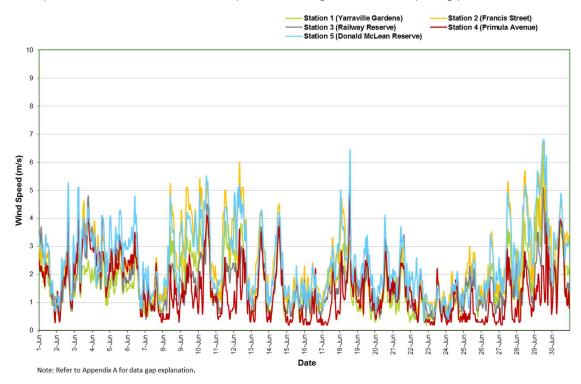
Wind Speed data for all AAQMS sites are presented in Figure 15 for the reporting period.

Figure 15: Wind speed (1 hour average) All AAQMS - June 2019

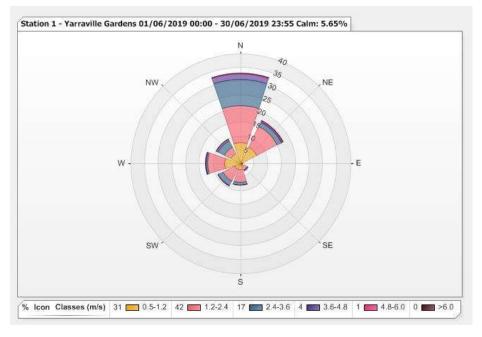
A wind rose (1 hour average) for Yarraville Gardens AAQMS is presented in Figure 16.

Figure 16: Wind speed (1 hour average) Station 1 - Yarraville Gardens

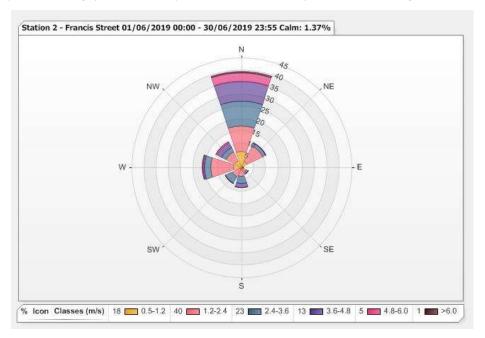
A wind rose (1 hour average) for Station 2 (Francis Street AAQMS) is presented in Figure 17.

Figure 17: Wind speed (1 hour average) Station 2 – Francis Street

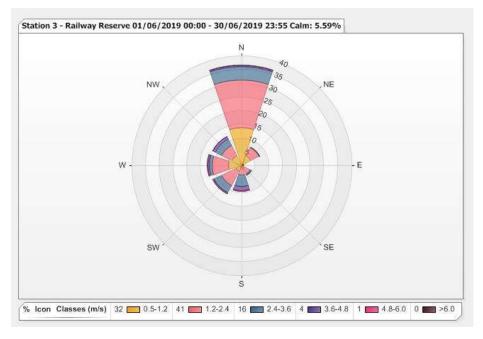
A wind rose (1 hour average) for Station 3 (Railway Reserve AAQMS) is presented in Figure 18.

Figure 18: Wind speed (1 hour average) Station 3 - Railway Reserve

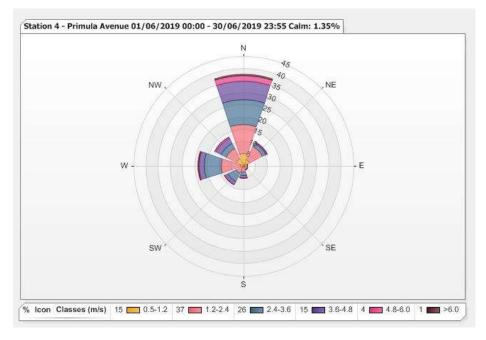
A wind rose (1 hour average) for Station 4 (Primula Avenue AAQMS) is presented in Figure 19.

Figure 19: Wind speed (1 hour average) Station 4 - Primula Avenue

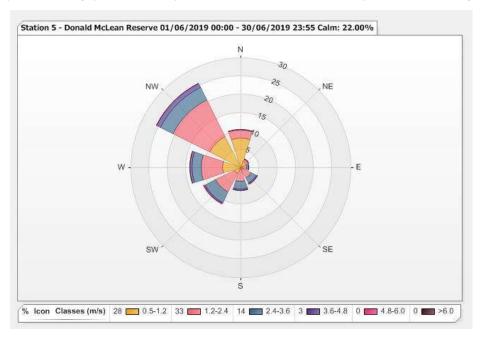
A wind rose (1 hour average) for Station 5 (Donald McLean Reserve AAQMS) is presented in Figure 20.

Figure 20: Wind speed (1 hour average) Station 5 - Donald McLean Reserve
